### PROPERTY CONDITION ASSESSMENT

**511 Forest Lodge Road, Pacific Grove, CA 93950**

**PROJECT 26007.60  
March 26, 2026**

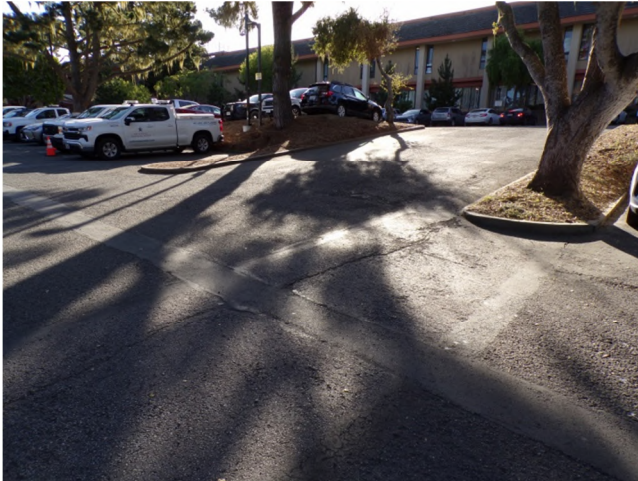
13. Degraded condition of asphalt paving—past repairs and general surface degradation shown.

- Allowance to provide general landscape upgrades, including stump grinding;
- Perform full depth and minor repairs to address degraded surface condition of asphalt paving to return it to “Good” condition;
- Reseal asphalt-paved parking lot and drive aisles;
- Restripe standard (non-Accessible) parking stalls;
- Allowance to provide remedial measures for problematic drain inlet;
- Provide new TPO roofing system on horizontal portion of flat roof HVAC equipment well;
- Provide new TPO membrane on vertical portion of flat roof HVAC equipment well on parapets;
- To promote better roof drainage, provide additional tapered insulation. This work should be performed in conjunction with the installation of the above TPO roofing systems;

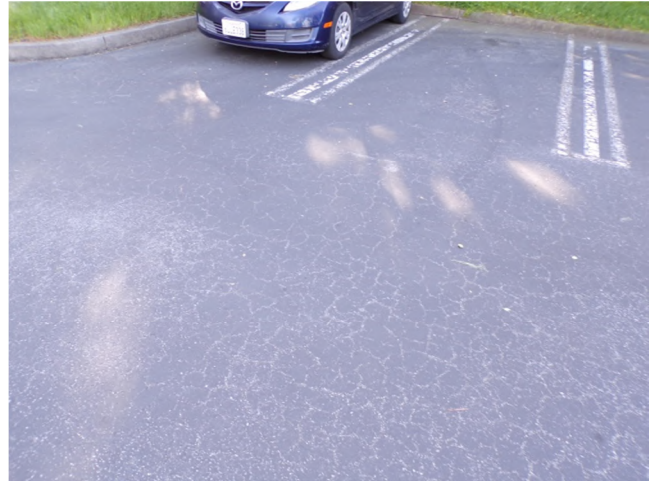
14. Degraded condition of asphalt paving—alligator cracking shown.

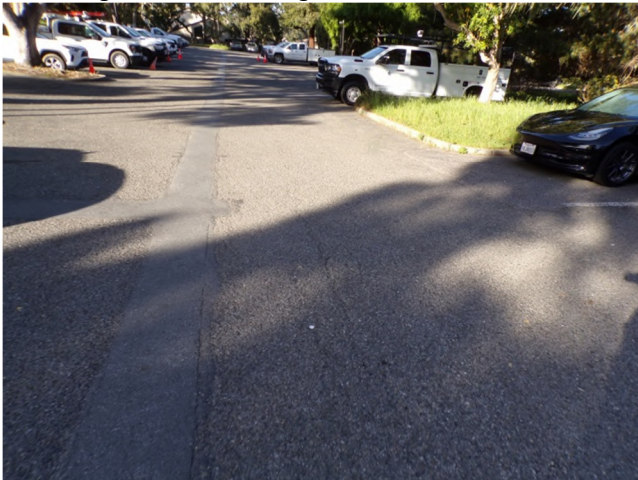
15. Degraded condition of asphalt paving—past repairs shown.

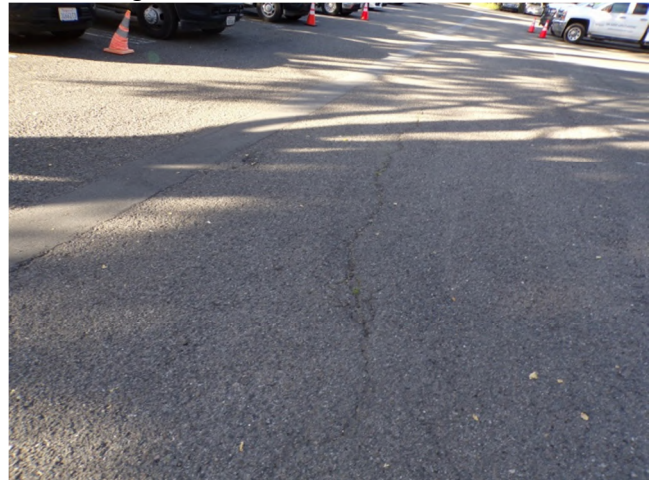
16. Degraded condition of asphalt paving—meandering cracking shown.

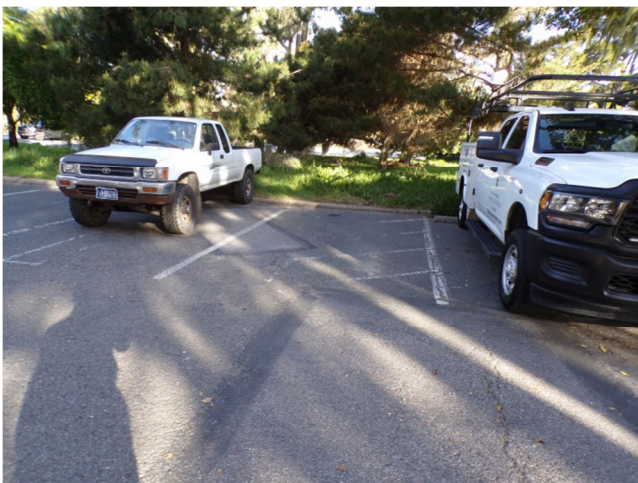
17. Restriping of all parking stalls will be required during the reserve term in conjunction with asphalt repairs.

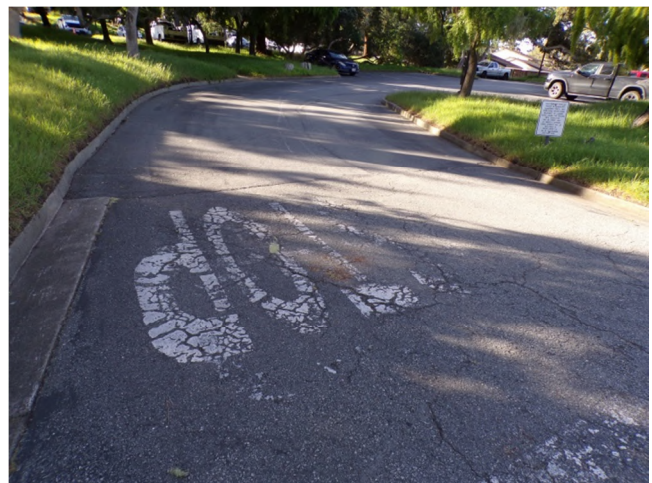
18. Degraded condition of asphalt paving—general surface and pavement marking degradation shown.

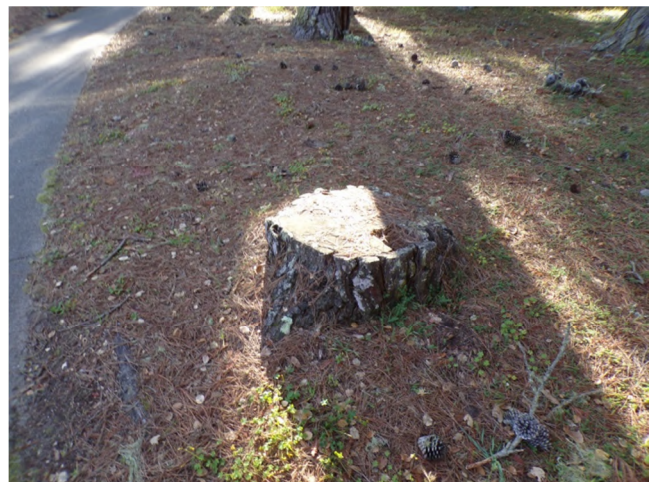
24. Numerous tree stumps are present.

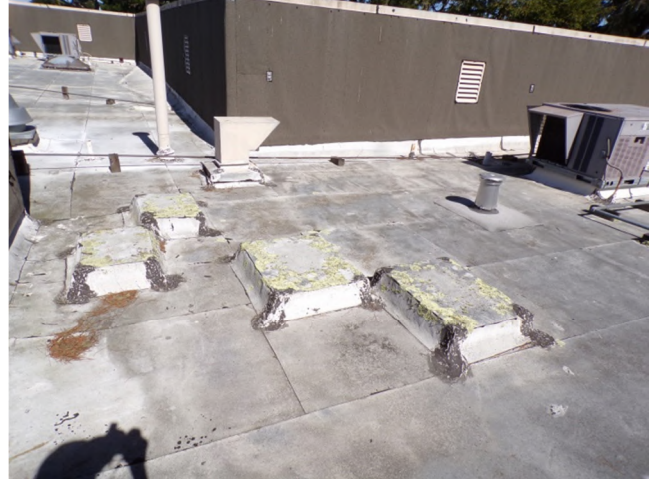
26. Both wings: The BUR system is in a generally run-down condition. East wing shown.

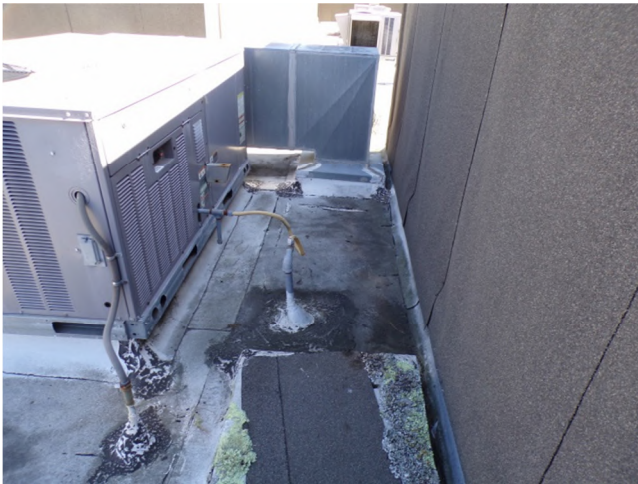
27. Both wings: The BUR system is in a generally run-down condition. East wing shown.

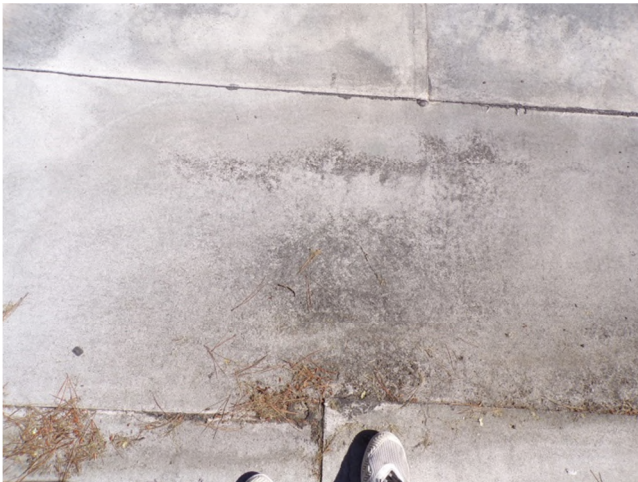
33. Both wings: Small accumulations of separated mineral granules were observed in several locations. West wing shown.

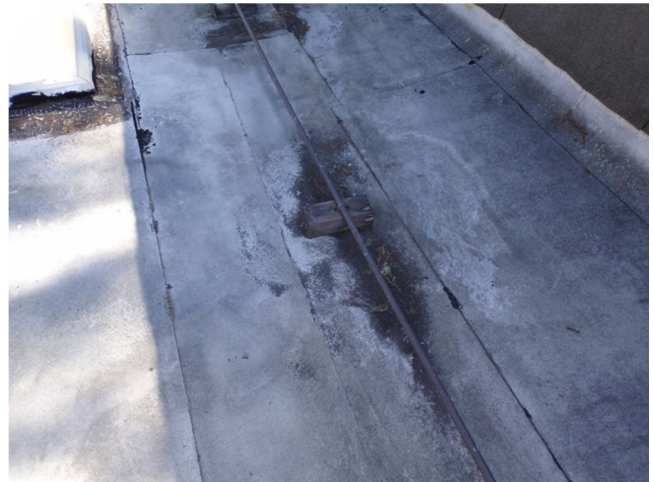
34. Both wings: Areas of past ponding are prevalent. East wing shown.

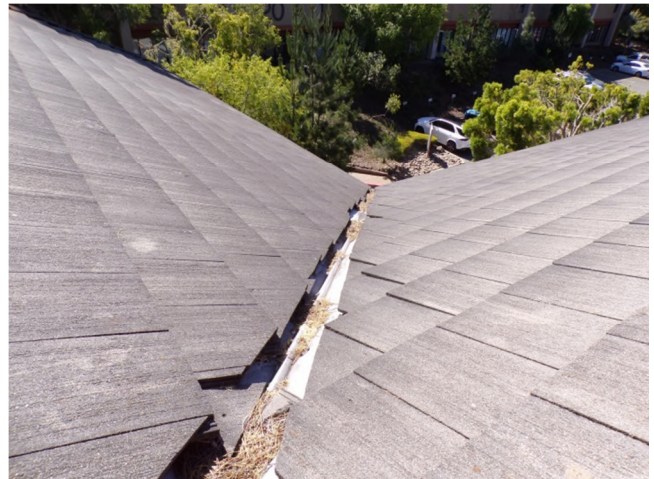
36. A concrete tile roofing system is installed on the pitched roofs. Broken tile in left foreground.

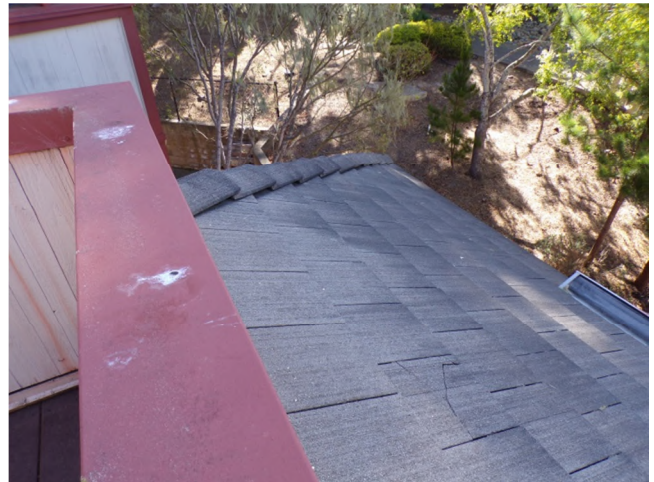
40. Cracked tiles on the pitched roofs were observed in various locations. Broken tile shown at right-center in foreground.

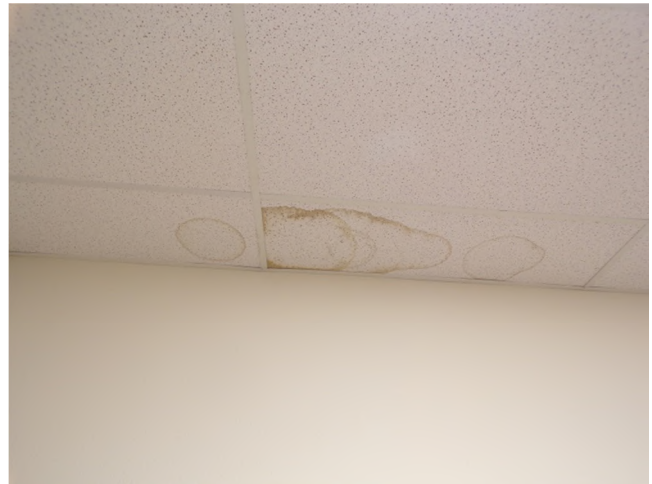
52. A small number of water stained ceiling tiles was observed in the second floor office areas we accessed.

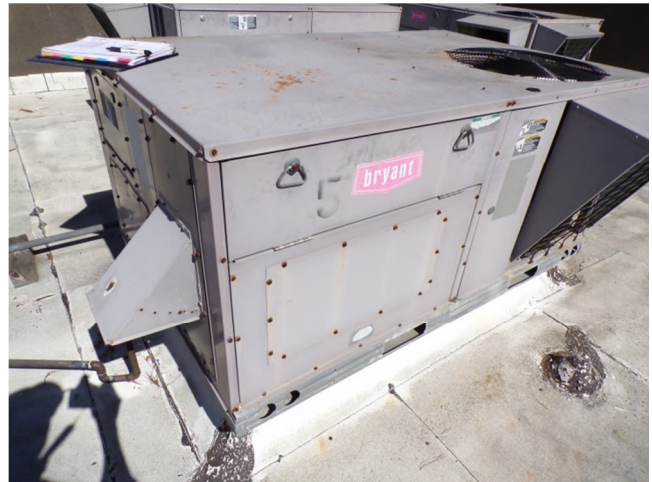
64. The provided cooling capacities (43 tons) appears inadequate for current tenant needs. AC 5 shown.

- Replace existing packaged unit HVAC equipment; provide 55 tons of cooling capacity for cost estimating purposes;
- Perform infrared scanning of electrical distribution systems;

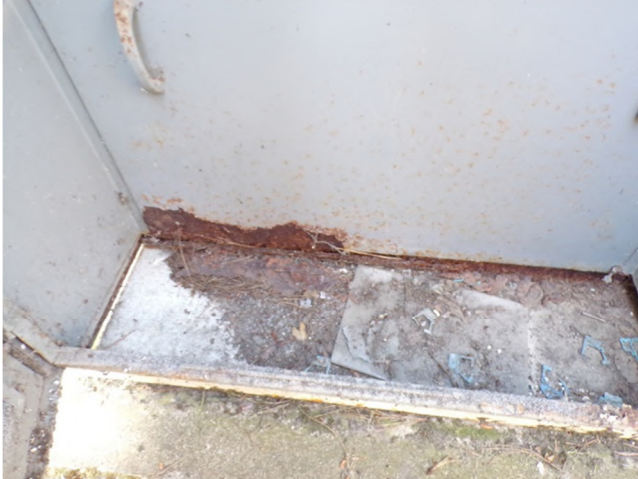
67. Rust-through at bottom of main disconnect enclosure.

- Allowance to perform concrete grinding to eliminate smaller tripping hazards;
- Allowance to provide sidewalk concrete panel replacement to eliminate more egregious tripping hazards;
- Conduct a video sewer line inspection;
- Replace 1,200 amp main electrical service entrance equipment.

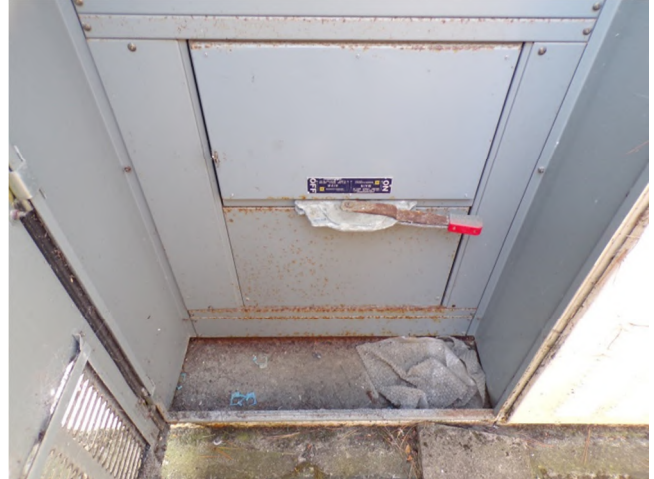
68. Rust was observed in all exterior electrical enclosures.

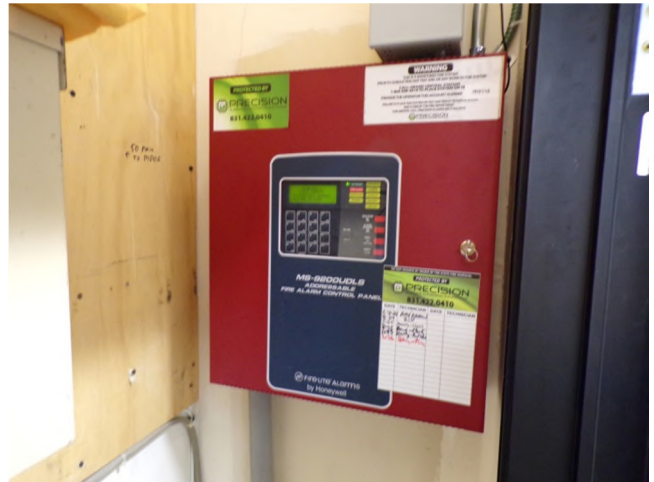
76. The FACP is no longer made and supported by the manufacturer.

- Install an automatic seismic shutoff valve on the gas service line at the meters;
- Allowance to replace obsolete fire alarm control panel;
- Restripe all four Accessible parking stalls and their Access aisles;

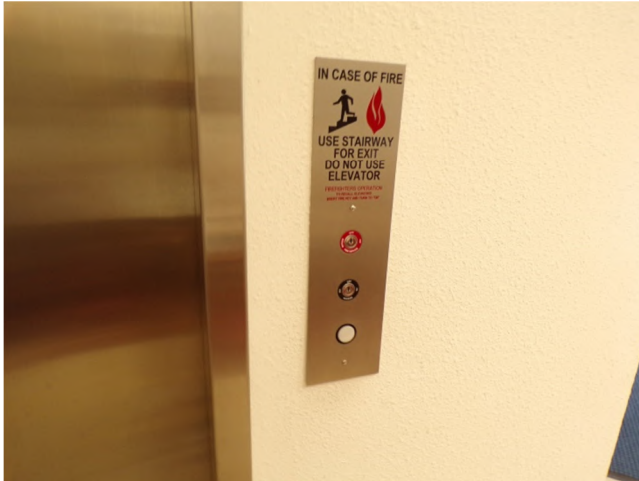
79. Required jamb-mounted floor designation signage is absent on both floors at elevator doors.

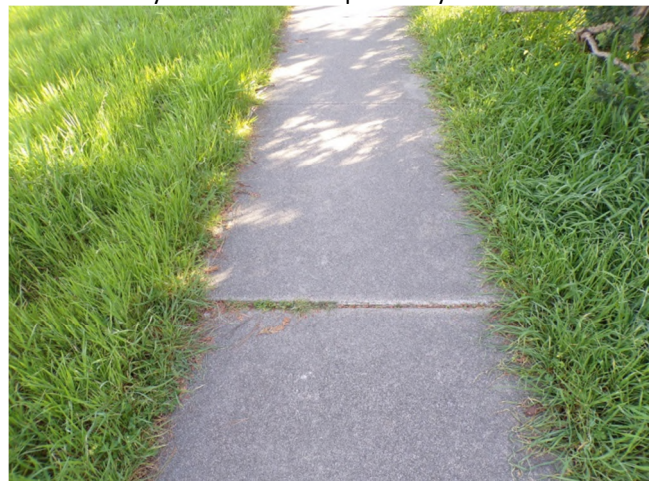
90. Changes in elevation in excess of ¼ inch in concrete panels create tripping hazards.

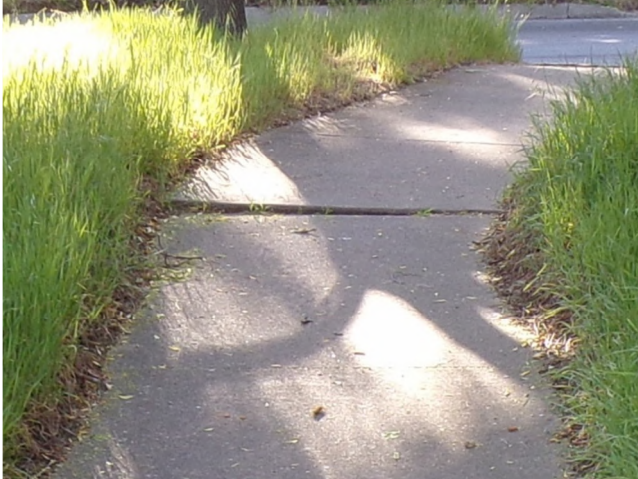
91. More egregious tripping hazards are also present.

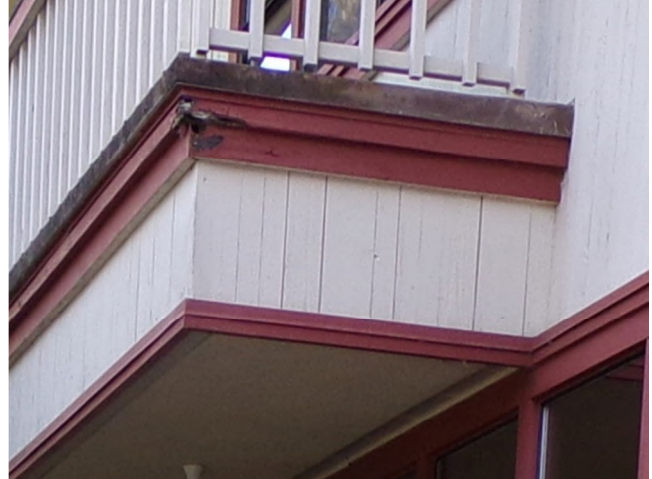
92. Rotten wood was observed in several exterior locations.

- Provide complete exterior repainting of all exterior elements with a paint finish;
- Allowance to replace rotten exterior wood;
- Annual contingency allowance for window seal repair/replacement;

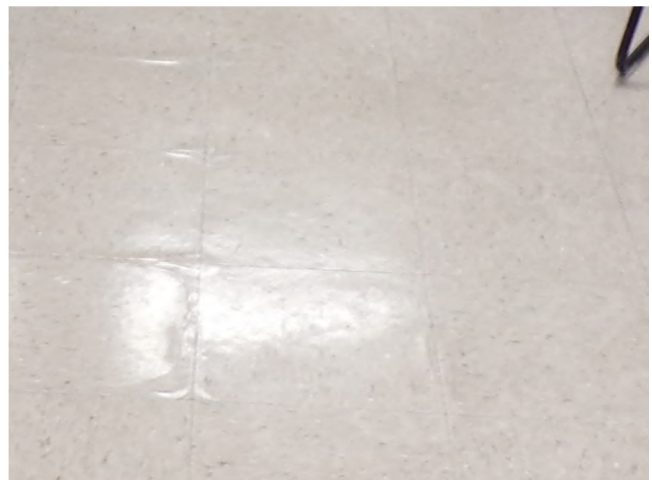
96. Edge puckering of VCT was observed.

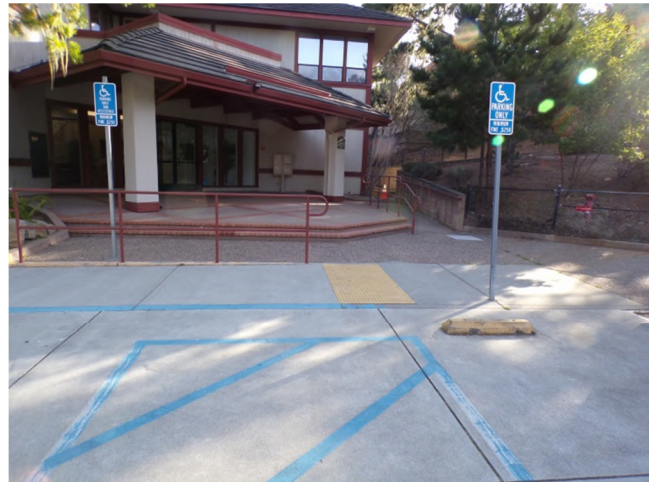
100. Truncated domes are located in only one required location near the Accessible parking stalls.
