## PROPERTY CONDITION ASSESSMENT

345 Middlefield Road, Bldg 15, Menlo Park, CA 94025

ALLWEST PROJECT 25097.60  
June 30, 2025

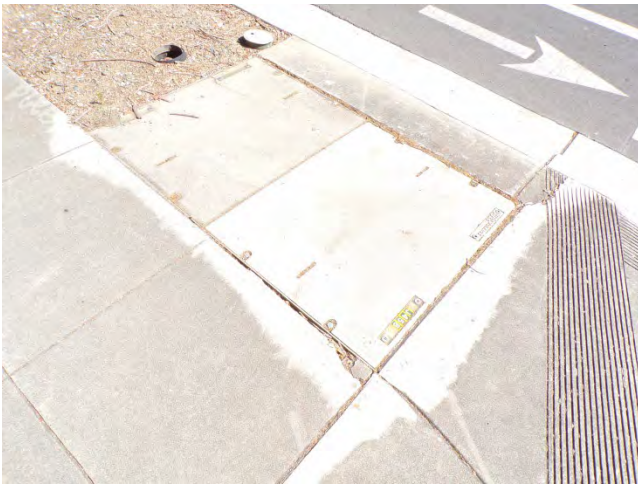
Current tripping hazards in sidewalks and walkways—these typically occur where concrete panels have a change in elevation greater than 1/4 inch—were observed in a small number of locations, and evidence of past concrete grinding to eliminate these hazards was also observed in a few locations. It can be anticipated that future concrete grinding will be required over the five-year reserve term to address tripping hazards that develop and those that are currently present; this work is a matter of routine maintenance and a cost estimate is not included in the spreadsheet.

9. Evidence of past concrete grinding was observed.

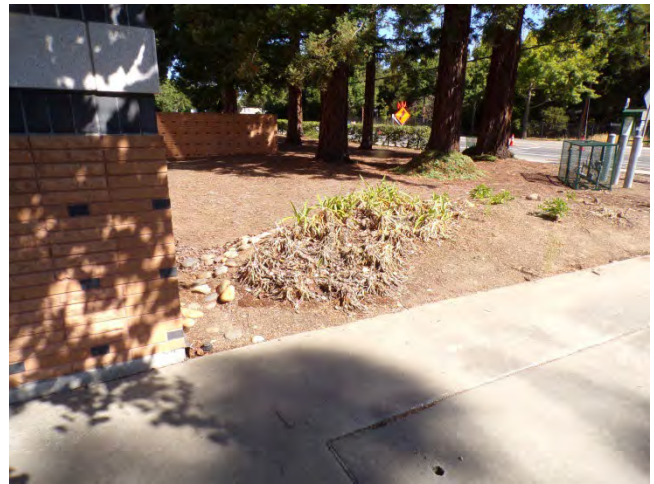
Landscaping with a sub-surface irrigation system is provided. Mature trees, shrubs, ground cover, flowering plants, and a small grass lawn are provided around Bldg 15. Large areas along the north, south, and west elevations do not have plantings, and the landscape plans indicate that they were intended to be covered in oak leaf mulch. Landscaping is also provided in a raised planter on the second floor level along the walkway leading to the building entrance at the east interstitial joint. Several plants adjacent to the subject building appeared in a degraded condition or dead. Replacement of degraded and dead plants is recommended.

10. Plants in a degraded condition were observed in several locations.

| No | Sec | Photos | ITEM | Avg EUL (yr) | EFF AGE (yr) | RUL (yr) | Quantity | Unit | Cost Estimate Source | Unit Cost |
|---|---|---|---|---|---|---|---|---|---|---|
| 1 | B.01 | 10, 11 | Return degraded landscape elements to "Good" condition. | N/A | N/A | N/A | 1 | LS | Allowance | \$20,000.00 |

An allowance to replace degraded landscape elements is included in the Immediate Needs and Replacement Reserves Analysis spreadsheet.

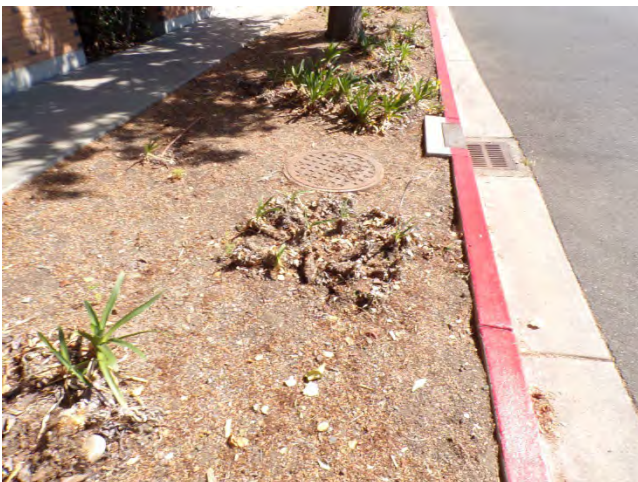
11. Plants in a degraded condition were observed in several locations.

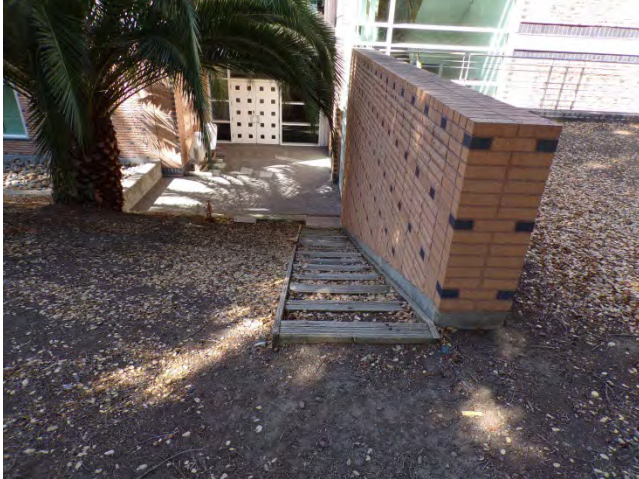
13. Two sets of timber stairs are located along the north elevation. The stairs are not compliant with current codes. Concrete/brick veneer retaining wall also shown.

| No | Sec | Photos | ITEM | Avg EUL (yr) | EFF AGE (yr) | RUL (yr) | Quantity | Unit | Cost Estimate Source | Unit Cost |
|---|---|---|---|---|---|---|---|---|---|---|
| 2 | B.07 | 13 | Replace two sets of timber stairs with fully code compliant stairs. | N/A | N/A | N/A | 1 | LS | Allowance | \$17,000.00 |

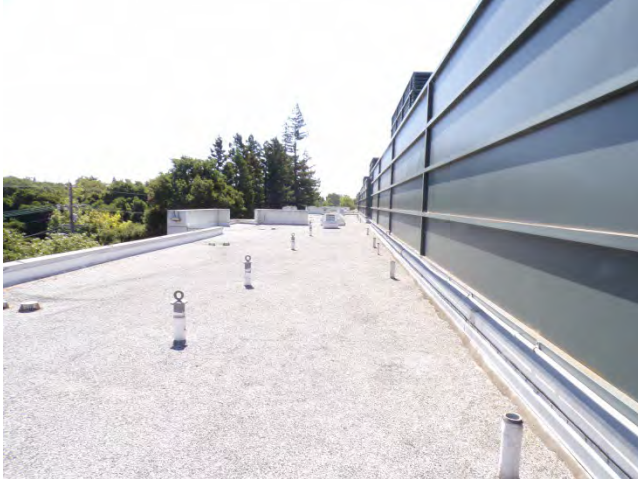
Building 365’s roofing systems appeared in “Good” to “Fair” condition. It appears a single-ply thermoplastic polyolefin (TPO) roofing system was installed time of original construction in 1995; the roofing membrane is covered with granite pea ballast. It appears that a modified bitumen roofing membrane was installed at the roof and overflow drain sump locations. However, ballast is not provided on the roof within the screen areas where mechanical equipment is located. No known, current leaks through the roofing system were reported. Owing to the roof’s 30-year age, replacement during the reserve term is recommended; the cost for this can be considered significant.

19. The roofing system dates to original construction in 1995.

- Replace two sets of timber stairs along north elevation with fully code compliant stairs;
- Provide new tear-off TPO roofing systems on main roof and three lower roofs;

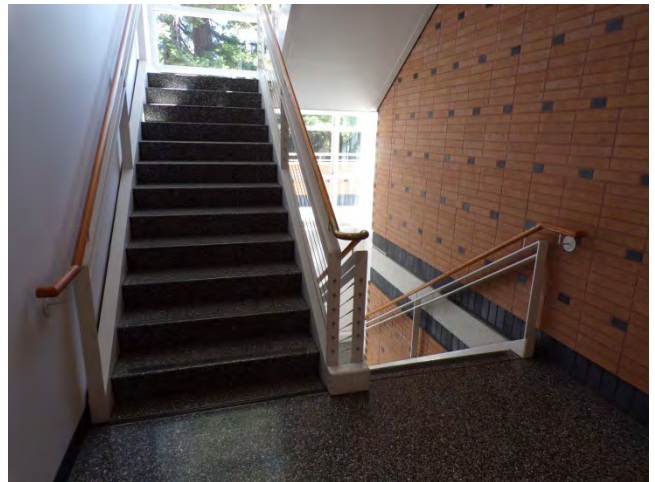
34. Interior finishes in stairwells. Railings are not compliant with current codes.

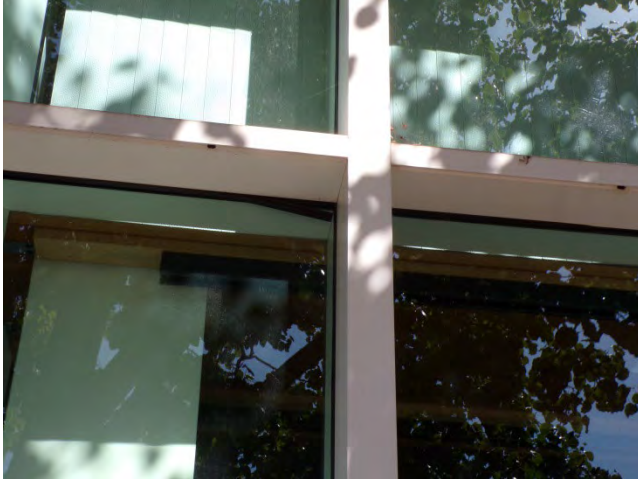
49. Drooping rubber window seal.

| No | Sec | Photos | ITEM | Avg EUL (yr) | EFF AGE (yr) | RUL (yr) | Quantity | Unit | Cost Estimate Source | Unit Cost |
|---|---|---|---|---|---|---|---|---|---|---|
| 5 | C.03 | 49, 50 | Contingency allowance for repairs and/or replacement of degraded window seals. | N/A | N/A | N/A | 1 | LS | Allowance | \$25,000.00 |

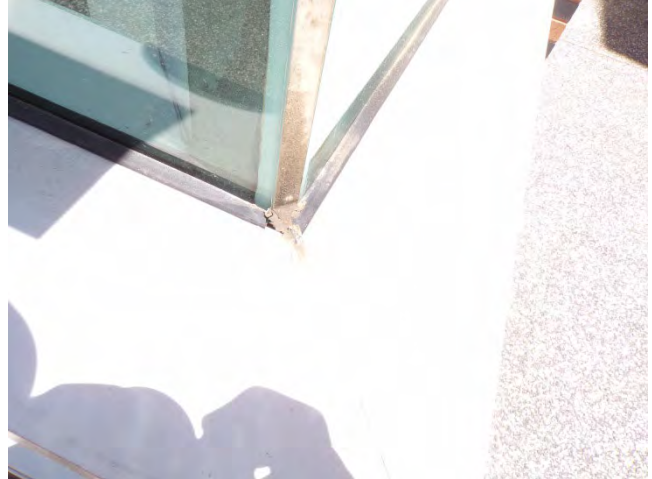
50. Shrunken rubber window seal with gap between seals shown.

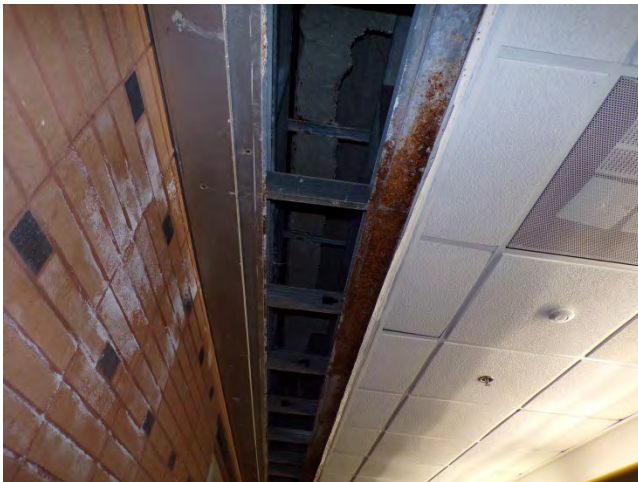
51. Water intrusion damage in first floor foyer near main mechanical room. Efflorescence also shown on brick wall.

| No | Sec | Photos | ITEM | Avg EUL (yr) | EFF AGE (yr) | RUL (yr) | Quantity | Unit | Cost Estimate Source | Unit Cost |
|---|---|---|---|---|---|---|---|---|---|---|
| 7 | E. | 51, 52 | Allowance to repair leak and to restore interior finishes to "Good" condition at area of water intrusion in the first floor foyer near main mechanical room. | N/A | N/A | N/A | 1 | LS | Allowance | \$8,500.00 |

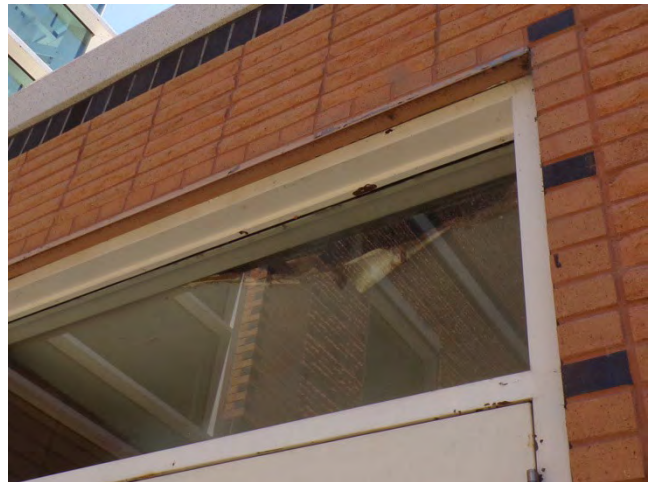
52. Water intrusion damage in first floor foyer near main mechanical room, as seen from exterior.

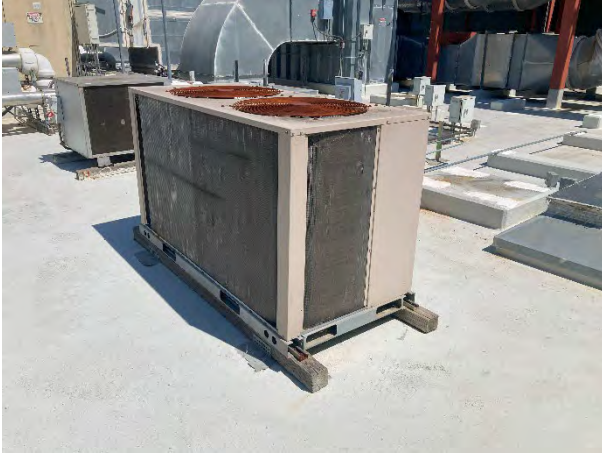
M-7. Supplemental packaged air conditioner.

| No | Sec | Photos | ITEM | Avg EUL (yr) | EFF AGE (yr) | RUL (yr) | Quantity | Unit | Cost Estimate Source | Unit Cost |
|---|---|---|---|---|---|---|---|---|---|---|
| 10 | F.02 | M-7 | Replace 10 ton packaged air conditioner, based upon EUL and existing condition. | 20 | 22 | 0 | 1 | EA | Estimate | \$30,000.00 |
