## PROPERTY CONDITION ASSESSMENT

2030 Harrison Street, San Francisco, CA 94110

PROJECT 26008.61  
May 1, 2026

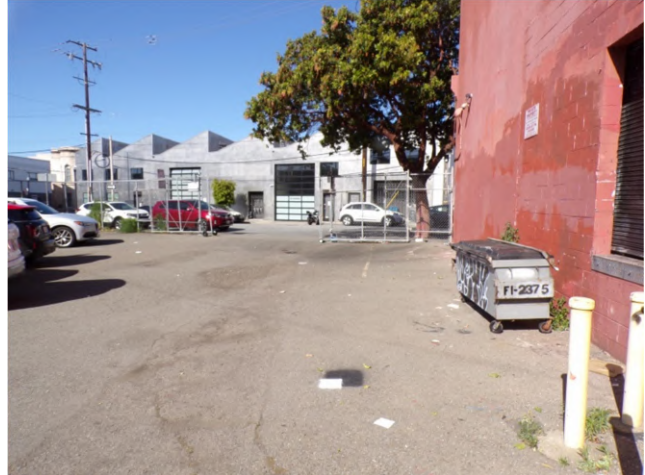
8. The asphalt-paved parking lot is in a generally run-down condition with cracking and surface degradation prevalent.

We recommend that minor and full-depth asphalt repairs be undertaken in conjunction with resealing the asphalt surface to return the asphalt paving to Good condition; we further recommend that the parking stalls be restriped. The costs for this work are included in the Spreadsheet.

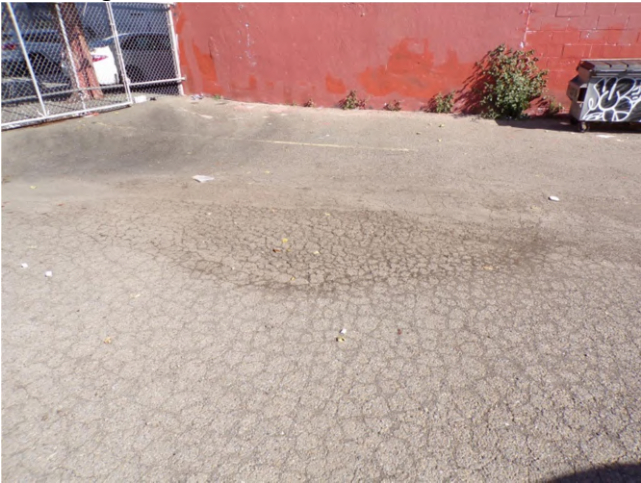
9. Alligator cracking and a depression in asphalt paving.

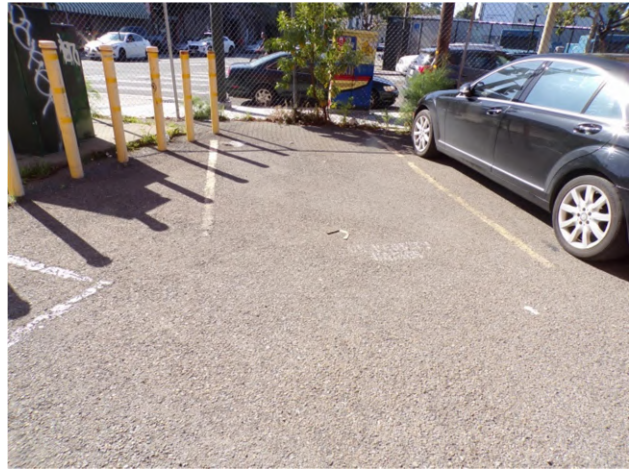
10. The parking stall pavement markings are in a degraded condition.

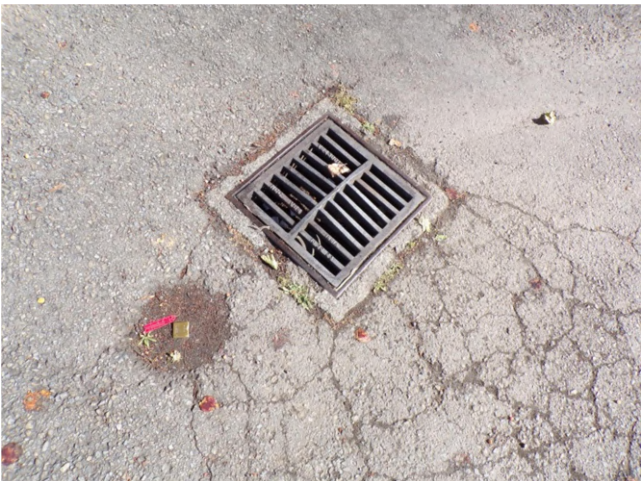
11. One grated drain inlet is provided in the parking lot. Degraded condition of asphalt paving also shown.

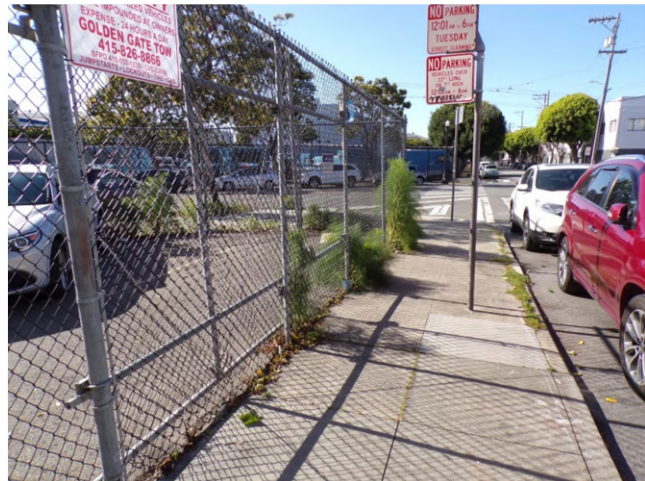
12. The chain-link fencing has an overall run-down appearance. Rust was observed on fencing.

Fencing: Good to Fair with the bias toward Fair. Galvanized chain-link fencing is provided around the parking area at the south end of the site. A manually operated rolling vehicular gate is installed on the west side of the parking area to regulate vehicular ingress/egress. A gate for pedestrian use is located in the east portion of the fence. The fencing and gates have an overall run-down appearance with rust observed in places; we recommend fence and gate replacement as an optional Modernization item in the Spreadsheet.

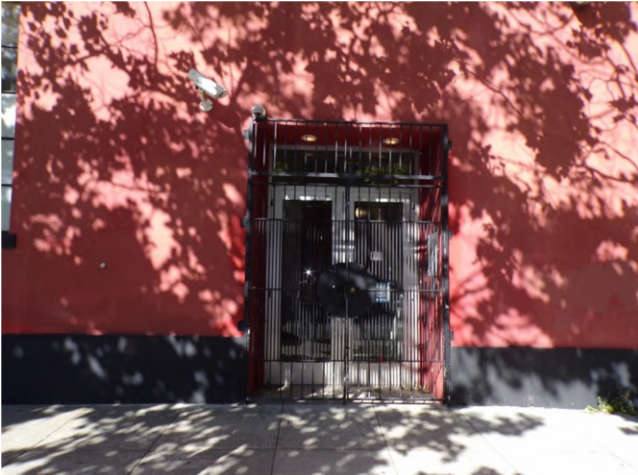
13. The secondary pedestrian entrance on the east elevation serves as an Accessible entrance. ISA signage is not provided at this entrance.

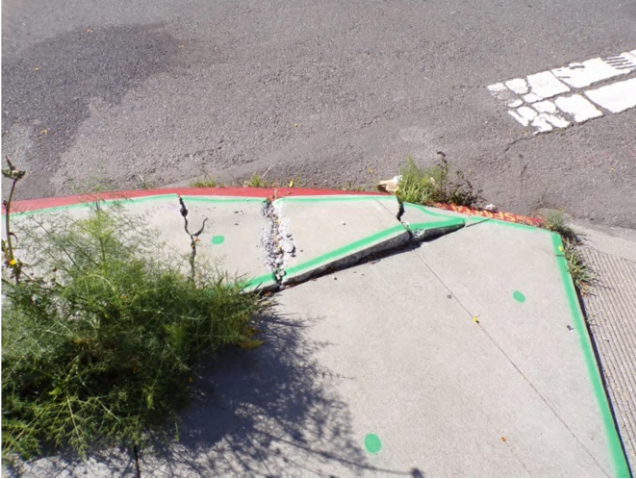
Tripping Hazards: Numerous changes of elevation in sidewalk panels in excess of ¼" were observed; these present tripping hazards.

19. Tripping hazards were observed in several locations. Green paint denotes the tripping hazards. Southwest corner of site shown.

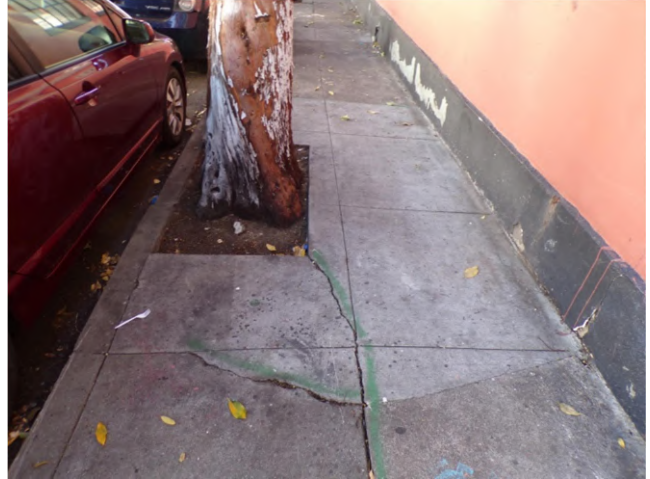
20. Tripping hazards were observed in several locations. Sidewalk along west elevation shown.

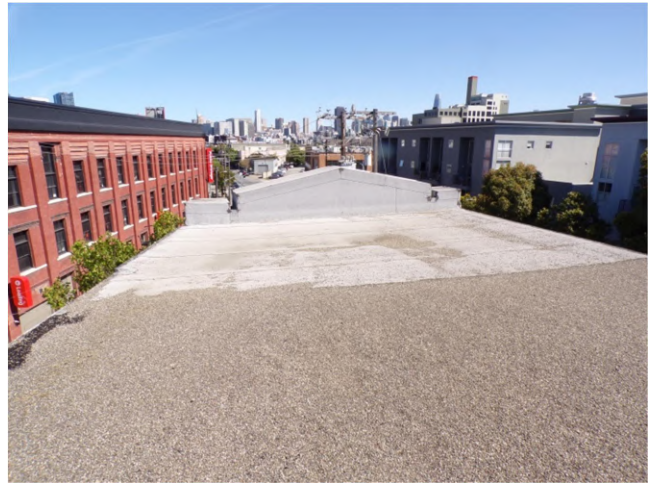
22. Main roof: At the far north end of the building, the pea gravel is not provided.

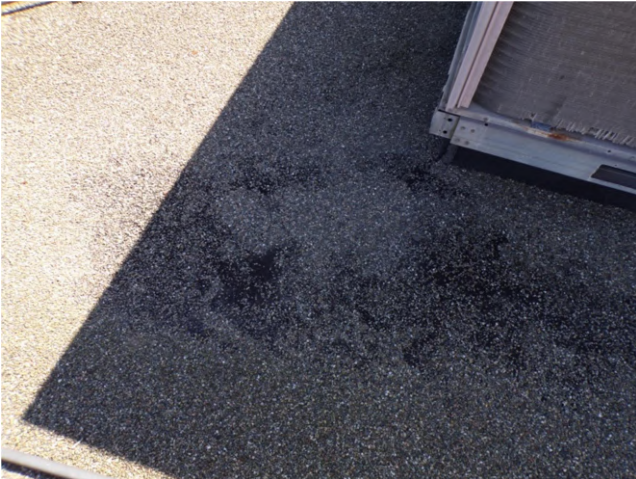
25. Main roof: The age of the roofing system is unknown; replacement is recommended.

recommend that new, tear-off roofing systems be provided on all roof areas during the reserve term.

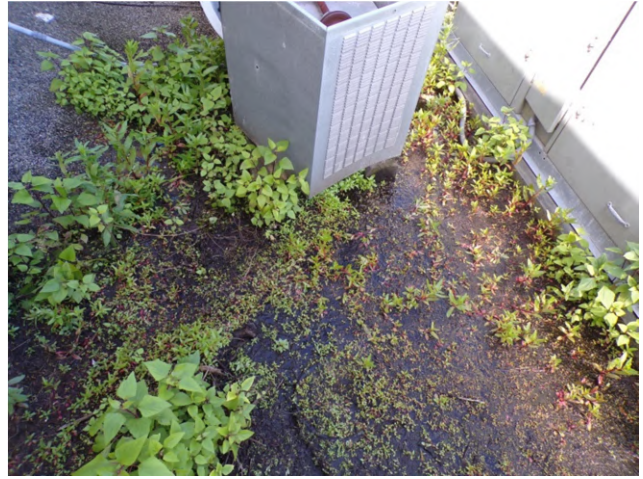
An area of longstanding ponded water was observed near the ventilation equipment at the foot of the north elevation of the fourth floor. There is no roof drain in the immediate vicinity of the ponded water and the make-up air (MUA) unit and the exhaust fan/duct complex serve as dams preventing water from flowing freely to the single roof drain on the main portion of the roof.

26. Main roof: An area of longstanding ponded water is present.

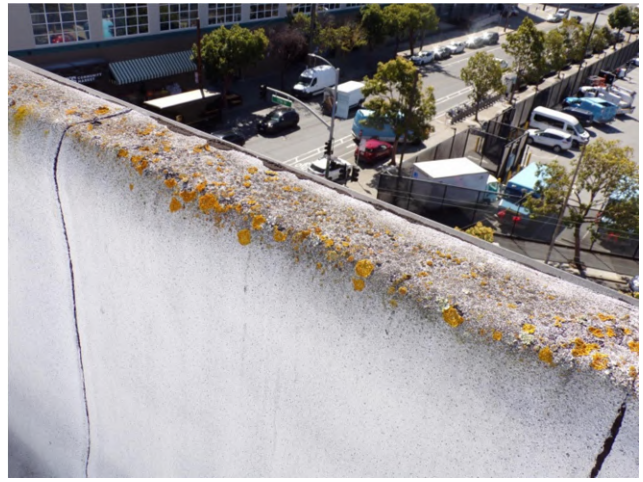
28. Fourth floor roof: The age of the roofing system is unknown; replacement is recommended.

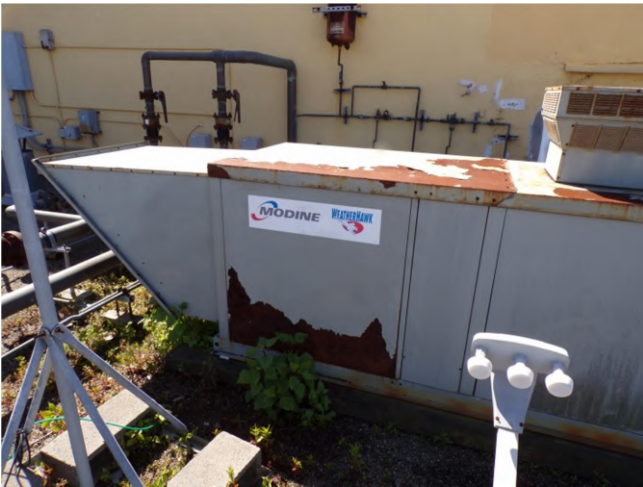
39. The age of the Modine make-up air unit is unknown. Replacement is recommended.

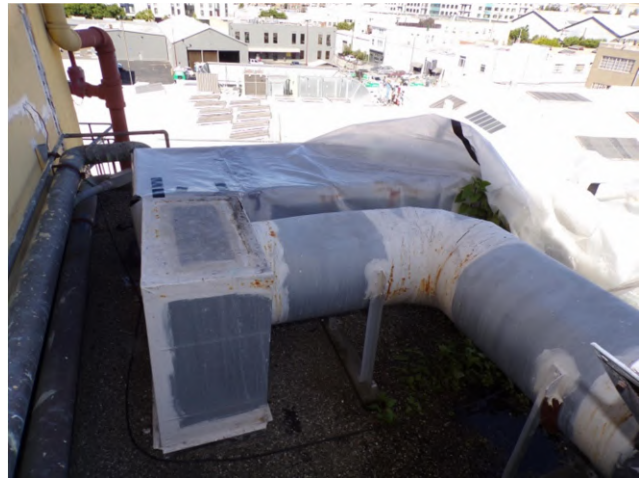
40. The age of the ventilation fan complex is unknown. Replacement is recommended.

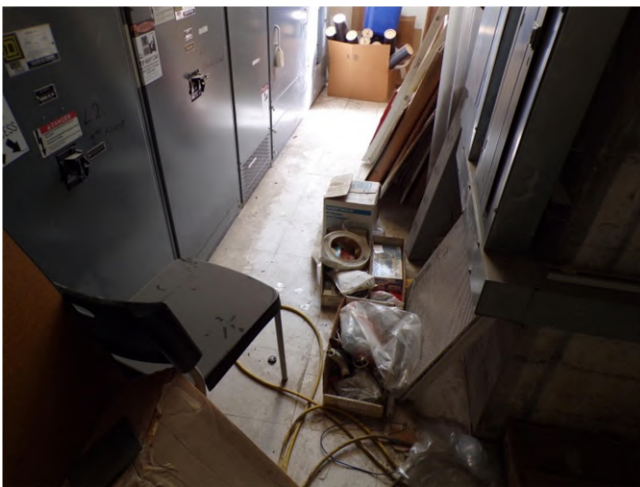
51. Items stored near or leaning on main electrical service equipment should be removed.

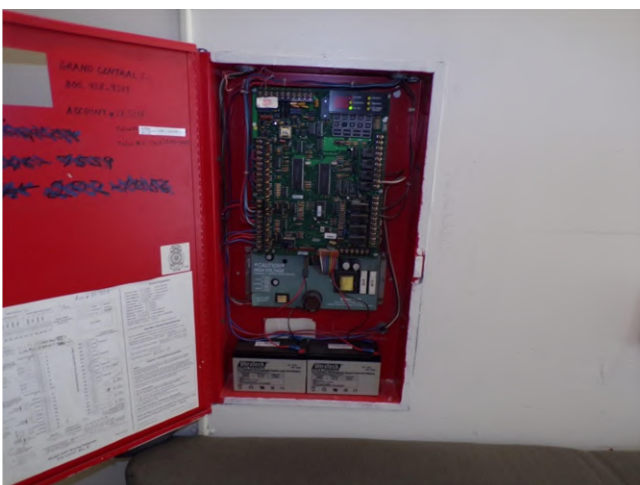
53. The FACP is a Silent Knight model 5207; it is out of production and obsolete.

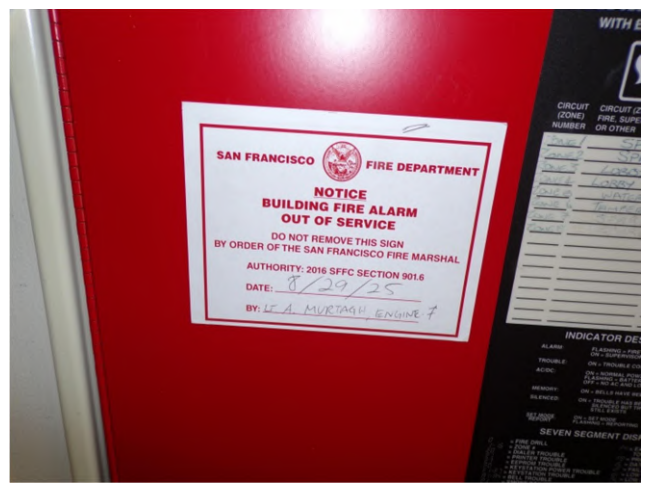
54. The fire alarm system is out of service owing to telephone line issues.

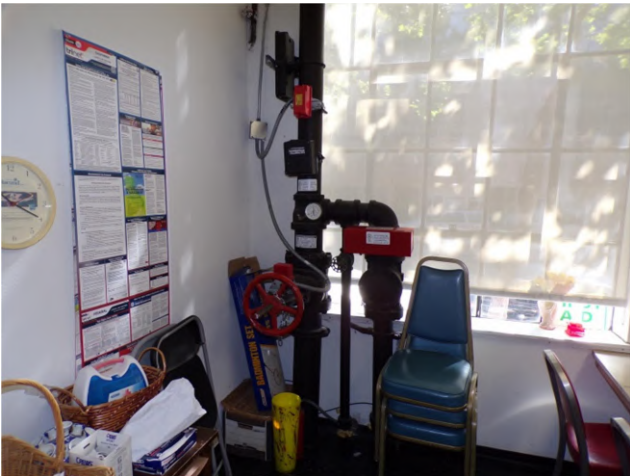
57. Five-year and annual NFPA fire sprinkler system inspections should be conducted, as required.

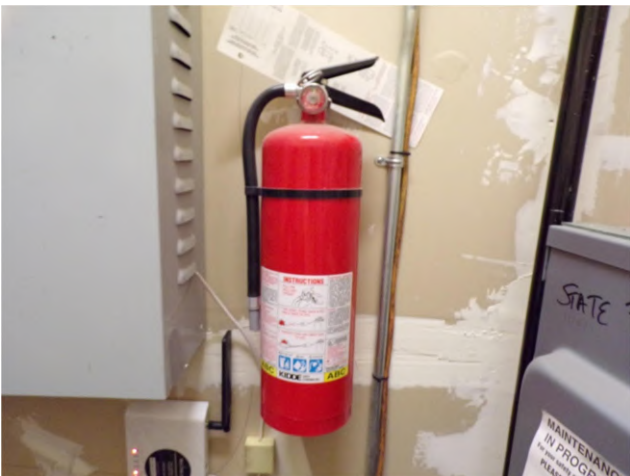
59. All observed fire extinguishers had expired tags or the tags were absent, as shown.

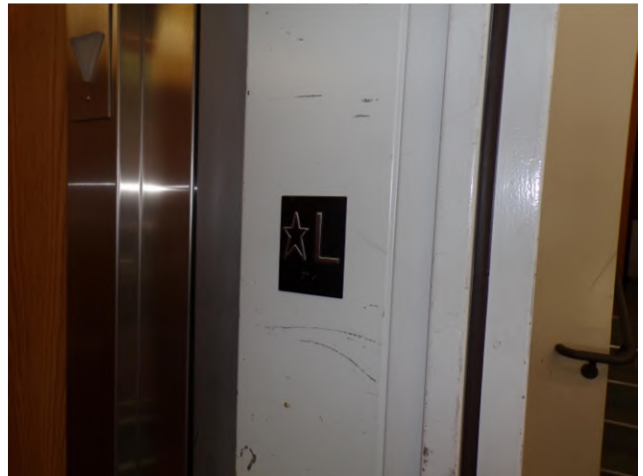
64. The installed door closure arrestors require physical contact. Replacement is recommended.

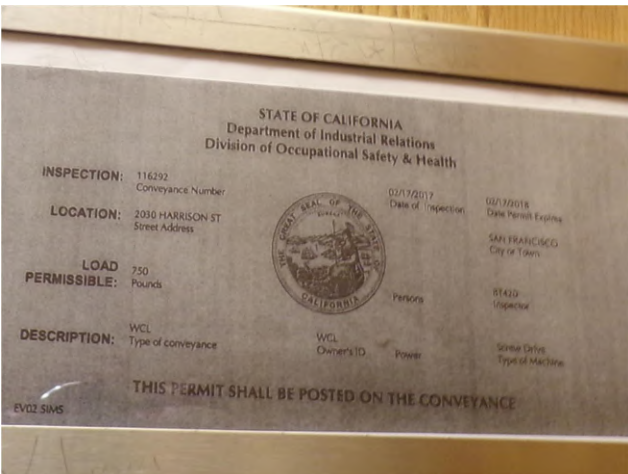
65. The permit on display in the elevator cab expired on February 17, 2018. We assume this is actually the permit for the wheelchair lift.

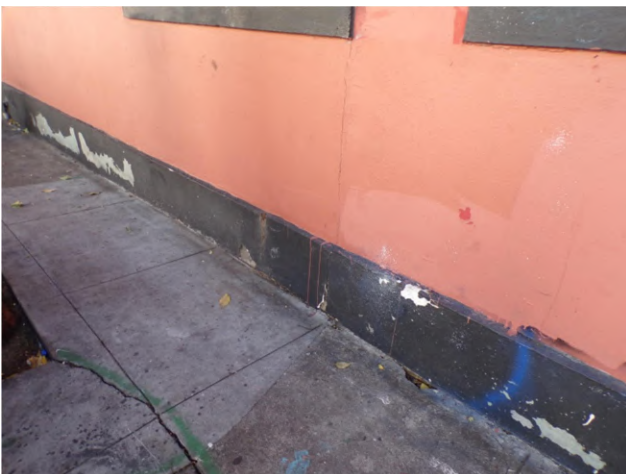
Cracking: Numerous cracks in the perimeter concrete walls were observed. Our observations of the cracks during our site visit were not exhaustive. Concrete cracks as part of its aging process, and the cracks are likely typically minor though they are unsightly. We recommend that, in conjunction with the general exterior repainting recommended below, patch repairs of the concrete cracks should be performed.

95. Concrete cracks and degraded condition of exterior paint finishes.

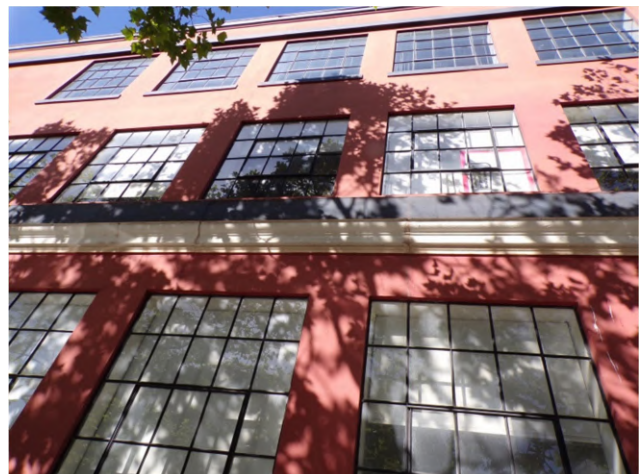
96. Concrete cracks and degraded condition of exterior paint finishes.

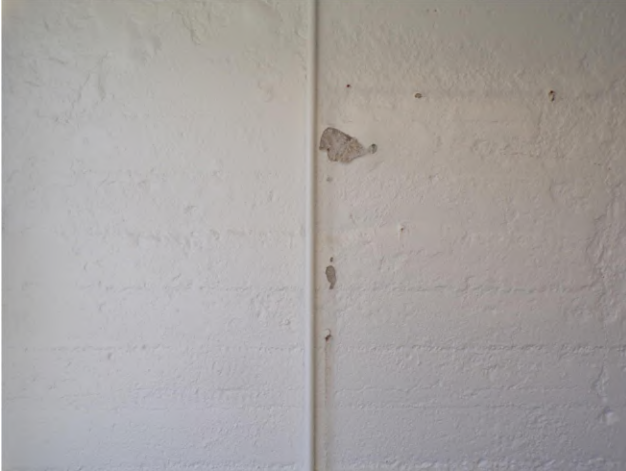
We observed one area in the interior on the third floor on the south perimeter wall where water penetration through the concrete wall has occurred. We were shown some windows along the east elevation on the second floor where known water penetration through the windows has occurred.

97. On the fourth floor, there is interior side evidence of water penetration through the perimeter concrete walls. Treatment with Xypex is recommended.

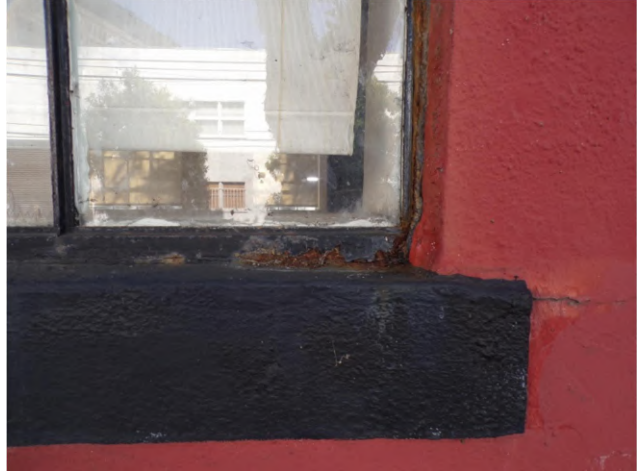
Exterior finishes and windows and doors appeared in Fair to Poor condition with the bias towards Poor. The perimeter cast-in-place concrete walls have a concrete stucco finish and are painted red with black and cream as accent colors. The steel window frames are painted black; rust is prevalent. In some instances, the rust is egregious and window frame restoration and/or replacement is recommended.

98. Rust is prevalent on the steel window frames.

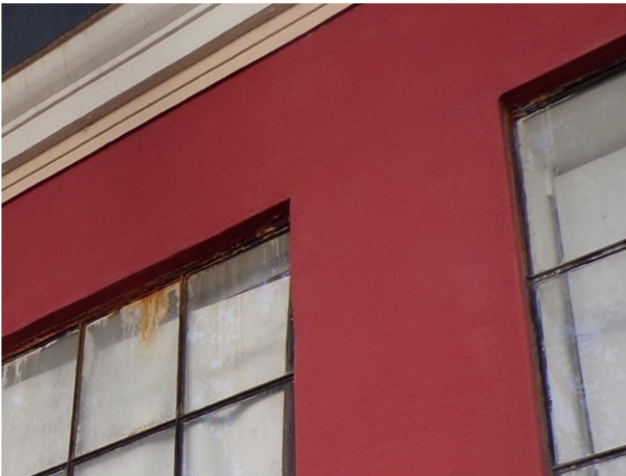
99. Rust is prevalent on the steel window frames.

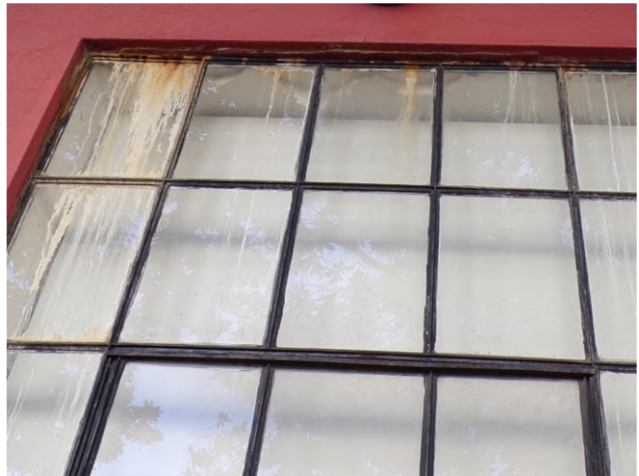
100. We recommend that the steel window frames be restored.

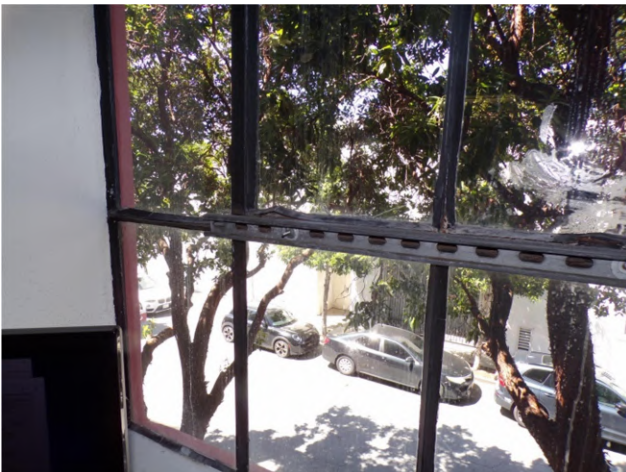
101. On the second floor, there is interior side evidence of water penetration through the windows. Buckled glazing compound shown.

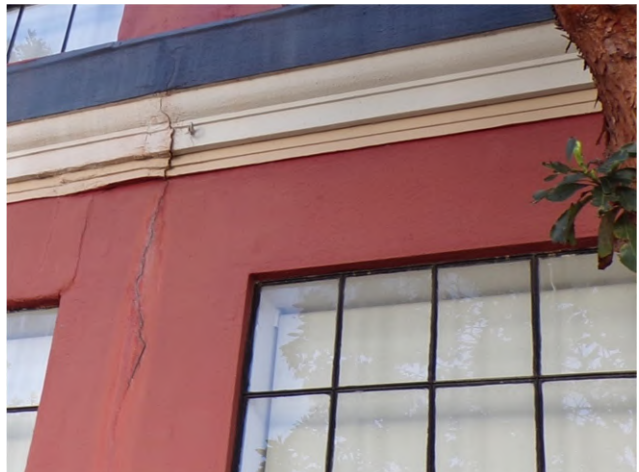
102. Degraded condition of exterior finishes with cracks shown.

We recommend complete rehabilitation of the exterior finishes on the perimeter walls, doors, and, as noted above, windows.

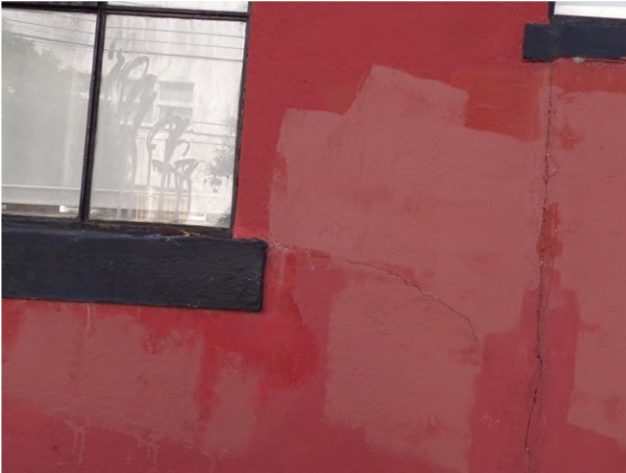
103. Degraded condition of exterior finishes with cracks shown.

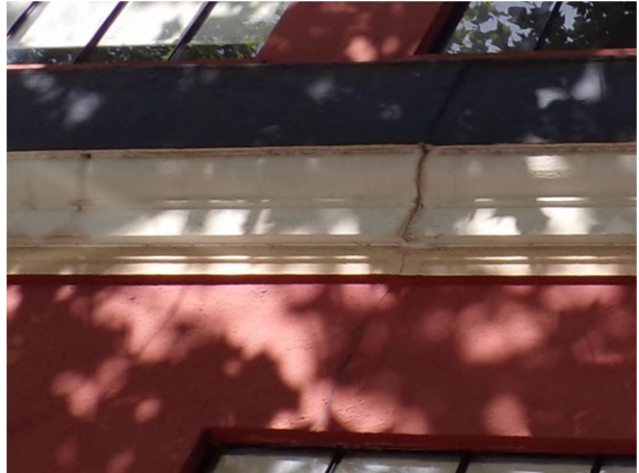
104. Degraded condition of exterior finishes with cracks shown.

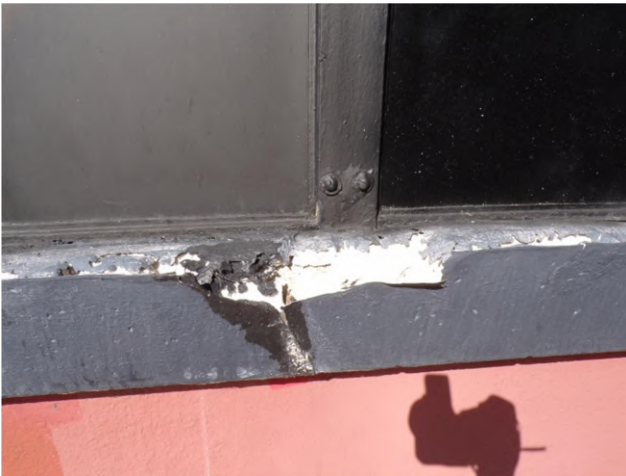
105. Degraded condition of exterior finishes with degraded paint and spalled concrete ledge shown.

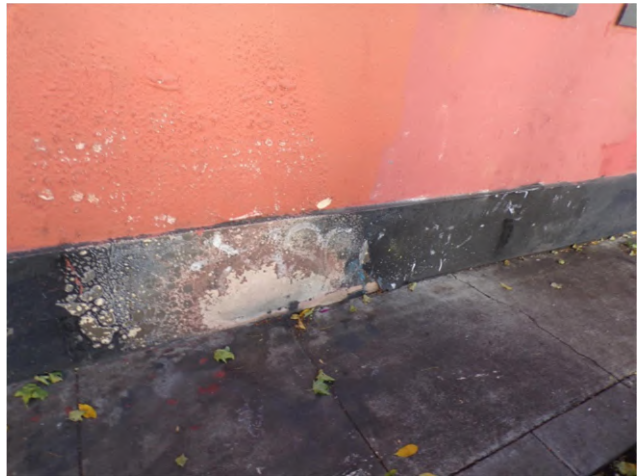
106. Degraded condition of exterior finishes with degraded paint shown.

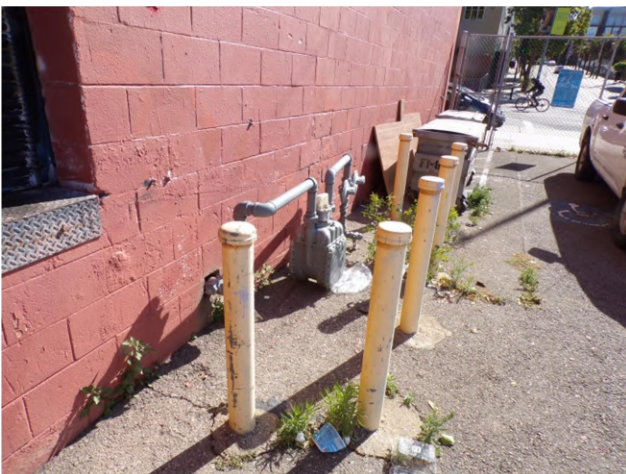
107. The gas service line is not fitted with an automatic seismic shutoff valve.

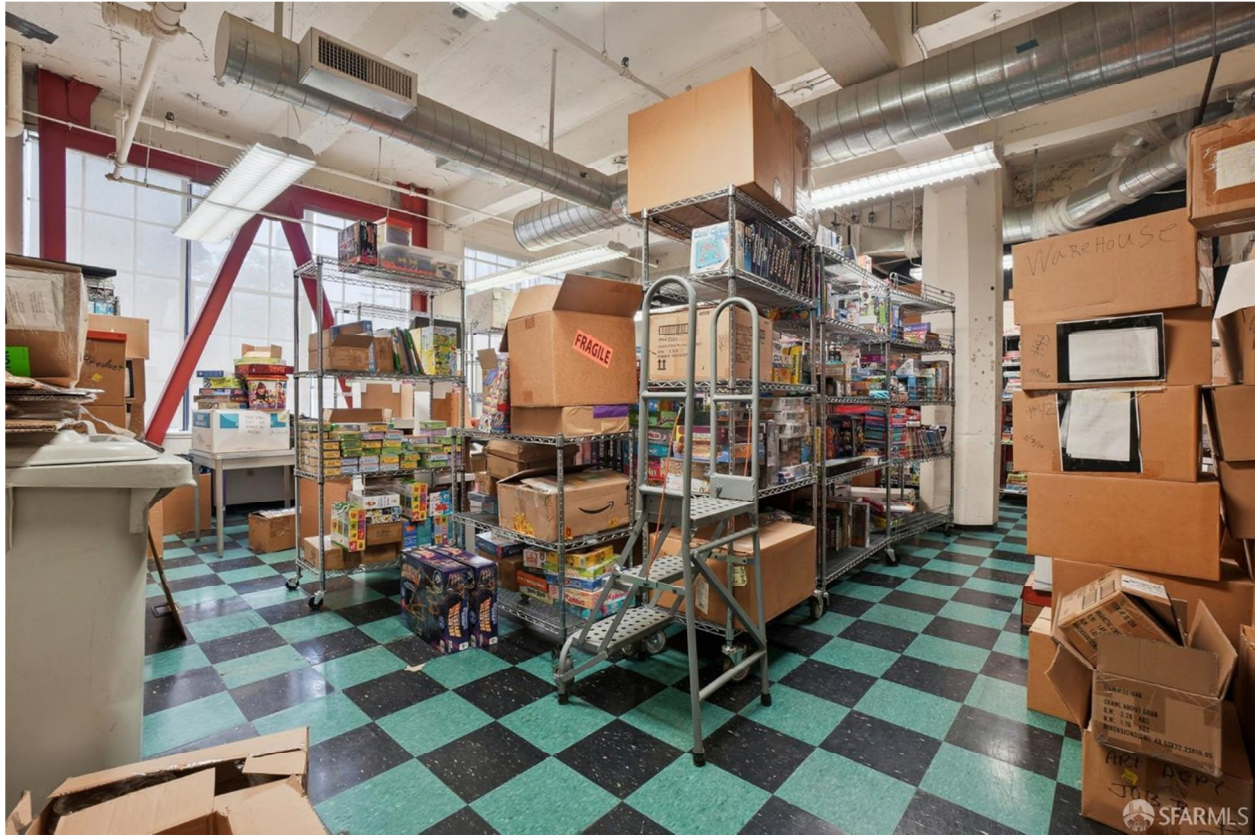
25. There is visible steel seismic bracing in the building (red-painted bracing near windows in photo below).

Do you know if the bracing dates to original construction? The bracing was reportedly installed in the late 1990s.
