# AllWest Environmental

## PROPERTY CONDITION ASSESSMENT

**5601 & 5733 San Leandro Street, Oakland, California 94621**

**ALLWEST PROJECT 22183.60  
February 10, 2023**

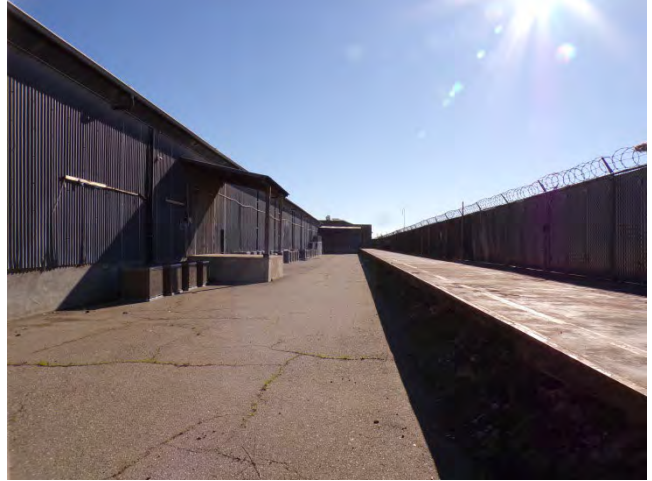
14. Bldg 5601W: Galvanized, ribbed steel wall panels are in an overall degraded condition. Raised concrete loading apron at right.

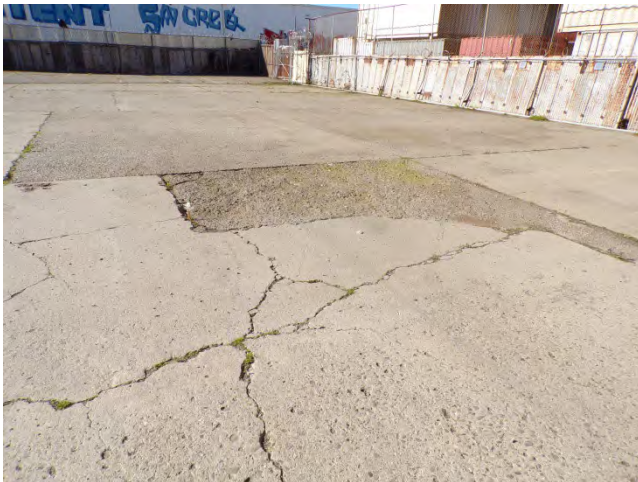
39. Bldg 5601W: Degraded condition of concrete parking area on north side of building.

| No | Sec | Photos | ITEM | Avg<br>EUL<br>(yr) | EFF<br>AGE<br>(yr) | RUL<br>(yr) | Quantity | Unit | Cost<br>Estimate<br>Source | Unit<br>Cost | Immediate Needs | Replacement Reserves | | | | | Years<br>1-5 Cumulative | Modernization<br>Costs (Optional) |
|---|---|---|---|---|---|---|---|---|---|---|---|---|---|---|---|---|---|---|
| 3 | B.02 | 39-41, 43-47 | Replace degraded concrete to return concrete site work to overall "Good" condition. | N/A | N/A | N/A | 32,000 | SF | Means | \$8.00 | | | | | | | | |

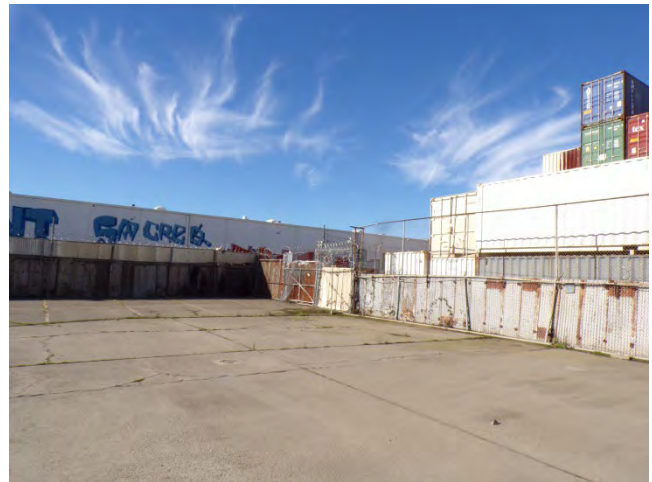
40. Bldg 5601W: Concrete parking area on north side of building. Site fencing is in an overall run-down condition in this portion of the property.

| No | Sec | Photos | ITEM | Avg<br>EUL<br>(yr) | EFF<br>AGE<br>(yr) | RUL<br>(yr) | Quantity | Unit | Cost<br>Estimate<br>Source | Unit<br>Cost | Immediate Needs | Replacement Reserves | | | | | Years<br>1-5 Cumulative | Modernization<br>Costs (Optional) |
|---|---|---|---|---|---|---|---|---|---|---|---|---|---|---|---|---|---|---|
| 11 | B.05 | 39,40,124,125 | Provide remedial measures to return fencing and facings on the subject property to "Good" condition. | N/A | N/A | N/A | 1 | LS | Allowance | \$50,000.00 | | \$4,000 | | | | | \$4,000 | |

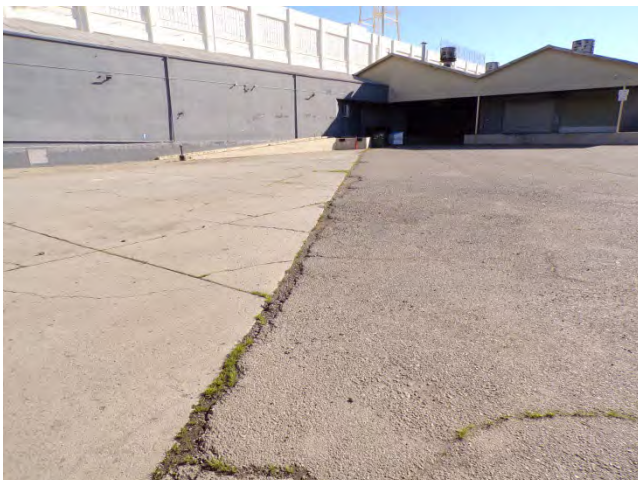
41. Bldg 5733W: Concrete paving at left; asphalt paving at right. Both types of paving are typically in a run-down condition throughout the property.

| No | Sec | Photos | ITEM | Avg<br>EUL<br>(yr) | EFF<br>AGE<br>(yr) | RUL<br>(yr) | Quantity | Unit | Cost<br>Estimate<br>Source | Unit<br>Cost | Immediate Needs | Replacement Reserves | | | | | Years<br>1-5 Cumulative | Modernization<br>Costs (Optional) |
|---|---|---|---|---|---|---|---|---|---|---|---|---|---|---|---|---|---|---|
| 4 | B.02 | 37,38,41,42,47-50 | Perform minor and full-depth repairs to address degraded surface condition of asphalt paving to return it to "Good" condition. | N/A | N/A | N/A | 1 | LS | Allowance | \$50,000.00 | | \$17,500 | | | | | \$17,500 | |

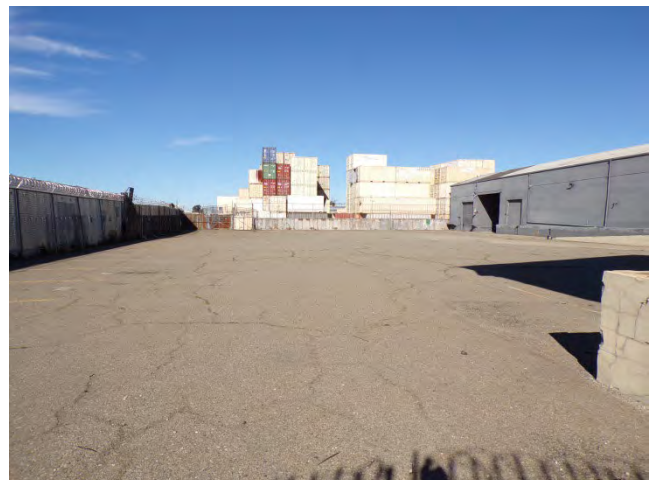
42. Bldg 5733W: Degraded asphalt paving requires repairs and resealing during the reserve term.

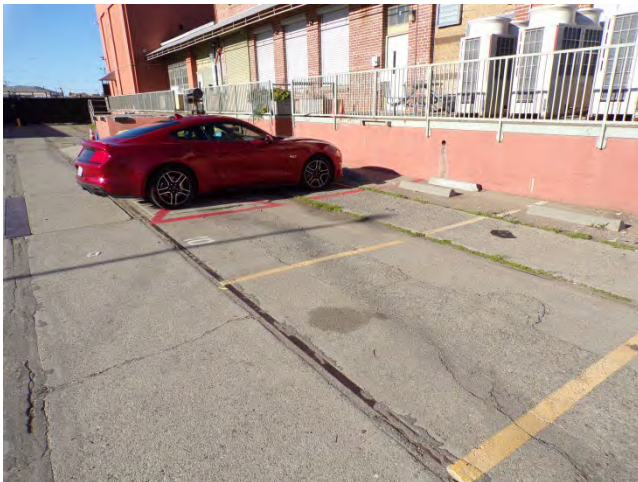
45. Bldg 5733E: The concrete-paved parking area is in a generally run-down condition.

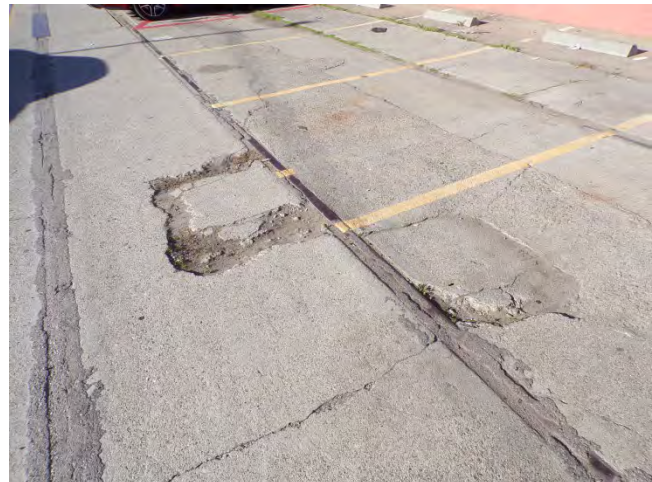
46. Bldg 5733E: Degraded condition of concrete paving.

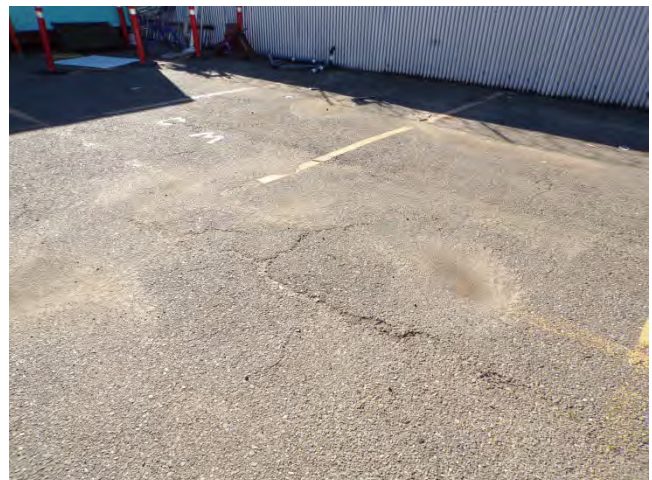
48. Bldg 5733W: Degraded condition of asphalt paving.

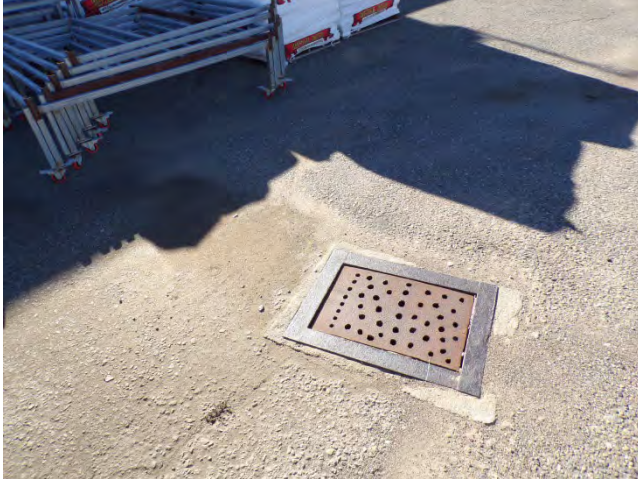
49. Bldg 5733W: Degraded condition of asphalt paving. Area drains are installed in several locations around the property.

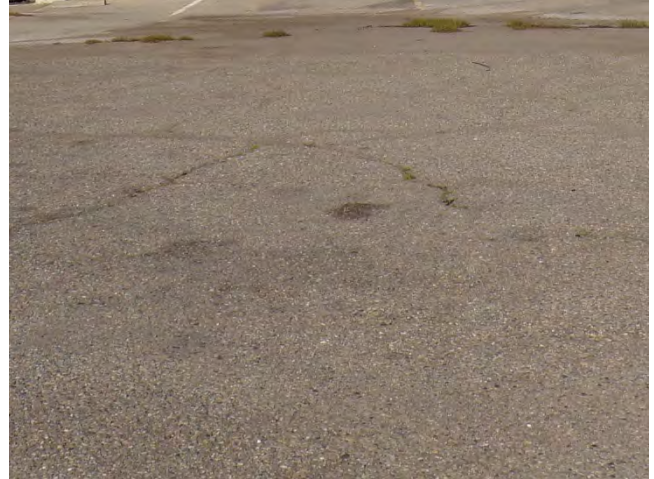
50. Bldg 5733W: Degraded condition of asphalt paving.

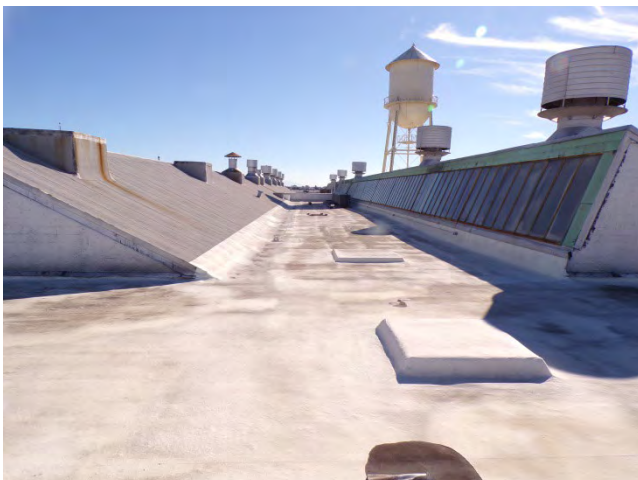
53. Bldg 5601E: The BUR roofing system is in an overall degraded condition.

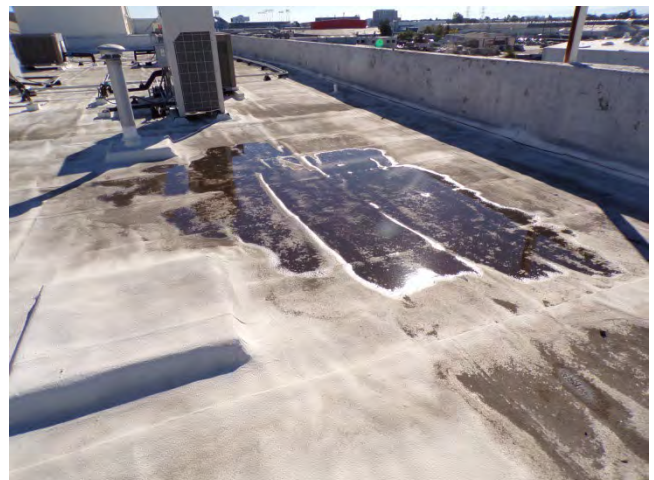
54. Bldg 5601E: Pooled water was observed in multiple locations.

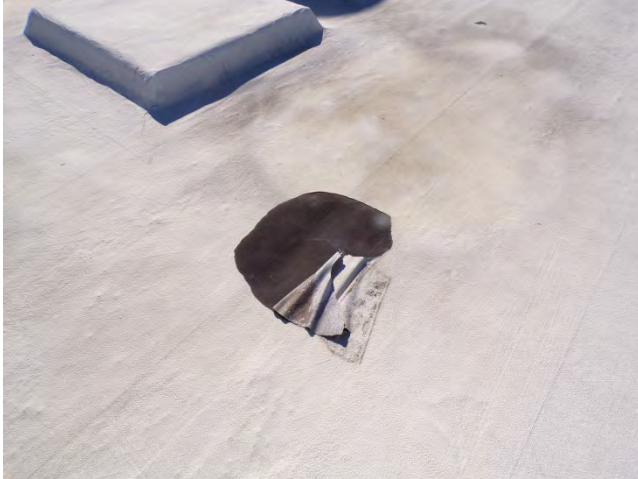
55. Bldg 5601E: The BUR roofing system is in an overall degraded condition.

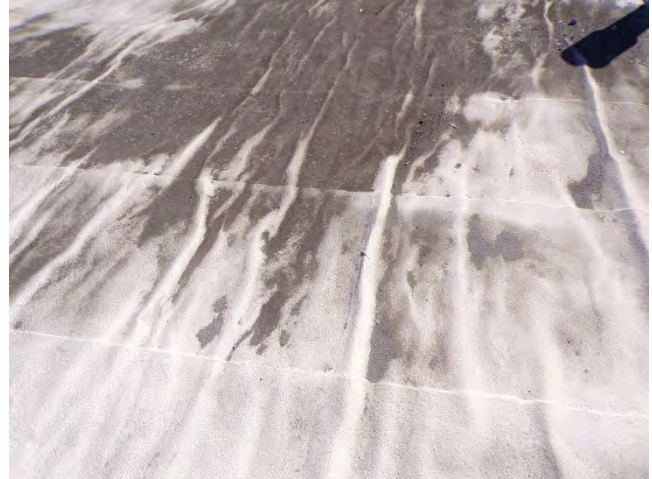
56. Bldg 5601E: The BUR roofing system is in an overall degraded condition.

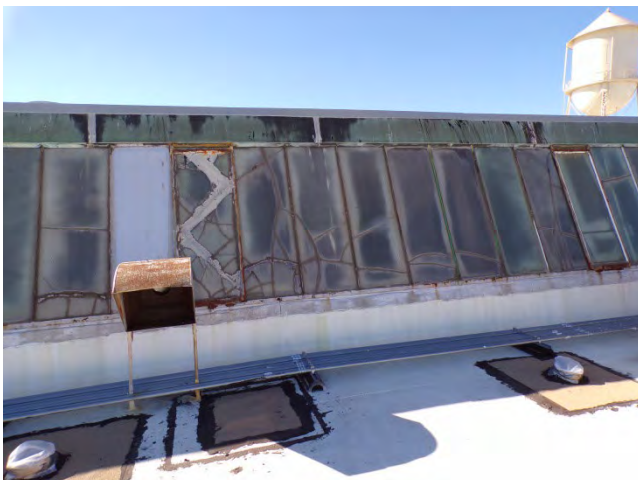
59. Bldg 5601E: Numerous broken windows were observed in the clerestories.

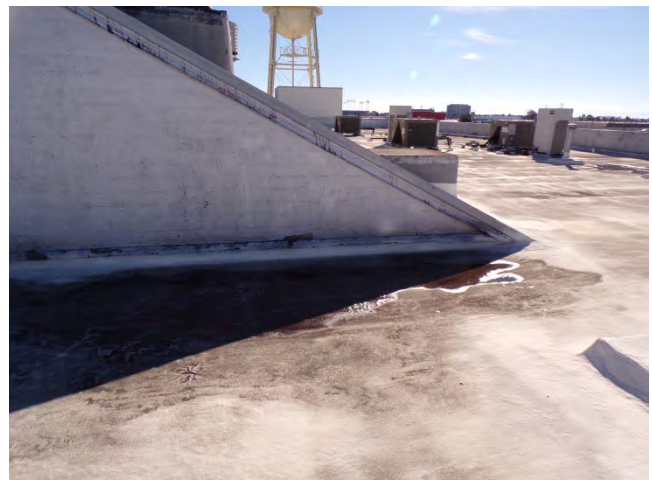
60. Bldg 5601E: Ponded water was observed in multiple locations.

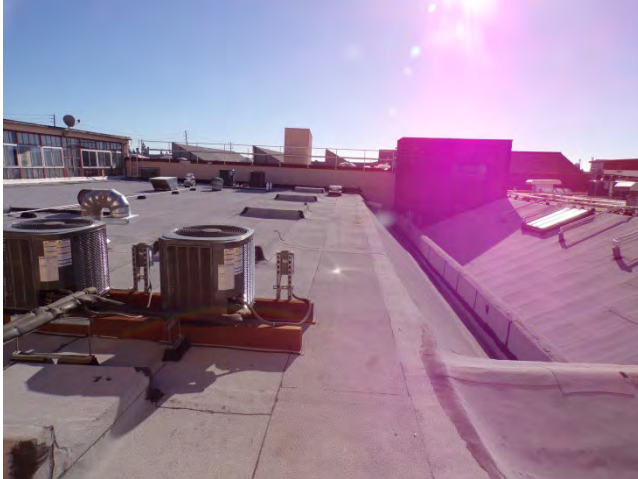
67. Bldg 5733E: The BUR roofing systems are in a generally run-down condition.

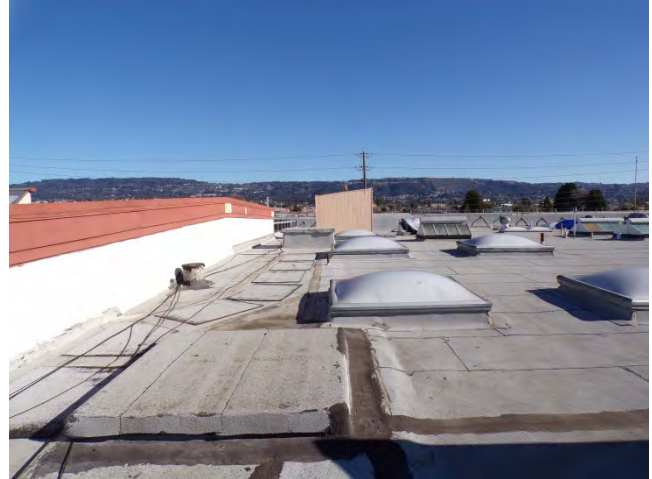
68. Bldg 5733E: The BUR roofing systems are in a generally run-down condition.

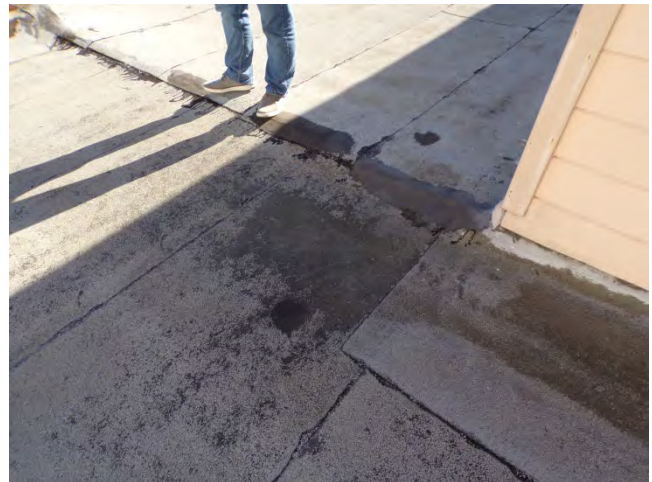
70. Bldg 5733E: The BUR roofing system is in an overall degraded condition.

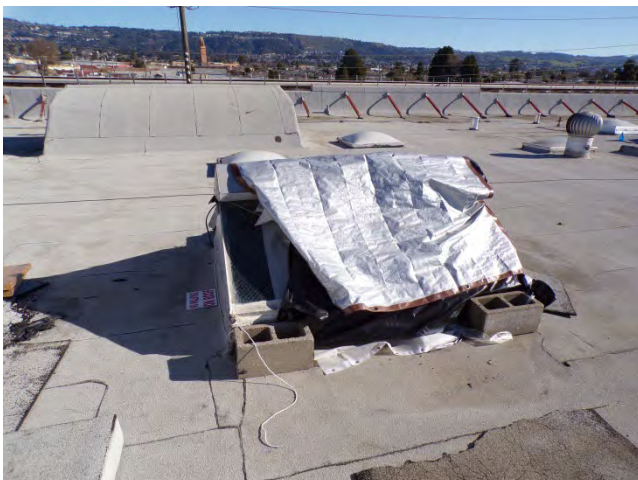
71. Bldg 5733E: Tenants have installed plastic sheeting on skylights that presumably leak.

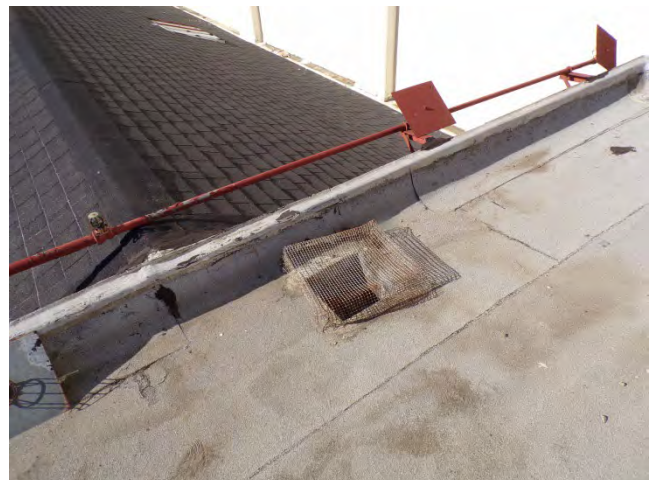
72. Bldg 5733E: Screened roof drains are installed; overflow protection is not provided.

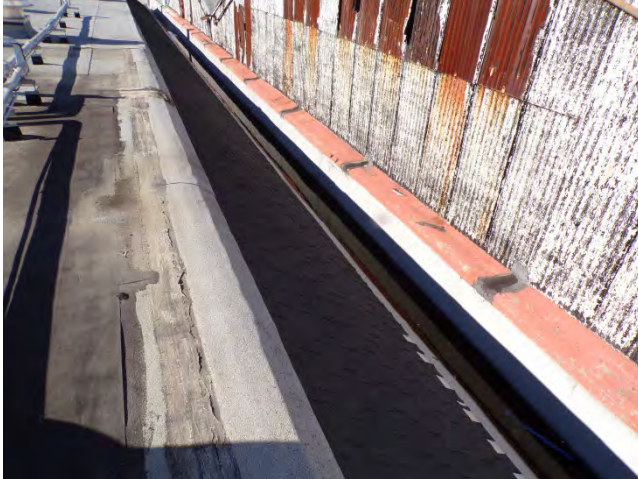
79. Bldg 5733W: Along the north side of the building, ponded water was observed at the foot of the pitched roof along most of its length.

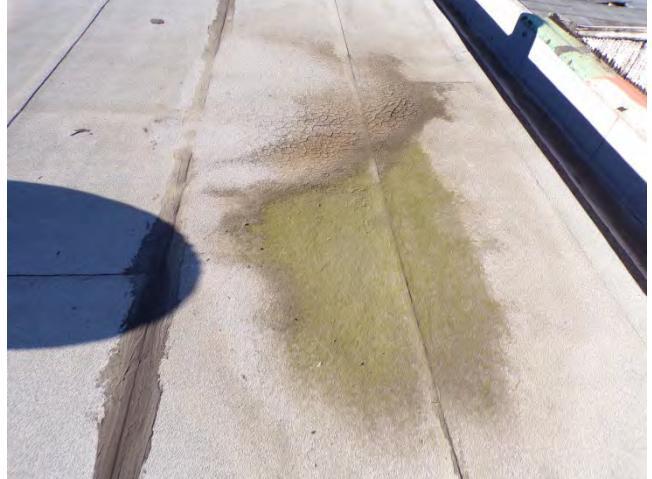
80. Bldg 5733W: The BUR roofing system is in an overall degraded condition. Area of past ponding shown.

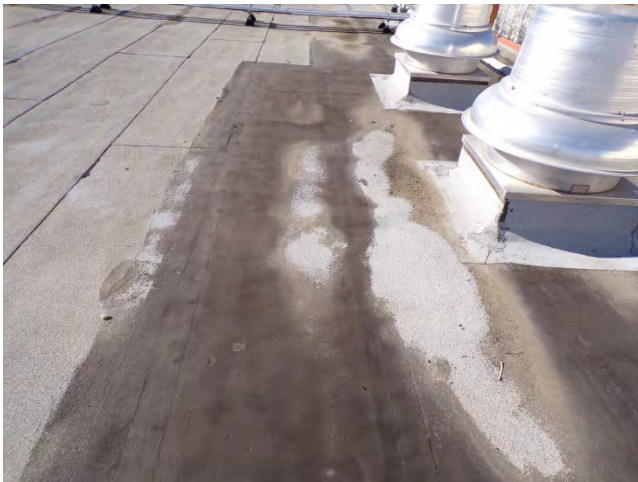
81. Bldg 5733W: The BUR roofing system is in an overall degraded condition. Separated mineral granules shown.

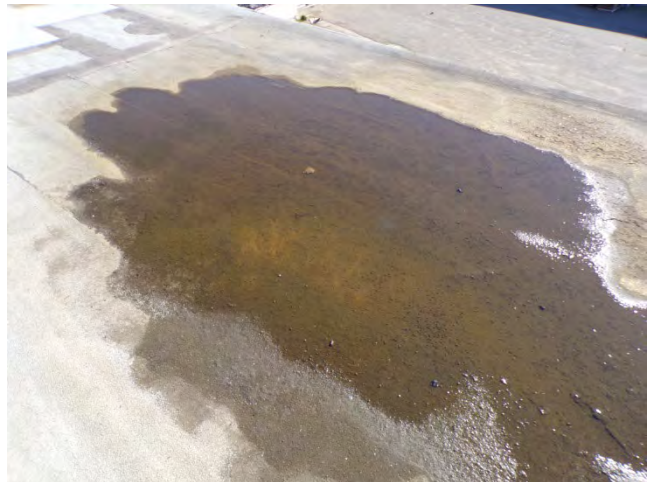
82. Bldg 5733W: Ponded water was present on the day of our site visit.

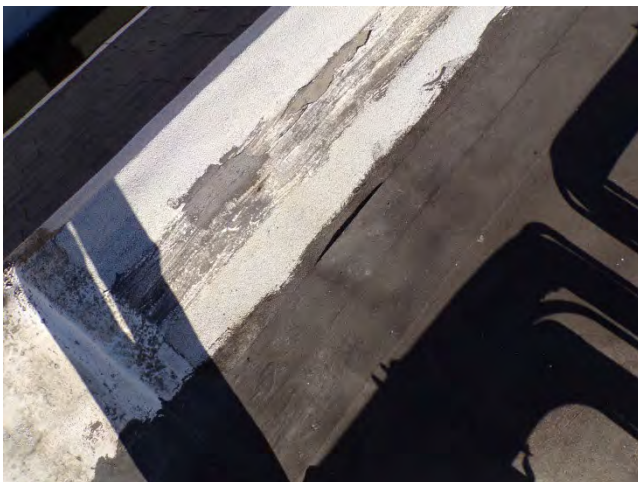
83. Bldg 5733W: The BUR roofing system is in an overall degraded condition. Split in roofing membrane at repair shown.

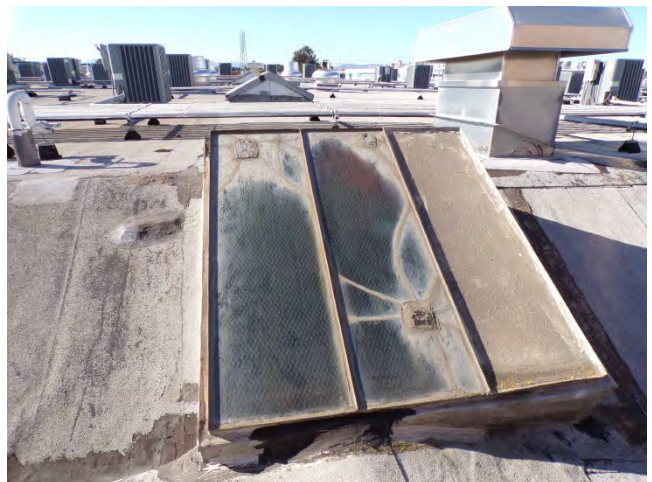
84. Bldg 5733W: Broken windows were observed in the skylights.

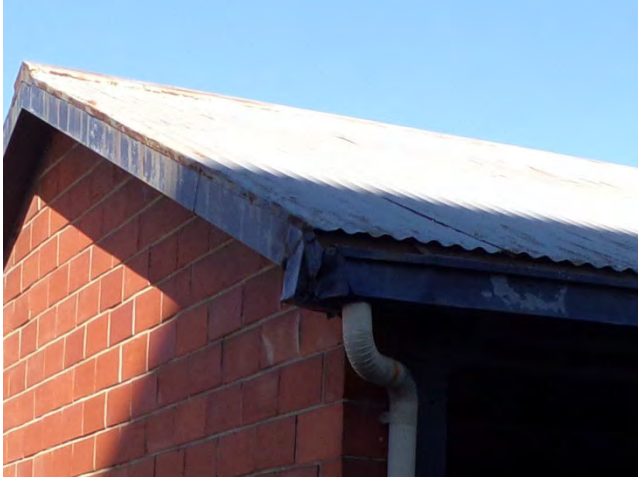
85. The ribbed steel panel roofing system on the carport is in a degraded condition; rust was observed in numerous locations.

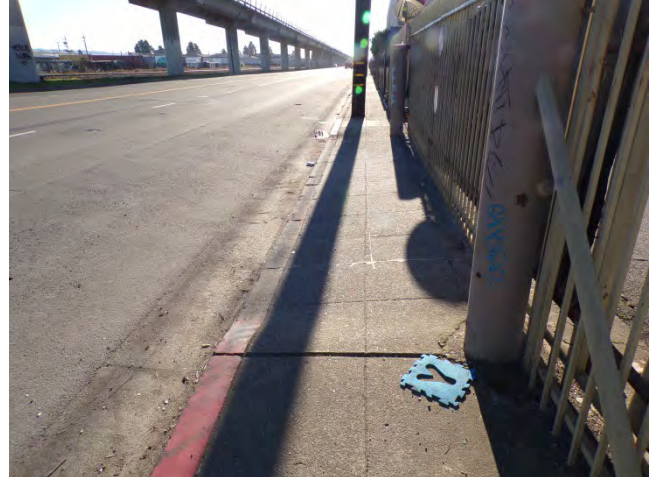
122. Changes in excess of 1/4" in concrete site work create tripping hazards.

| No | Sec | Photos | ITEM | Avg<br>EUL<br>(yr) | EFF<br>AGE<br>(yr) | RUL<br>(yr) | Quantity | Unit | Cost<br>Estimate<br>Source | Unit<br>Cost | Immediate Needs | Replacement Reserves | | | | | Years<br>1-5 Cumulative | Modernization<br>Costs (Optional) |
|---|---|---|---|---|---|---|---|---|---|---|---|---|---|---|---|---|---|---|
| 1 | B.02 | 122 | Provide repairs to address deficiencies in concrete site work to eliminate tripping hazards. | N/A | N/A | N/A | 1 | LS | Allowance | \$7,500.00 | \$7,500 | | | | | | | |

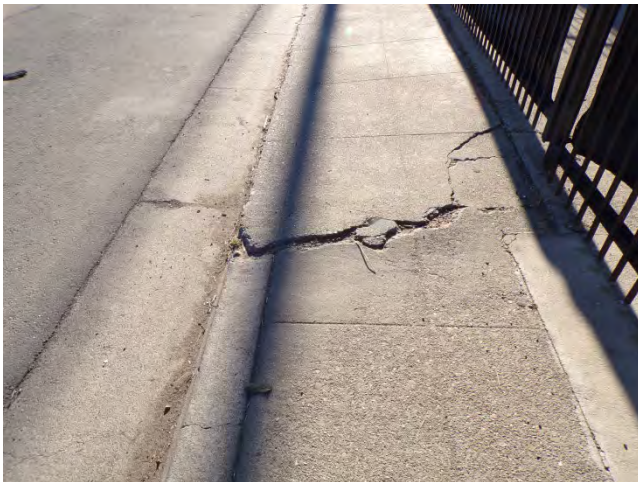
123. Deficiencies in concrete site work that do not create tripping hazards were also observed.

| No | Sec | Photos | ITEM | Avg<br>EUL<br>(yr) | EFF<br>AGE<br>(yr) | RUL<br>(yr) | Quantity | Unit | Cost<br>Estimate<br>Source | Unit<br>Cost | Immediate Needs | Replacement Reserves | | | | | Years<br>1-5 Cumulative | Modernization<br>Costs (Optional) |
|---|---|---|---|---|---|---|---|---|---|---|---|---|---|---|---|---|---|---|
| 2 | B.02 | 123 | Provide minor concrete repairs unrelated to tripping hazards. | N/A | N/A | N/A | 1 | LS | Allowance | \$17,500.00 | | | | | | | | |

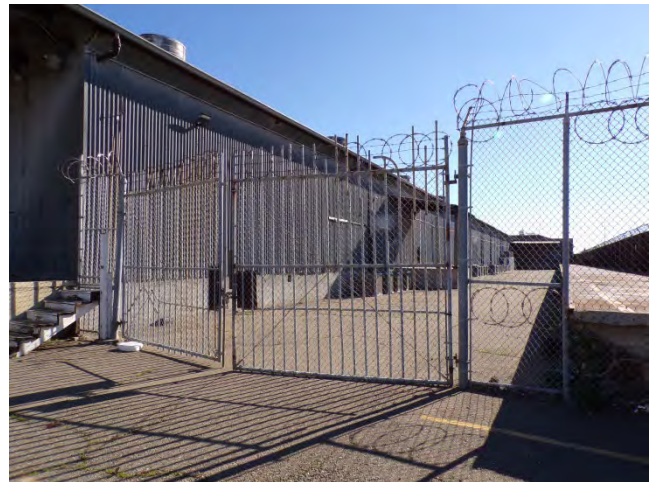
124. Deficiencies with fences and gates were observed. Most fencing at the property has an overall run-down appearance.

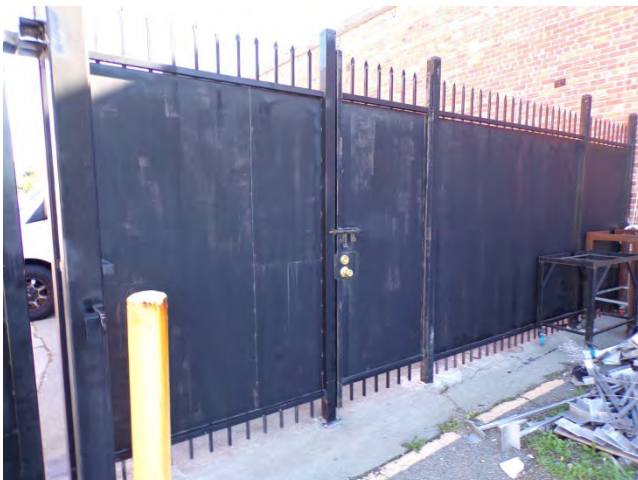
125. Deficiencies with fences and gates were observed. Painted fences should be repainted.

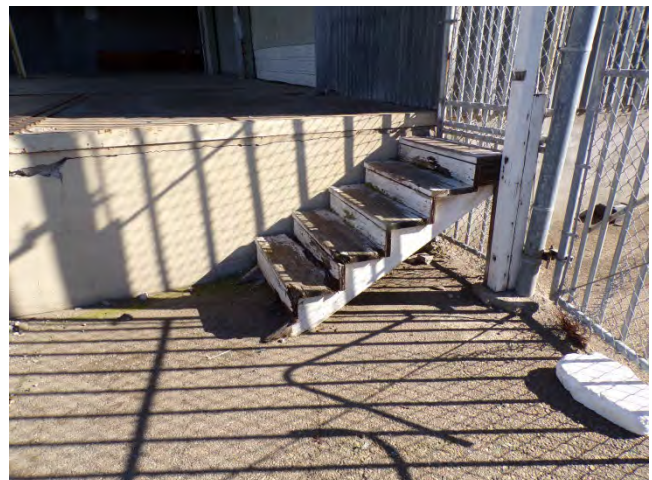
126. The wood-framed stairs near the northwest corner of Bldg 5733W are highly degraded. Railings are lacking. Complete replacement is recommended.

| No | Sec | Photos | ITEM | Avg<br>EUL<br>(yr) | EFF<br>AGE<br>(yr) | RUL<br>(yr) | Quantity | Unit | Cost<br>Estimate<br>Source | Unit<br>Cost | Immediate Needs | Replacement Reserves | | | | | Years<br>1-5 Cumulative | Modernization<br>Costs (Optional) |
|---|---|---|---|---|---|---|---|---|---|---|---|---|---|---|---|---|---|---|
| 12 | B.07 | 126,127 | Provide remedial measures to return exterior stairs, ramps, and railings to "Good" condition. | N/A | N/A | N/A | 1 | LS | Allowance | \$17,500.00 | | \$1,000 | | | | | \$1,000 | |

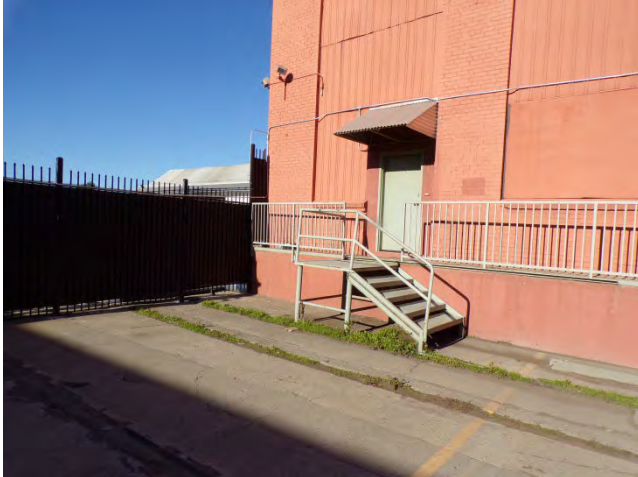
127. Various deficiencies were observed with exterior stairs. Damaged non-compliant railings shown.

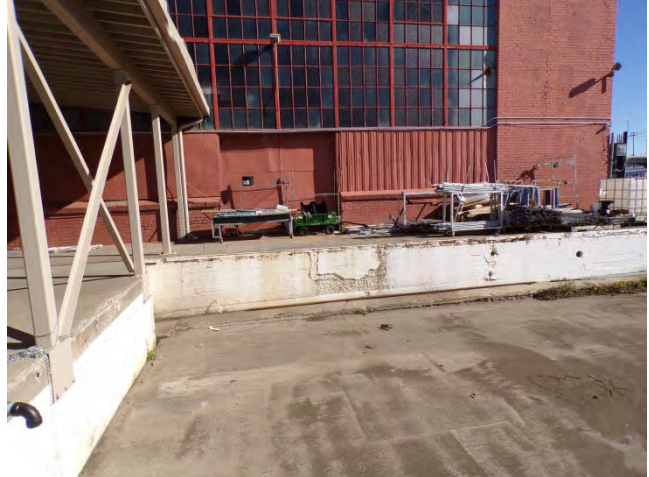
128. Various deficiencies were observed in loading areas. Degraded concrete shown.

| No | Sec | Photos | ITEM | Avg<br>EUL<br>(yr) | EFF<br>AGE<br>(yr) | RUL<br>(yr) | Quantity | Unit | Cost<br>Estimate<br>Source | Unit<br>Cost | Immediate Needs | Replacement Reserves | | | | | Years<br>1-5 Cumulative | Modernization<br>Costs (Optional) |
|---|---|---|---|---|---|---|---|---|---|---|---|---|---|---|---|---|---|---|
| 13 | B.08 | 11,128,129 | Provide remedial measures to address miscellaneous, minor deficiencies at loading areas. | N/A | N/A | N/A | 1 | LS | Allowance | \$10,000.00 | | \$50,000 | | | | | \$50,000 | |

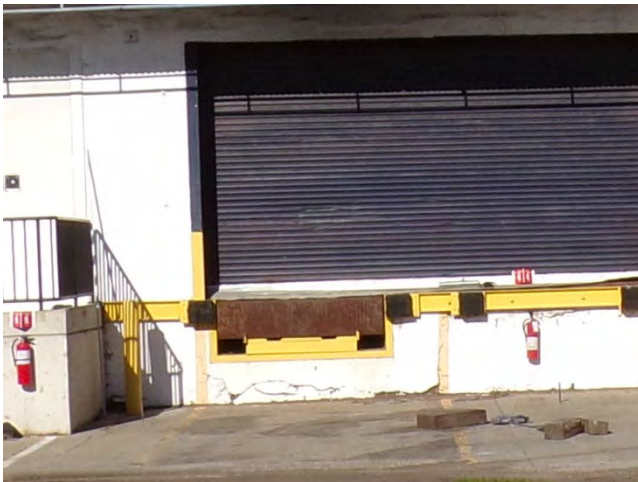
129. Various deficiencies were observed in loading areas. Rusted leveler should be repainted.

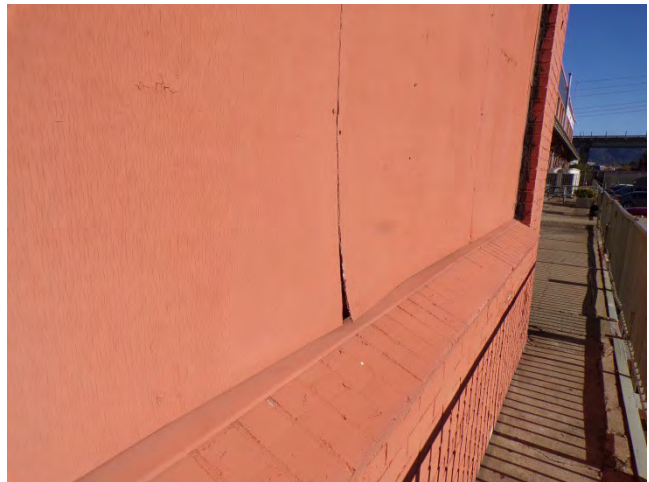
130. Exterior wood was observed in a degraded condition. South elevation of Bldg 5733E shown.

| No | Sec | Photos | ITEM | Avg<br>EUL<br>(yr) | EFF<br>AGE<br>(yr) | RUL<br>(yr) | Quantity | Unit | Cost<br>Estimate<br>Source | Unit<br>Cost | Immediate Needs | Replacement Reserves | | | | | Years<br>1-5 Cumulative | Modernization<br>Costs (Optional) |
|---|---|---|---|---|---|---|---|---|---|---|---|---|---|---|---|---|---|---|
| 28 | C.02 | 25,130,131 | Bldg 5733E: Allowance to replace degraded and temporary wood exterior elements. | N/A | N/A | N/A | 1 | LS | Allowance | \$20,000.00 | | \$27,000 | | | | | \$27,000 | |

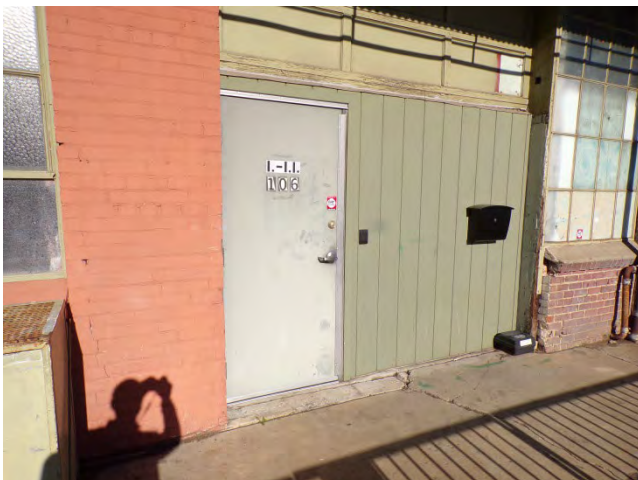
131. Exterior wood was observed in a degraded condition. South elevation of Bldg 5733E shown.

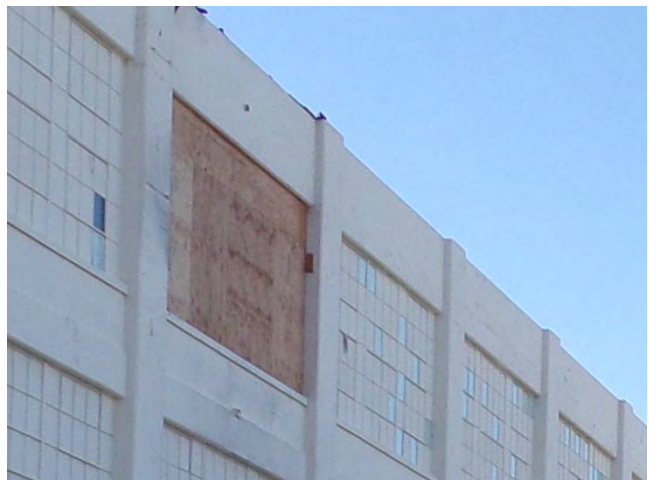
132. Bldg 5601E: One window bay on the third floor of the north elevation has been infilled with plywood.

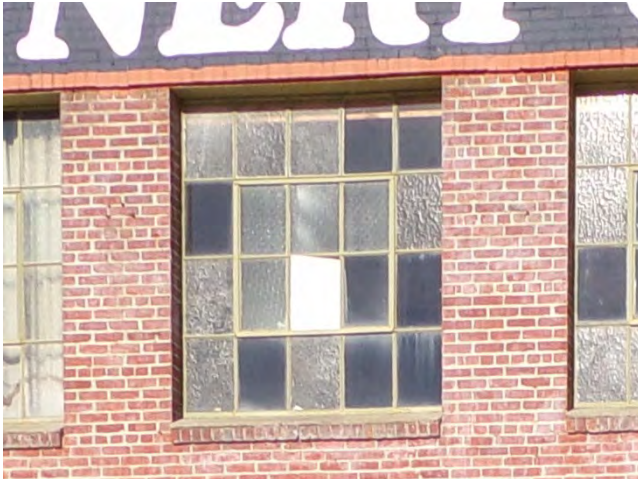
133. Various deficiencies were observed with exterior glazing. Glass pane replaced with cardboard shown.

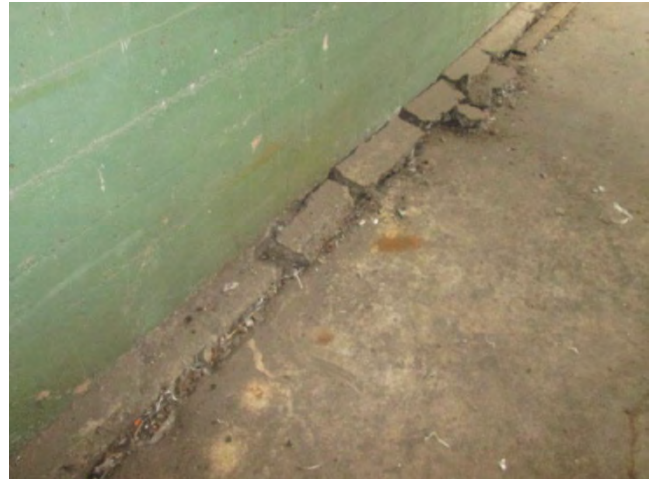
134. Various deficiencies were observed in loading areas. Degraded concrete shown. (Photo from 2017 PCA.)

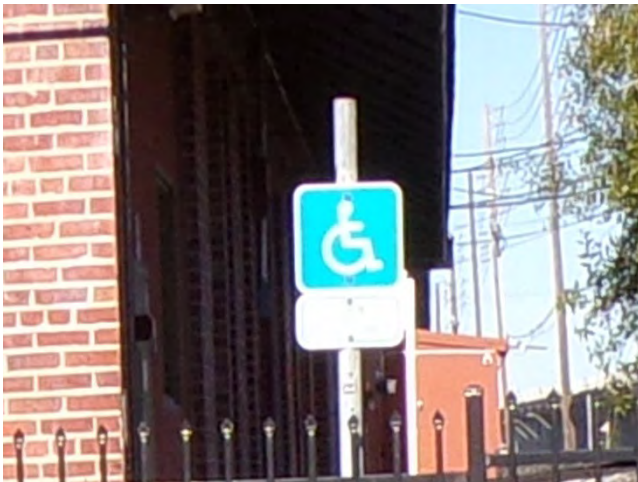
135. Bldg 5601E: Accessibility signage lacks fine amount sign.

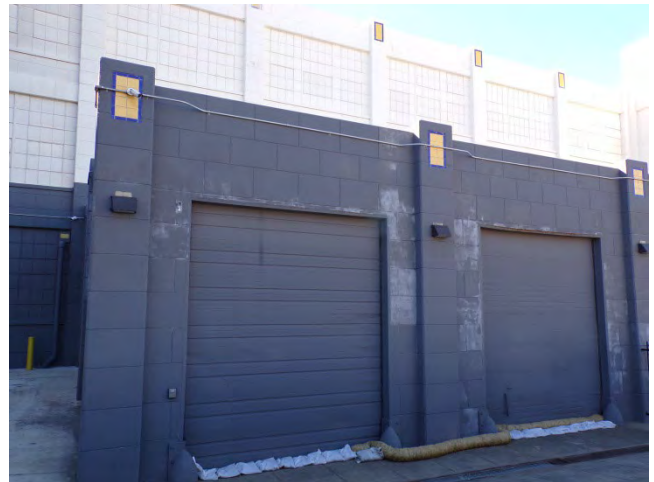
136. Steel framing at lintels is in a degraded condition; replacement is recommended.
