## PROPERTY CONDITION ASSESSMENT

870 Santa Cruz Avenue, Menlo Park, CA 94025

ALLWEST PROJECT 24117.60  
October 11, 2024

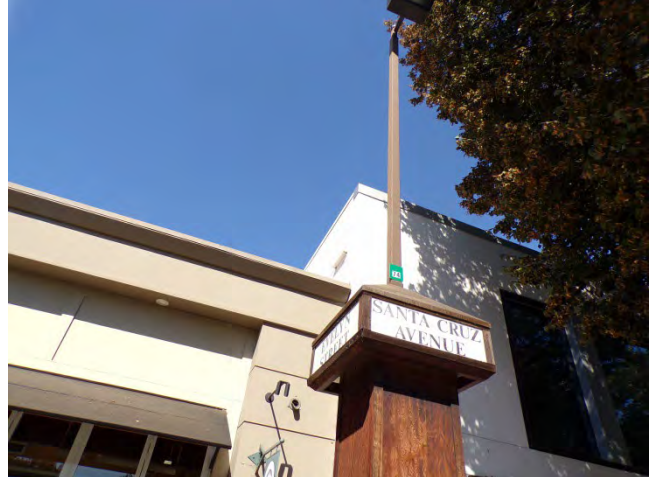
2. Portion of south elevation (white CMU wall) at center of photo above adjacent building.

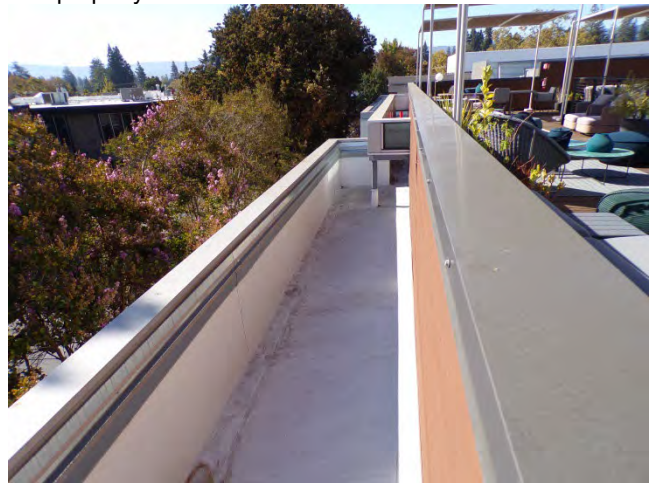
16. The PVC roofing system appeared in "Good" condition.

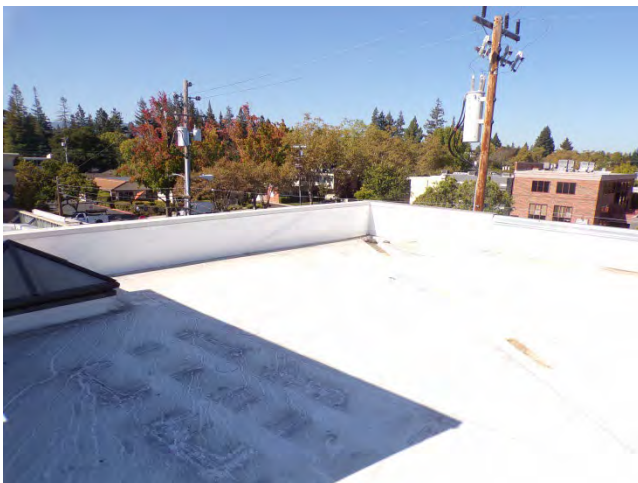
17. The PVC roofing system should be cleaned as part of routine maintenance.

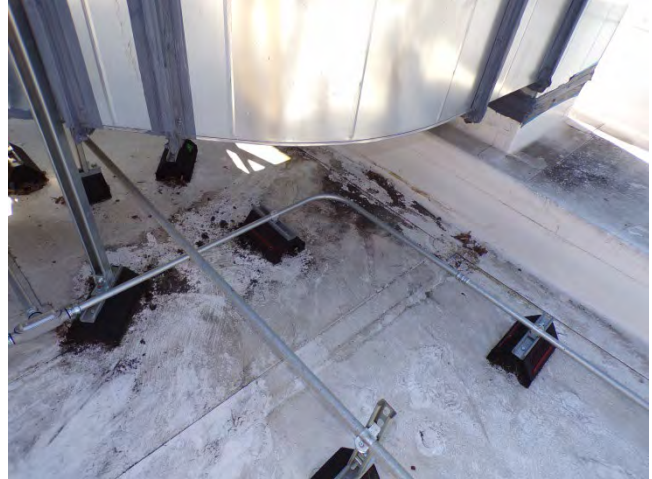
20. The roofing system should be inspected and cleaned as part of routine maintenance.

An annual contract to provide semi-annual roof drain checks and annual maintenance is in effect. AllWest recommends that this practice be continued as a part of routine maintenance; there is no cost estimate associated with this recommendation.

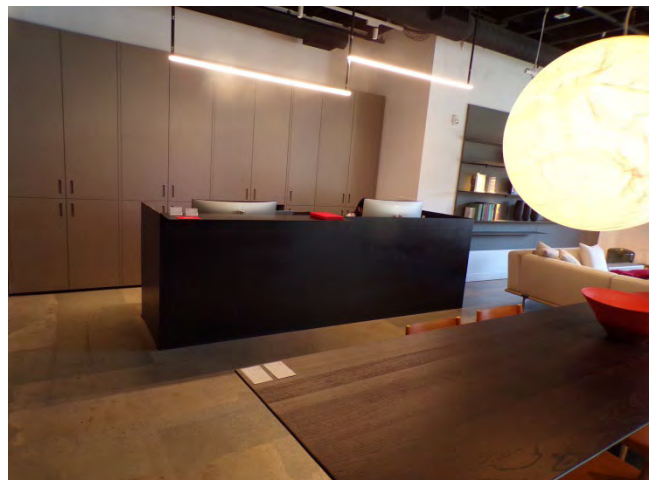
30. First floor: Interior finishes and fixtures in showroom area. Reception desk lacks dual-height feature for Accessibility.

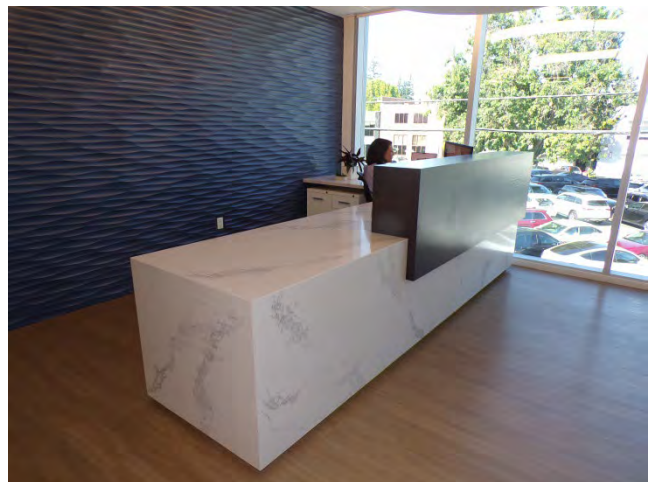
42. Suite 202: Interior finishes and fixtures. Reception desk has dual-height feature for Accessibility.

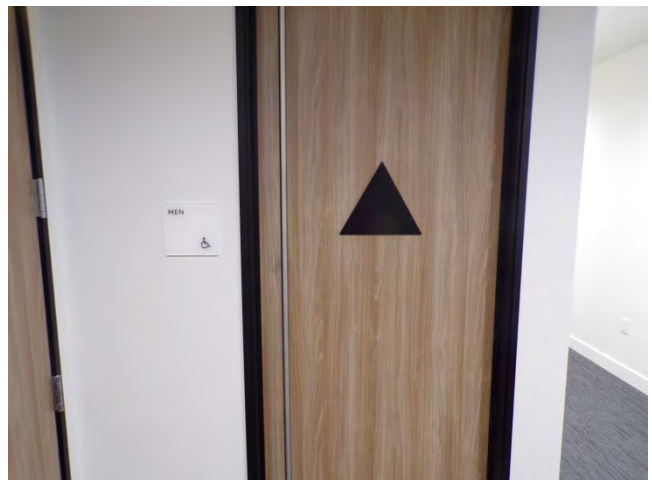
48. All restroom doors lack the California-required geometric door sign for Accessibility. First floor shown.

| No | Sec | Photos | ITEM | Avg<br>EUL<br>(yr) | EFF<br>AGE<br>(yr) | RUL<br>(yr) | Quantity | Unit | Cost<br>Estimate<br>Source | Unit<br>Cost | Immediate Needs | Replacement Reserves | | | | | Years<br>1-5 Cumulative | Modernization<br>Costs (Optional) | |
|---|---|---|---|---|---|---|---|---|---|---|---|---|---|---|---|---|---|---|--|
| 4 | G.03 | 48, 49 | Provide remedial measures to address minor deficiencies for restroom Accessibility. | N/A | N/A | N/A | 1 | EA | Allowance | \$350.00 | | | | | | | | | |

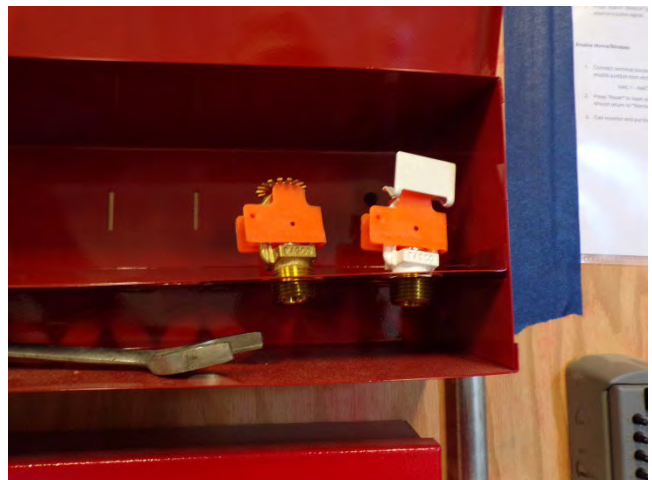
78. Only two spare sprinkler heads are in the sprinkler head spares box; six are required, as is a wrench (shown). The box is in the main service room next to the FACP.
