### PROPERTY CONDITION ASSESSMENT

## 2 & 8 Medical Plaza Drive, Roseville, CA 95661

**PROJECT 26006.60**  
**April 13, 2026**

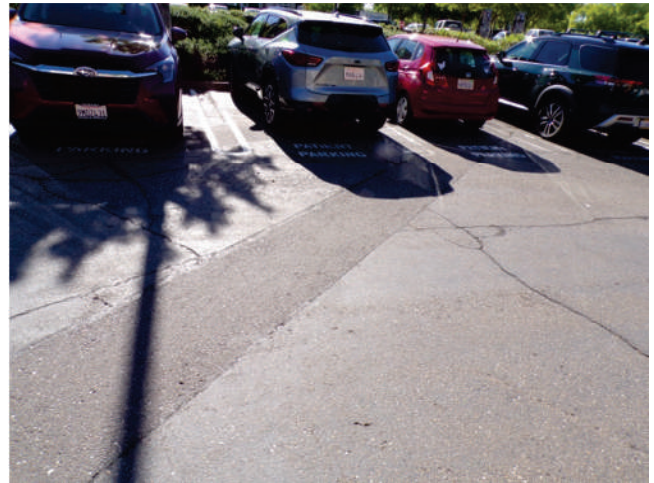
22. MOB 2: Past full-depth repairs and meandering cracking in asphalt paving.

- Both buildings: Perform full-depth and minor repairs to address degraded surface condition of asphalt paving;
- Both buildings: Reseal asphalt-paved parking lot and drive aisles;

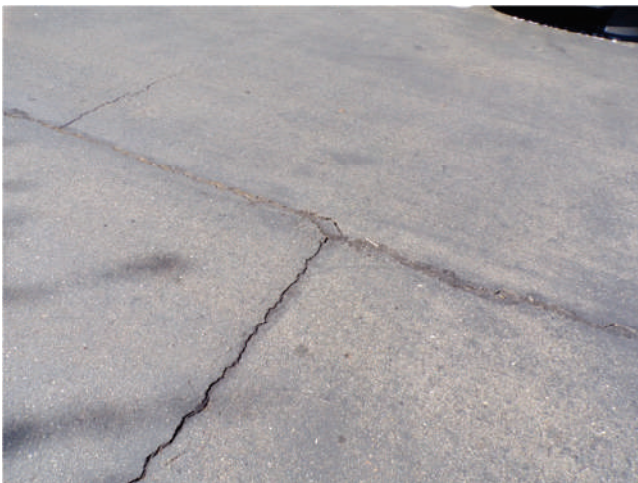
23. MOB 2: Linear cracking in asphalt paving.

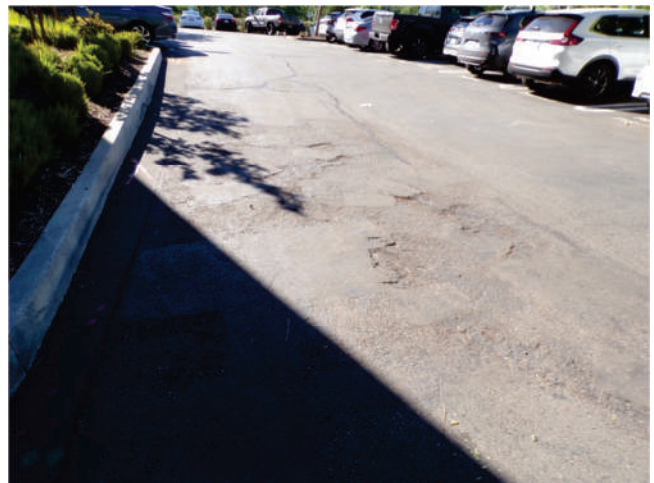
24. MOB 2: Surface degradation of asphalt paving.

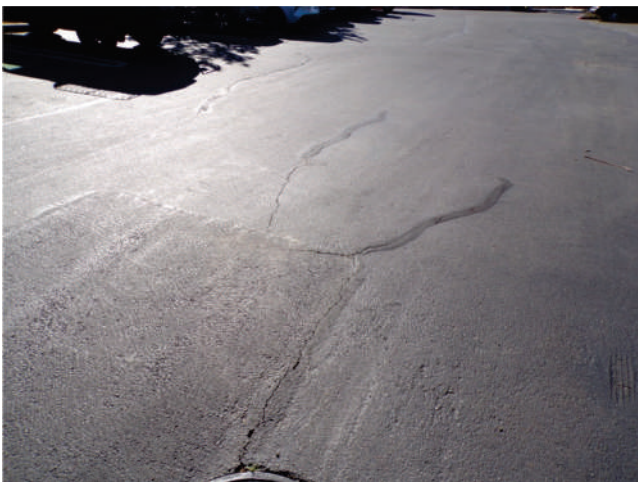
29. MOB 8: Past full-depth repair and meandering cracking in asphalt paving.

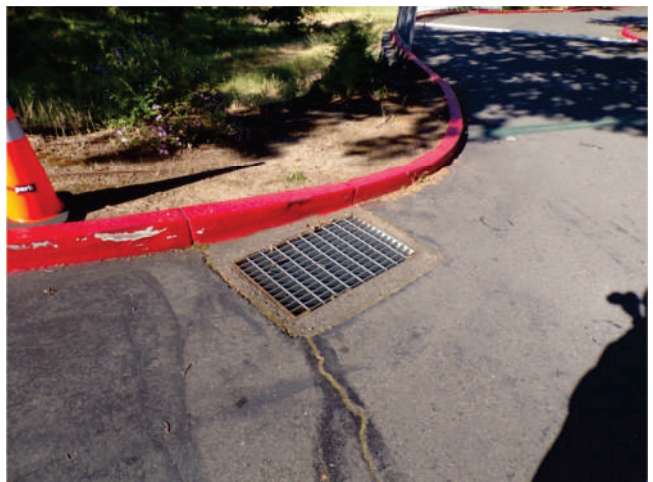
30. MOB 8: Drain inlets are located in several locations in the parking lot. Degraded condition of asphalt paving also shown.

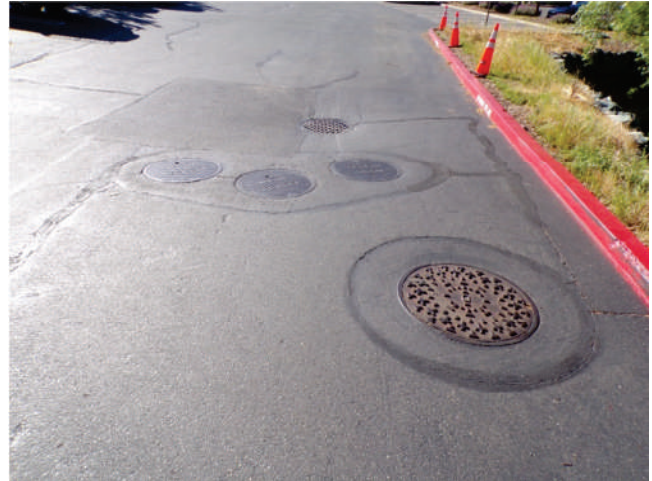
32. MOB 8: Past full-depth repairs. Meandering and linear cracking in asphalt paving also shown.

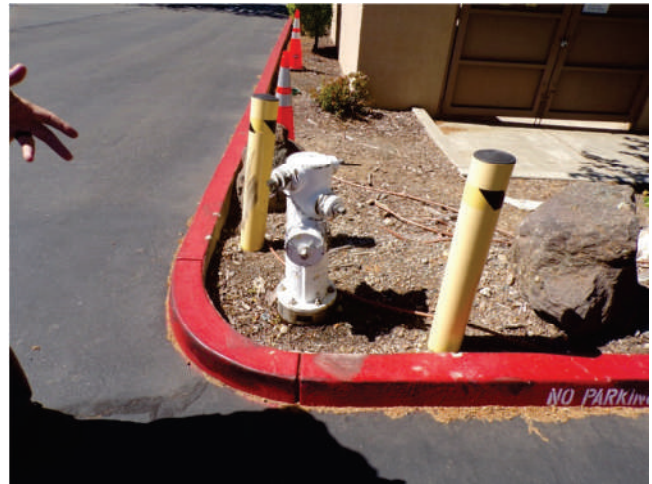
34. MOB 8: Fire hydrant and bollards. The hydrant has been damaged by vehicular contact on two reported occasions. An automatic check valve has been installed at base of hydrant.

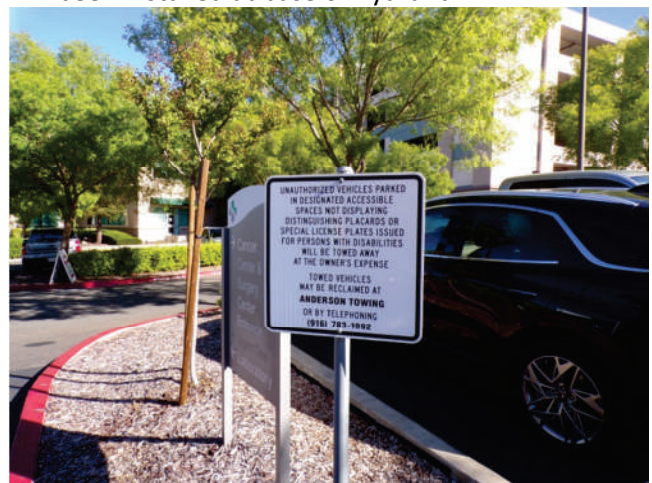
36. MOB 8: The required signs at parking lot entrances have conflicting towed vehicle retrieval information at the two subject buildings.

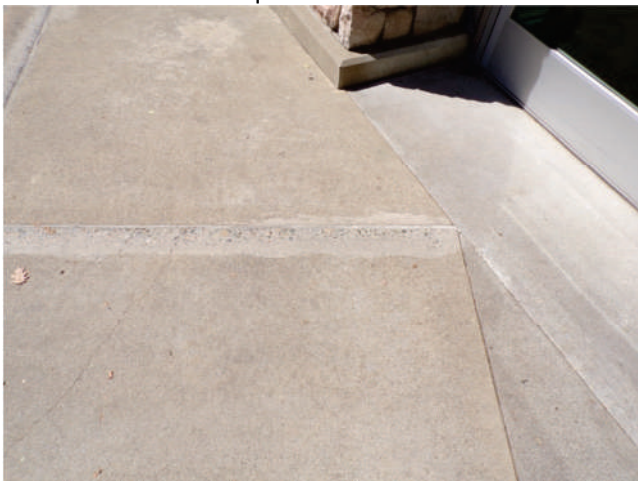
41. MOB 2: Evidence of past concrete grinding.

- Both buildings: Restripe standard (non-Accessible) parking stalls;
- Both buildings: Allowance for periodic concrete grinding to address tripping hazards;

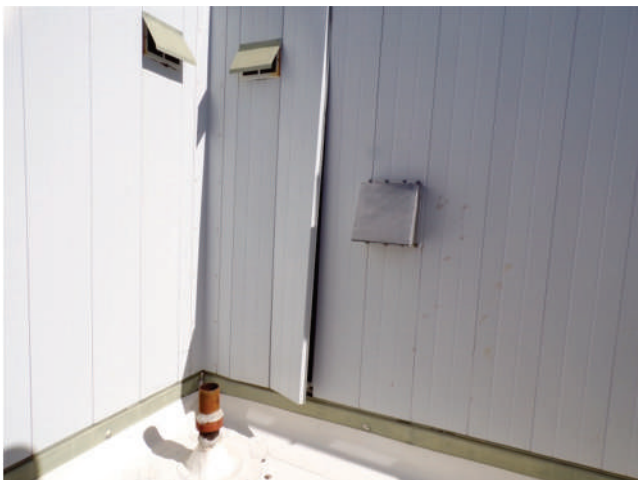
53. MOB 2, south wing: One of the interlocking metal parapet facing panels is misaligned.

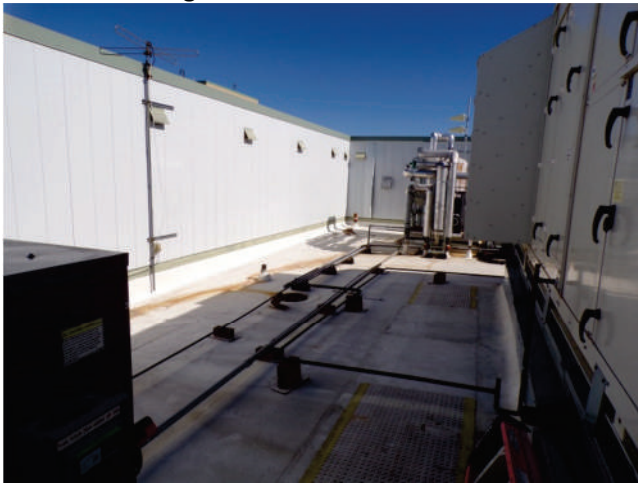
57. MOB 2, north wing: Rust stains are caused by the boiler on this wing's roof.

- MOB 2: Replace rooftop natural gas boiler, based upon existing condition;
- Perform infrared scan services on electrical distribution panels throughout both buildings;

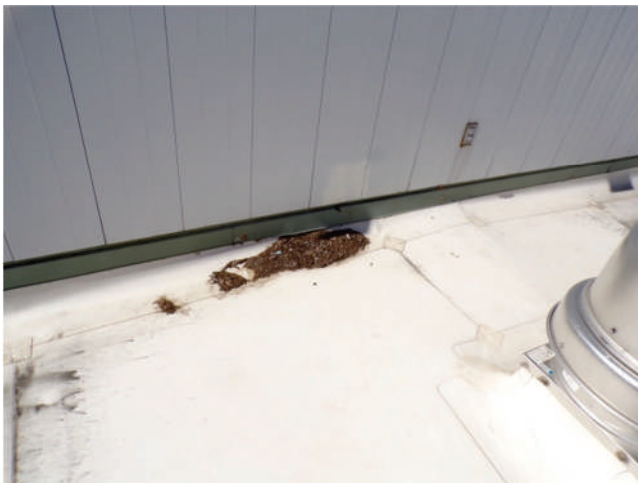
59. MOB 2, north wing: Minor accumulations of dead vegetation and other debris were observed on both the north and south wing flat roof areas.

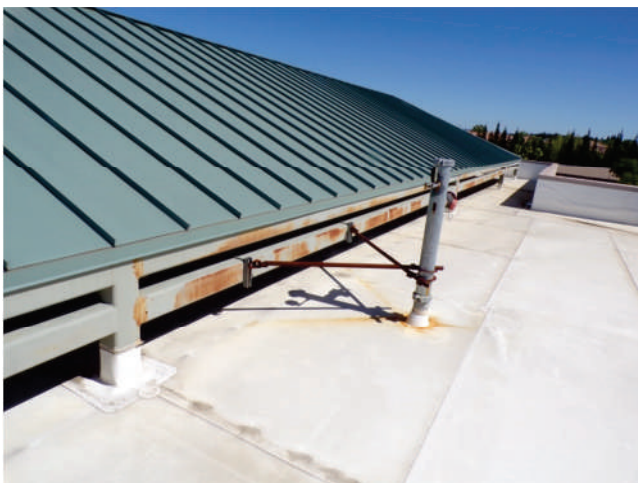
71. MOB 2: Rust is prevalent on the painted steel mansard frames.

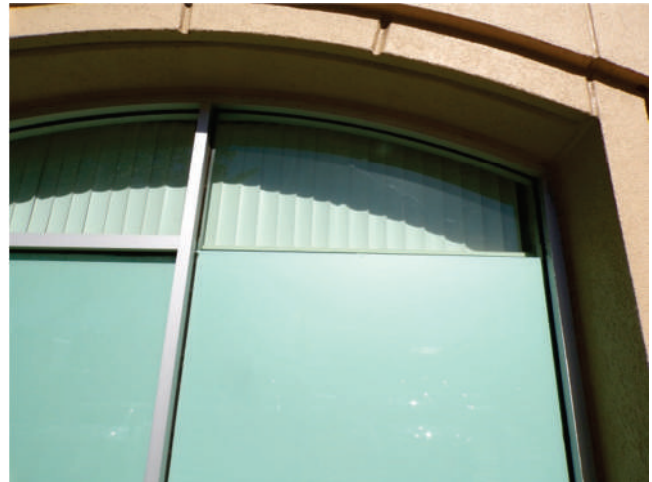
118. MOB 2: An aluminum muntin is missing at a window on the south elevation, east wing.

- MOB 2: Provide complete exterior repainting of all exterior elements with a paint finish;
- MOB 8: Replace missing aluminum muntin on south elevation window;

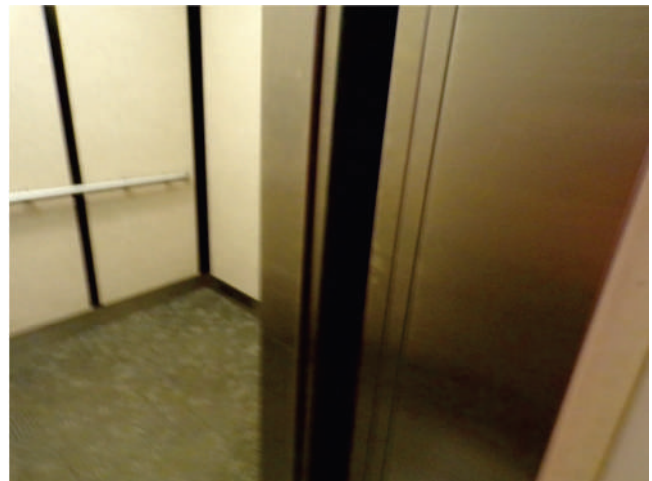
120. MOB 2: Both elevators in this building have door closure arrestors that require physical contact to activate.

The elevators appeared in generally "Good" condition. Each building is provided with two hydraulic passenger elevators, installed as part of building construction in 1998 (MOB 2) and 2016 (MOB 8). Elevator capacities at MOB 2 are 3,500 and 4,500 pounds. The two elevators at MOB 8 are rated at 4,500 pounds. It is recommended to provide complete modernization for the two MOB 2 elevators. Modernization includes upgraded drive components, new controllers, door closure arrestors, and interior finishes.
