## PROPERTY CONDITION ASSESSMENT

La Bahia Hotel & Spa, 215 Beach Street, Santa Cruz, CA 95060

ALLWEST PROJECT 26004.60  
February 6, 2026

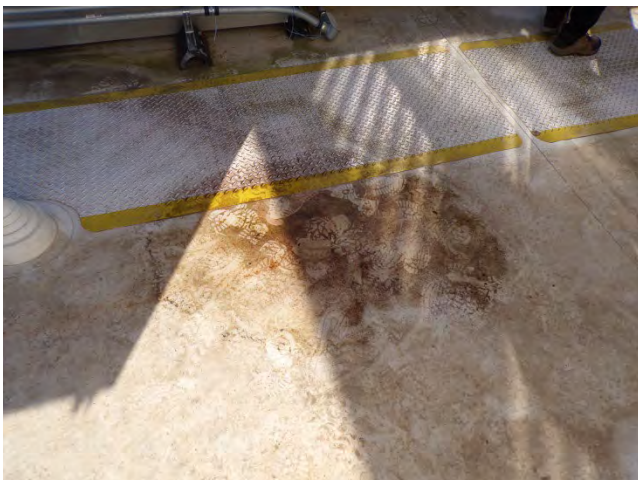
17. Main Bldg: TPO roof staining from past ponded water shown. Allwest recommends a contract for annual roof inspections and cleanings be initiated and maintained for both buildings.

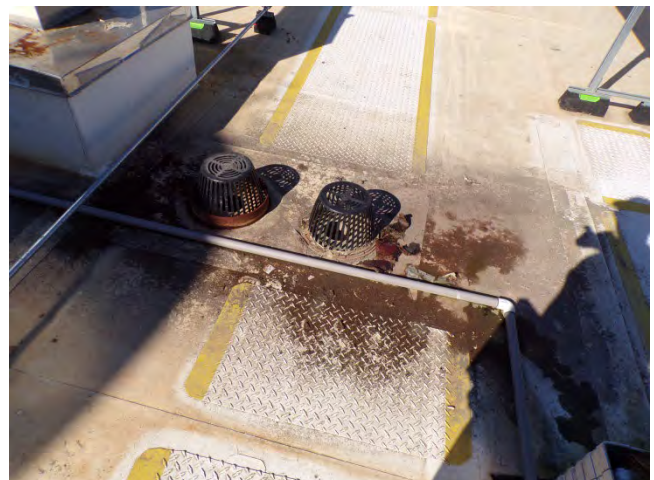
18. Main Bldg: Roof and overflow drain combinations are installed. Evidence of past ponded water also shown.

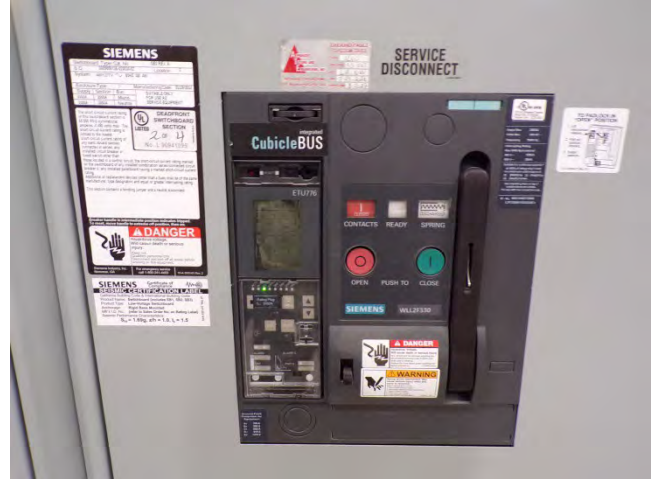
62. Main Bldg: The 3,000 amp main circuit breaker was ground fault performance tested on August 24, 2024. Re-testing is required on a three-year interval.

- Main Bldg: Provide periodic touch-up painting of steel supports and curb caps for HVAC equipment to mitigate rust;
- Both buildings: Conduct infrared scanning of the electrical distribution equipment on a three-year schedule;
- Main Bldg: Conduct ground fault performance testing of the 3,000 amp main circuit breaker on a three-year schedule.

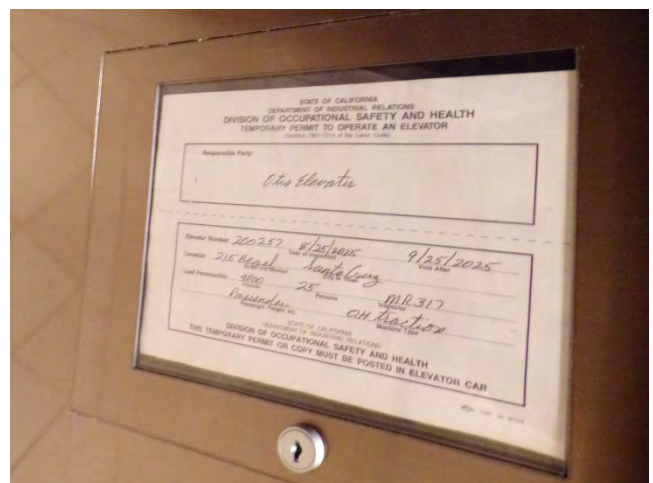
84. Main Bldg: The temporary permits on display in the elevator cabs had expired. Inspections have been requested with the State of California.

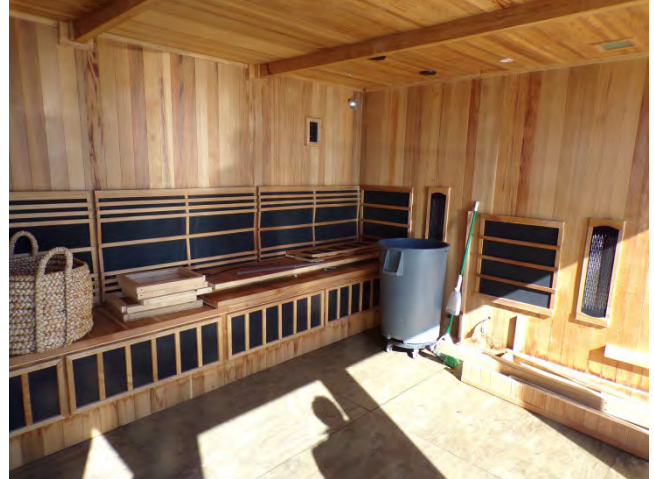
98. Main Bldg: The sauna room suffered water flooding during a storm and the floor was damaged; repairs are underway.

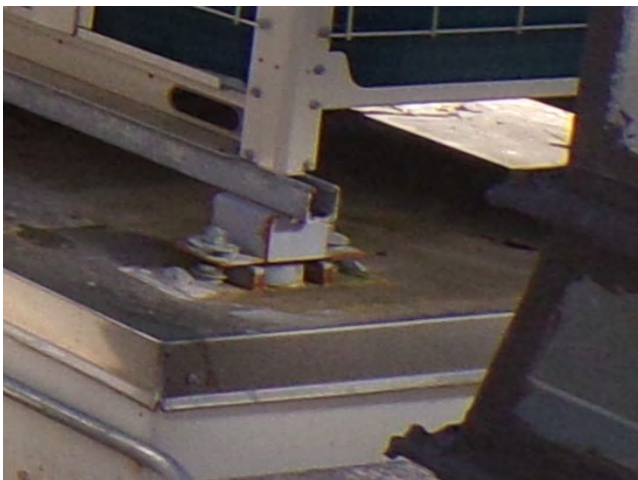
101. Main Bldg: Rust on steel supports for HVAC equipment.

| IMMEDIATE REPAIRS & REPLACEMENT RESERVE ANALYSIS | | | | | | | | | | | <div><div></div><div>AllWest</div></div> | | | | | | | | | | |
|---|---|---|---|---|---|---|---|---|---|---|---|---|---|---|---|---|---|---|---|--|--|
| 3 | F.02 | 101, 102 | Main Bldg: Provide periodic touch-up painting of steel supports for HVAC equipment to mitigate rust. | N/A | N/A | N/A | 1 | LS | Allowance | \$2,500.00 | | | \$2,500 | | \$2,500 | | \$2,500 | | \$7,500 | | |

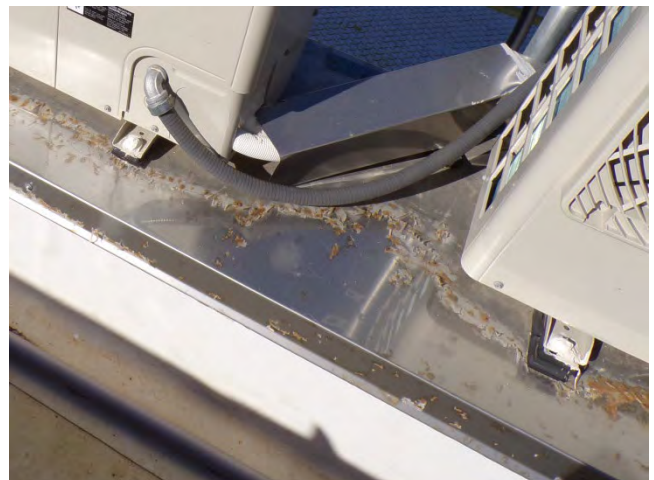
102. Main Bldg: Rust on steel caps on HVAC equipment curbs where plastic film coating is damaged.
