## PROPERTY CONDITION ASSESSMENT

**Sonoma Country Day School, 4400 Day School Place  
Santa Rosa, CA 95403**

**ALLWEST PROJECT 22088.60  
November 9, 2022**

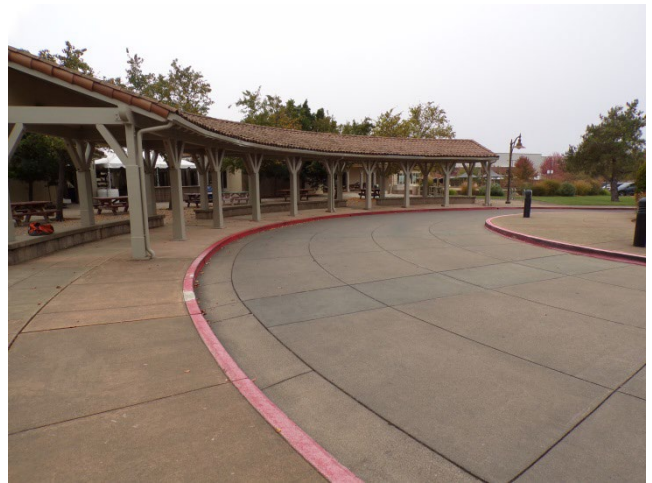
10. Main Bldg: Afternoon student pick-up shade shelter and drive aisle. Accessible pick-up areas are not provided at either the north (shown) or south student drop-off areas.

- Provide truncated domes in required locations;
- Provide compliant curb ramp on west side of Day School Place at Aviation Boulevard;
- Provide Accessible loading areas to the north and south of Main Bldg;
- Provide seven additional wheelchair spaces in auditorium;
- Provide compliant visually contrasting stripes on exterior and interior stairs;
- Provide second handrail at small concrete exterior stairs near southwest corner of Main Bldg;
- Provide remedial measures to address various plumbing and restroom deficiencies for Accessibility (four line items in spreadsheet).

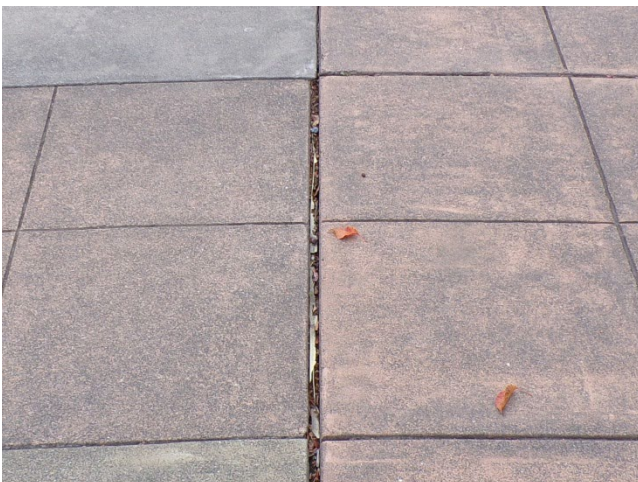
23. Degraded plastic control joint caps are recommended for replacement.

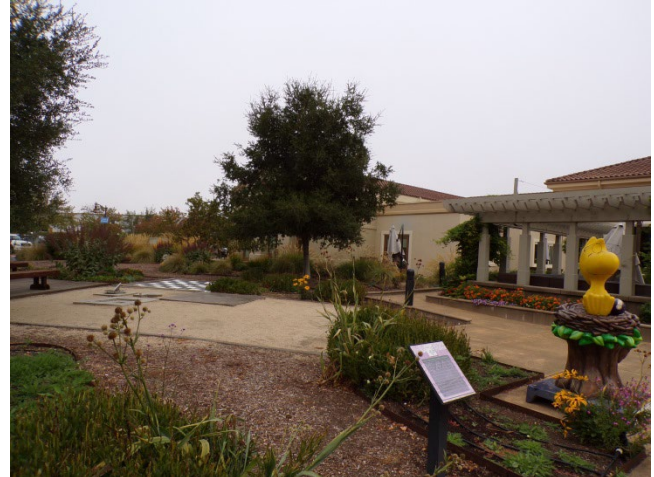
26. Main Bldg: Landscaped area near front entrance. Degraded wood chips should be replenished.

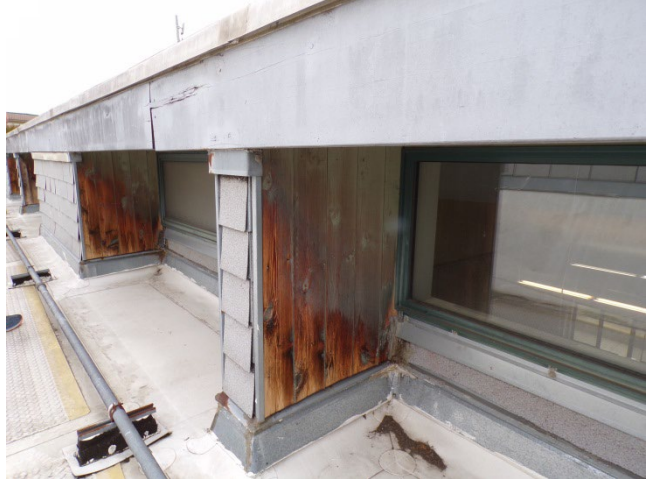
38. Main Bldg: Clerestory wood trim throughout is in a degraded condition.

| No | Sec | Photo No. | ITEM | Avg EUL (yr) | EFF AGE (yr) | RUL (yr) | Quantity | Unit | Cost Estimate Source | Unit Cost | Immediate Needs | Replacement Reserves | | | | | | | | | | Years 1-10 Cumulative | Modernization Costs (Optional) | | | |
|---|---|---|---|---|---|---|---|---|---|---|---|---|---|---|---|---|---|---|---|---|---|---|---|--|--|--|
| 6 | C.01 | 38 | Main Bldg: Provide remedial measures to address degradation of wood trim around clerestory windows. | 23 | UNK | UNK | 1 | LS | Estimate | \$6,000.00 | | \$6,000 | | | | | | | | | | \$6,000 | | | | |

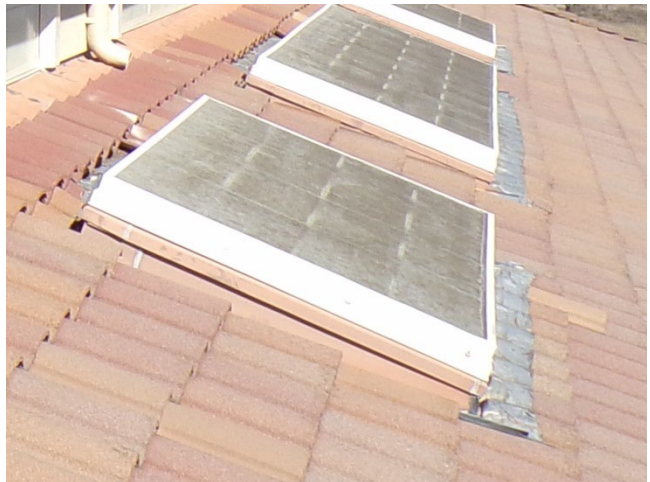
40. Gym skylights with deteriorating fiberglass panels.

| No | Sec | Photo No. | ITEM | Avg EUL (yr) | EFF AGE (yr) | RUL (yr) | Quantity | Unit | Cost Estimate Source | Unit Cost | Immediate Needs | Replacement Reserves | | | | | | | | | | Years 1-10 Cumulative | Modernization Costs (Optional) | | | |
|---|---|---|---|---|---|---|---|---|---|---|---|---|---|---|---|---|---|---|---|---|---|---|---|--|--|--|
| 11 | C.03 | 39,40,60 | Both buildings: Replace degraded translucent fiberglass panels at skylights and clerestory windows. | 20 | 23 | UNK | 1 | LS | Estimate | \$40,000.00 | | | \$40,000 | | | | | | | | | \$40,000 | | | | |

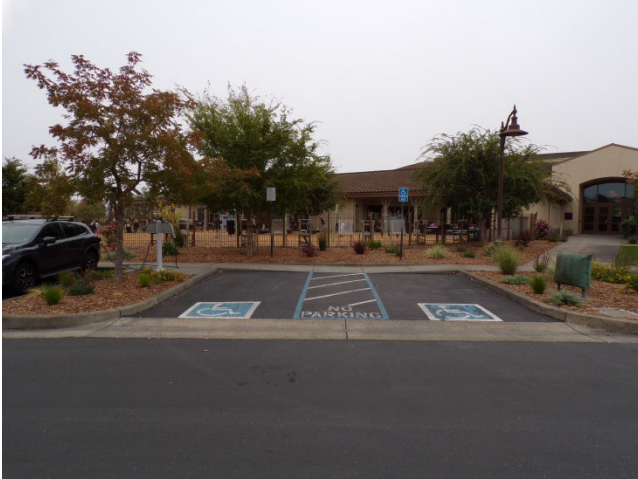
67. Accessible parking lacking correct signage; the fine amount sign is absent. Signage is typically in a degraded condition.

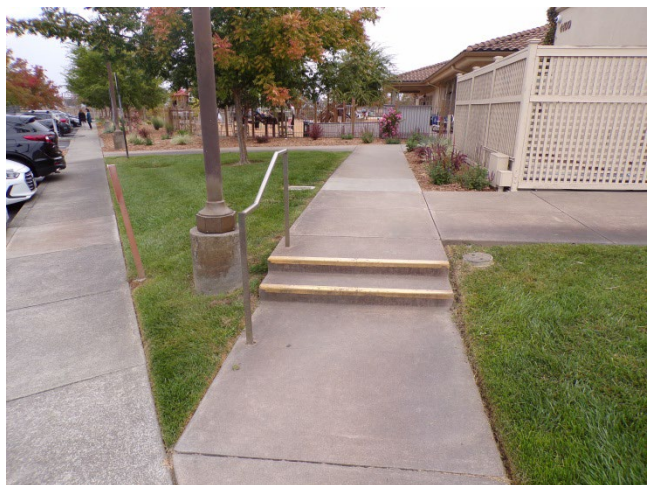
78. Main Bldg: The stairs near the southwest corner of the building have a handrail on one side only. Tread striping should be renewed.

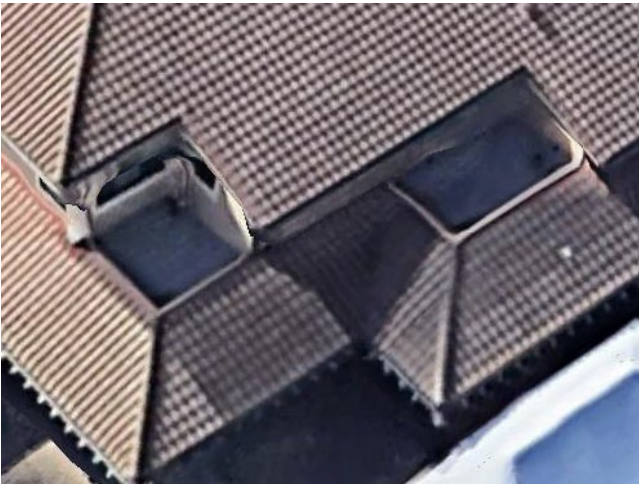
81. Gym: Two small areas of BUR are recommended for replacement.

| No | Sec | Photo No. | ITEM | Avg EUL (yr) | EFF AGE (yr) | RUL (yr) | Quantity | Unit | Cost Estimate Source | Unit Cost | Immediate Needs | Replacement Reserves | | | | | | | | | | Years 1-10 Cumulative | Modernization Costs (Optional) | | | |
|---|---|---|---|---|---|---|---|---|---|---|---|---|---|---|---|---|---|---|---|---|---|---|---|--|--|--|
| 4 | C.01 | 81 | Gym: Replace two original BUR roofing systems with single-ply TPO systems. | 23 | 20 | 0 | 250 | SF | Contractor | \$10.00 | | \$2,500 | | | | | | | | | | \$2,500 | | | | |

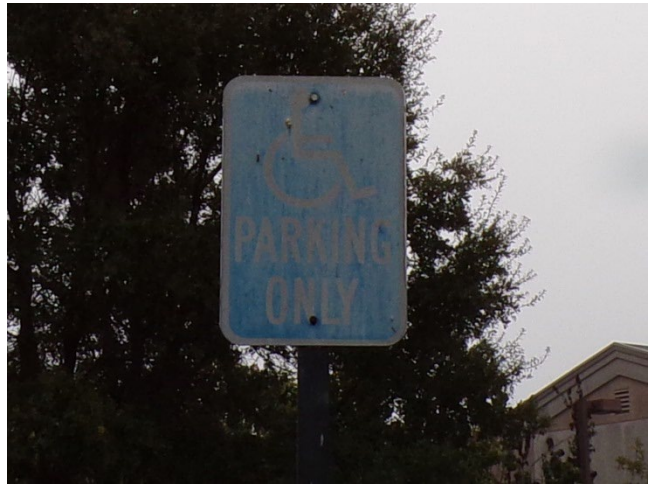
82. Accessible parking signage is typically in a degraded condition.

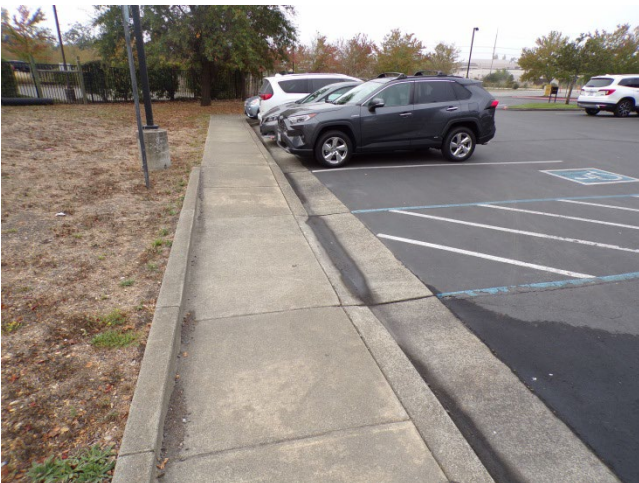
83. Truncated domes are not installed in any required location at the school.

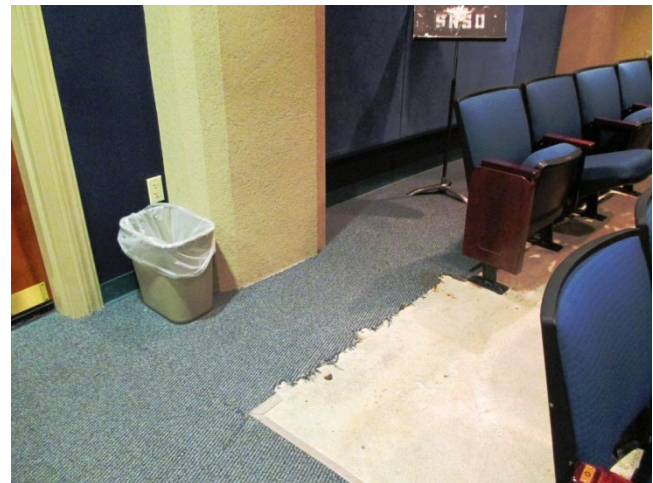
84. Main Bldg: AllWest recommends that seven additional wheelchair spaces be provided.

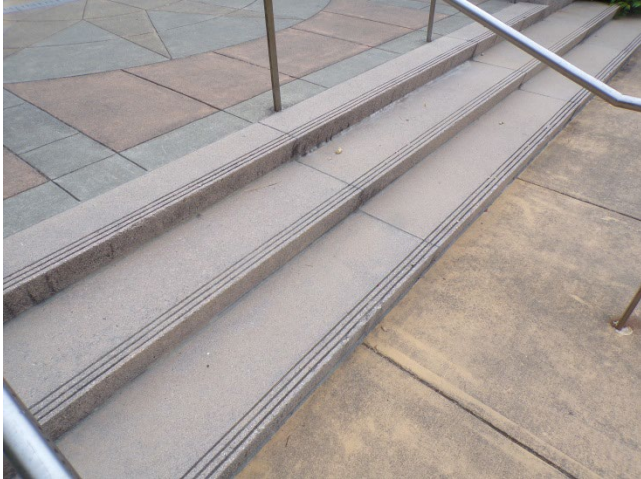
85. Main Bldg: Grooved stripes in stair treads are no longer compliant with current Accessibility codes.

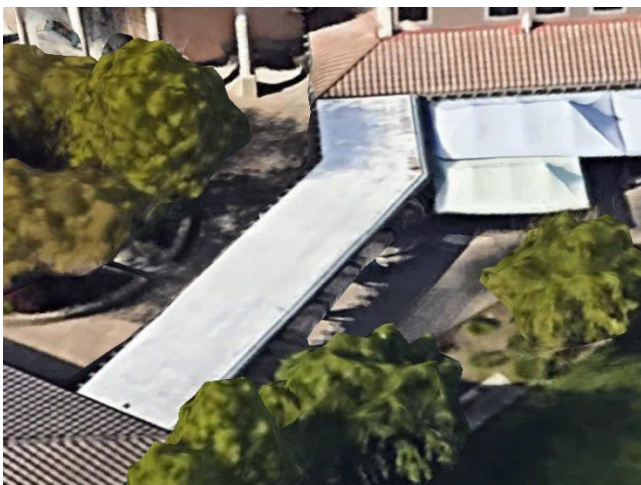
89. AllWest recommends that the BUR system on the covered walkway be replaced.

| No | Sec | Photo No. | ITEM | Avg EUL (yr) | EFF AGE (yr) | RUL (yr) | Quantity | Unit | Cost Estimate Source | Unit Cost | Immediate Needs | Replacement Reserves | | | | | | | | | | Years 1-10 Cumulative | Modernization Costs (Optional) | | | |
|---|---|---|---|---|---|---|---|---|---|---|---|---|---|---|---|---|---|---|---|---|---|---|---|--|--|--|
| 5 | C.01 | 89 | Covered walkway: Replace the original BUR roofing system with single-ply TPO system. | 23 | 20 | 0 | 950 | SF | Contractor | \$10.00 | | \$9,500 | | | | | | | | | | \$9,500 | | | | |

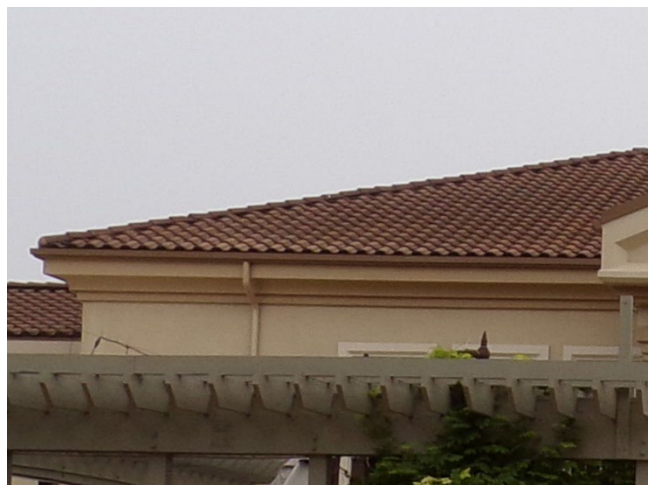
90. Main Bldg: Gutters on south elevation were reported to have leaks.

| No | Sec | Photo No. | ITEM | Avg EUL (yr) | EFF AGE (yr) | RUL (yr) | Quantity | Unit | Cost Estimate Source | Unit Cost | Immediate Needs | Replacement Reserves | | | | | | | | | | Years 1-10 Cumulative | Modernization Costs (Optional) | | | |
|---|---|---|---|---|---|---|---|---|---|---|---|---|---|---|---|---|---|---|---|---|---|---|---|--|--|--|
| 7 | C.01 | 90 | Main Bldg: Replace leaking gutters on south elevation. | N/A | N/A | N/A | 1 | LS | Estimate | \$2,650.00 | | \$2,650 | | | | | | | | | | \$2,650 | | | | |

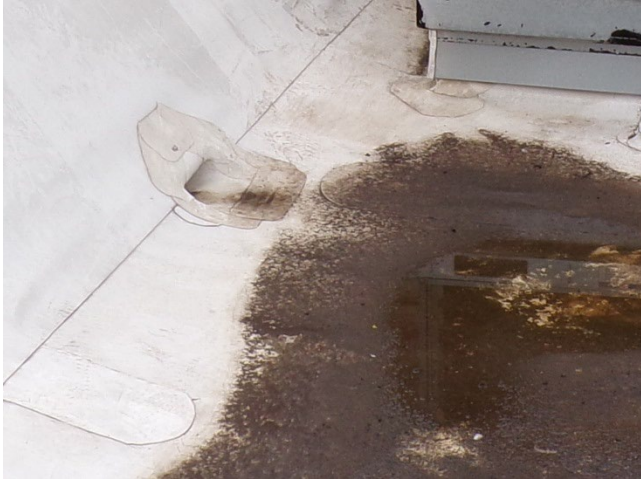
91. Main Bldg: A leak was reported near this scupper above the northwest wing.

| No | Sec | Photo No. | ITEM | Avg EUL (yr) | EFF AGE (yr) | RUL (yr) | Quantity | Unit | Cost Estimate Source | Unit Cost | Immediate Needs | Replacement Reserves | | | | | | | | | | Years 1-10 Cumulative | Modernization Costs (Optional) | | | |
|---|---|---|---|---|---|---|---|---|---|---|---|---|---|---|---|---|---|---|---|---|---|---|---|--|--|--|
| 8 | C.01 | 60,91 | Both buildings: Allowance to provide roof repairs to address known leaks. | N/A | N/A | N/A | 1 | LS | Estimate | \$7,500.00 | | \$7,500 | | | | | | | | | | \$7,500 | | | | |

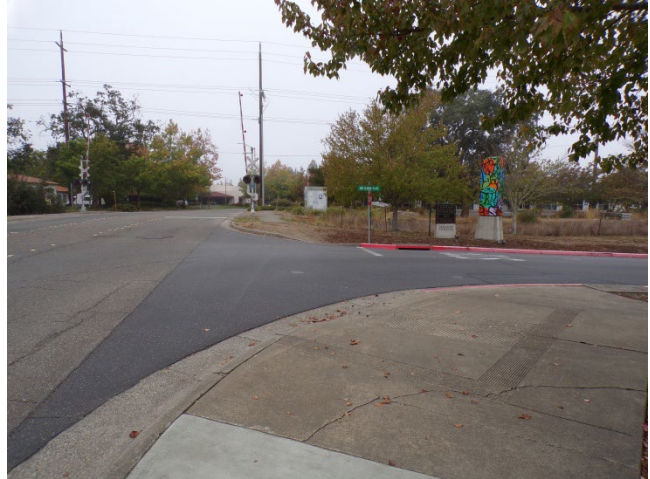
92. The curb ramp (foreground) lacks truncated domes; the far corner lacks a curb ramp altogether.

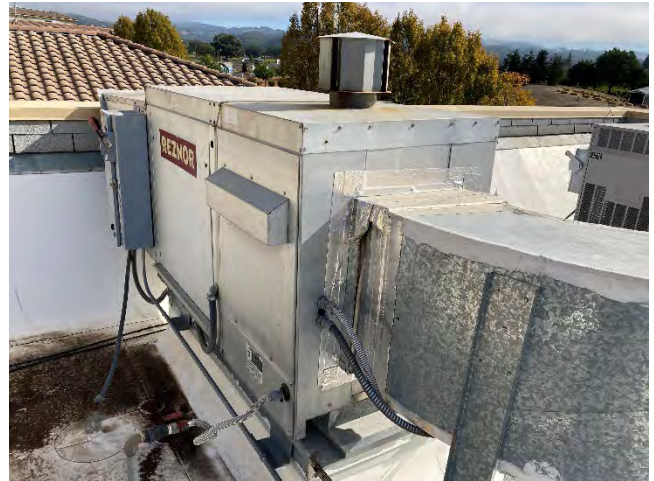
M-8. Main Bldg: Natural gas-fired kitchen make-up air unit.

| No | Sec | Photo No. | ITEM | Avg EUL (yr) | EFF AGE (yr) | RUL (yr) | Quantity | Unit | Cost Estimate Source | Unit Cost | Immediate Needs | Replacement Reserves | | | | | | | | | | Years 1-10 Cumulative | Modernization Costs (Optional) | | | |
|---|---|---|---|---|---|---|---|---|---|---|---|---|---|---|---|---|---|---|---|---|---|---|---|--|--|--|
| 27 | F.02 | M-8 | Replace natural gas fired make-up air unit, based upon EUL and existing condition. | 25 | 20 | 5 | 1 | EA | Estimate | \$50,000.00 | | | | | \$50,000 | | | | | | | \$50,000 | | | | |

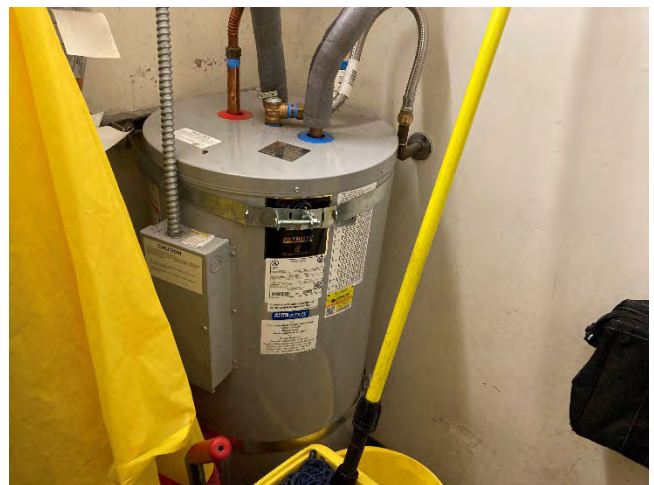
M-24. Electric domestic water heater.

| No | Sec | Photo No. | ITEM | Avg EUL (yr) | EFF AGE (yr) | RUL (yr) | Quantity | Unit | Cost Estimate Source | Unit Cost | Immediate Needs | Replacement Reserves | | | | | | | | | | Years 1-10 Cumulative | Modernization Costs (Optional) | | | |
|---|---|---|---|---|---|---|---|---|---|---|---|---|---|---|---|---|---|---|---|---|---|---|---|--|--|--|
| 37 | F.05 | M-24 | Replace 6-gallon water electric water heaters as they reach the end of their serviceable lives in Main Building. | 20 | 20 | 0 | 8 | EA | Estimate | \$200.00 | | | \$400 | \$400 | \$400 | \$400 | | | | | | \$1,600 | | | | |

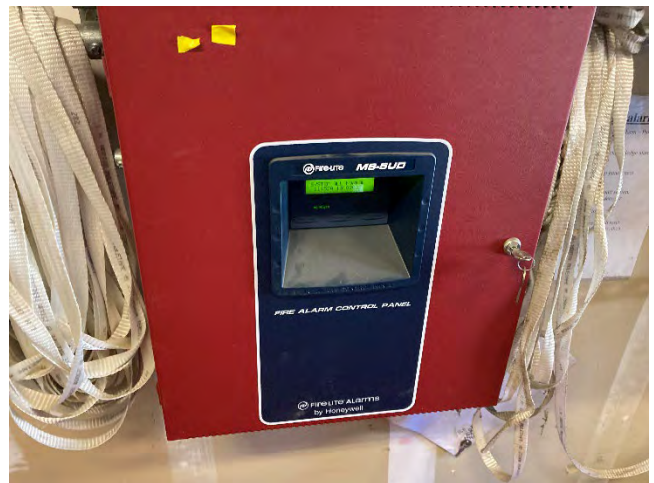
M-28. Fire alarm panel.

| No | Sec | Photo No. | ITEM | Avg EUL (yr) | EFF AGE (yr) | RUL (yr) | Quantity | Unit | Cost Estimate Source | Unit Cost | Immediate Needs | Replacement Reserves | | | | | | | | | | Years 1-10 Cumulative | Modernization Costs (Optional) | | | |
|---|---|---|---|---|---|---|---|---|---|---|---|---|---|---|---|---|---|---|---|---|---|---|---|--|--|--|
| 42 | F.06 | M-28 | Upgrade one fire alarm panel, based upon EUL and existing condition. | 15 | 20 | 0 | 1 | EA | Estimate | \$15,000.00 | \$15,000 | | | | | | | | | | | \$0 | | | | |
