## PROPERTY CONDITION ASSESSMENT

**Our Lady of Loretto Church & School, 1806 Novato Boulevard  
Novato, CA 94947**

**ALLWEST PROJECT 23017.60  
February 27, 2023**

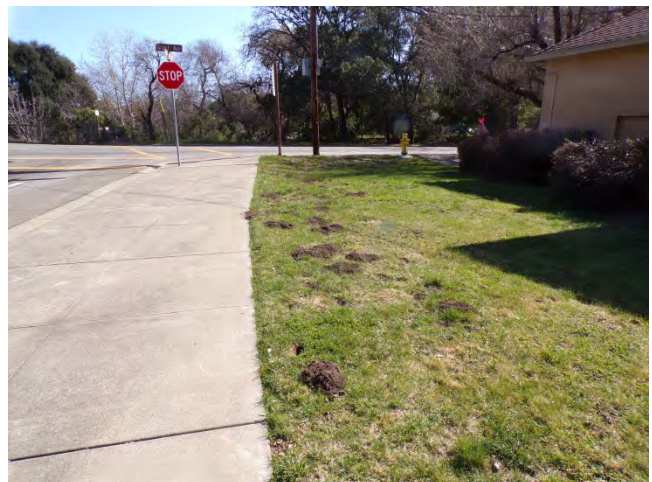
Landscaping elements appeared in generally "Good" condition, though some degraded plants—and missing plants—were observed. There are voids in the asphalt paving where we presume plants were once located. The grass lawn areas have a generally unkempt appearance with weeds, dead grass, and bare spots present. Remedial

18. Grass lawns are in a degraded condition.

| No | Sec | Photos | ITEM | Avg<br>EUL<br>(yr) | EFF<br>AGE<br>(yr) | RUL<br>(yr) | Quantity | Unit | Cost<br>Estimate<br>Source | Unit<br>Cost | Immediate Needs | Replacement Reserves | | | | | | Modernization<br>Costs (Optional) | | | | | | | | | | |
|---|---|---|---|---|---|---|---|---|---|---|---|---|---|---|---|---|---|---|---|---|---|---|---|---|--|--|--|--|
| 1 | B.01 | 18,28 | Provide remedial measures to return all landscaping elements to overall "Good" condition. | N/A | N/A | N/A | 1 | LS | Allowance | \$25,000.00 | | | | | | \$25,000 | | | | | | | | | | | | |

measures to return all landscaping elements to "Good" condition are recommended.

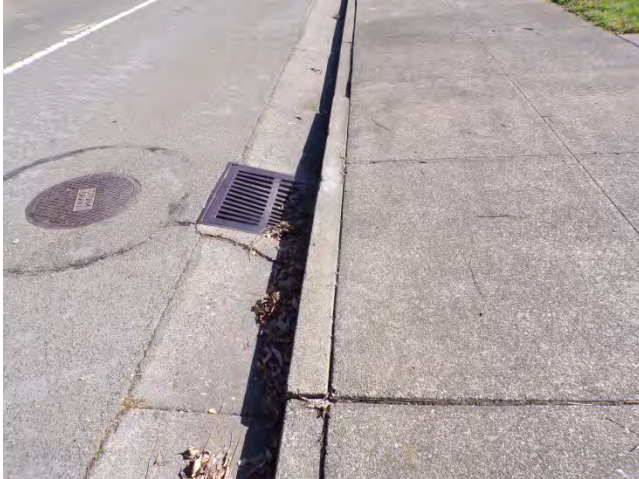
19. Changes in elevation in excess of ¼" create tripping hazards.

| No | Sec | Photos | ITEM | Avg<br>EUL<br>(yr) | EFF<br>AGE<br>(yr) | RUL<br>(yr) | Quantity | Unit | Cost<br>Estimate<br>Source | Unit<br>Cost | Immediate Needs | Replacement Reserves | | | | | | Modernization<br>Costs (Optional) | | | | | | | | | | |
|---|---|---|---|---|---|---|---|---|---|---|---|---|---|---|---|---|---|---|---|---|---|---|---|---|--|--|--|--|
| 2 | B.02 | 18-23 | Provide remedial measures to return concrete sitework to overall "Good" condition. | N/A | N/A | N/A | 1 | LS | Means | \$40,000.00 | | | | | | \$40,000 | | | | | | | | | | | | |

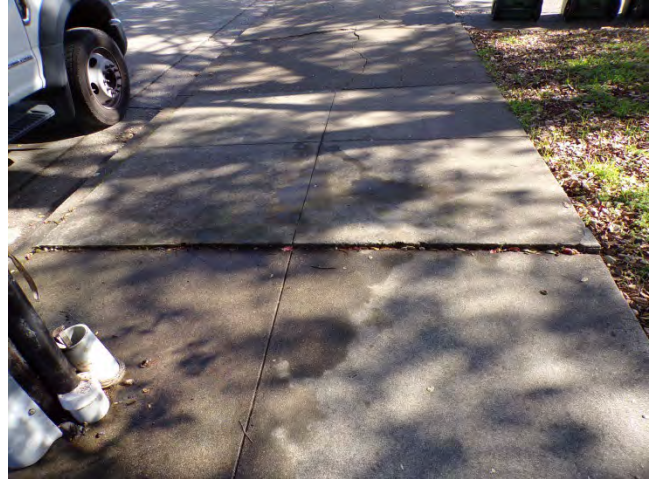
20. Changes in elevation in excess of ¼" create tripping hazards.

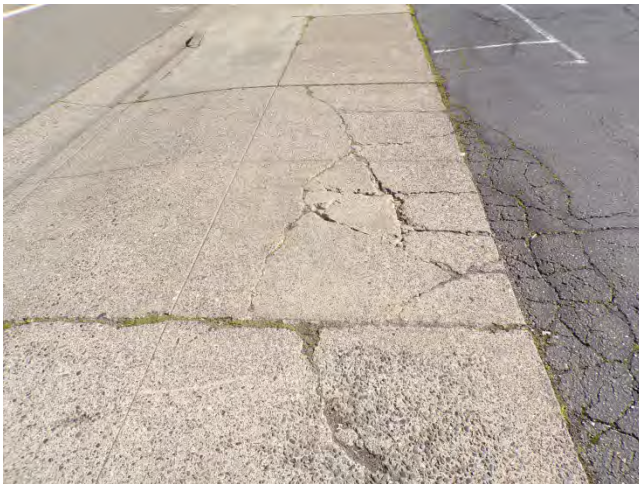
21. Degraded concrete sitework unrelated to tripping hazards were also observed.

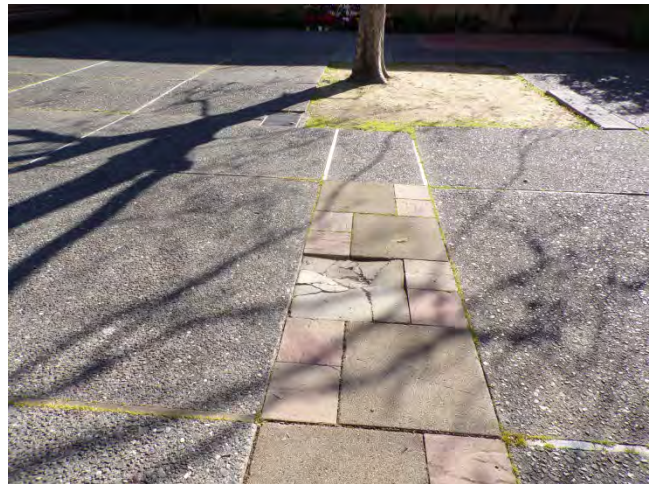
22. Degraded courtyard paving.

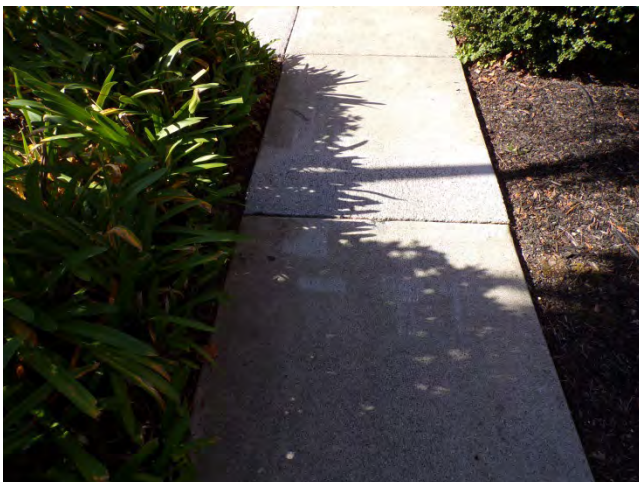
23. Evidence of concrete grinding was observed.

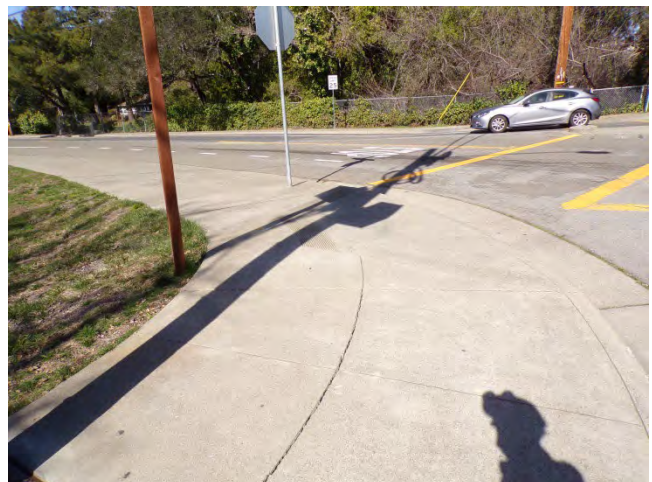
24. Truncated domes are not installed at the curb ramp at the intersection of Grant and Virginia Avenues.

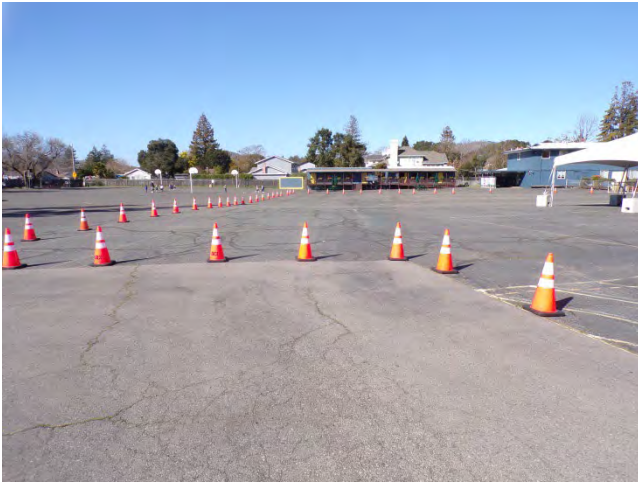
27. The asphalt paving is in a generally degraded condition.

| No | Sec | Photos | ITEM | Avg<br>EUL<br>(yr) | EFF<br>AGE<br>(yr) | RUL<br>(yr) | Quantity | Unit | Cost<br>Estimate<br>Source | Unit<br>Cost | Immediate Needs | Replacement Reserves | | | | | | Modernization<br>Costs (Optional) | | | | | | | | | | |
|---|---|---|---|---|---|---|---|---|---|---|---|---|---|---|---|---|---|---|---|---|---|---|---|---|--|--|--|--|
| 3 | B.02 | 15, 27-32 | Perform minor and full-depth repairs to address degraded surface condition of asphalt paving to return it to "Good" condition. | N/A | N/A | N/A | 1 | LS | Allowance | \$200,000.00 | | | | | | \$200,000 | | | | | | | | | | | | |

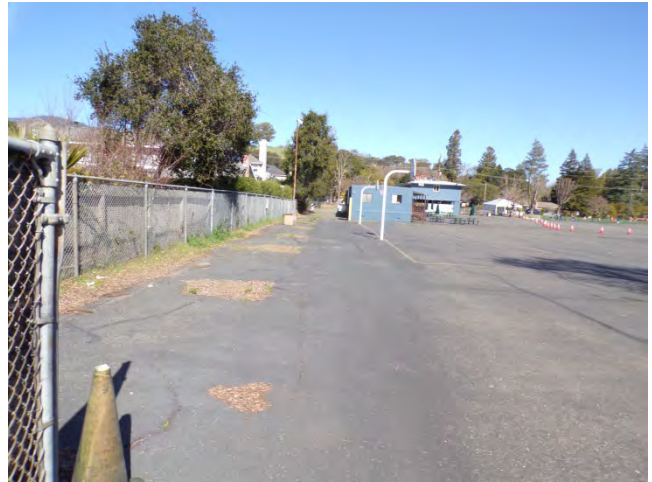
28. Along the west site perimeter, voids in the asphalt paving were observed. AllWest presumes that plants were once installed in these voids.

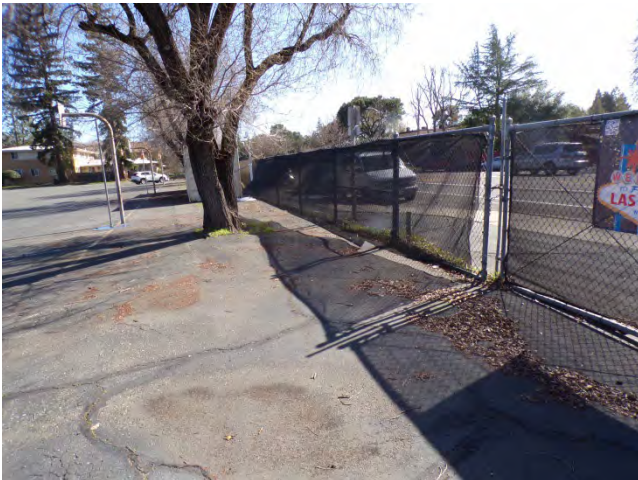
29. Upheavals and depressions in asphalt paving.

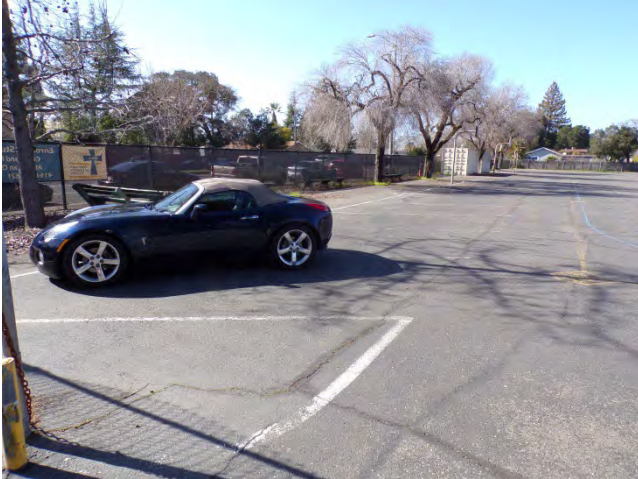
31. Parking stall striping is in an overall degraded condition.

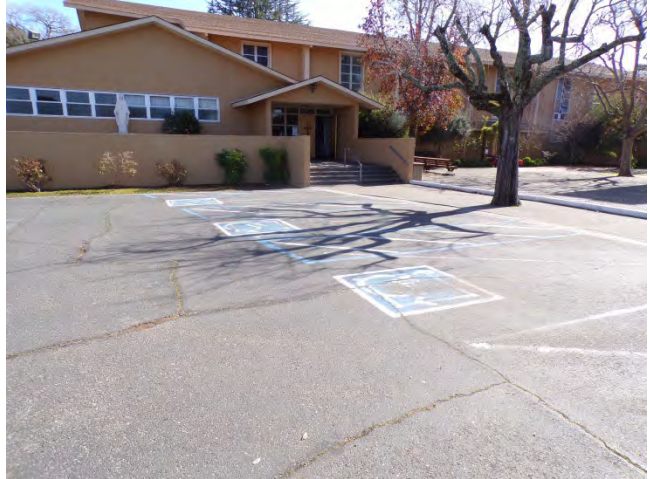
32. Accessible parking stall striping and pavement markings are in a degraded condition. Accessible stalls also lack required signage.

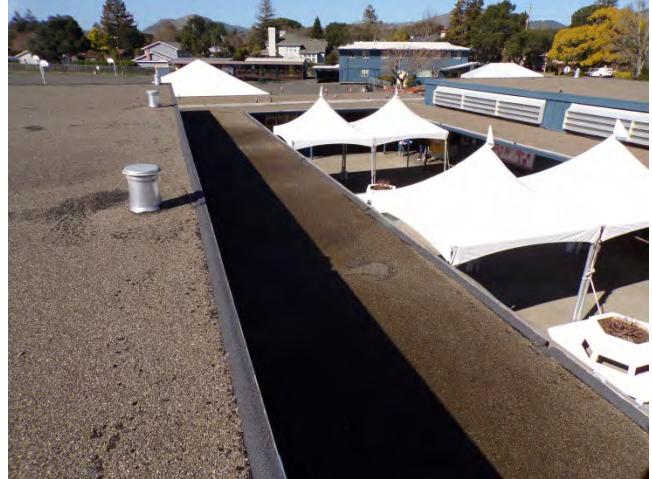
44. School: Replacement of this roofing sytem—and those on all other buildings—is recommended during the reserve term.

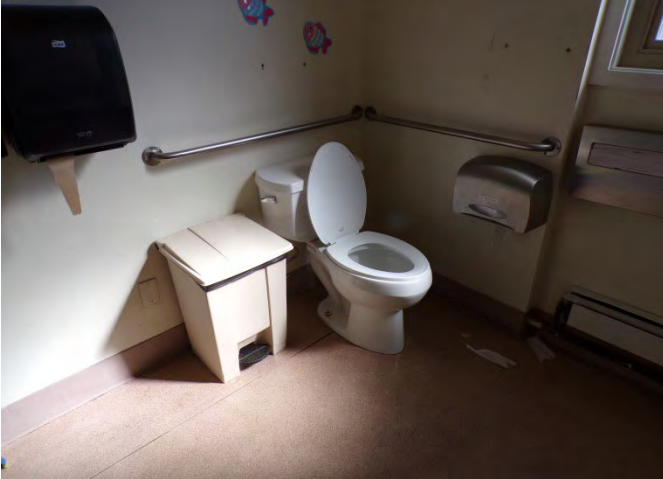
84. School: Finishes and fixtures in office area restroom.  
Many restroom sinks have non-compliant faucet handles for Accessibility.

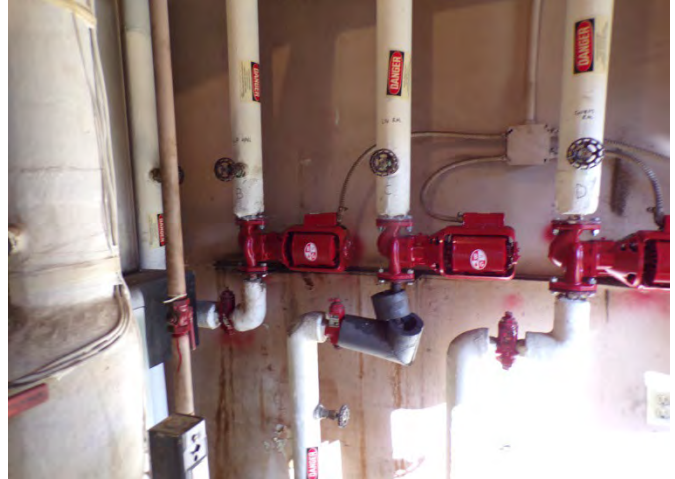
91. Rectory: A natural gas-fired boiler provides hot water to a hydronic loop heating system. The boiler has a rigid gas line connection.

| No | Sec | Photos | ITEM | Avg<br>EUL<br>(yr) | EFF<br>AGE<br>(yr) | RUL<br>(yr) | Quantity | Unit | Cost<br>Estimate<br>Source | Unit<br>Cost | Immediate Needs | Replacement Reserves | | | | | | Modernization<br>Costs (Optional) | | | | | | | | | | |
|---|---|---|---|---|---|---|---|---|---|---|---|---|---|---|---|---|---|---|---|---|---|---|---|---|--|--|--|--|
| 19 | F.02 | 91 | Rectory: Replace natural gas-fired boiler. | 35 | 60 | 0 | 1 | LS | Estimate | \$7,500.00 | | | | | | \$7,500 | | | | | | | | | | | | |

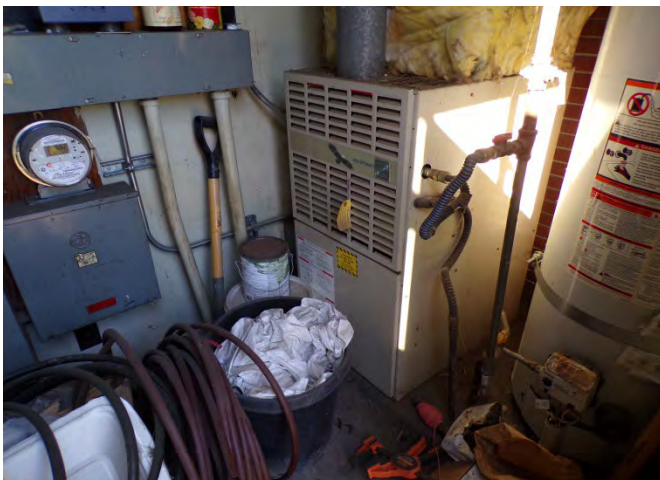
94. Hall Bldg: The Lennox furnaces were manufactured in October of 1975.

| No | Sec | Photos | ITEM | Avg<br>EUL<br>(yr) | EFF<br>AGE<br>(yr) | RUL<br>(yr) | Quantity | Unit | Cost<br>Estimate<br>Source | Unit<br>Cost | Immediate Needs | Replacement Reserves | | | | | | Modernization<br>Costs (Optional) | | | | | | | | | | |
|---|---|---|---|---|---|---|---|---|---|---|---|---|---|---|---|---|---|---|---|---|---|---|---|---|--|--|--|--|
| 21 | F.02 | 94 | MODERNIZATION: Hall Bldg: Replace two natural gas-fired furnaces. | 40 | 48 | N/A | 2 | EA | Estimate | \$6,000.00 | | | | | | | \$12,000 | | | | | | | | | | | |

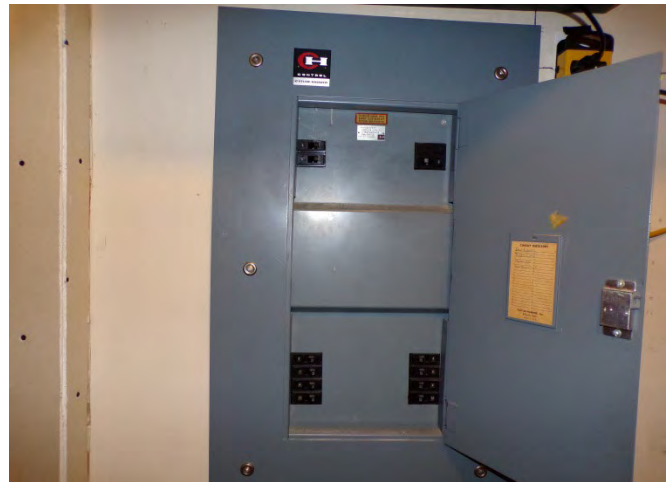
99. Church: This electrical panel is lacking an interior cover plate.

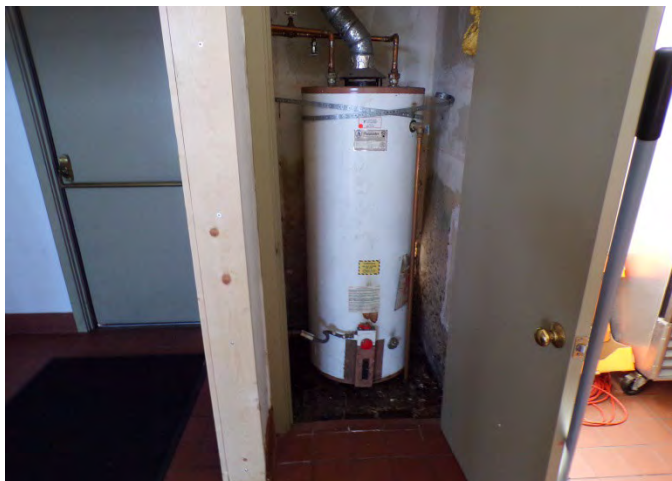
106. Church: The 20-gallon electric water heater has seismic strapping. This unit was manufactured in December of 1995.

| No | Sec | Photos | ITEM | Avg<br>EUL<br>(yr) | EFF<br>AGE<br>(yr) | RUL<br>(yr) | Quantity | Unit | Cost<br>Estimate<br>Source | Unit<br>Cost | Immediate Needs | Replacement Reserves | | | | | | Modernization<br>Costs (Optional) | | | | | | | | | | |
|---|---|---|---|---|---|---|---|---|---|---|---|---|---|---|---|---|---|---|---|---|---|---|---|---|--|--|--|--|
| 29 | F.05 | 106 | Church and Mod Bldg N: Replace 20-gallon electric water heaters. | 20 | 28 | 0 | 2 | EA | Allowance | \$500.00 | | | | | | \$1,000 | | | | | | | | | | | | |

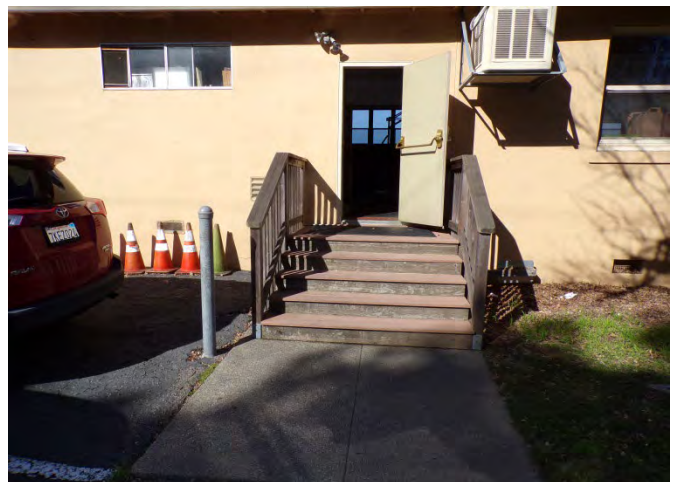
119. Railings at exterior stairs are not compliant with current Accessibility requirements. (Church shown.)
