**PROPERTY CONDITION ASSESSMENT**

**Tiburon Baptist Church  
445 Greenwood Beach Road  
Tiburon, California 94920**

**June 26, 2023**

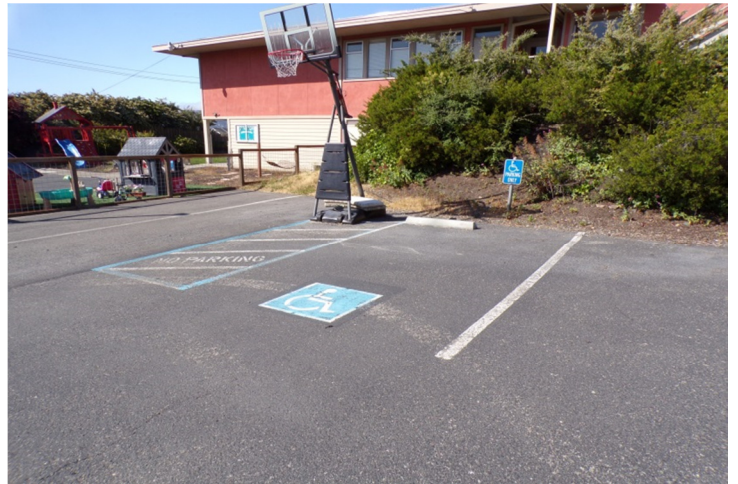
Comment: Alligator, meandering, and linear cracking were present in many areas of the asphalt-paved lots. Evidence of past full-depth repairs was observed. Parking stall striping and other pavement markings are in a somewhat degraded condition. The date of the last parking lot re-seal was reported as October of 2017. We recommend that parking lot re-sealing and re-striping be performed on a five-year schedule. In addition, full depth and minor repairs should be performed to address asphalt degradation during the reserve term.

9. Typical view of parking lot, looking west. Large area of repair at center (darker asphalt). Alligator cracking in foreground.

| IMMEDIATE NEEDS & REPLACEMENT RESERVES ANALYSIS: TIBURON BAPTIST CHURCH, TIBURON CA | | | | | | | | | | | | | | | | | | | | | | | | |
|---|---|---|---|---|---|---|---|---|---|---|---|---|---|---|---|---|---|---|---|---|---|---|---|--|
| 2 | B | 9-12 | Allowance to provide full depth and minor repairs to address cracking in asphalt parking lot and drive aisles. | N/A | N/A | N/A | 1 | LS | Allowance | \$50,000.00 | | \$40,000 | | | | | \$10,000 | | | | | \$50,000 | | |

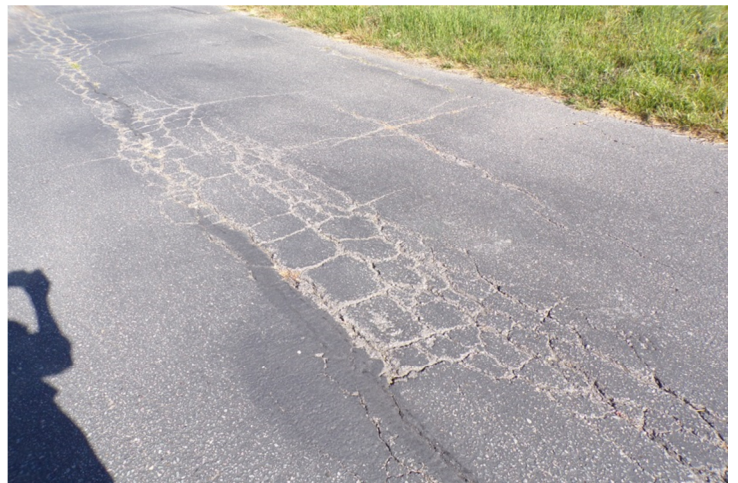
11. Degraded condition of asphalt surface of parking lot and drive aisles.

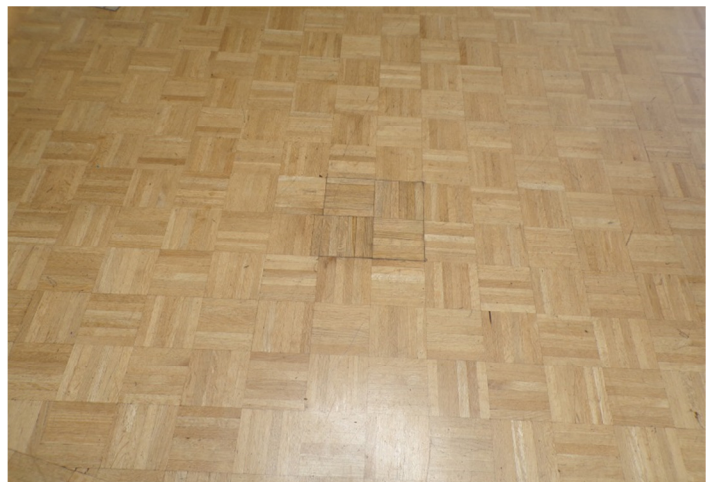
35. Parquet wood flooring has been repaired in various portions of the building.

| IMMEDIATE NEEDS & REPLACEMENT RESERVES ANALYSIS: TIBURON BAPTIST CHURCH, TIBURON CA | | | | | | | | | | | | | | | | | | | | | | | | |
|---|---|---|---|---|---|---|---|---|---|---|---|---|---|---|---|---|---|---|---|---|---|---|---|--|
| 32 | L | 23,35,36 | Repair or replace, as required, damaged or missing wood parquet flooring. | N/A | N/A | N/A | 1 | LS | Allowance | \$1,500.00 | | \$1,500 | | | | | | | | | | \$1,500 | | |

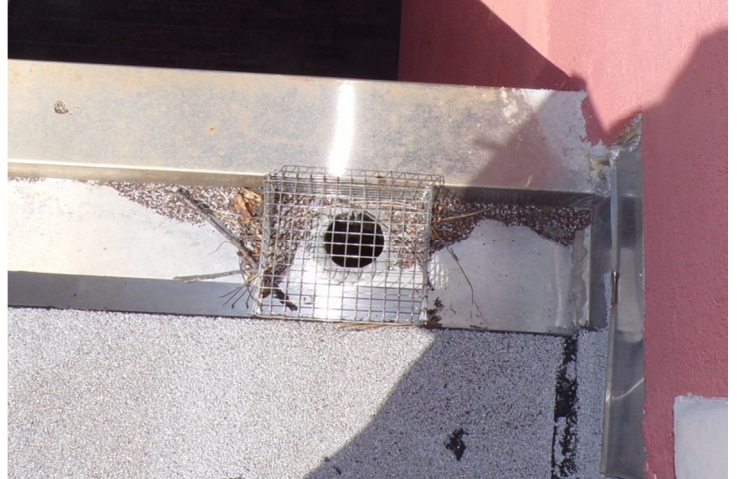
38. Roof drains are provided with wire screens; some were partially blocked with accumulated dead vegetation and other debris.

We recommend that an annual roofing maintenance contract providing for semi-annual inspections, cleanings, and minor repairs be initiated and maintained.

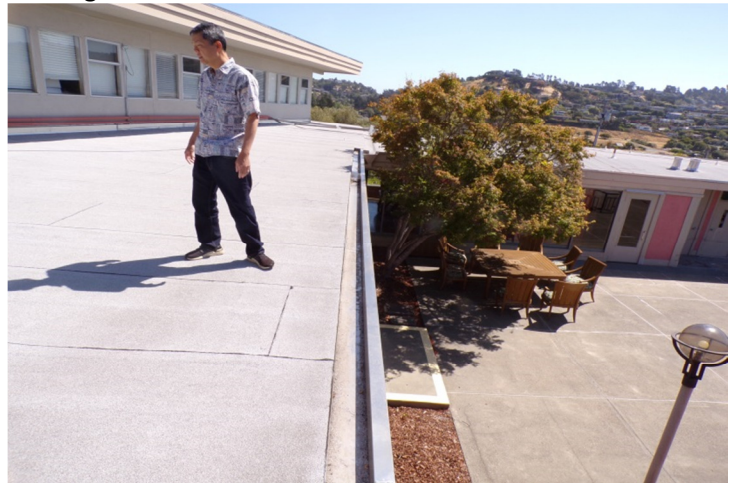
39. New BUR roofing systems were installed in September 2017. Mineral granule separation has already occurred.

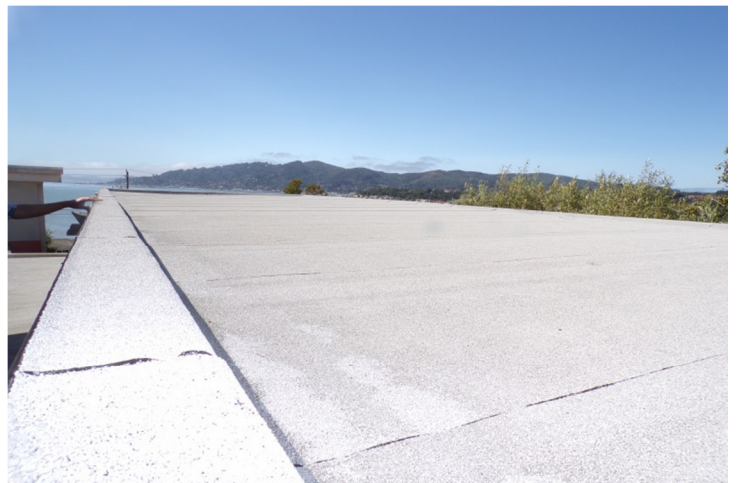
41. A drainage problem was described at this location adjacent to the elevator shaft (in background).

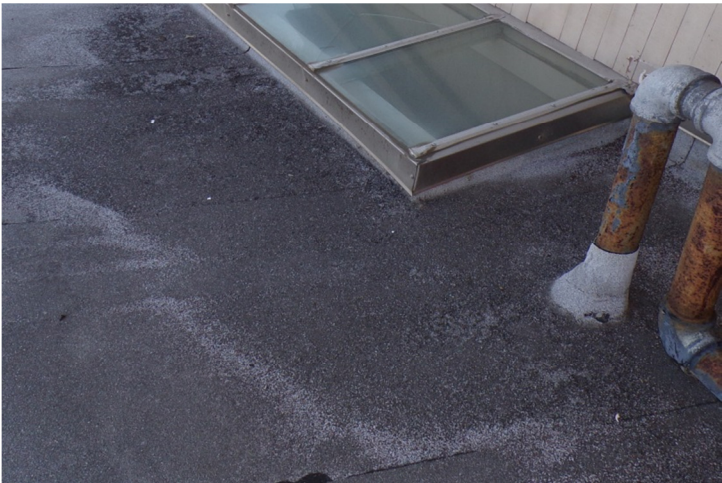
44. Two sets of aluminum framed skylights are installed in the vicinity of the Sanctuary on the roof above the main floor. Second pane from bottom is cracked.

| IMMEDIATE NEEDS & REPLACEMENT RESERVES ANALYSIS: TIBURON BAPTIST CHURCH, TIBURON CA | | | | | | | | | | | | | | | | | | | | | | | | |
|---|---|---|---|---|---|---|---|---|---|---|---|---|---|---|---|---|---|---|---|---|---|---|---|--|
| 15 | E | 44 | Replace broken glass pane in skylight at north end of Sanctuary. | N/A | N/A | N/A | 1 | LS | Allowance | \$500.00 | | \$500 | | | | | | | | | | \$500 | | |

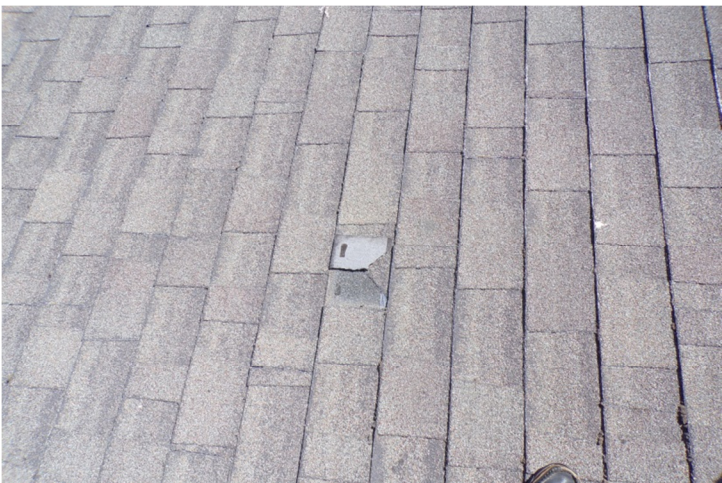
46. Asphalt composite shingles on lower-sloped pitched roofs are in a degraded condition. North side of building shown.

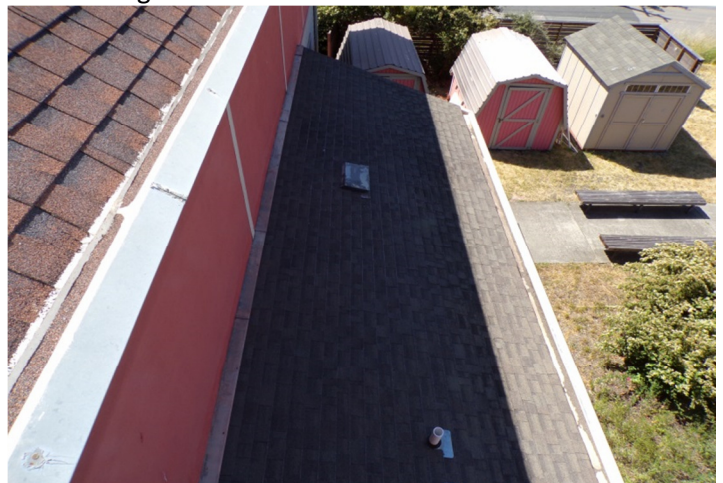
47. Asphalt composite shingles are provided above main level spaces on north side of building. Cracked and folded shingle shown.

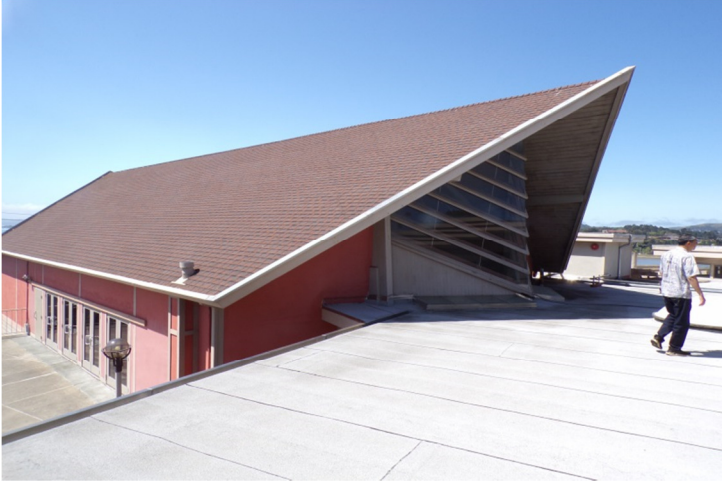
48. Asphalt composite shingles on lower-sloped pitched roofs are in a degraded condition. West side of building shown.

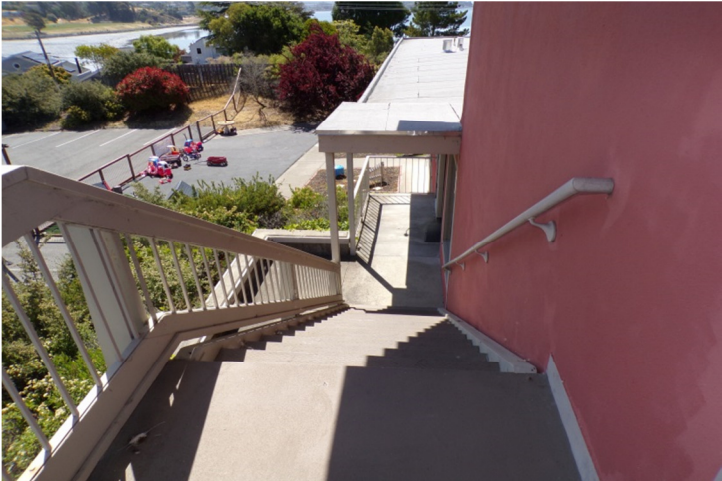
Nonetheless, the guardrails and handrails are not compliant with current codes. Upgrades to the guardrails and handrails are recommended.

60. Both sets of exterior concrete stairs no longer comply with current building and Accessibility codes.

| IMMEDIATE NEEDS & REPLACEMENT RESERVES ANALYSIS: TIBURON BAPTIST CHURCH, TIBURON CA | | | | | | | | | | | | | | | | | | | | | | | | |
|---|---|---|---|---|---|---|---|---|---|---|---|---|---|---|---|---|---|---|---|---|---|---|---|--|
| 12 | D | 60,61 | MODERNIZATION: Replace both sets of exterior concrete stairs with steel stairs that comply fully with current building and Accessibility codes. | N/A | N/A | N/A | 1 | LS | Allowance | \$35,000.00 | | | | | | | | | | | | \$0 | | |

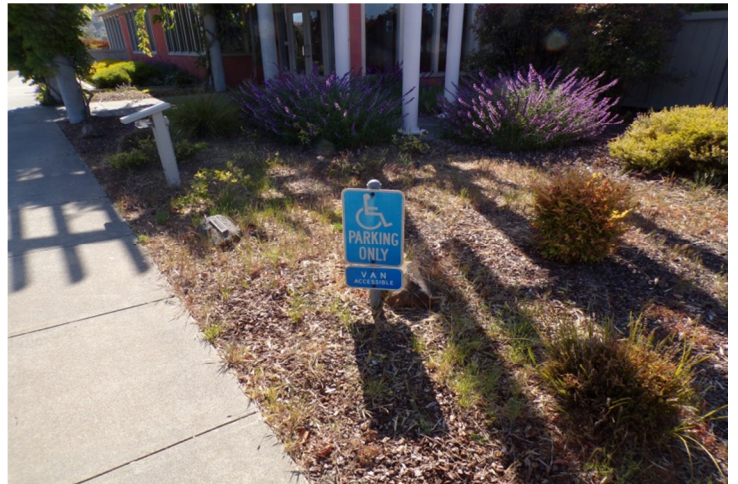
63. Path of travel pavement markings from north Accessible parking stall are lacking.

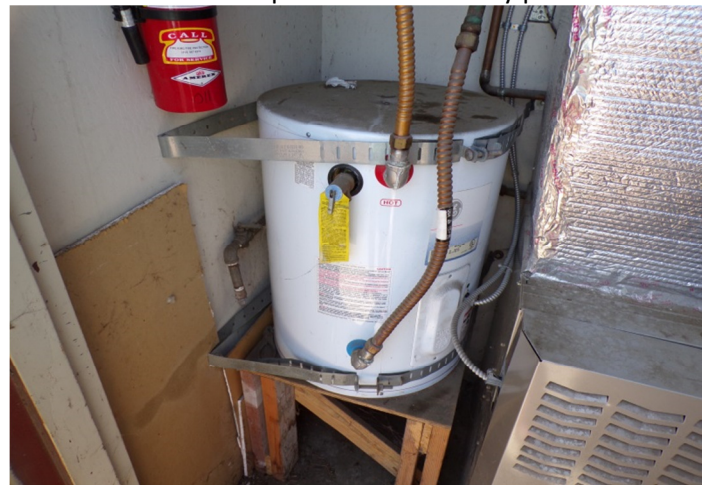
75. We recommend that all water heaters be replaced during the reserve term. Natural gas-fired water heater in main level mechanical room shown.

| IMMEDIATE NEEDS & REPLACEMENT RESERVES ANALYSIS: TIBURON BAPTIST CHURCH, TIBURON CA | | | | | | | | | | | | | | | | | | | | | | | | |
|---|---|---|---|---|---|---|---|---|---|---|---|---|---|---|---|---|---|---|---|---|---|---|---|--|
| 19 | F | 75 | Replace one 30 gallon gas-fired water heater as the unit has reached the end of its serviceable life. | 20 | 23 | 0 | 1 | EA | Estimate | \$2,000.00 | | \$2,000 | | | | | | | | | | \$2,000 | | |

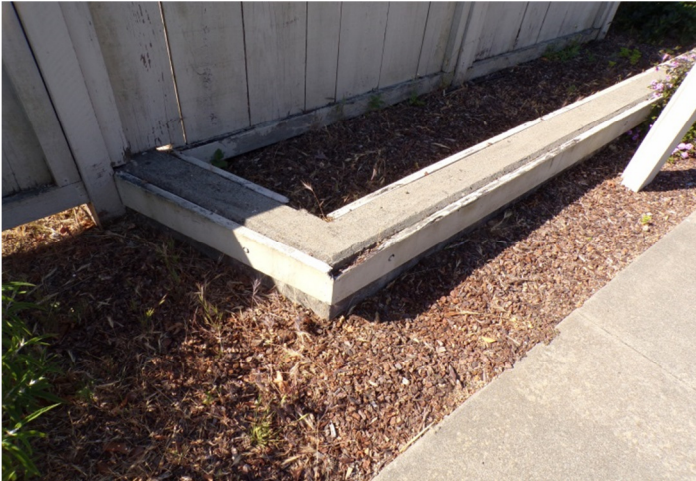
Obvious Signs of Settlement: None observed and none reported, with the exception of possible soil settlement at the small concrete patio area on the west side of the building.

84. Possible differential settlement was reported at concrete-paved patio on west side of building (2016 photo).

| IMMEDIATE NEEDS & REPLACEMENT RESERVES ANALYSIS: TIBURON BAPTIST CHURCH, TIBURON CA | | | | | | | | | | | | | | | | | | | | | | | | |
|---|---|---|---|---|---|---|---|---|---|---|---|---|---|---|---|---|---|---|---|---|---|---|---|--|
| 6 | C | 84 | MODERNIZATION: Conduct civil/structural engineering investigation to evaluate possible soil settlement at patio, if condition worsens. | N/A | N/A | N/A | 1 | LS | Allowance | \$4,000.00 | | | | | | | | | | | | \$4,000 | | |

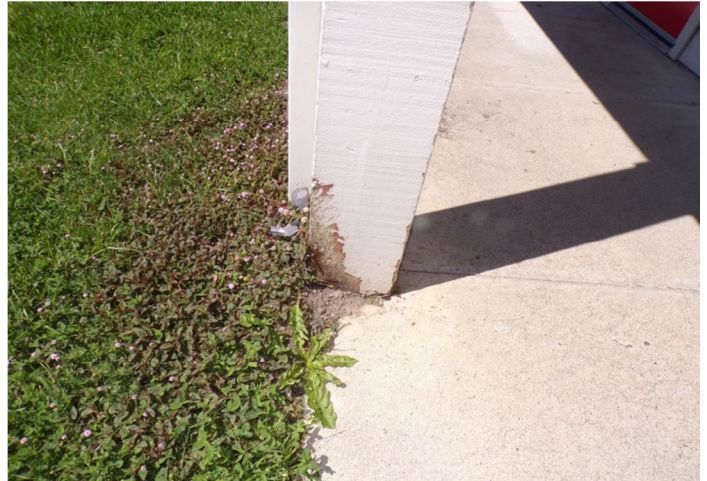
85. Degraded exterior wood was observed in several locations.

| IMMEDIATE NEEDS & REPLACEMENT RESERVES ANALYSIS: TIBURON BAPTIST CHURCH, TIBURON CA | | | | | | | | | | | | | | | | | | | | | | | | |
|---|---|---|---|---|---|---|---|---|---|---|---|---|---|---|---|---|---|---|---|---|---|---|---|--|
| 9 | D | 58,85,86 | Allowance to replace and to make repairs to degraded exterior wood building elements during exterior re-painting (including glulam columns at Sanctuary). | N/A | N/A | N/A | 1 | LS | Allowance | \$165,000.00 | | \$165,000 | | | | | | | | | | \$165,000 | | |
