# SEISMIC RISK ASSESSMENT FOR DUE DILIGENCE

**2030 Harrison Street**  
**San Francisco, California**  
**1 May 2026**

**SGH Project 268064**

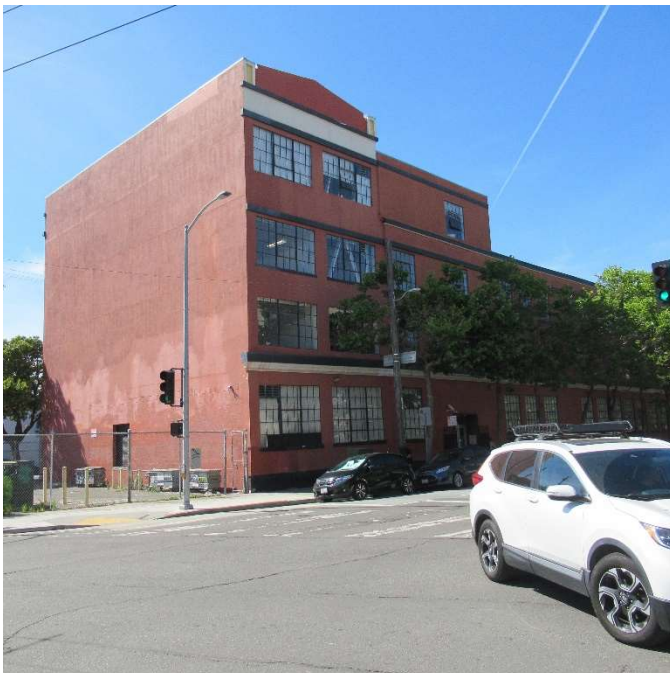
**Photo 6**

Addition Building south and east elevation. Note 3rd floor steel braced frame.

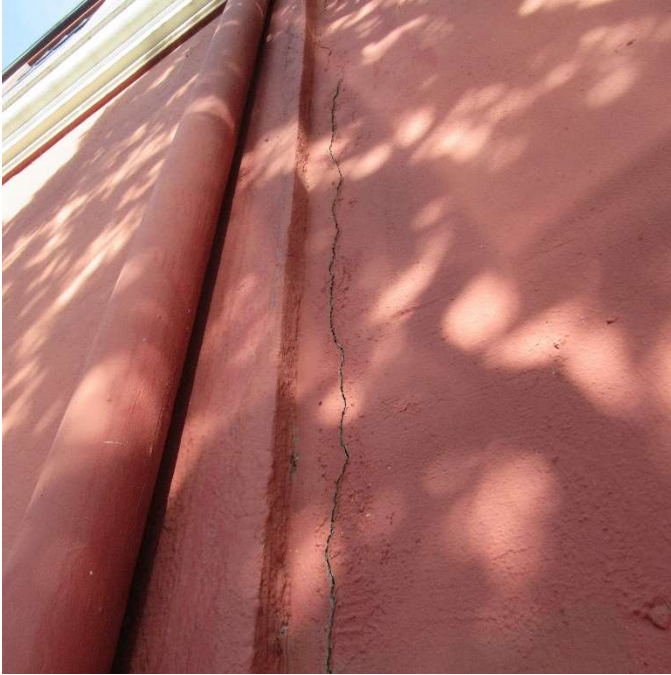
**Photo 9**

Stucco cracking at Original to Addition Building joint due to minor differential movement.

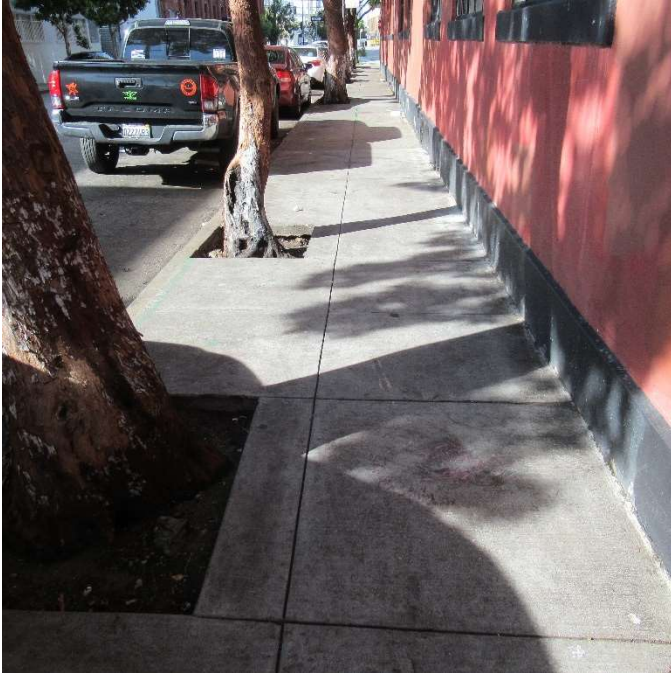
**Photo 11**

Ms. Silver reported minor building condition issues and the concrete spalls exposing corroded reinforcing steel on the south wall of the Addition Building. She also indicated the surrounding sidewalks have reverse slopes that drain runoff water toward the building.

Original Building west sidewalk that slopes down, negative slope, towards building due to tree root growth.

Note that these recommendations are separate and in addition to the condition-related repairs to the Addition Building's south wall, the Original Building's heavy timber framing repairs, and the surrounding grade slope towards the building. These potential repairs are outside the scope of the seismic evaluation.

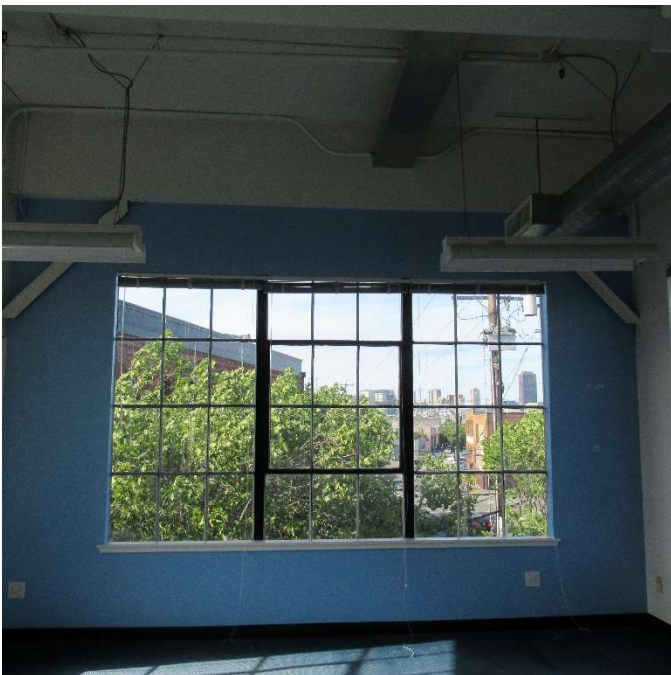
**Photo 14**

Original Building north wall third story with knee braces to stiffen wall.

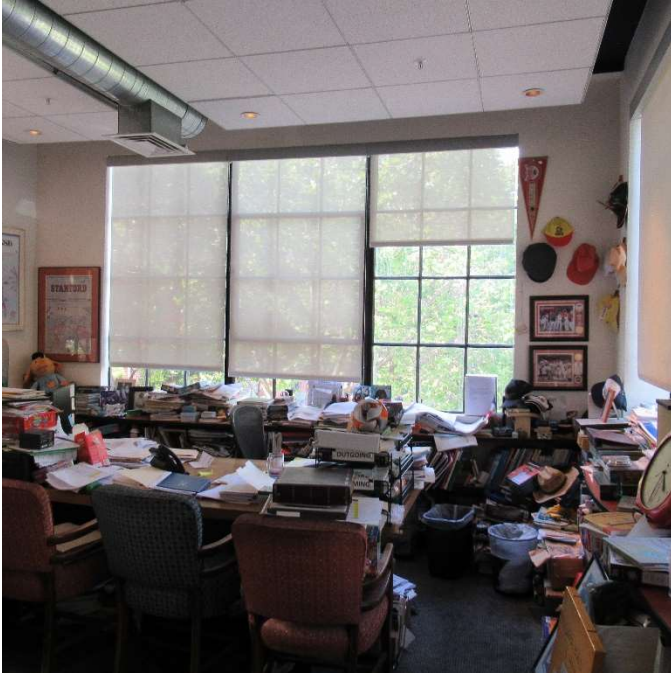
**Photo 15**

Original Building north wall second story with no apparent seismic retrofit.

Voluntary seismic retrofit measures can be implemented to reduce a building's damageability. A partial seismic retrofit to address the open north elevation of the Original Building at the second and third story levels would reduce the building's damageability. We recommend considering the following limited measures to reduce the structure's seismic risk:

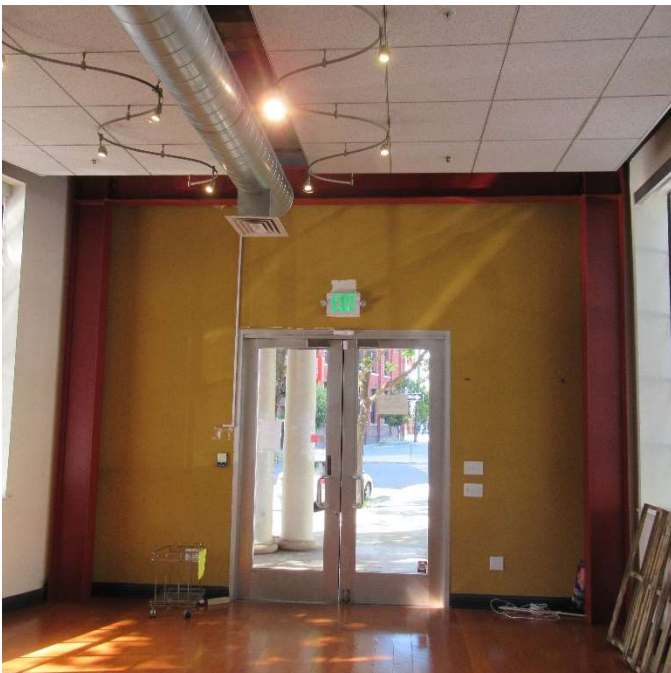
**Photo 16**

We observed retrofit steel braced frames on all floors on the east and west sides in the Addition Building and a retrofit first story steel moment frame on the north side in the Original Building. While our permit search did not reveal the date of construction, we presume the retrofit was completed in the early 1990s.

Original Building first story retrofit steel moment frame building's north end.

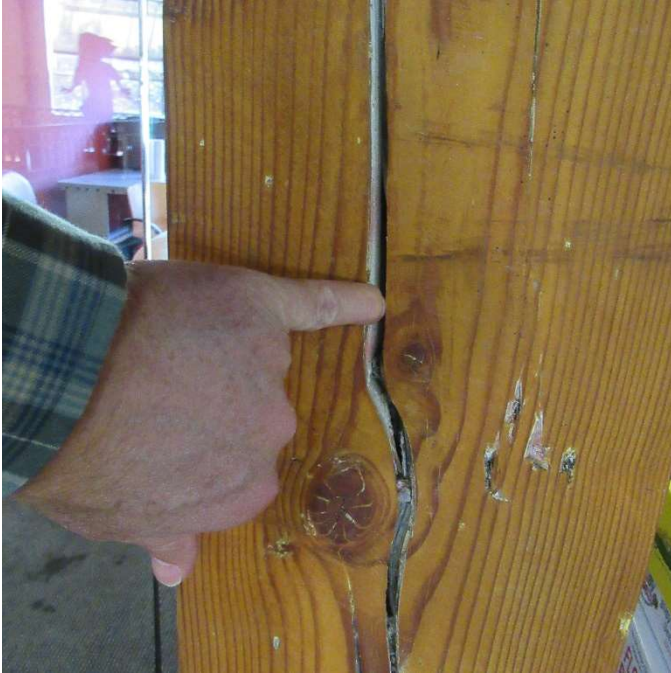
**Photo 19**

We observed many Original Building heavy timber beams and columns with large checking cracks. We judge these cracks to not be seismically significant but some of the cracks may merit repair or member strengthening for serviceability and gravity loads.

Original Building heavy timber column with large checking crack.

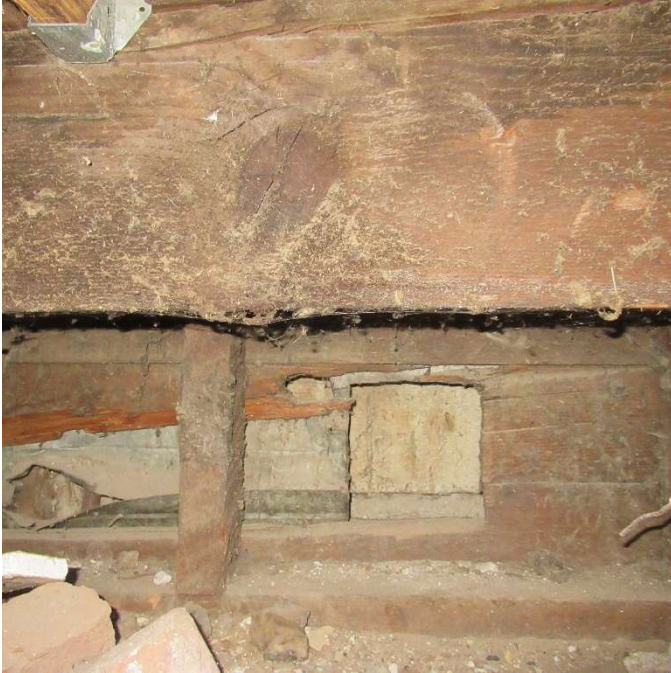
**Photo 21**

and interior plaster will also contribute to the shear walls' strength and stiffness. We observed an example of cripple wall bracing in the very limited crawl space access. We could observe very few sill plate conditions at the foundation but presume the sill plates are bolted to the foundation.

Original Building crawl space with partially cut cripple wall sheathing.

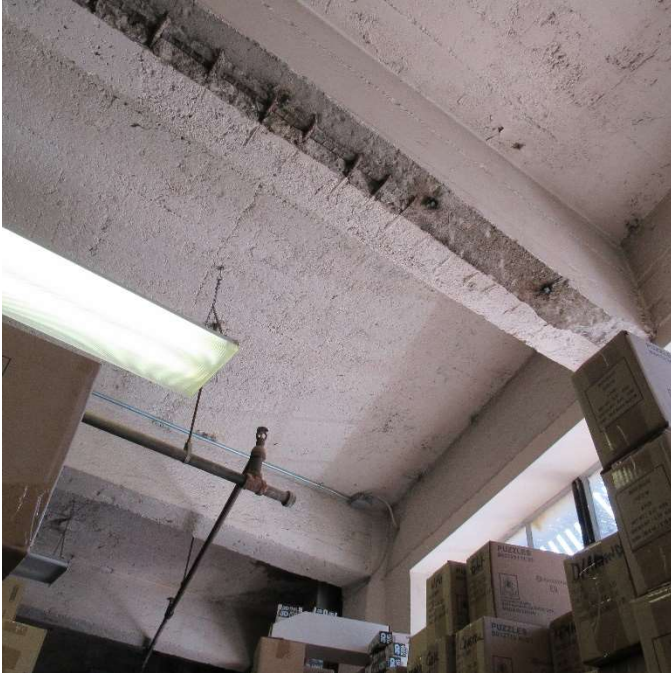
**Photo 29**

Addition Building damaged concrete beam exposing reinforcing steel.

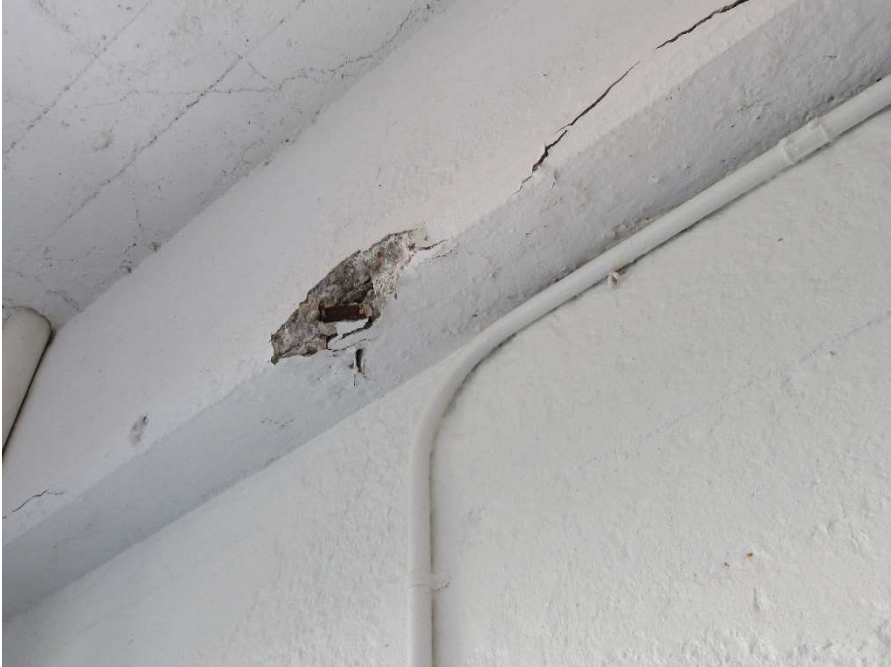
**Photo 32**

The buildings' seismic force resisting system appears typical for the vintage of design and construction. The Addition Building's south shear wall has some cracking and spalling but the condition is not likely to play a significant role in the building's seismic response.

Addition Building south wall concrete beam with cracking and exposed corroded reinforcing steel.
