## PROPERTY CONDITION ASSESSMENT

**301 Battery Street, San Francisco, CA 94111**

**Project 26030.60  
September 22, 2026**

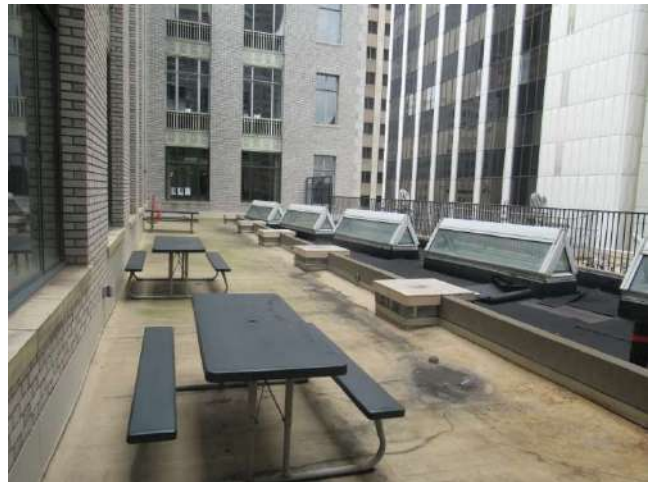
10. Fourth floor terrace is constructed with a cast-in-place concrete slab over a waterproof membrane. The row of triangular skylights was apparently installed after 2019.

- Allowance to refinish steel-framed window assemblies;
- Provide new elastomeric deck coating on fourth floor roof terrace;
- Replace 53 tons of water source heat pump capacity as units reach the end of their serviceable lives;

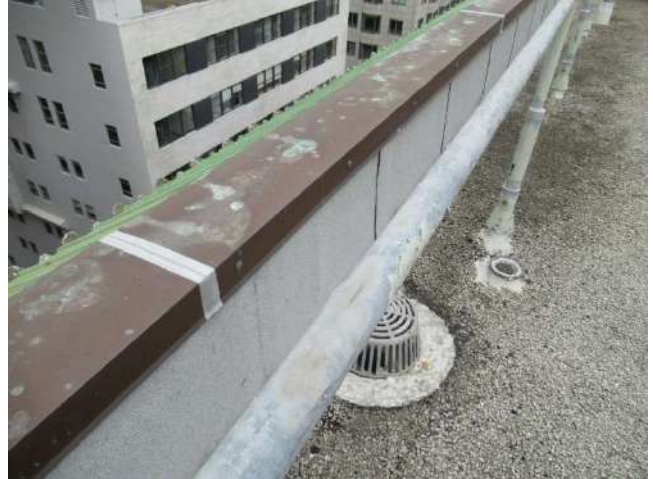
The BUR roof is assumed to have been replaced during the 1989 renovation, though its actual age is unknown; it appears worn and has exceeded its EUL. We generally apply a 20-year EUL for BUR roofing systems; BUR roof replacement is recommended during the reserve term.

13. Built-up roofing system at top roof.

- Allowance for remedial measures to address deficiencies identified in evaluation report cited above;
- Replace built-up roofing systems in all flat-roofed areas where installed;

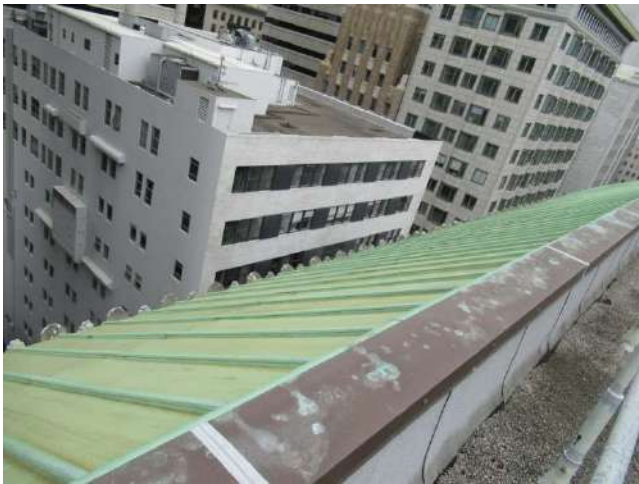
15. Sloped copper roofing systems are provided.

We are including in the Spreadsheet an allowance for copper roofing repairs to address minor leaking. Additionally, we are including as an optional Modernization expense a cost estimate to replace the copper roofing system, should that be deemed necessary during the ten-year term of our analysis.

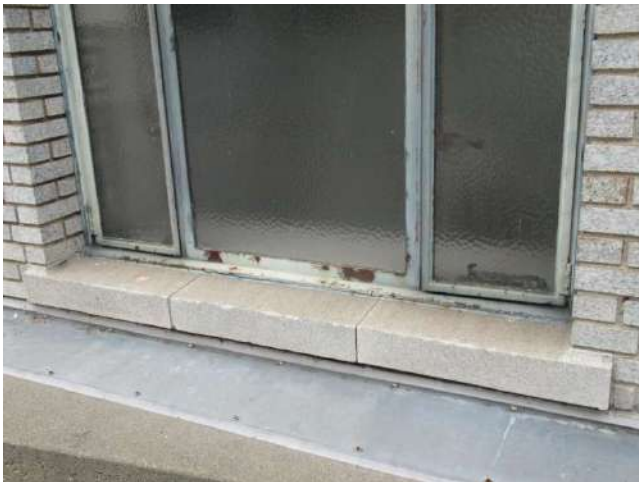
21. Window frames show considerable deterioration in some areas.

- Allowance for repairs to address leaks at copper roofing systems;
- Conduct evaluation of steel-framed windows to determine the extent of rust damage and make recommendations for remedial measures along with cost estimates;

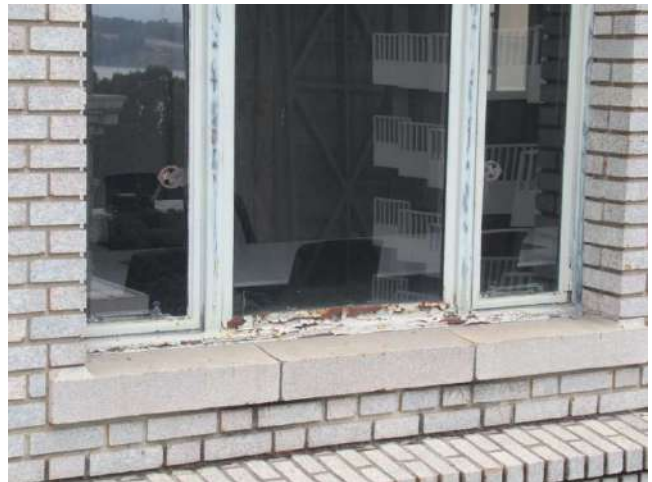
22. Steel window frames require refinishing in some locations.

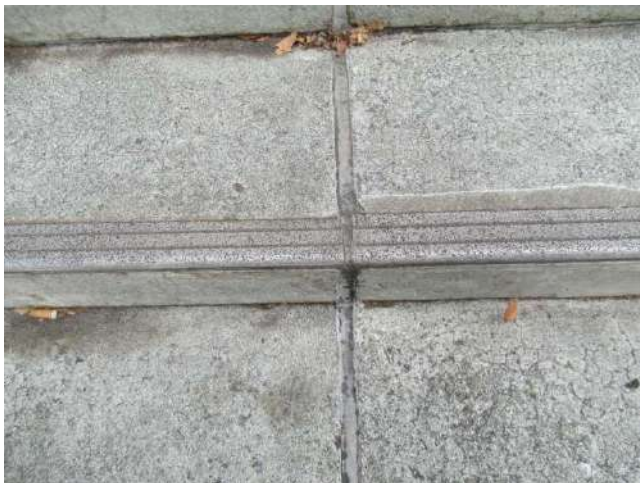
Minor leaks into the basement at the exterior stairs have occurred when washing the stairs. We are including in the Spreadsheet cost estimates for an evaluation of the exterior waterproofing elements at grade at on the stairs, as well as an allowance to provide prospective repairs.

65. Elastomeric seals at the building stair entrances at east and west sides of building. No cracks or breaks were visible, but leaks were reported after power washing was done.

- Allowance to replace degraded landscaping elements;
- Conduct evaluation of exterior site waterproofing elements at grade level and at exterior stairs to determine what remedial measures are required to mitigate water intrusion into basement level(s). Evaluation can be conducted in coordination with the separate evaluation discussed in the bullet item for windows;

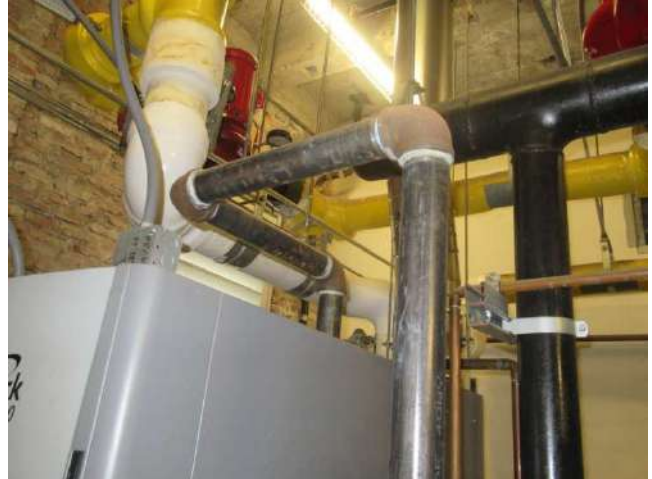
68. The gas supply to the boilers is the 2 1/2" diameter pipe in the foreground. A flexible connection to the boiler is not provided.

- Allowance for supply air fan shaft replacements in the event of failure due to age;
- Replace standard electrical receptacles with GFCI type when within six feet of a water source;
- Replace the rigidly piped natural gas connections on the boilers with flexible connections for earthquake safety;
- Replace remaining standard porcelain plumbing fixtures with low-flush porcelain fixtures as required by the San Francisco Water Department for water conservation purposes;
- Replace water heaters as they reach the end of their serviceable lives;
- Conduct a video snake sewer line inspection by licensed plumber;
- Allowance for potential main fire alarm panel hardware and software upgrades;
- Modernize hydraulic elevator equipment;
- Modernize traction elevator equipment;
- Install sanitary napkin dispensers which are compliant with current Accessibility requirements.

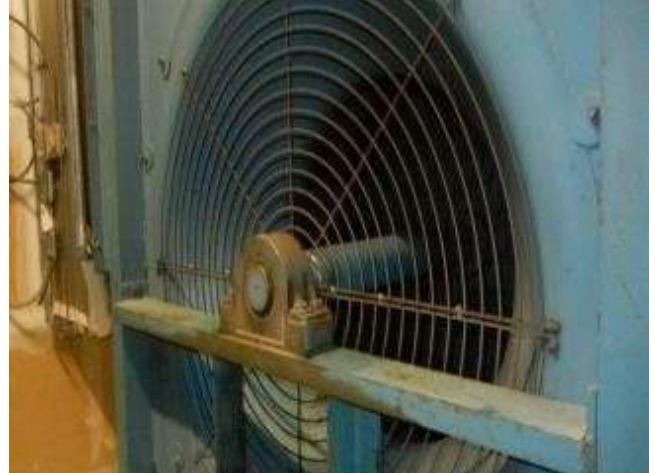
74. One of two supply air fans serving floors 1 through 7. Due to the age of the fans, shaft replacement should be anticipated during the reserve term. (2019 photo)
