## PROPERTY CONDITION ASSESSMENT

285 Sobrante Way, Sunnyvale, CA 94086

ALLWEST PROJECT 24152.60  
December 19, 2024

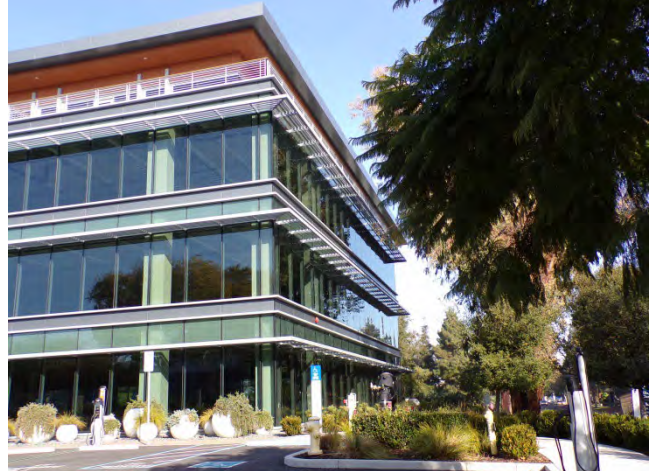
2. East elevation at right—portion of south elevation at left.

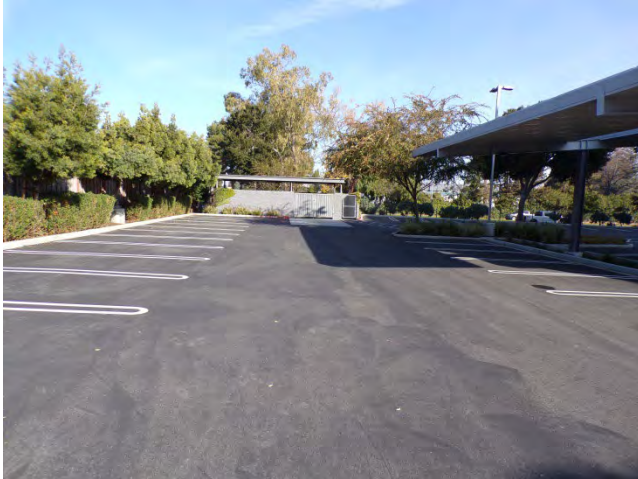
19. The asphalt-paved parking lot appeared in "Excellent" condition.

AllWest generally recommends asphalt resealing on a five-year schedule. However, in this case—since the asphalt condition remains virtually "Excellent" and vehicular usage will remain close to non-existent until the building is occupied—it is AllWest's opinion that resealing and restriping can be deferred beyond the five year term of our analysis.

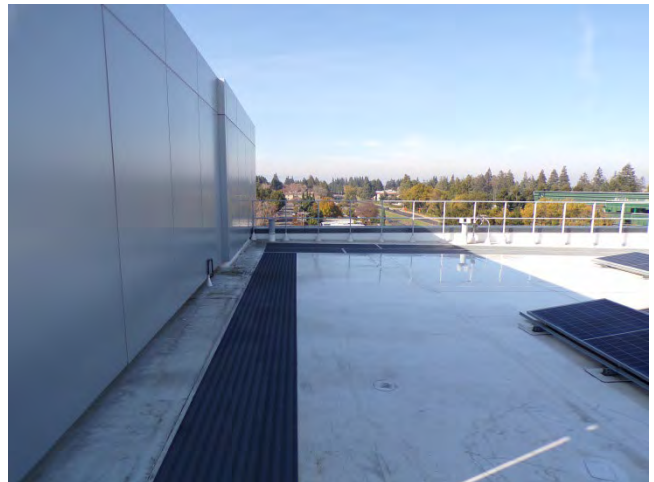
28. HVAC equipment screens are installed on the roof. They consist of aluminum composite panels on galvanized steel stud framing (at left).

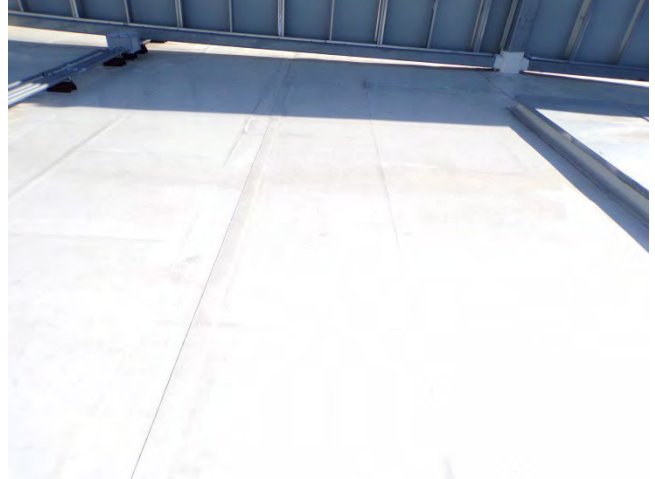
32. The roofing system has a 20-year NDL warranty.

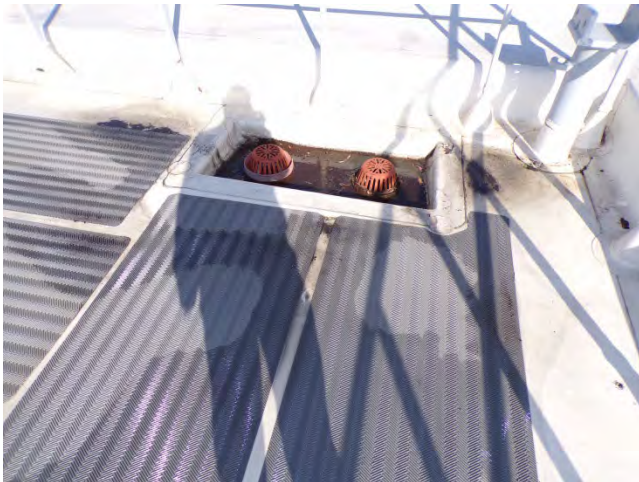
33. Near three drain combinations, the roof has a spongy feel when walking on it.

Soft areas in the roofing system near roof drains were sensed in three locations. These are at the northeast and southeast corners of the building and at the first drain combination to the west of the southeast corner. In these areas the roof has a spongy feel and a sound can be heard underfoot when stepping on these areas. AllWest recommends that a roofing contractor—and perhaps the roofing installer, Courtney, Inc.—be contacted to investigate if water penetration below the TPO membrane has occurred in the affected locations. No cost estimate is included for this recommendation; we are basing this exclusion on the fact that the roofing system is still within its manufacturer’s warranty period. The installer’s warranty has expired.

AllWest observed and photographed the underside of the roof deck at these three drain locations—and at others—and perceived no conclusive indication that current, active leaks through the roofing system were occurring. Below the southeast corner drain, there is a small rust stain on the concrete floor slab. AllWest presumes that at some time, a very small amount of water dropped from the drainpipe directly above the stain.

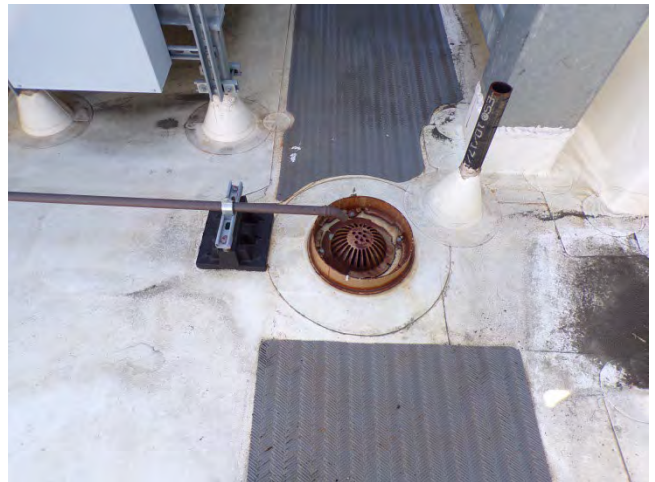
34. A grated drain without an overflow drain is provided for HVAC system condensate.

The main roofing system has minimal slopes conveying storm water and atmospheric condensation water—as opposed to HVAC condensate—to 4” atrium grated roof and overflow drain combinations in nine locations. The drains are located in recessed, shallow sumps. The sumps were largely clear of debris, though small amounts of standing water—as a result of atmospheric condensation drainage—were observed in the sumps. Condensation build-up on TPO roofing systems is more prevalent than on built-up roofing (BUR) systems. One grated roof drain, without an overflow drain, is provided for HVAC condensate drainage.

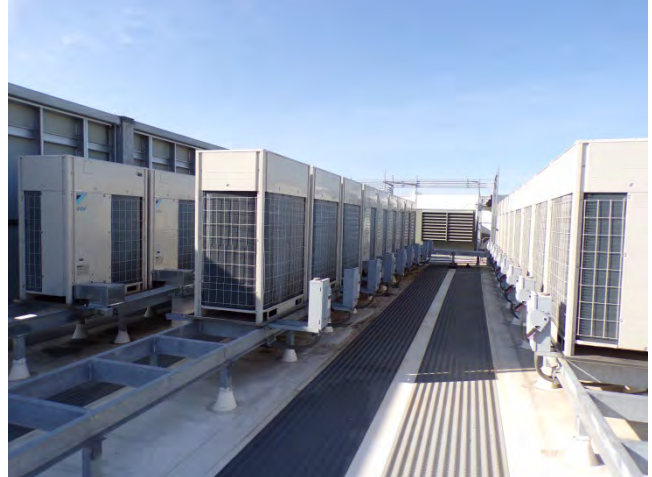
68. Twenty-seven *Daikin* rooftop VRV heat recovery compressor units are installed.

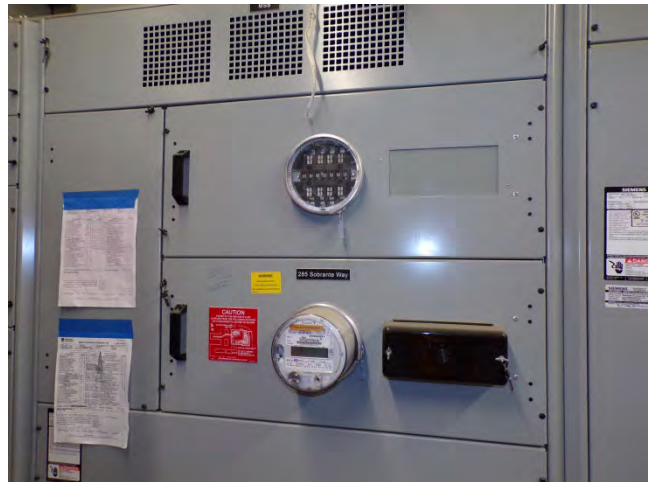
76. A *Seimens* 4,000 amp main service entrance panel is installed.

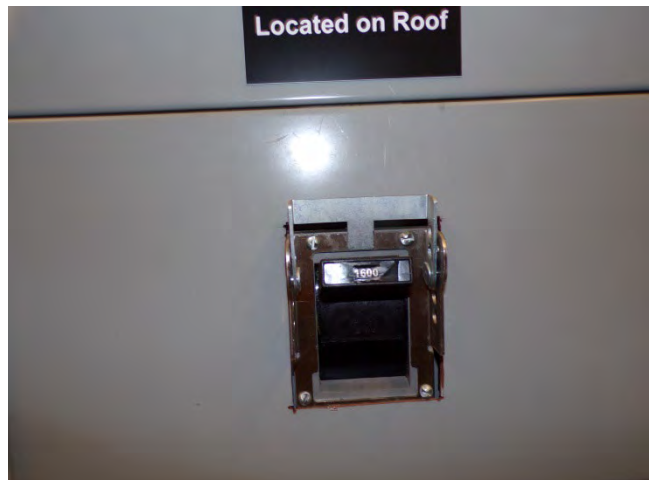
78. A 1,600 amp sub-main serves the rooftop HVAC equipment.

The five-year replacement reserves are estimated at **\$11,952**, which includes a 2.5% per year inflation factor. Expenditures include conducting ground fault performance testing and inspection of circuit breakers rated 1,000 amps and greater and infrared scanning of electrical distribution systems.
