## PROPERTY CONDITION ASSESSMENT

**Summerwood Apartments, 444 Saratoga Avenue  
Santa Clara, CA 95050**

**ALLWEST PROJECT 24120.60  
October 3, 2024**

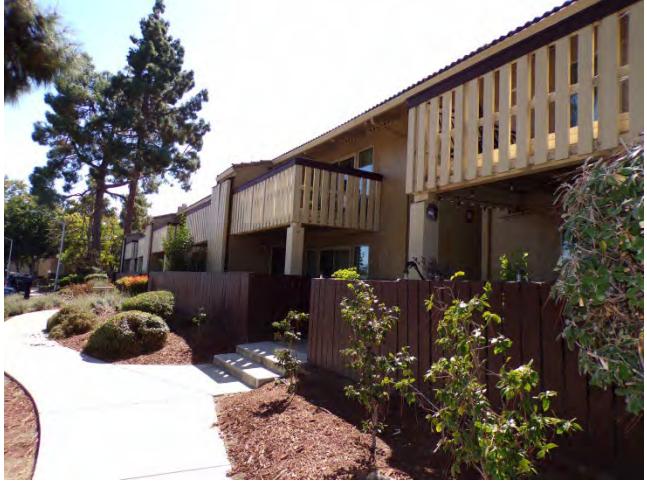
2. Bldg 1: Partial view of east elevation. Balcony railings on this building have been replaced.

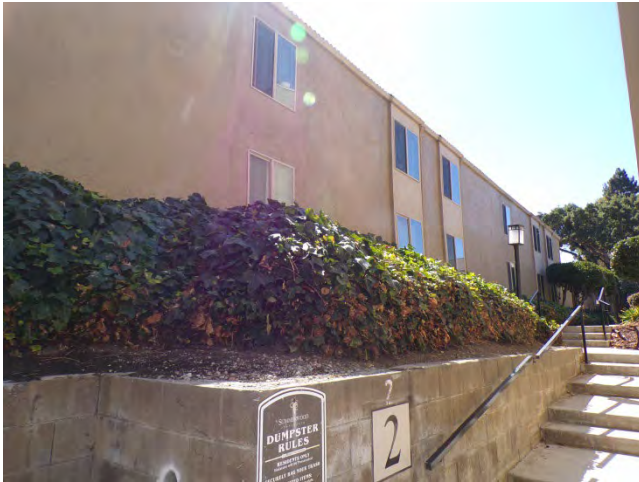
3. Bldg 2: North elevation. This is one of 12 buildings without tuck-under parking.

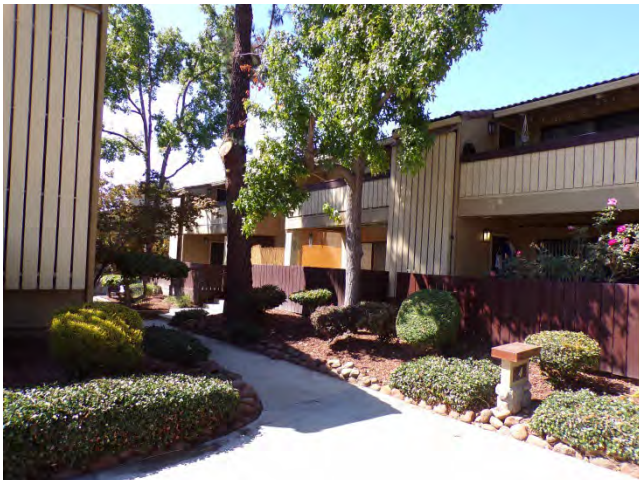
5. Bldg 4: Partial view of south elevation. Landscaping is attractive and appeared in generally "Good" condition.

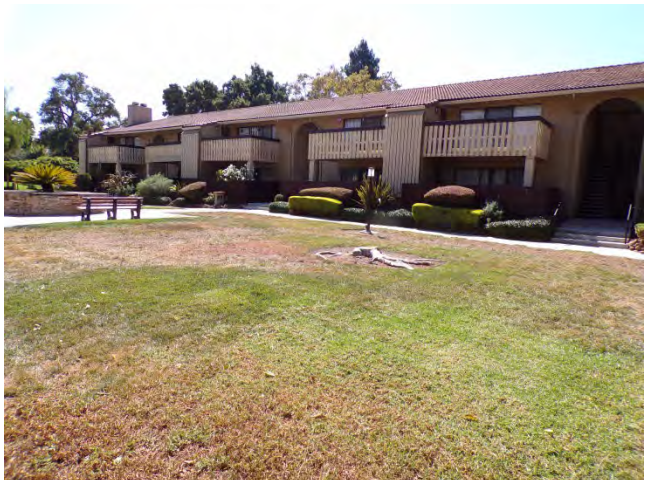
6. Bldg 5: Partial view of east elevation. Some landscaping elements are in a degraded condition. Dead grass and tree stump shown.

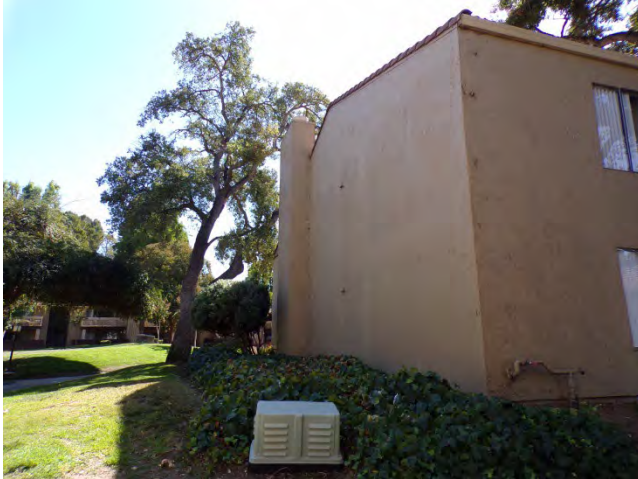
7. Bldg 6: East elevation. Short elevations on the residential buildings have no windows.

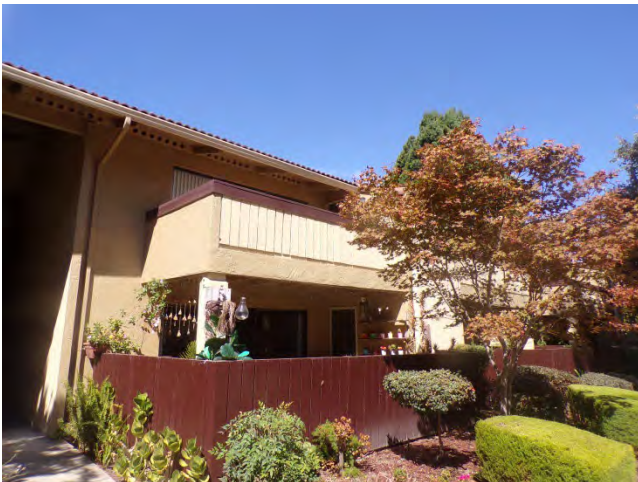
9. Bldg 8: South elevation. Balcony railings have been replaced. This is the older design for the replaced railings with the stucco portion left in place on the short side of the balcony.

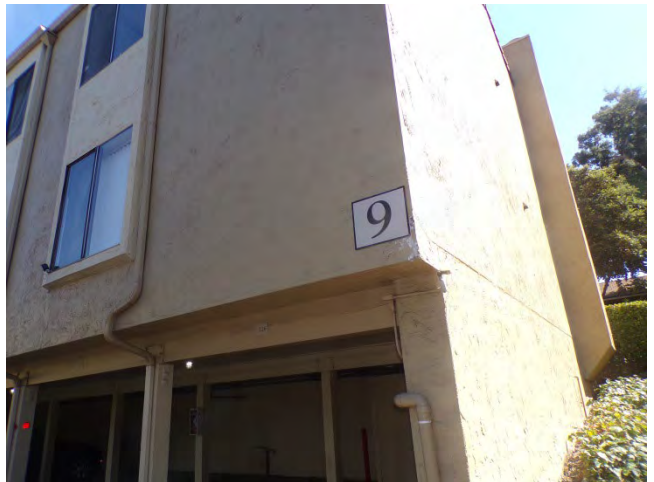
10. Bldg 9: North elevation. Buildings also carry identification signs mounted on an exterior wall.

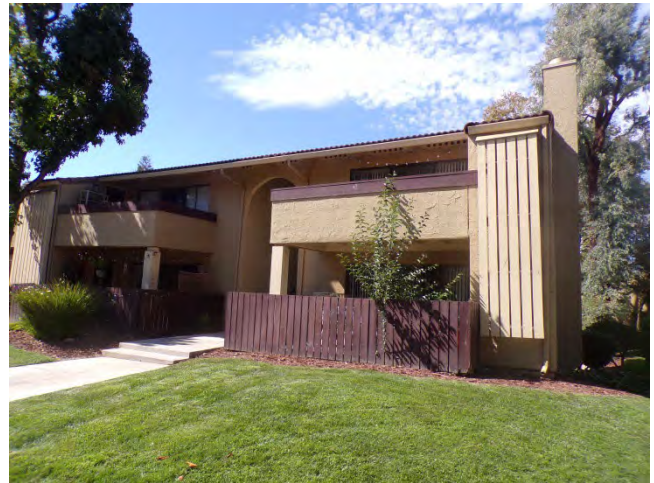
16. Bldg 15: South elevation. The primarily stucco and wood trim balcony railing on both the long and short sides of the balcony is the original design.

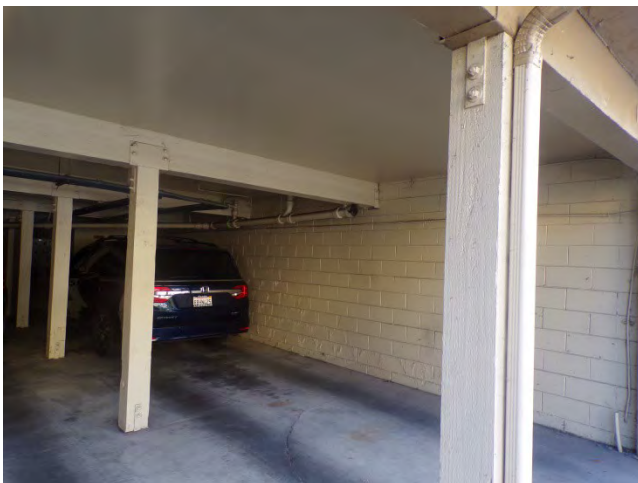
17. Bldg 16: The condition of the finishes in the tuck-under parking areas is typically degraded. Evidence of water penetration through the CMU wall also shown.

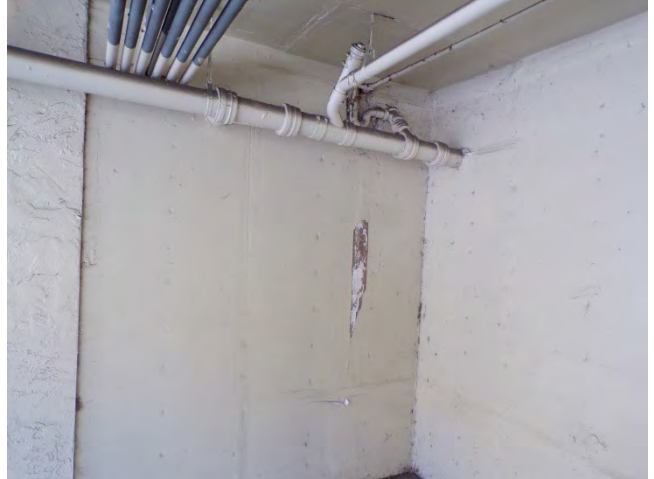
20. Bldg 19: Minor damage to gypsum board finishes—in varying degrees—is typical in tuck-under parking areas.

- Residential buildings: Provide complete exterior repainting of all elements with a paint finish. Work to repair minor damage to stucco and gypsum board walls should be performed in conjunction with repainting;

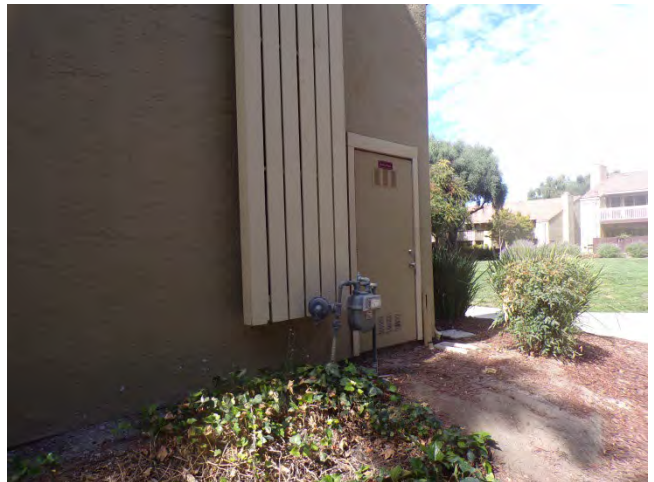
22. Bldg 21: Hot water boilers are located in closets which are accessible from the exterior. Vertically-oriented wood planks are used as a decorative and screening element.

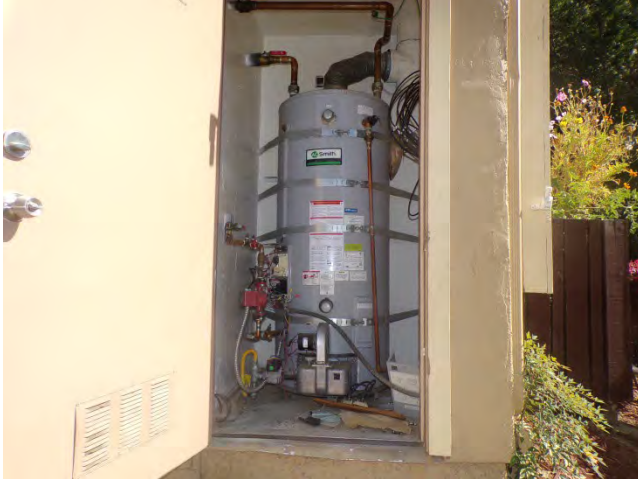
25. Bldg 24: Hot water boilers are located in closets which are accessible from the exterior. Observed boilers were installed between 2004 and 2024. This one was installed in 2017.

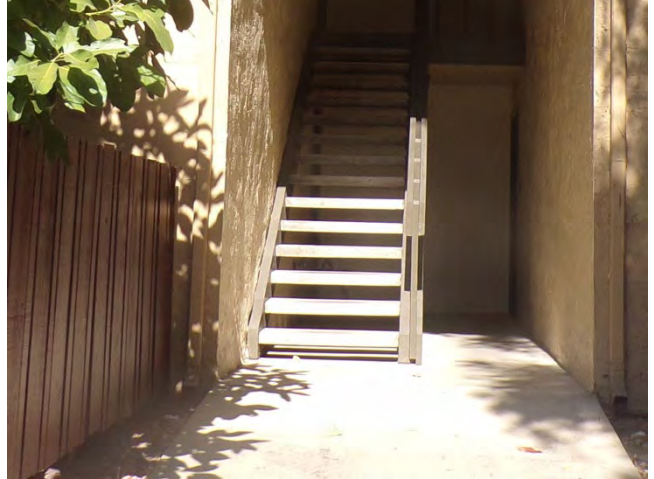
26. Bldg 25: Exterior stairs lack closed risers and handrails on both sides. Guardrails are also non-compliant with current codes.

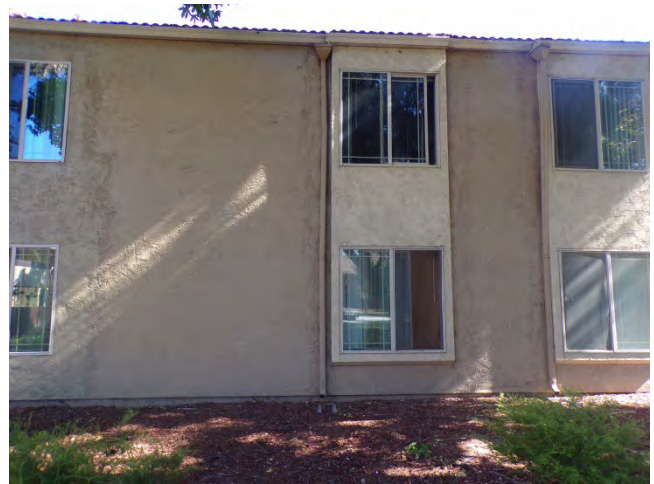
34. Bldg 33: North elevation. New plastic frame windows were installed in this building—and others—in 2014.

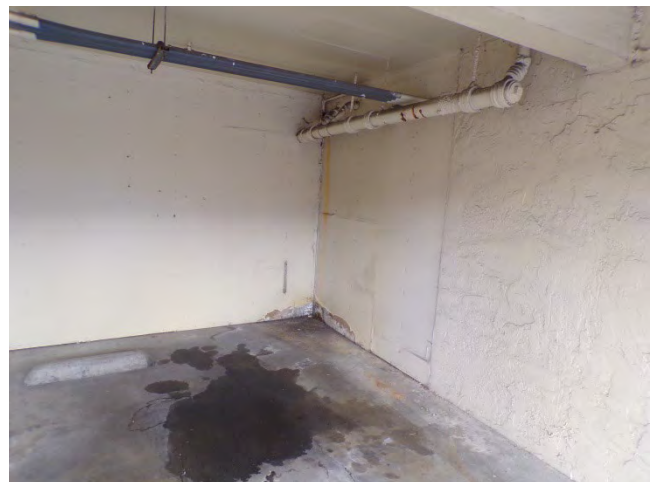
36. Bldg 35: Minor damage to gypsum board finishes—in varying degrees—is typical in tuck-under parking areas.

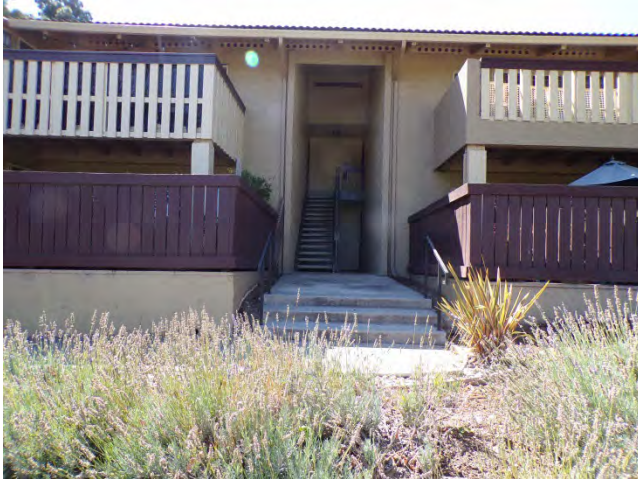
37. Bldg 36: Exterior stairs lack visually contrasting stripes on all treads, as required, except at the Leasing Office. Note the variety in balcony railings.

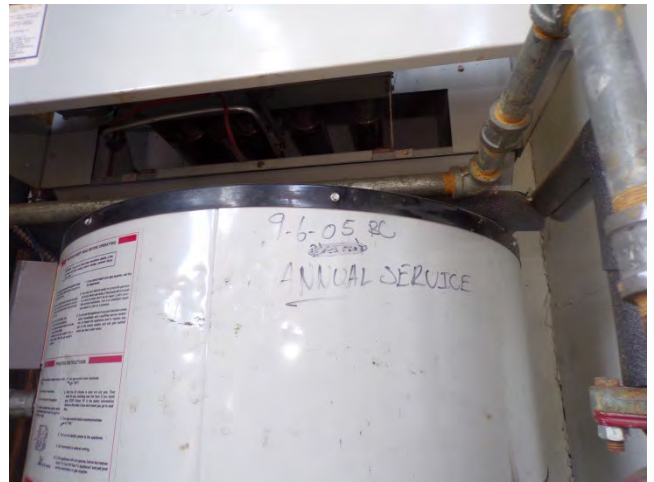
40. Bldg 39: The boiler in this building was the oldest one AllWest observed with a marking indicating September 6, 2005.

- Replace ten natural gas-fired 100 gallon hot water boilers;
- Provide flexible gas line connections on fourteen boiler gas lines;
- General allowance to provide Accessibility upgrades to exterior site elements and parking to achieve a higher level of Accessibility compliance than currently exists;

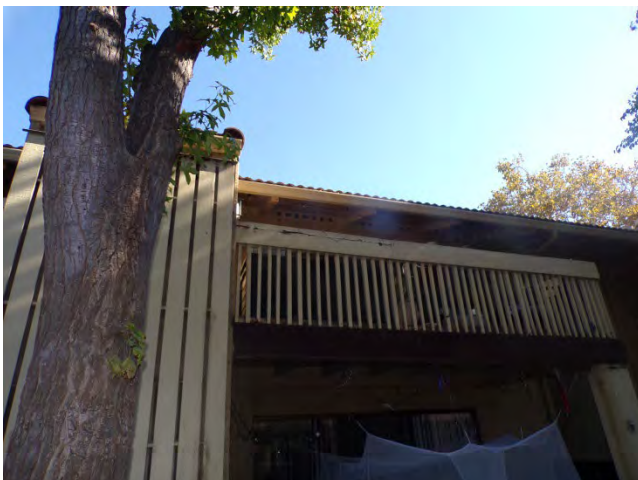
41. Bldg 40: Damaged wood on balcony railing. First railing update design.

- Carports: Provide complete exterior repainting of all elements with a paint finish;
- Residential buildings: Replace degraded wood exterior elements, other than at balconies;

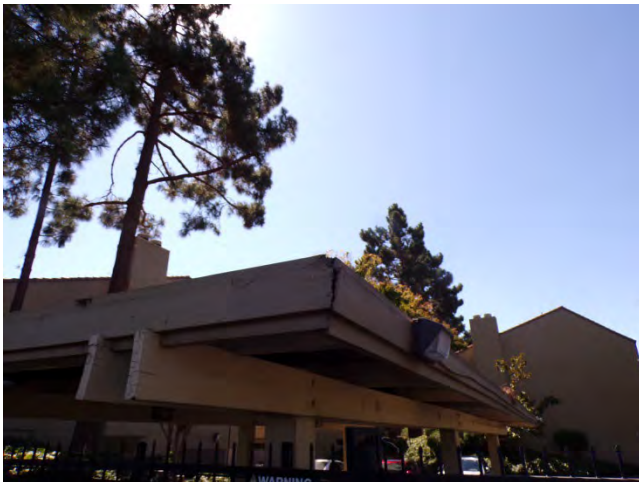
45. Degraded wood elements on carports should be replaced.

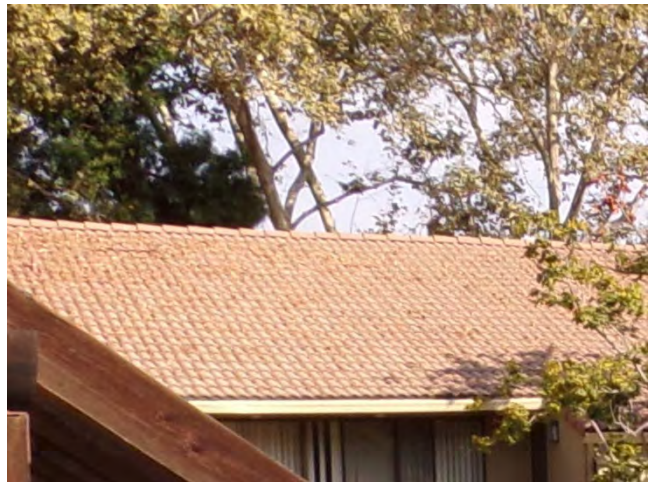
46. Red concrete barrel tile roofs were installed on all buildings between 2007 and 2011.

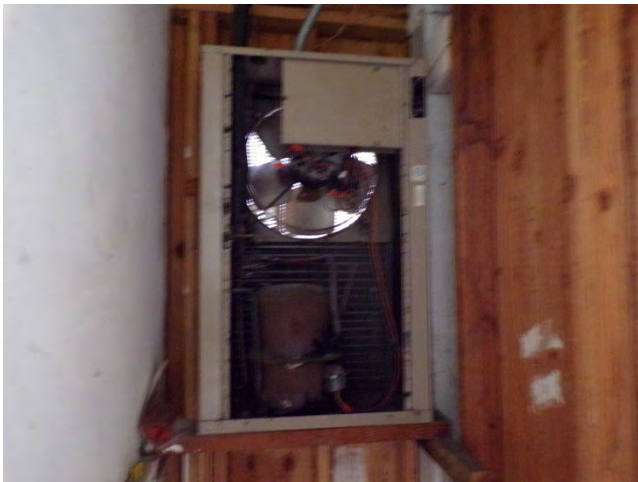
The MEP systems appeared in “Good” to “Fair” condition. The vast majority of apartments use their original split-system air conditioners—each with a two-ton cooling capacity—and small, in-wall electric heaters; electric baseboard heaters were installed in the bedrooms in these apartments around 2009 in all but six units. Reportedly, twenty-six apartments have received more recent air conditioner upgrades where

57. Two ton air conditioning units, manufactured by *Fedders*, are installed in a majority of apartments in exterior service closets. These date to original construction.

- Install heat pumps for air conditioning upgrades in 442 apartments where not already provided;
- Perform infrared scanning of electrical distribution systems;

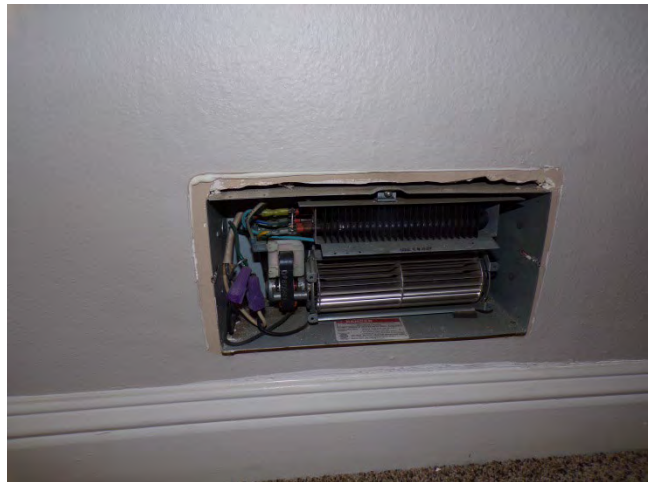
58. Small, electric in-wall heaters are installed in those apartments that have the original air conditioning units.

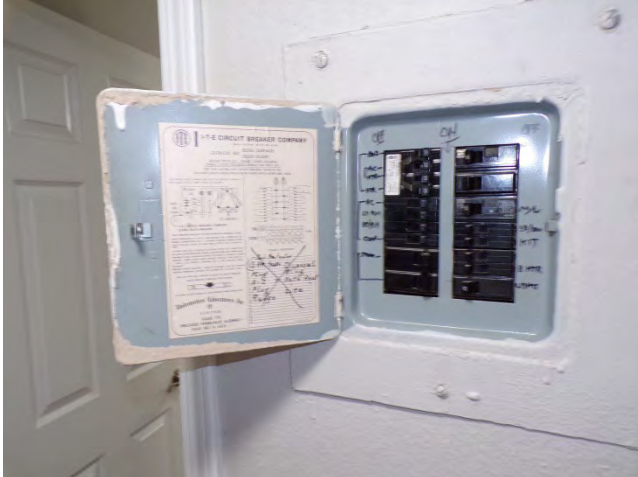
61. Original ITE 125 amp branch circuit breaker panel with original breakers are found in apartments with the older *Fedders* air conditioners.

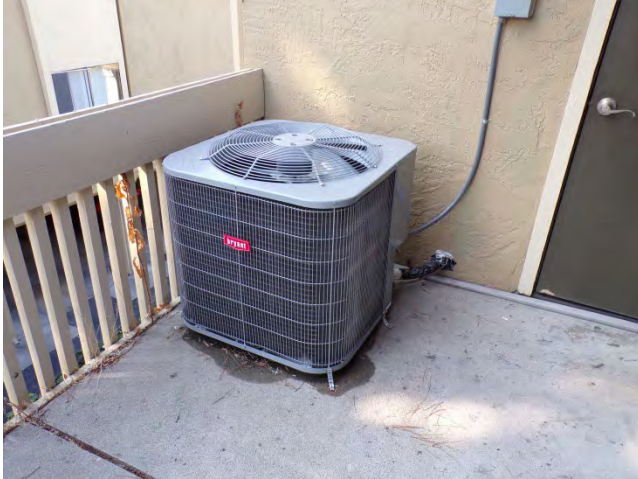
85. Apartment 8C: A two ton *Bryant* split-system heat pump was installed in 2023. This is one of the newer upgraded air conditioning systems.

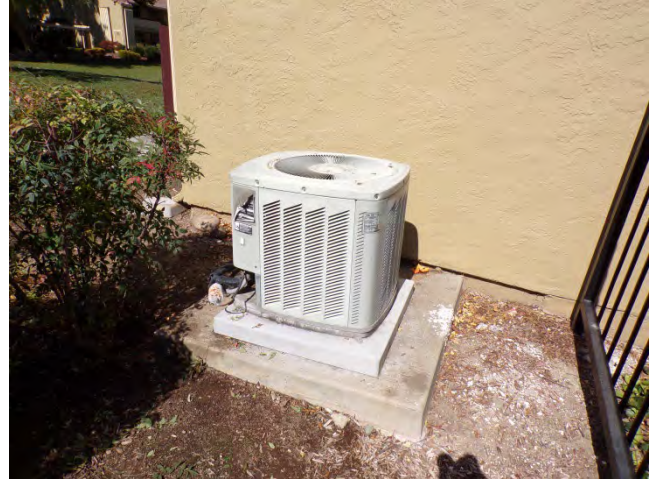
86. Apartment 32J: A three ton *Trane* split-system air conditioner was installed in 2002. This is one of the older upgraded air conditioning systems. This is the only unit of this type at the property.

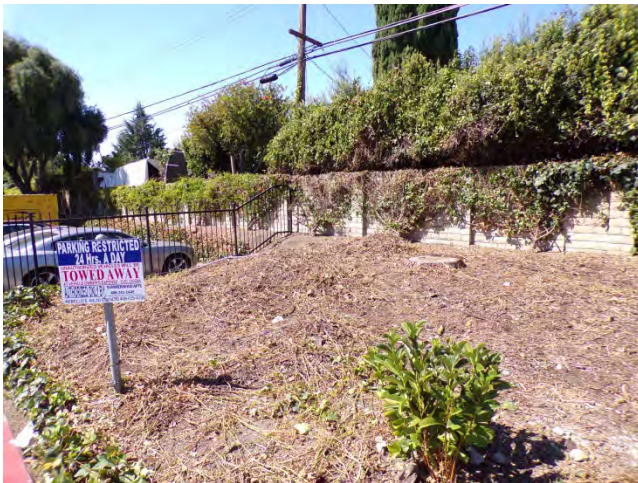
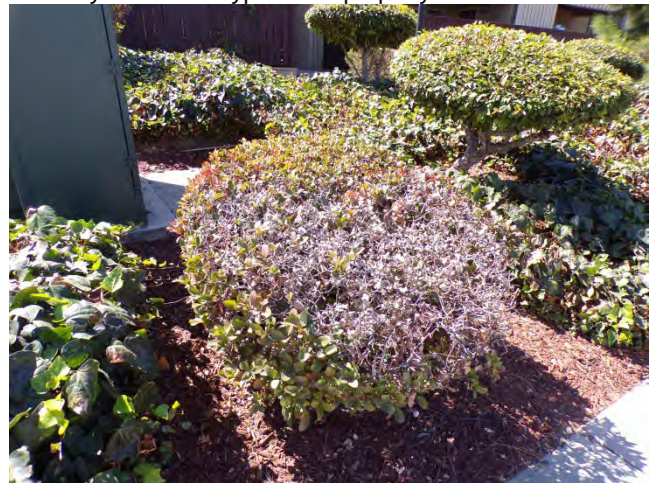
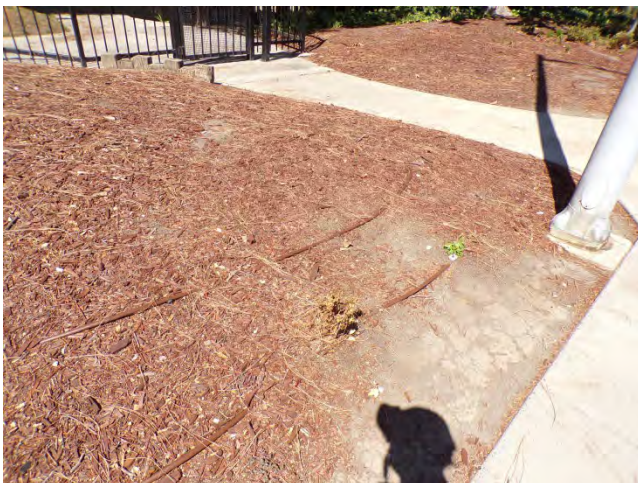
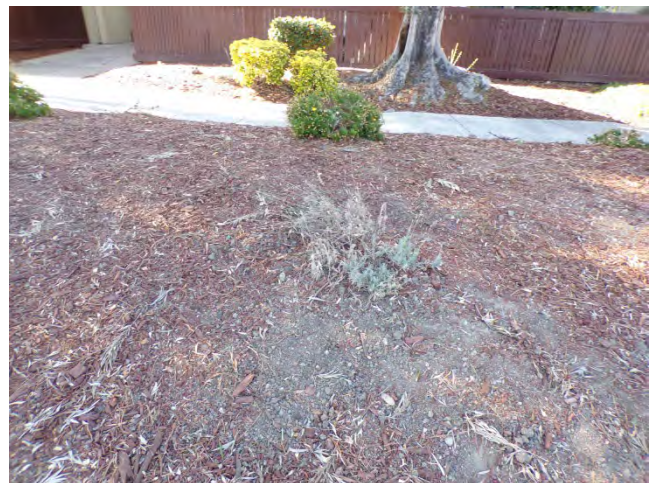
87. Degraded elements of landscaping were observed; tree stump shown.

88. Degraded elements of landscaping were observed; dying shrub shown.

89. Degraded elements of landscaping were observed; dead shrub shown.

90. Degraded elements of landscaping were observed; dying shrub shown.

- Allowance to return all landscaping elements to "Good" condition;
- Perform full-depth and minor repairs to asphalt paving;
- Re-seal asphalt paved parking lot;

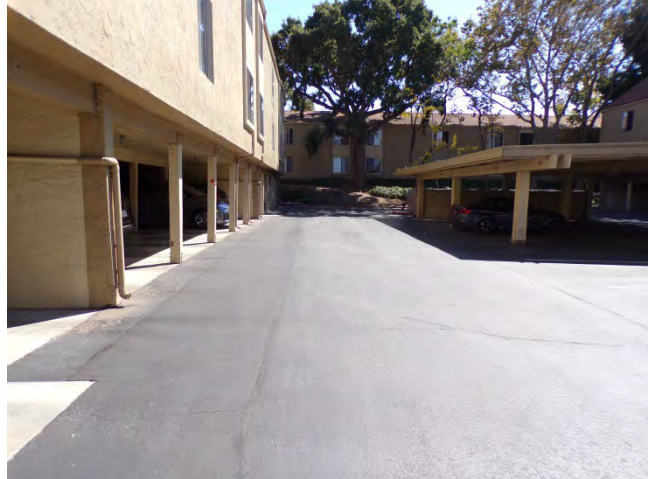
92. The asphalt paving appeared in generally "Good" condition, though it is not without deficiencies.

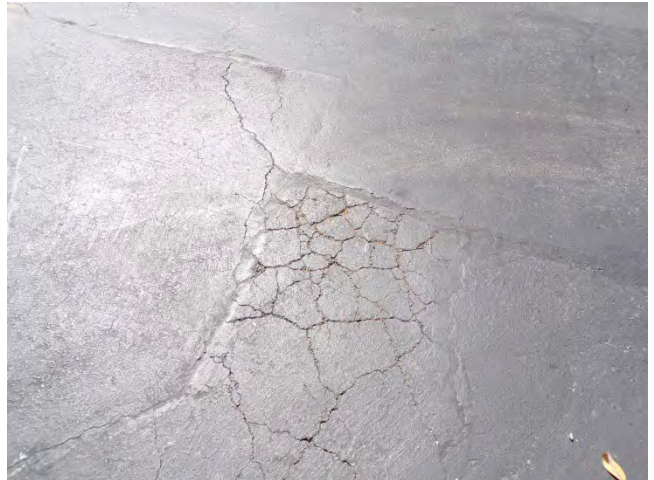
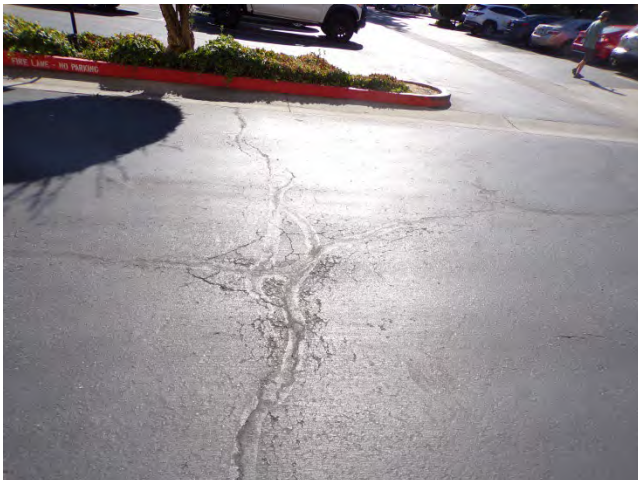
94. Degraded portions of the asphalt paving were observed in numerous locations.

95. Degraded portions of the asphalt paving were observed in numerous locations.

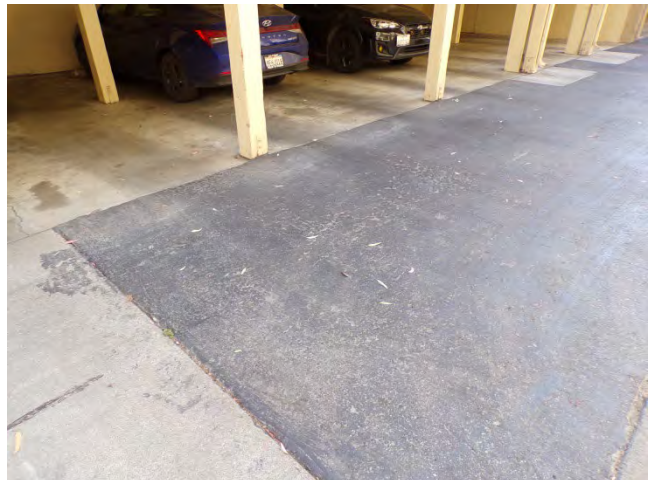
96. AllWest recommends that asphalt repairs and re-sealing be conducted during the reserve term.

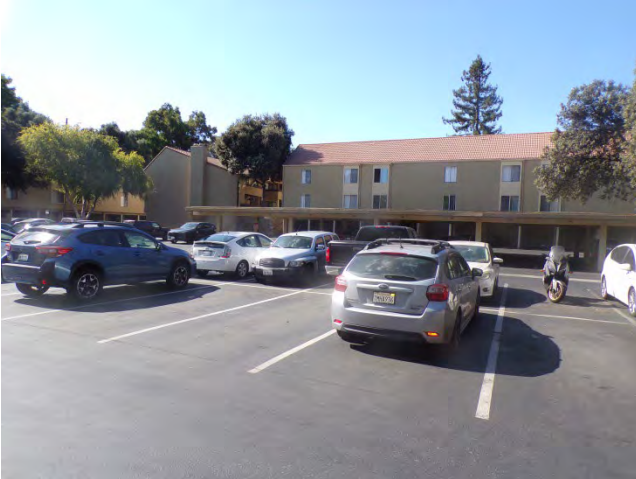
97. Parking stall re-striping will also be required in conjunction with recommended asphalt repairs and re-sealing.

- Re-stripe regular (non-Accessible) parking stalls in uncovered parking areas and under carports;
- Perform concrete grinding to address changes of elevation in concrete sitework to eliminate tripping hazards;

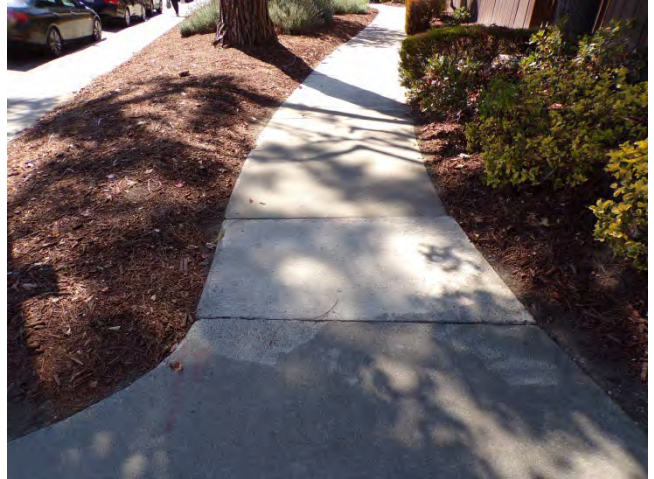
98. Changes in elevation greater than 1/4" in concrete site work create tripping hazards.

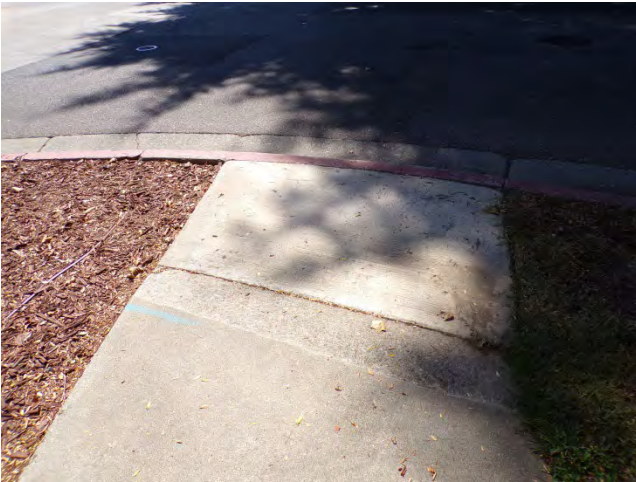
99. Abundant evidence of past concrete grinding to address tripping hazards was observed around the site.

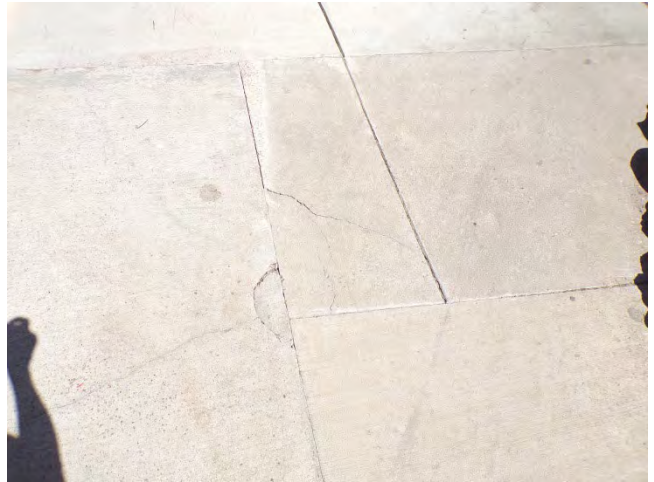
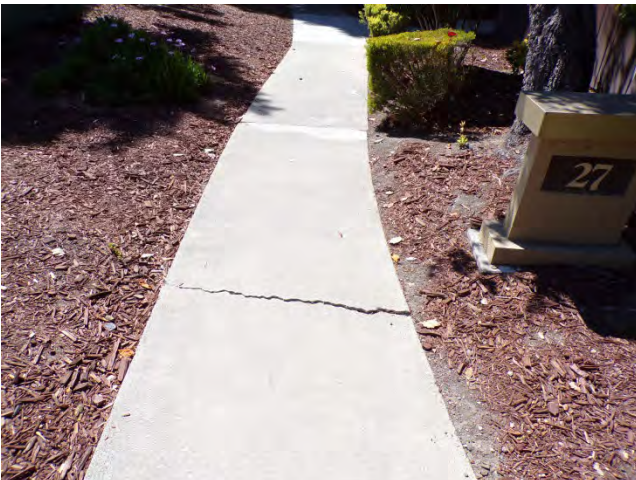
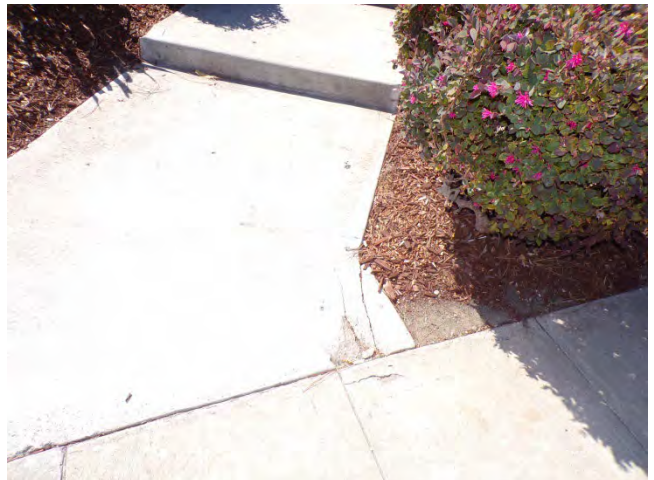
100. Degraded portions of the concrete site were observed in numerous locations.

101. Degraded portions of the concrete site were observed in numerous locations.

102. Degraded portions of the concrete site were observed in numerous locations.

- Provide remedial measures to address degraded condition of concrete sitework, other than minor tripping hazards;
- Provide new, pumps, filters, and timers to return fountains to working condition;

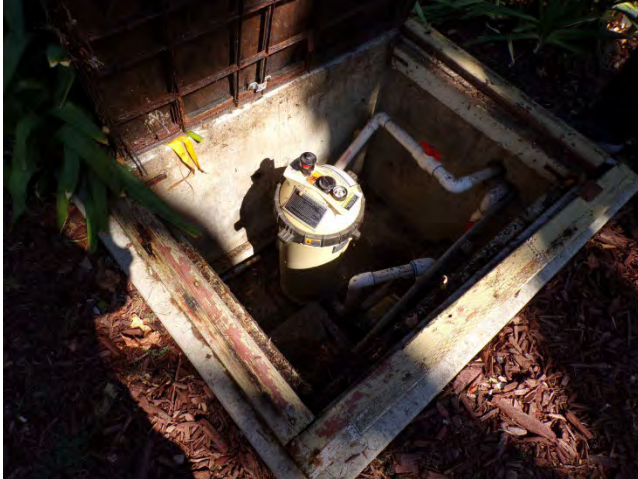
103. There are four fountains on the property; none are functional. Rehabilitation of the fountain equipment is recommended.

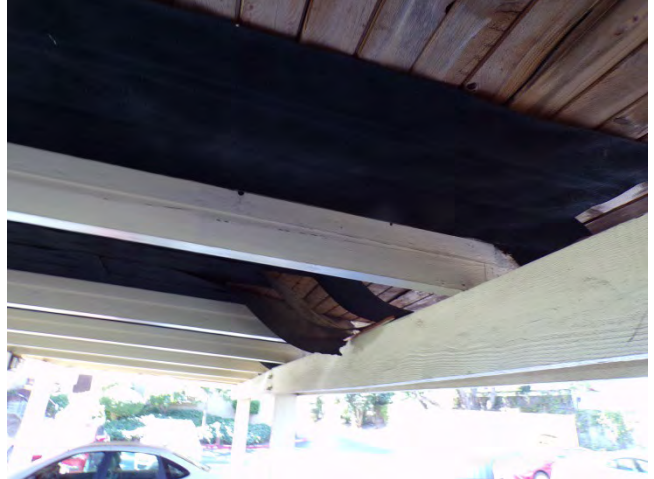
104. The tar paper on the underside of some carports is in a degraded condition.

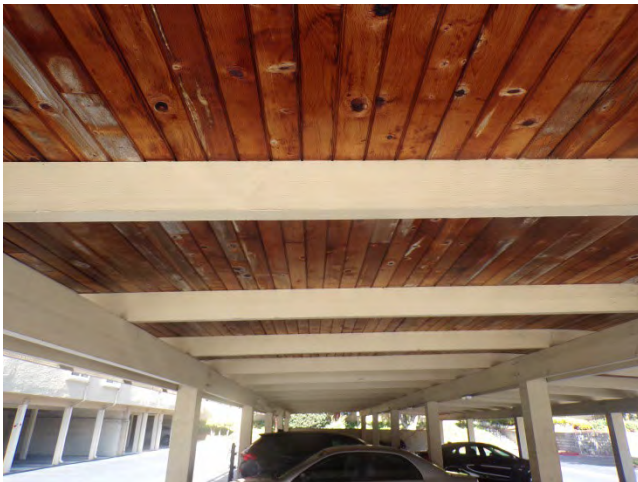
105. At some carports, the tar paper is absent altogether.

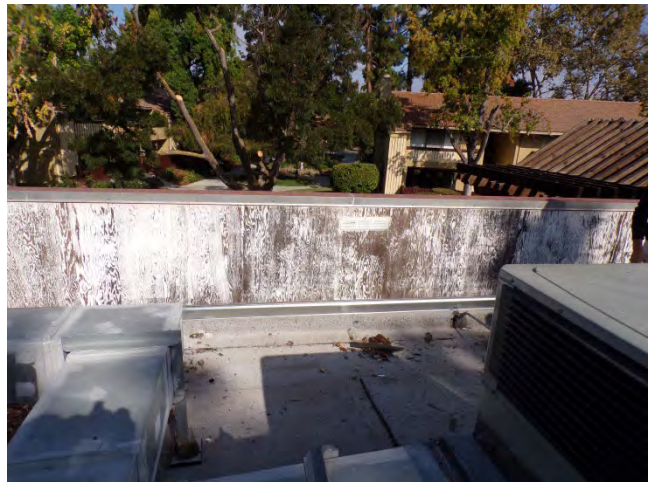
106. Clubhouse: The paint on the plywood facings of the interior side of the parapets is in a degraded condition. Repainting is recommended.

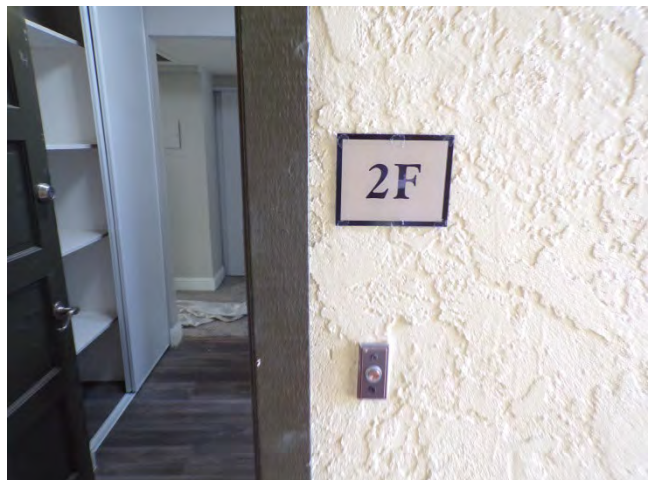
108. It was reported that concrete slab repairs to address differential settlement had been performed in units 2E, 2F, 2J, 33B, and 40A.

- Residential buildings: Contingency allowance to provide replacements of windows and sliding doors, if required;
- Contingency allowance to provide concrete slab repairs to address differential settlement, if required;

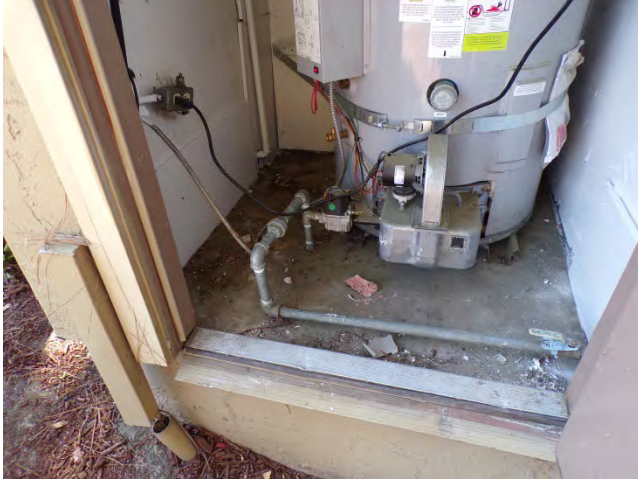
109. Rigid gas line connections were observed on some boilers.

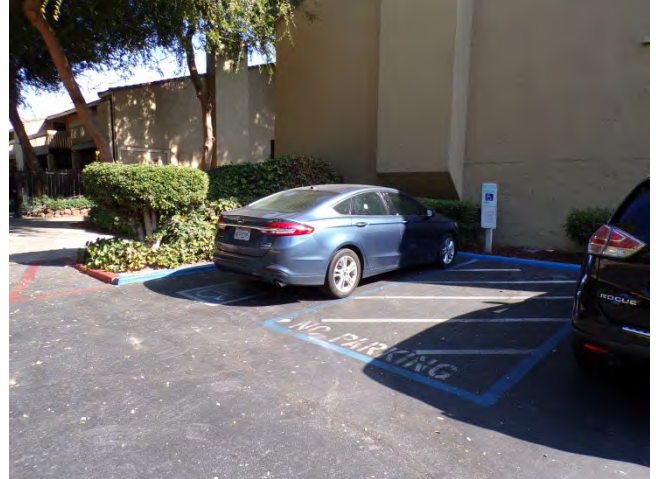
110. One standard Accessible parking stall is located near the west elevation of Bldg 12.

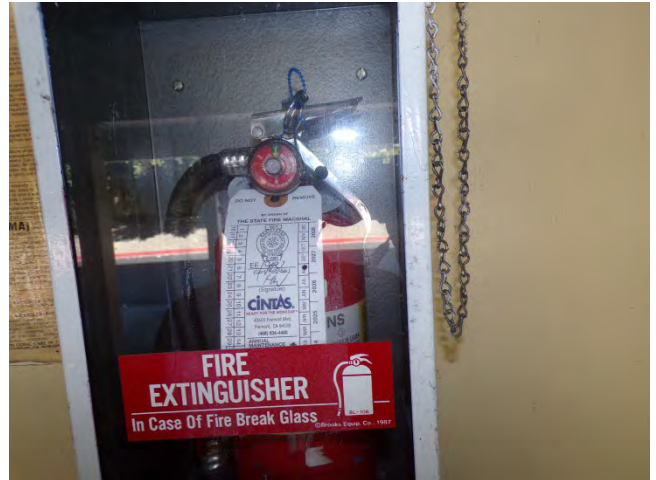
112. All observed fire extinguishers had current inspection tags.
