### PROPERTY CONDITION ASSESSMENT

**511 Forest Lodge Road, Pacific Grove, CA 93950**

**PROJECT 26007.60  
March 26, 2026**

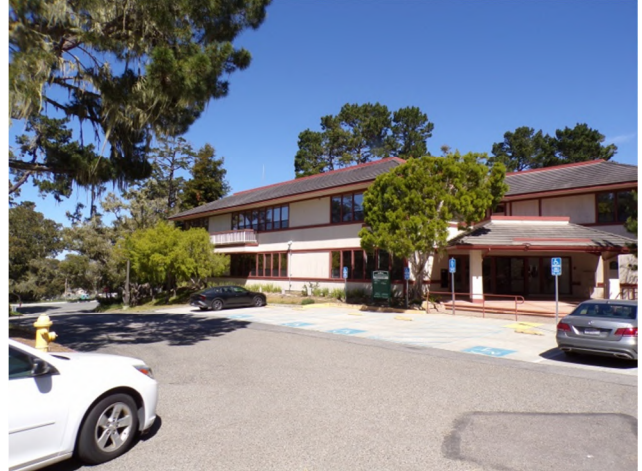
2. West elevation of west wing. This is the primary elevation facing the parking lot.

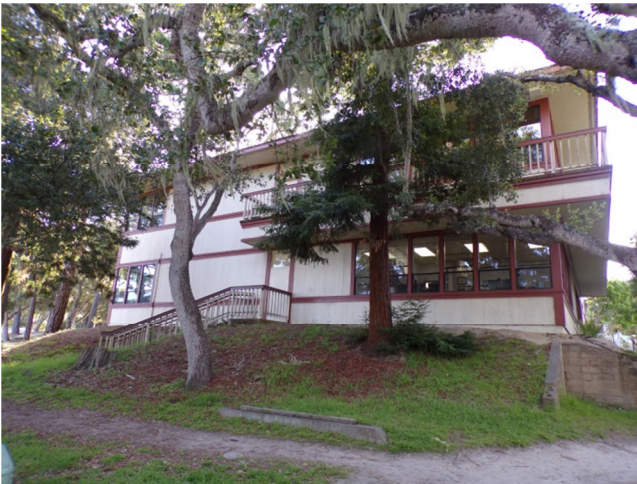
3. North elevation of west wing.

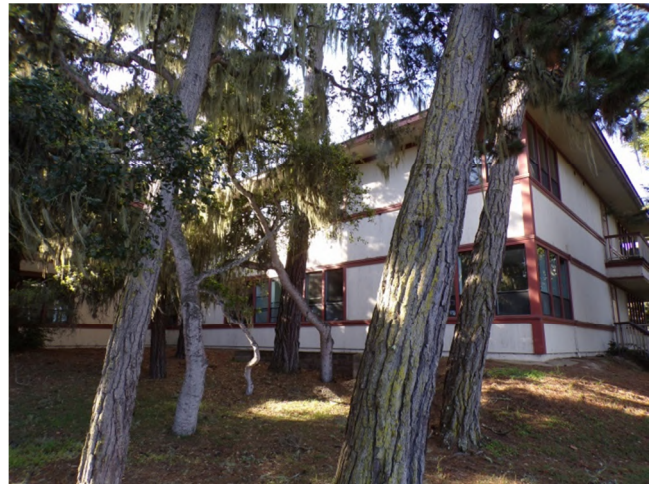
4. East elevation of west wing.

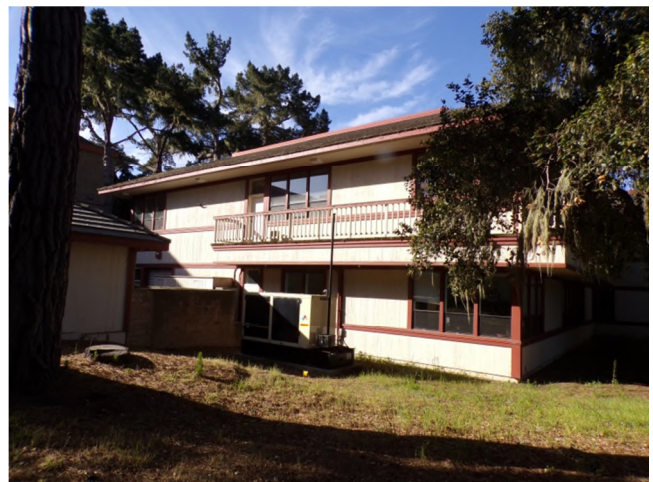
6. East elevation of east wing.

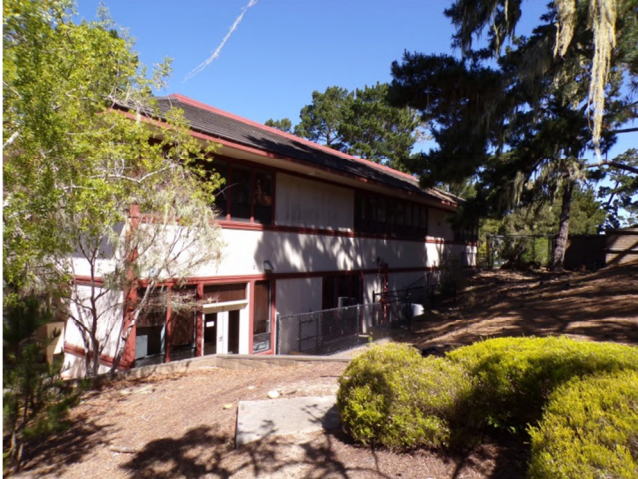
7. South elevation of east wing.

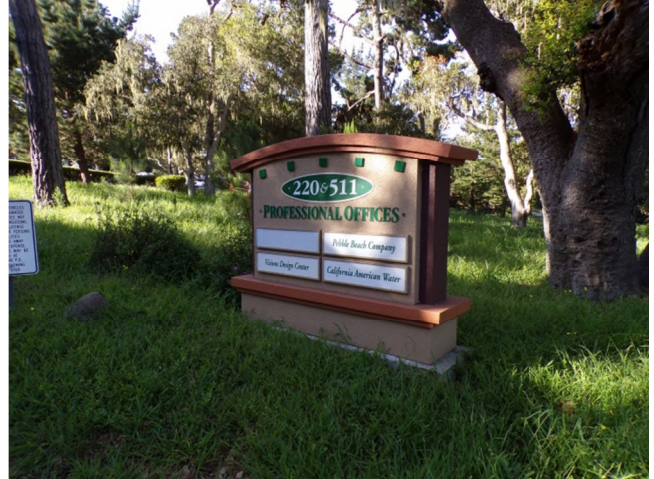
8. Small monument sign on west side of east curb cut.

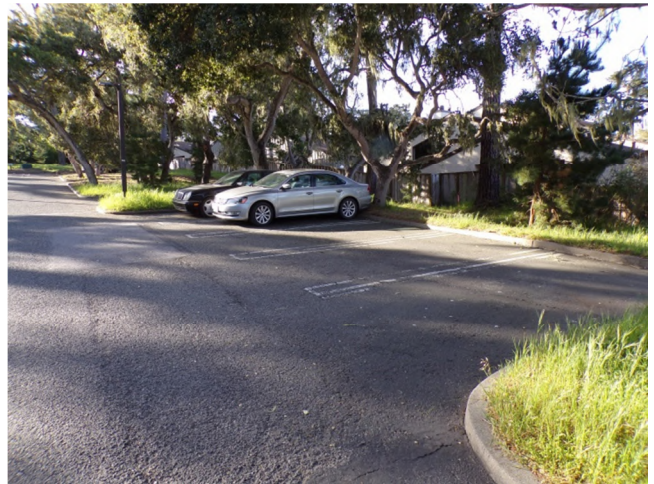
10. West portion of parking lot, looking south-southwest.

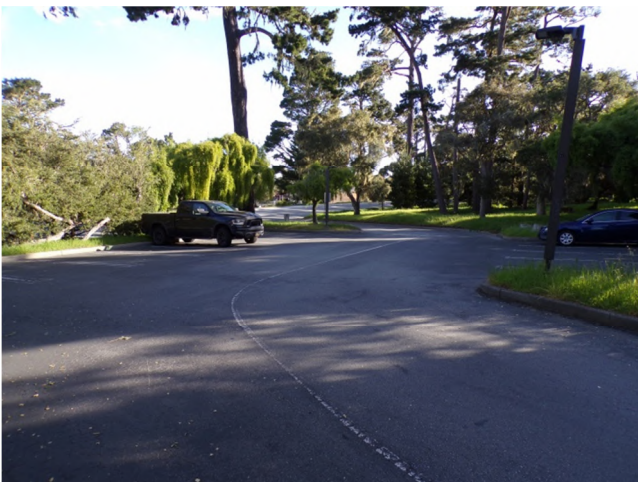
11. North portion of parking lot, looking northeast.

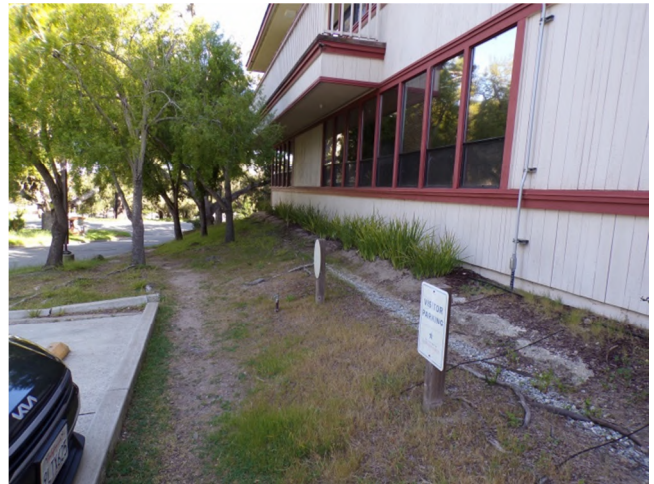
22. Purposefully planted vegetation immediately adjacent to the building is minimal.

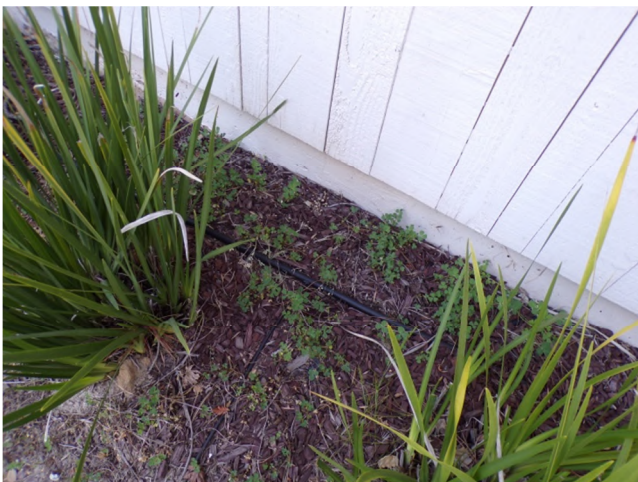
23. The irrigation system is only installed in proximity to the building perimeter. The grassy areas are typically unserved by the irrigation system.

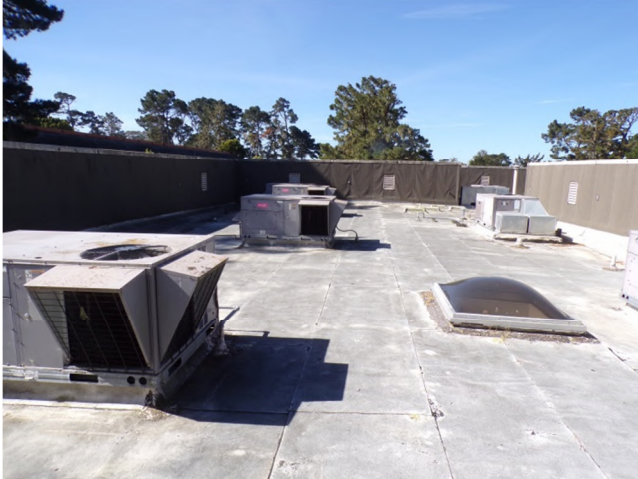
The roofing systems are evaluated in "Good" to "Poor" condition. The building has two significantly different roofing systems. The flat roof area of the HVAC equipment well has a 4-ply built-up roofing (BUR) system with a mineral granule top sheet ("Poor"). Around the perimeter of the building, a concrete tile roofing system is installed on the mansard pitched roof areas ("Good" to "Fair"). Building permit records indicate that the BUR roof may have been replaced in August of 2007; available permit information is scant and does not specify the type of roofing system involved. The age of the concrete tile roof is unknown. Replacement of the BUR roofing systems is recommended as a near-term replacement reserve item. This is a core building element and the cost for replacement can be considered significant. Replacement of the concrete tile roofing systems is suggested as an optional Modernization item; the cost for this can also be considered significant.

25. East wing: A BUR roofing system is installed.

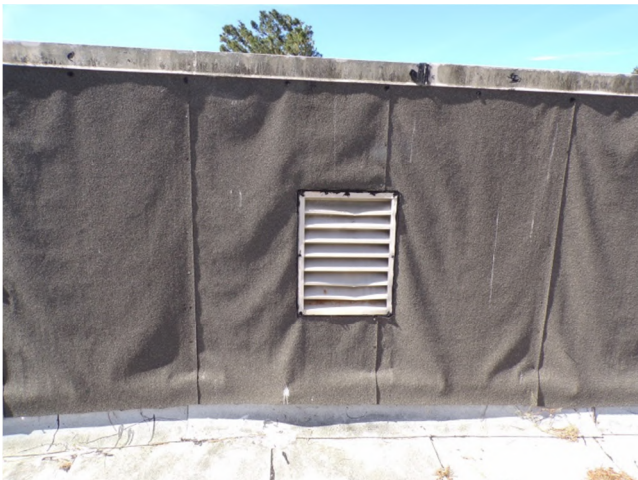
29. Both wings: A gray mineral granule cap sheet is applied to the inside face of the parapets. East wing shown.

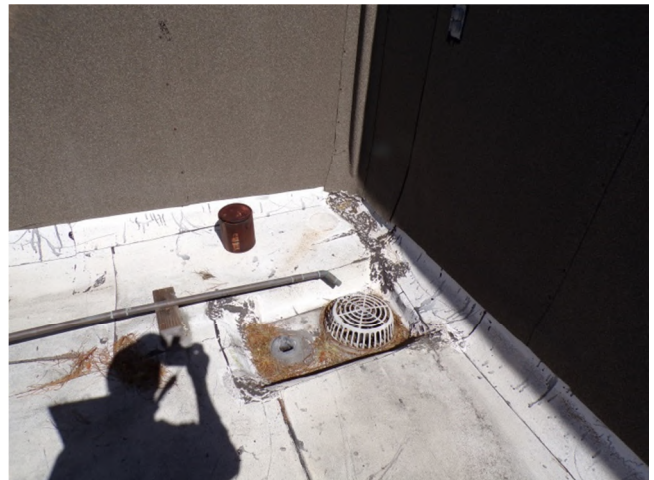
30. Both wings: The roof and overflow drains are located in shallow sumps. West wing shown.

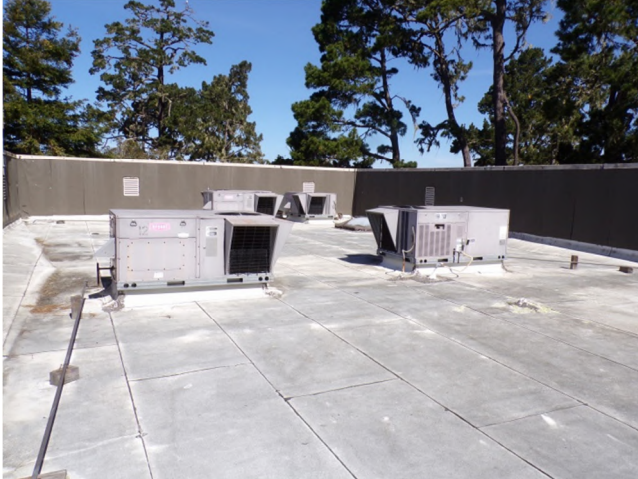
31. West wing: A BUR roofing system is installed.

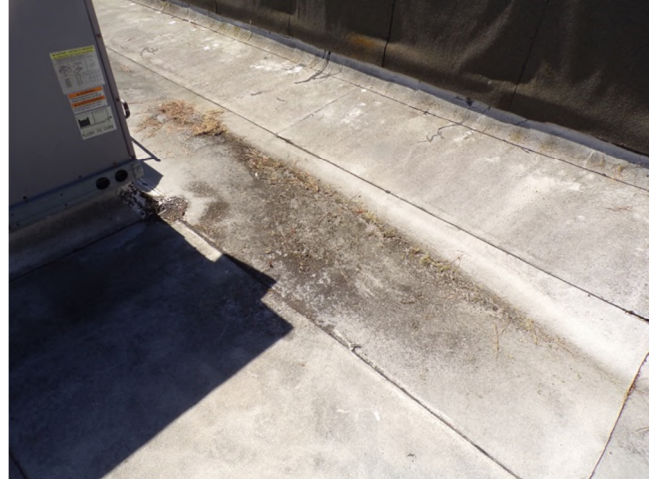
32. Both wings: Areas of past ponding are prevalent. West wing shown.

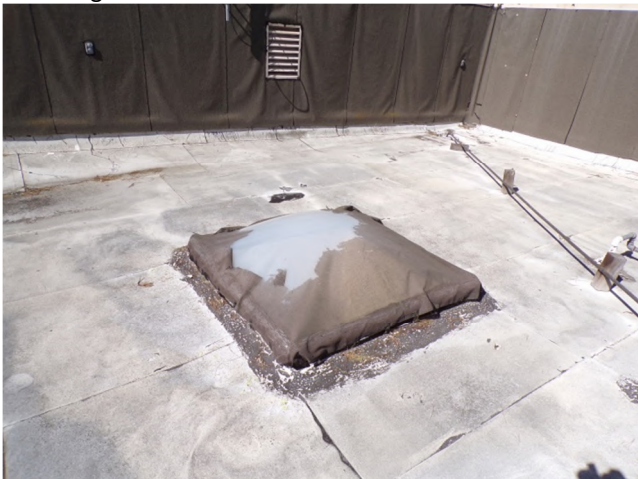
35. Four skylights are installed; two on each wing. East wing shown.

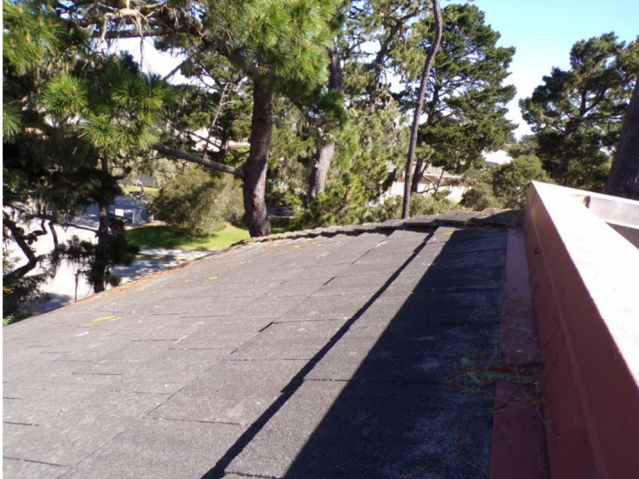
37. The concrete tile roof likely dates to original construction.

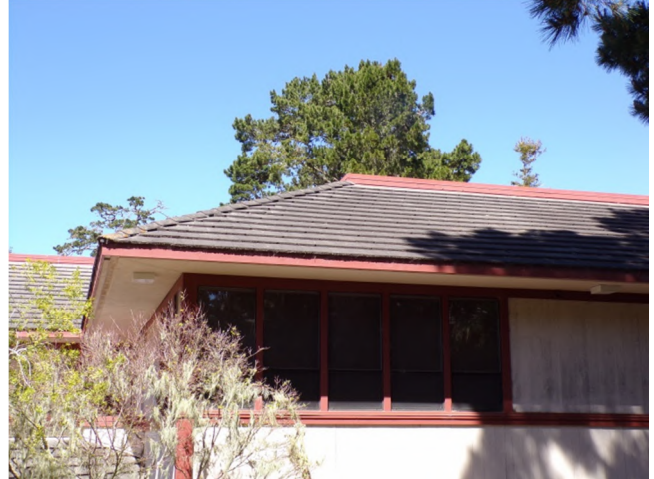
38. Most of our observations of the concrete tile roof were conducted from grade.

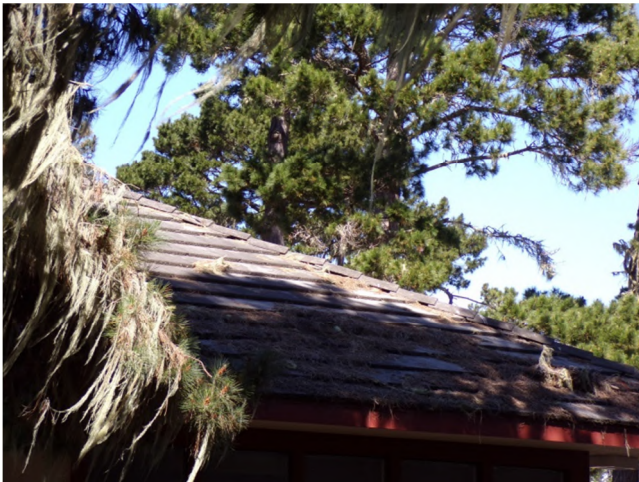
39. Accumulations of dead vegetation on the tile roof at southeast corner of east wing.

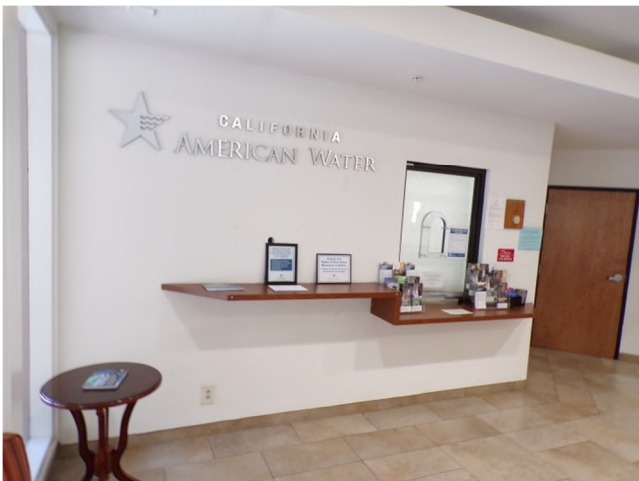
41. Interior finishes in main lobby.

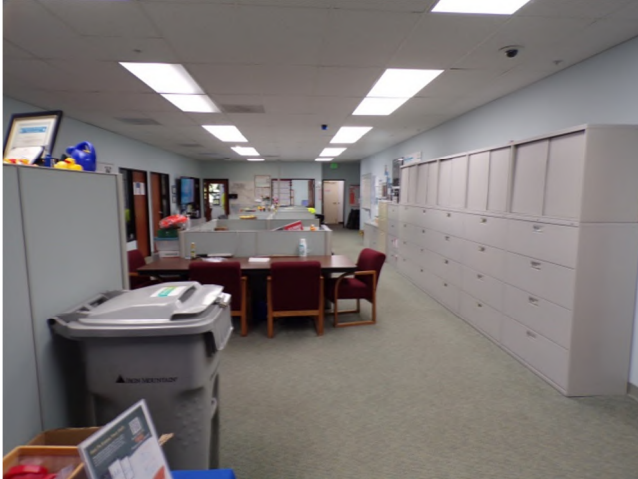
43. Interior finishes and fixtures in open office area.

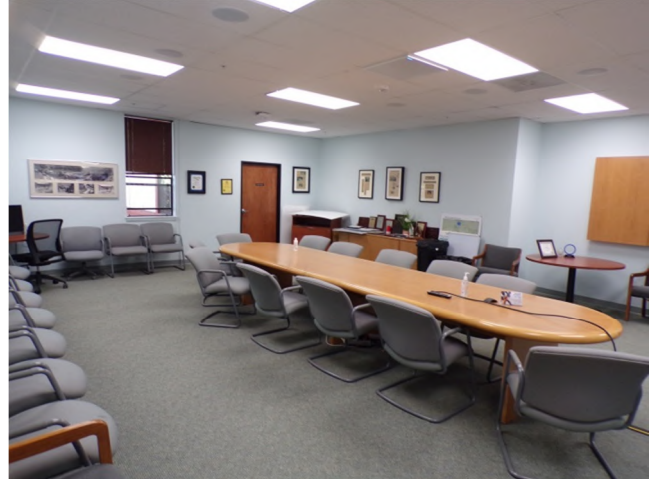
44. Interior finishes and fixtures in conference room.

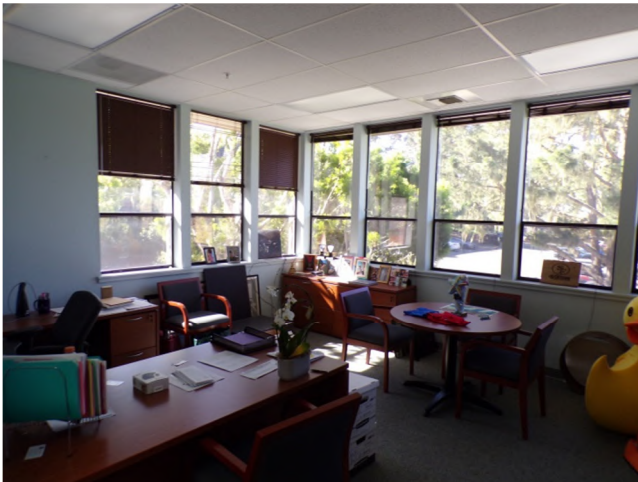
45. Interior finishes and fixtures in private office.

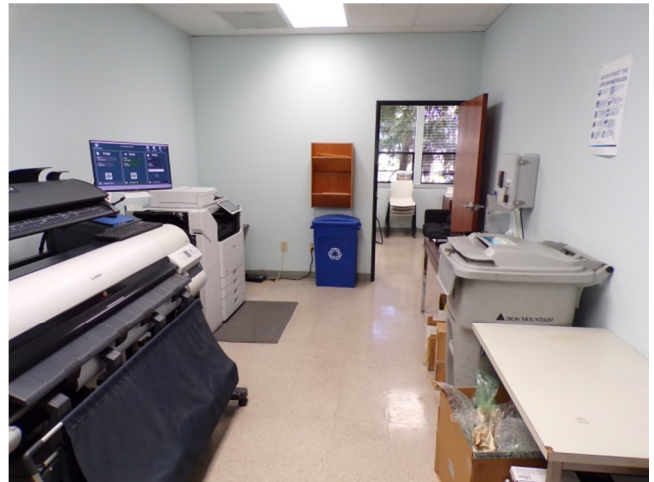
46. Interior finishes and fixtures in copier room.

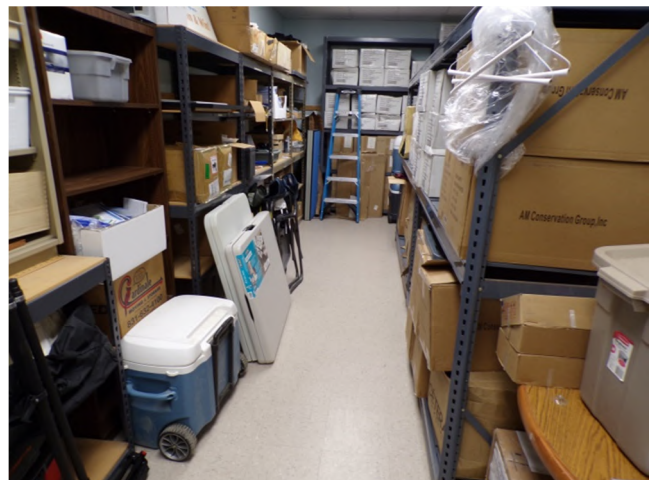
48. Interior finishes in storeroom.

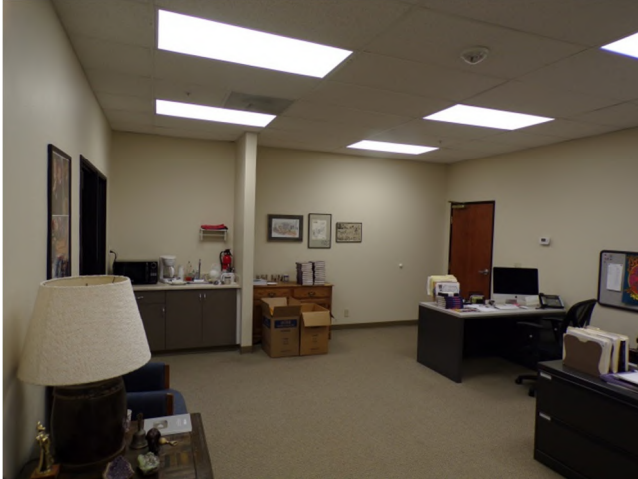
49. Interior finishes and fixtures in open office area.

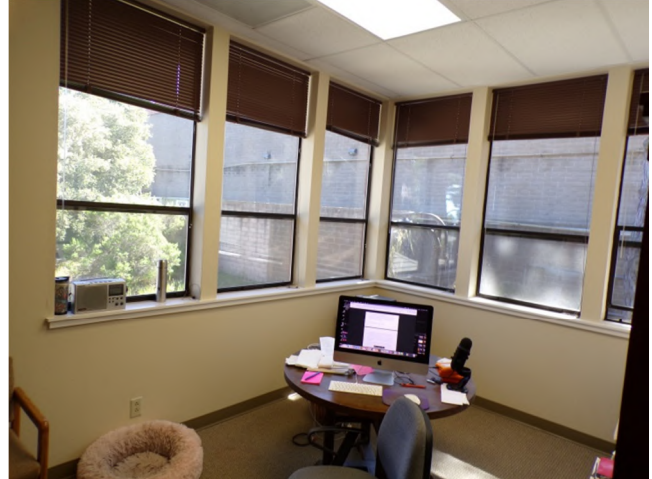
50. Interior finishes and fixtures in private office.

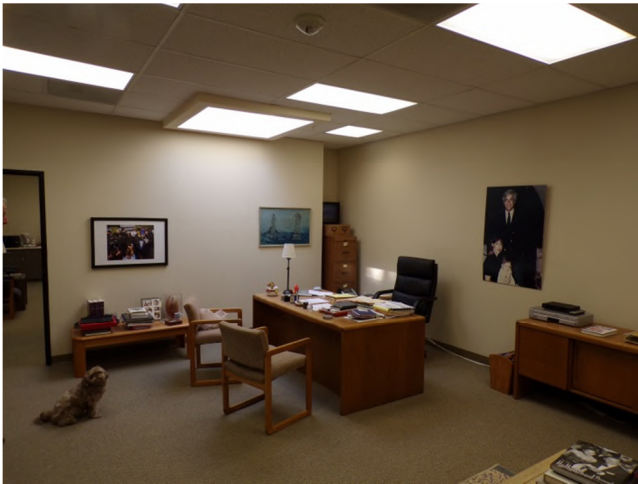
51. Interior finishes and fixtures in private office.

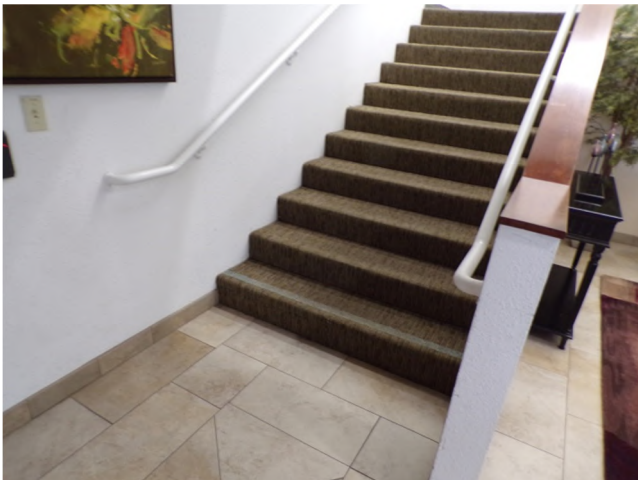
53. Interior finishes at stairs near main lobby.

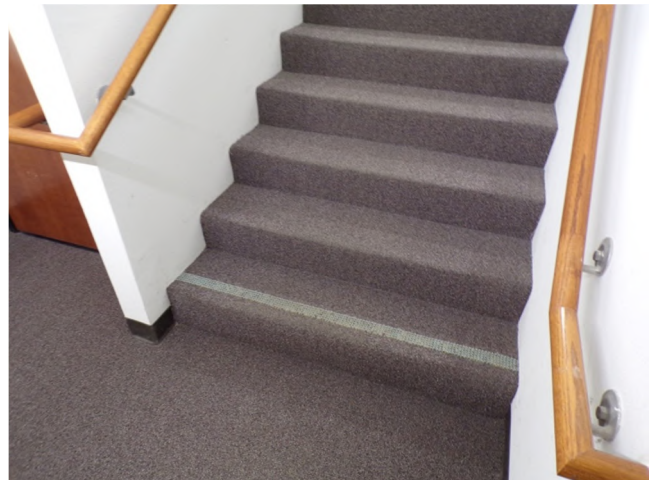
54. Interior finishes at secondary stairs.

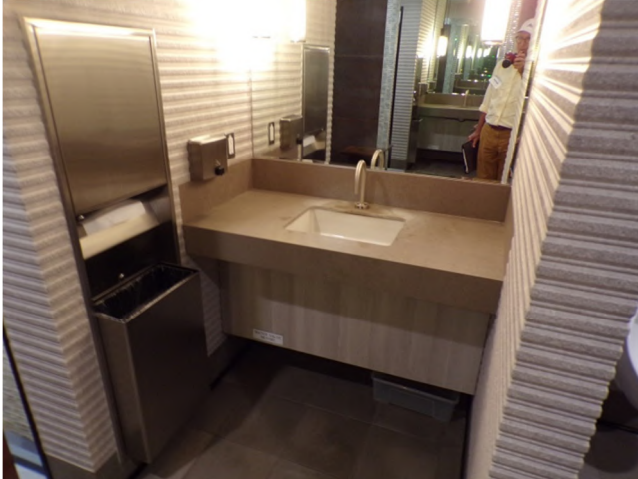
55. Interior finishes and fixtures in restrooms. The same finishes and fixtures are used in all four restrooms.

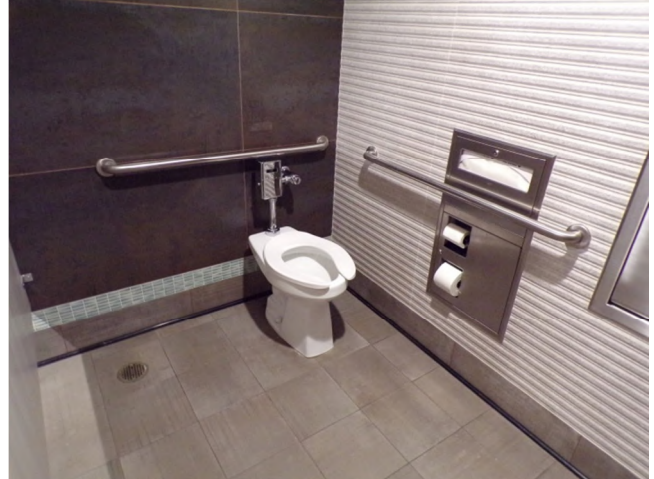
56. Interior finishes and fixtures in restrooms.

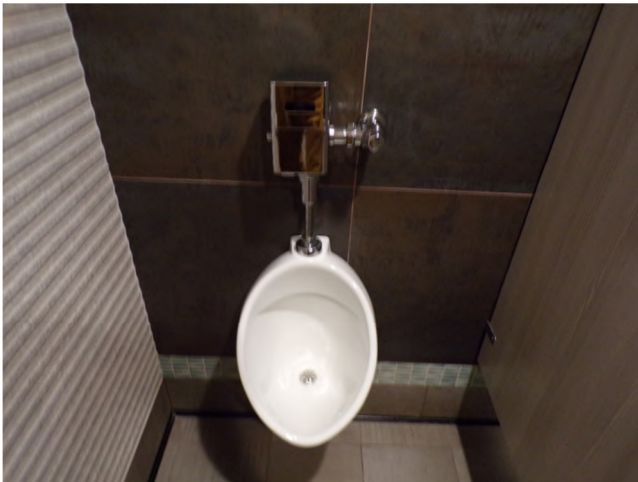
57. Interior finishes and fixtures in restrooms.

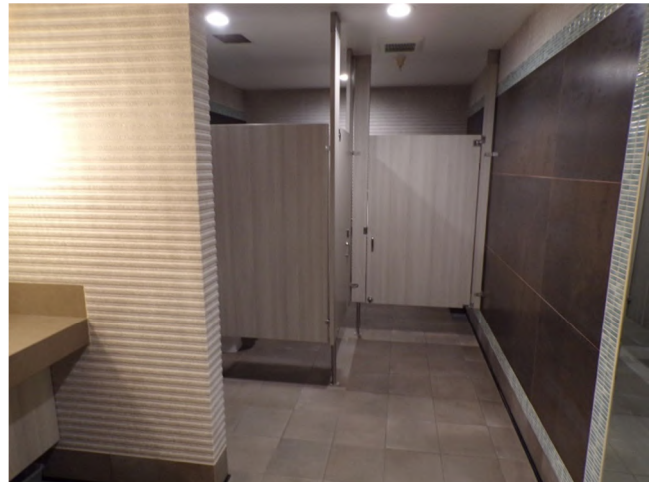
58. Interior finishes and fixtures in restrooms.

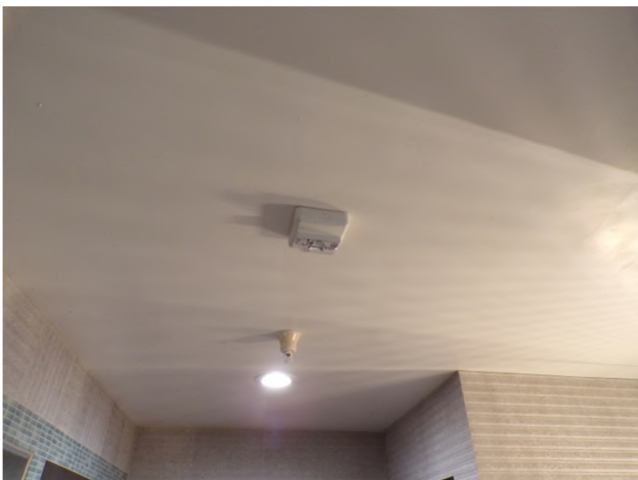
59. Horn/strobe alarm devices are installed in all restrooms.

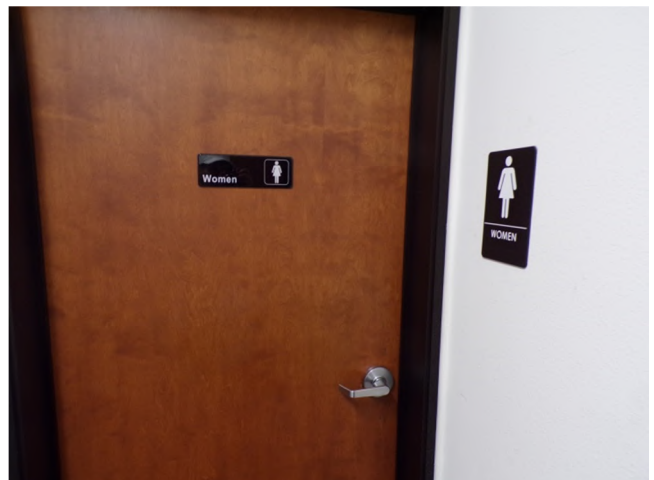
60. Accessibility signage with Braille (at right) is installed at restroom entrances.

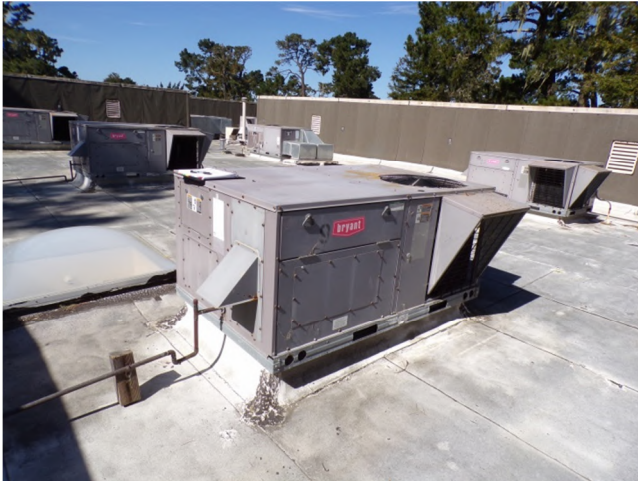
61. Twelve packaged units are installed. AC 9 shown. All twelve are generally similar in physical appearance.

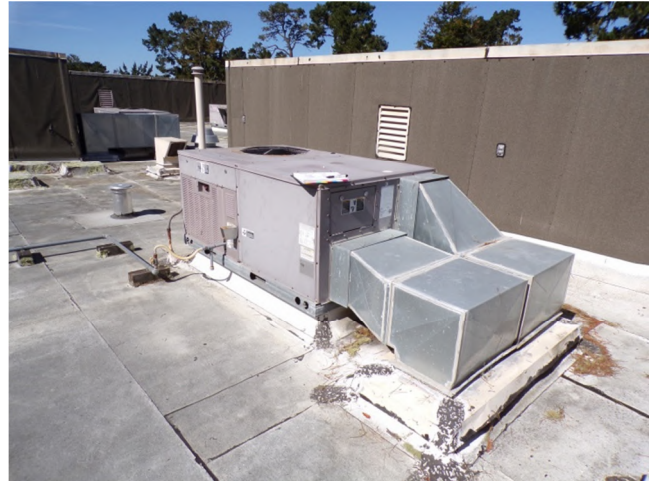
62. All packaged units were manufactured by Bryant in 2007. AC 2 shown.

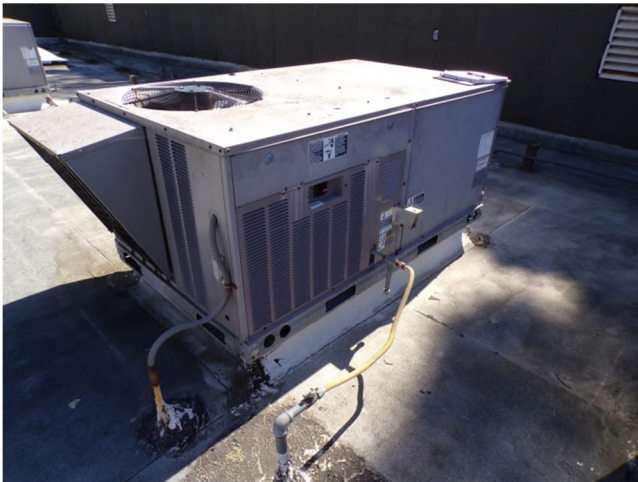
63. The furnaces all have flexible gas line connections. AC 7 shown.

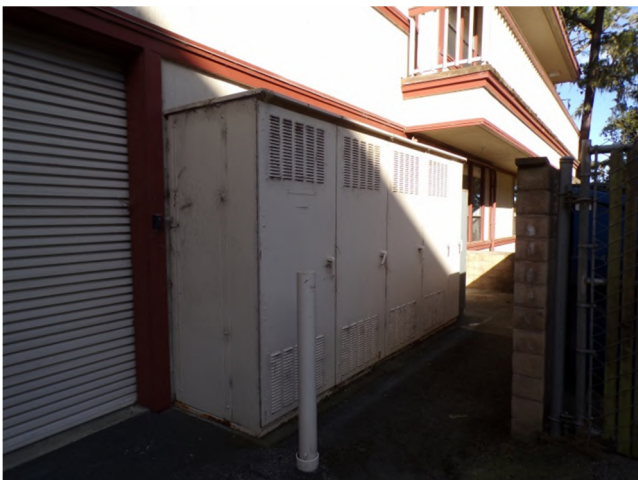
65. The main electrical service entrance equipment is located in an exterior location on the east side of the building.

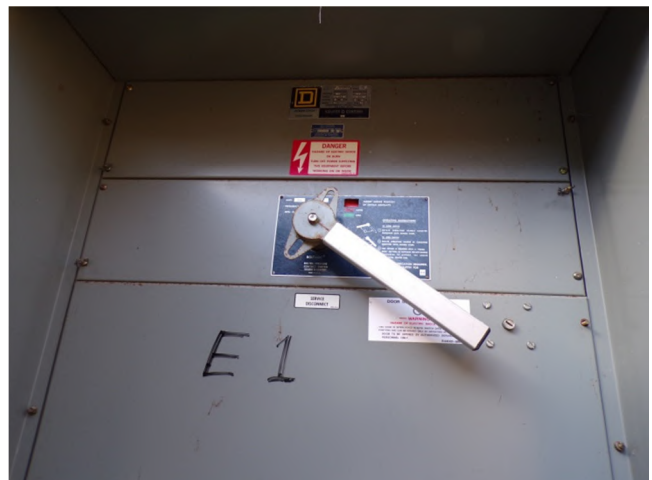
66. The main service equipment and the main disconnect are both rated at 1,200 amps.

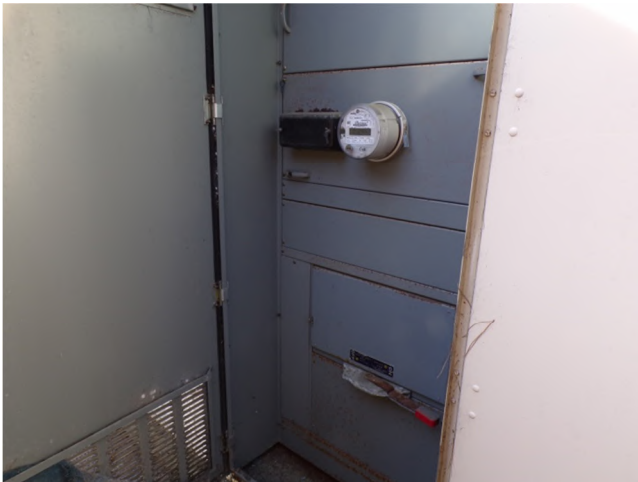
69. One electric meter is installed.

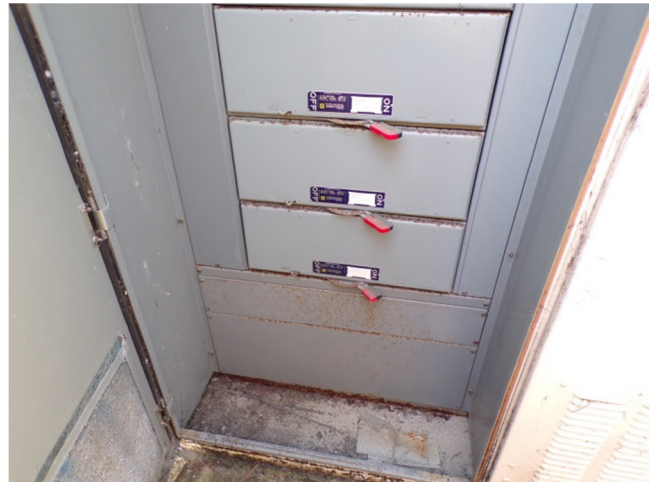
70. Each sub-main breaker is typically rated at 200 amps.

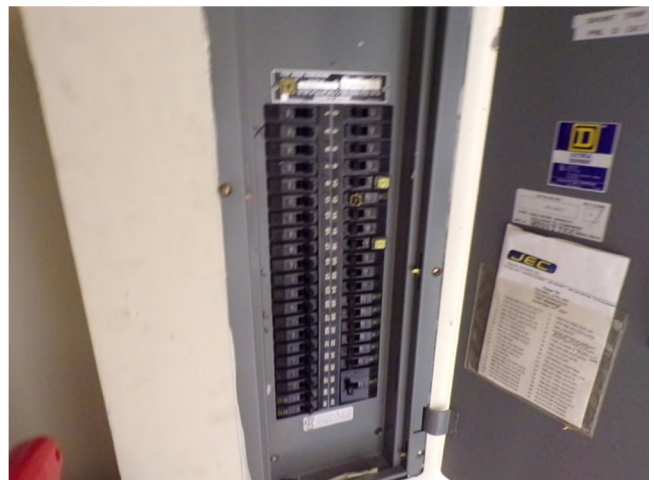
72. Branch sub-panels are found in interior locations.

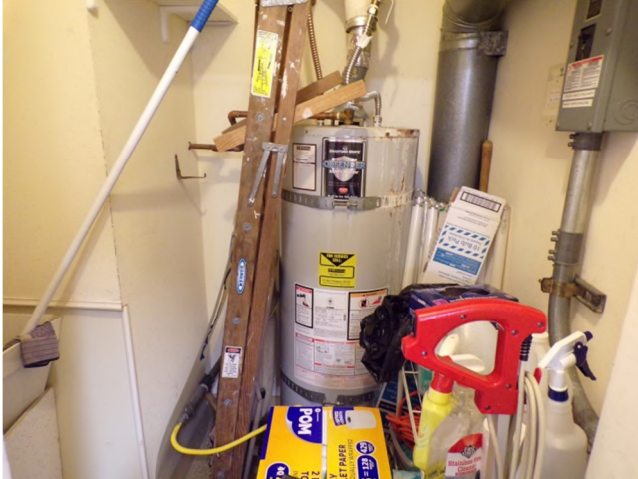
73. A 40 gallon gas-fired water heater is installed in the second floor janitor's closet.

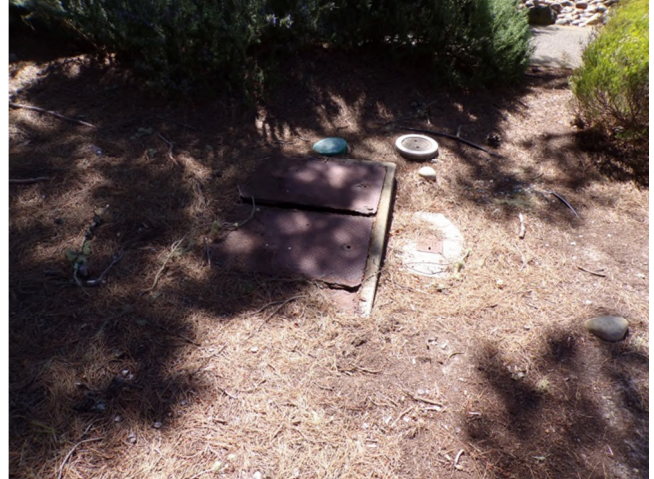
74. Water utility service is likely supplied from the adjacent parcel to the south.

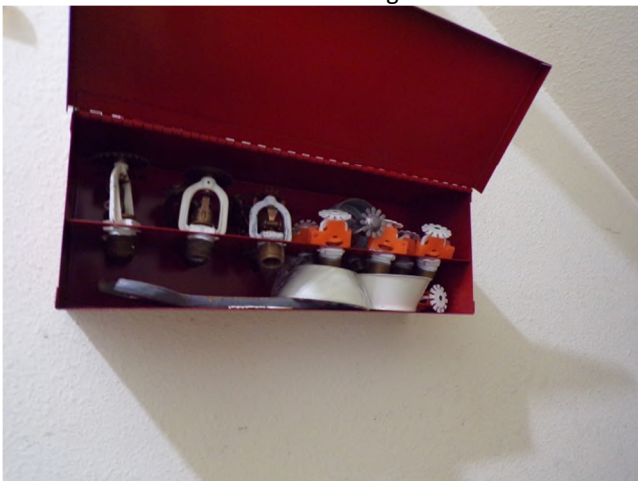
77. The spare sprinkler heads are found in the first floor janitor's closet.

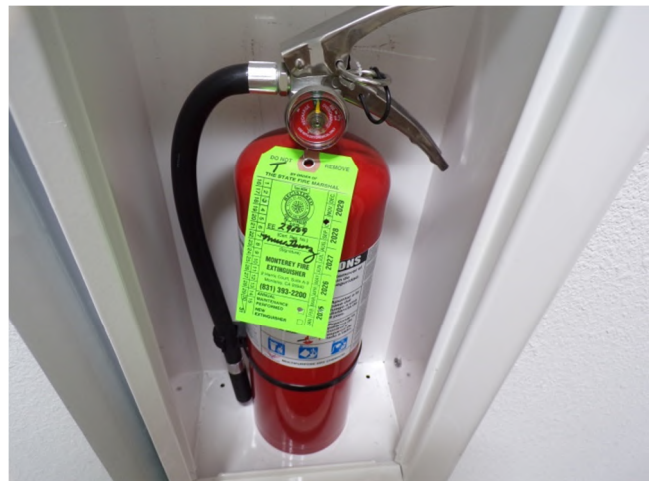
78. All observed fire extinguishers had valid inspection tags.

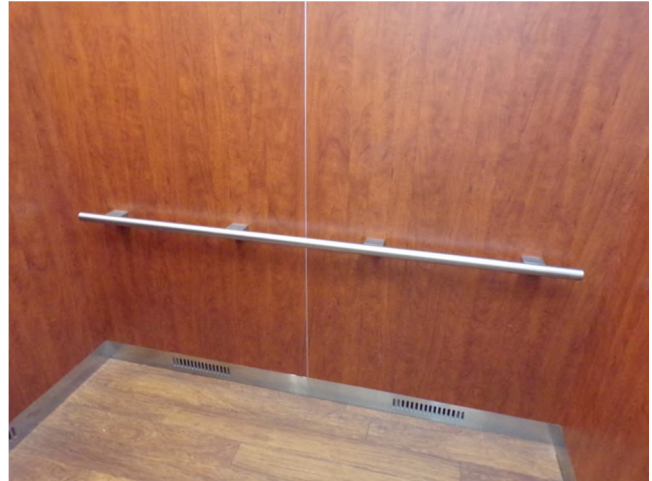
80. Interior finishes and stainless steel handrail in elevator cab.

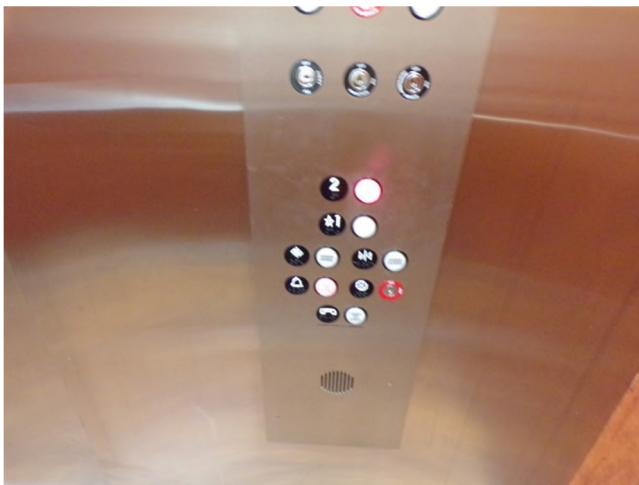
81. Elevator control panel in cab.

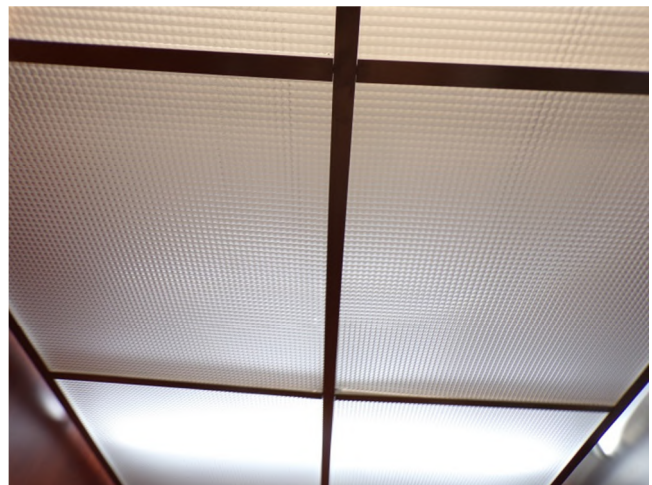
82. Ceiling diffuser grid in elevator cab.

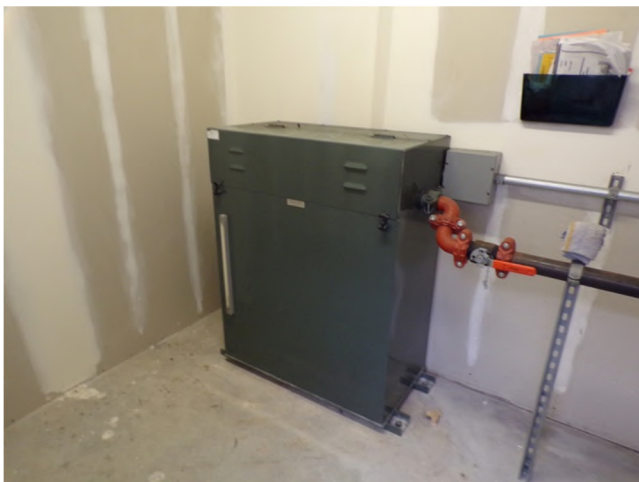
83. Hydraulic pump for elevator.

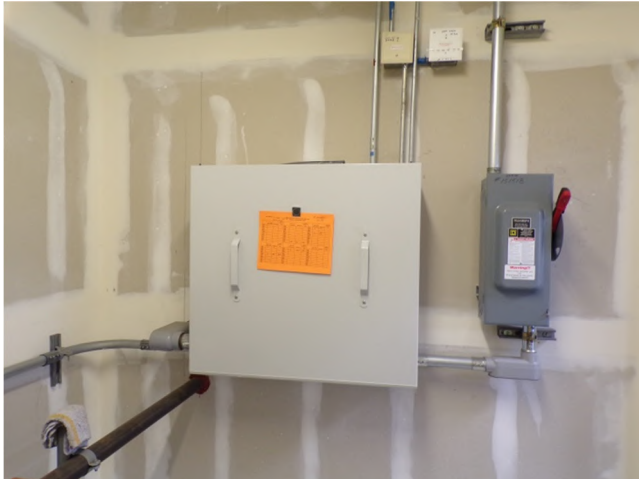
85. Elevator controller panel.

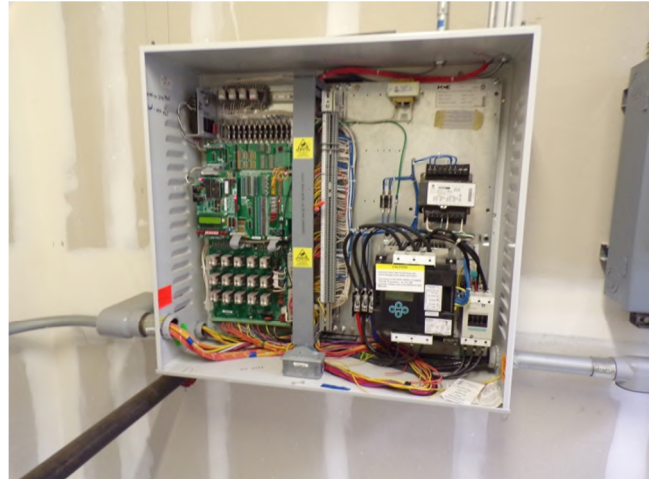
86. The elevator controller was modernized in 2007. A fully digital unit was installed.

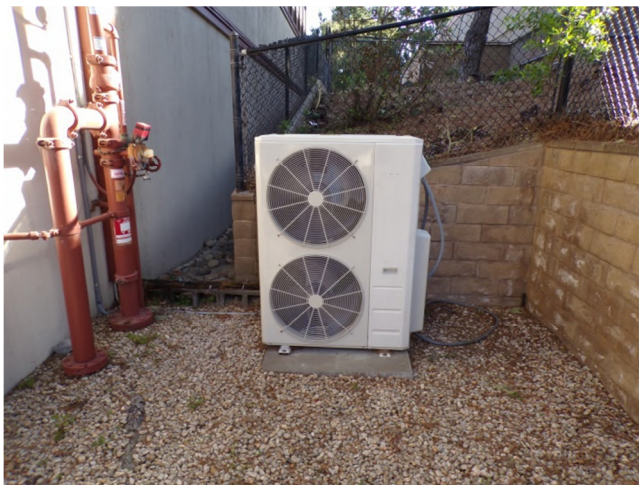
87. The CAC/BDP mini split-system was installed and is maintained by California American Water. It provides conditioned air to their server room only.

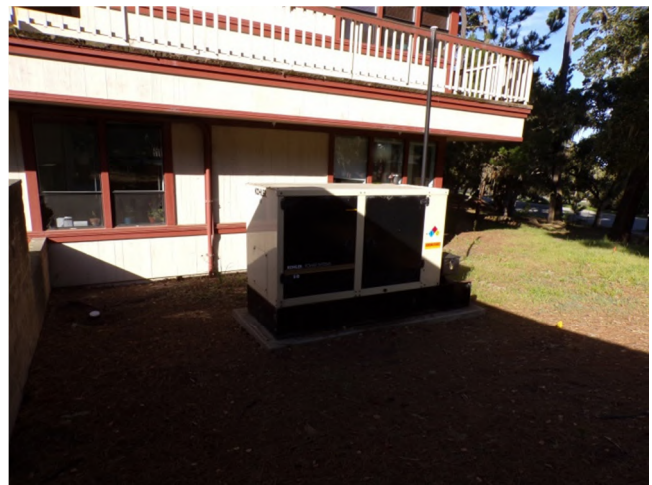
88. The emergency generator was installed and is maintained by California American Water. It provides electricity to their tenant space only.

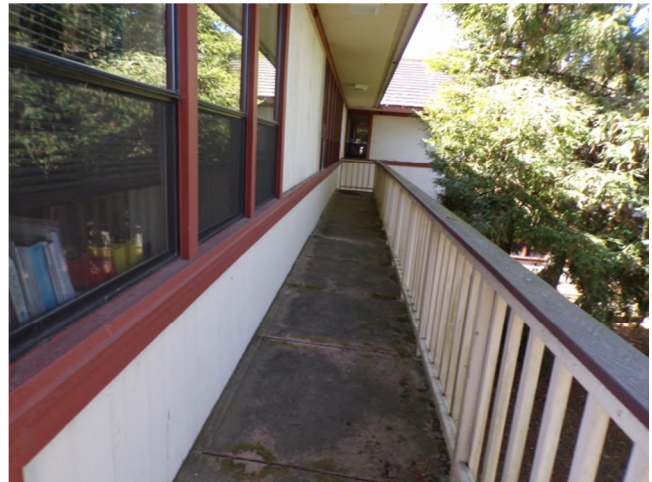
94. Two L-shaped balconies are provided.

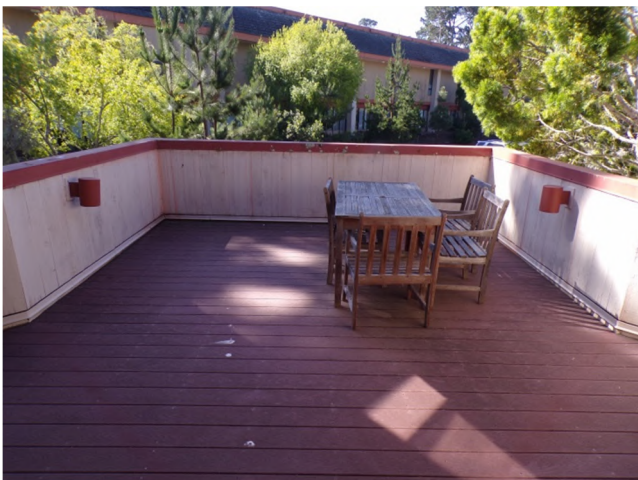
95. A balcony with a seating area is located at the west reentrant angle.

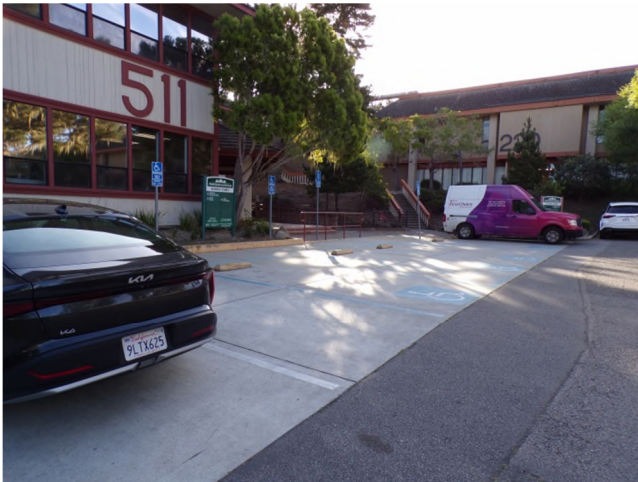
99. The Accessible parking stalls are located in close proximity to the main pedestrian entrance.

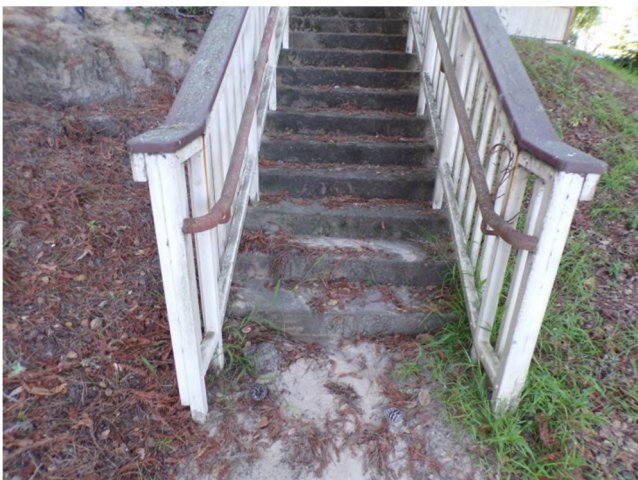
101. The north exterior stairs lack visually contrasting stripes on each tread, as required.

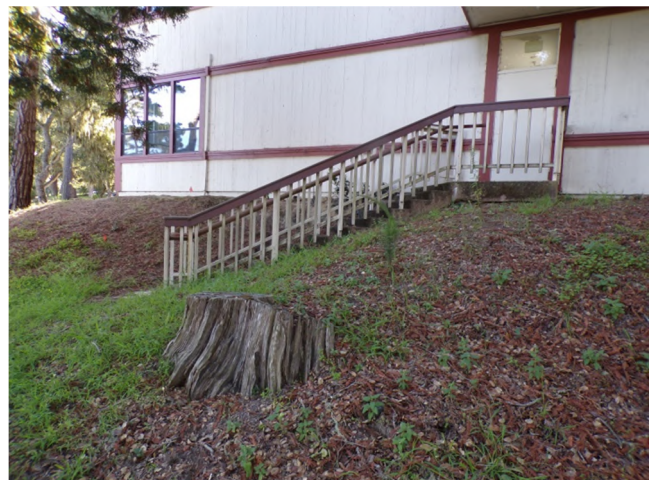
102. The railings of the north exterior stairs are non-compliant with current codes.

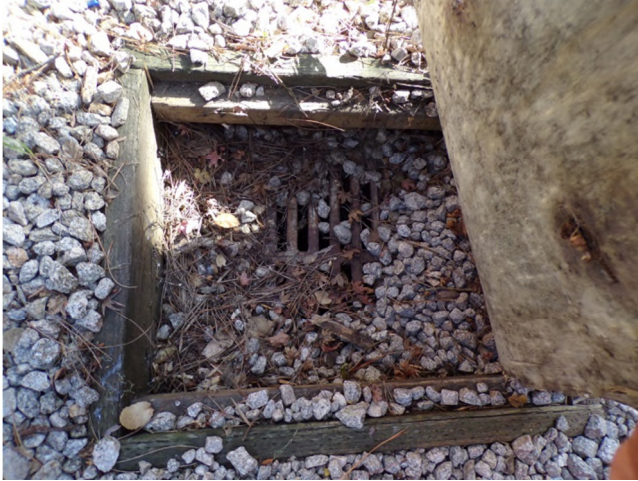
103. An area drain near the main building entrance is be fitted with a temprary plwood cover.
