## PROPERTY CONDITION ASSESSMENT

345 Middlefield Road, Bldg 15, Menlo Park, CA 94025

ALLWEST PROJECT 25097.60  
June 30, 2025

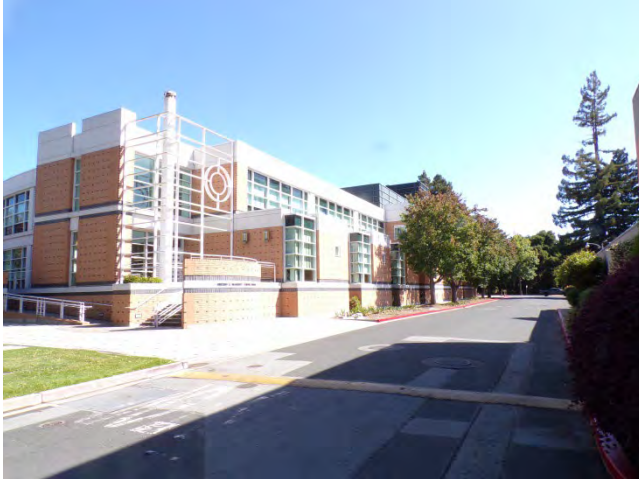
1. Southeast corner of Bldg 15 with east elevation at center. Survey Lane shown to the right of the building.

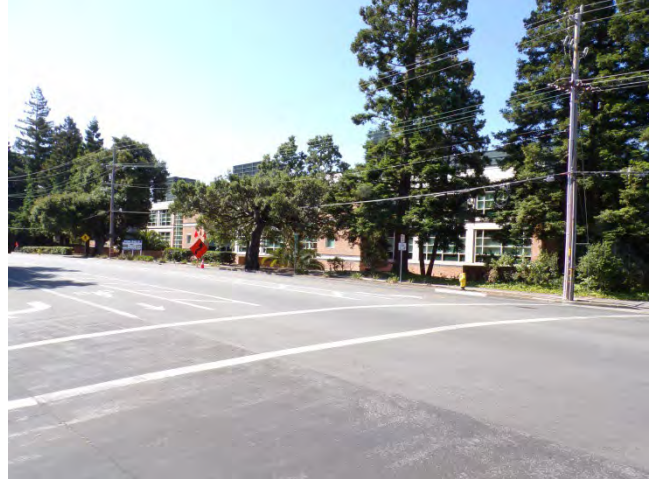
2. North elevation along Middlefield Road.

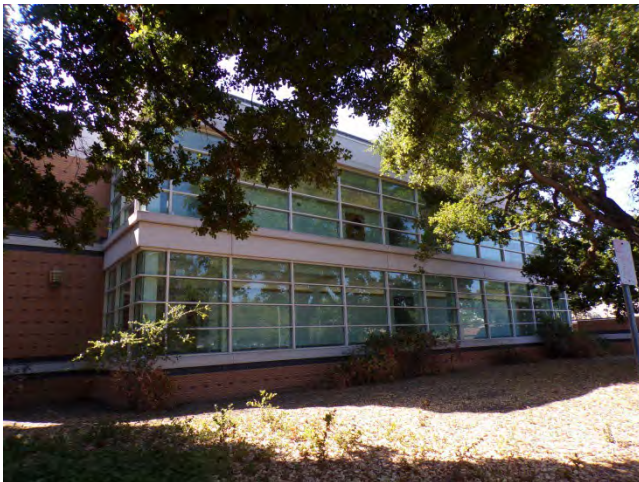
3. Portion of west elevation.

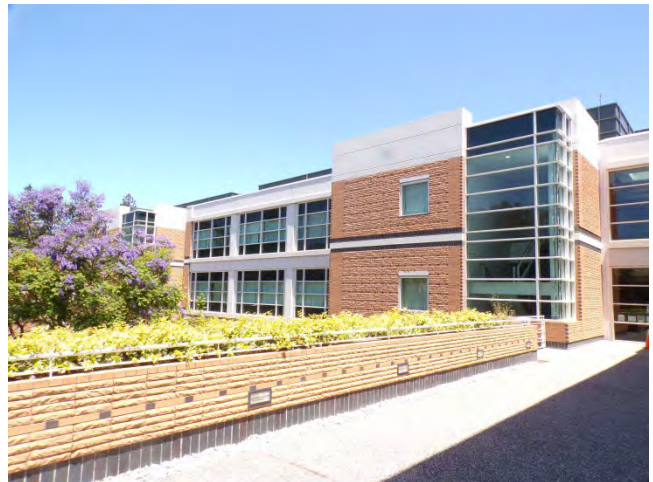
4. Portion of south elevation.

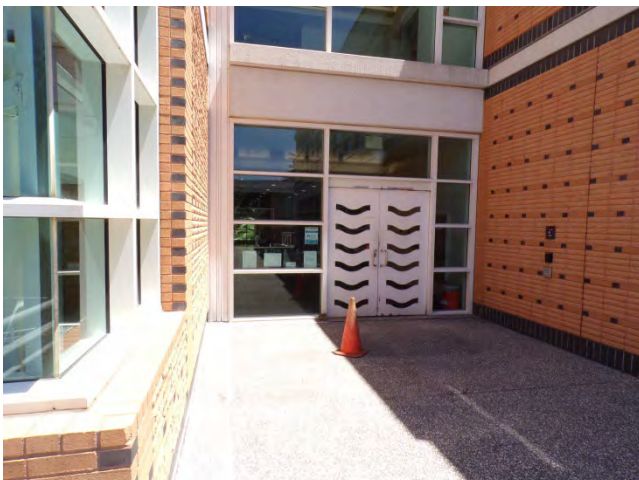
5. Main entrance on second floor level to offices and labs.

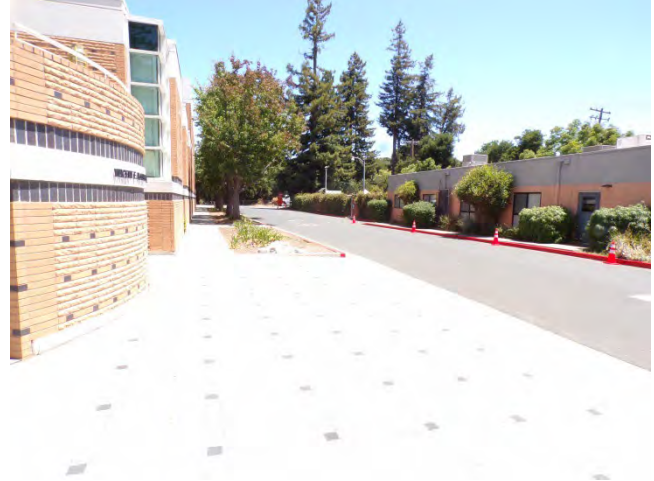
8. Survey Lane sidewalk, looking east-northeast.

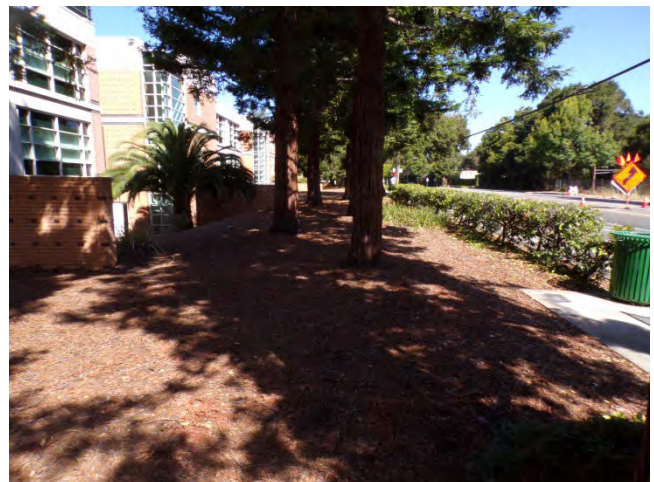
Near Bldg 15, landscaping is provided with a sub-surface irrigation system serving plants around Bldg 15, along the perimeter of the property, and in various locations elsewhere around the entire parcel. At Bldg 15, mature trees, shrubs, flowering plants, and a small grass lawn are installed. Several plants adjacent to the subject building appeared in a degraded condition or dead.

12. Large areas of the landscape are covered with mulch in lieu of plantings. North side of building shown.

- Return all landscaping elements to "Good" condition;

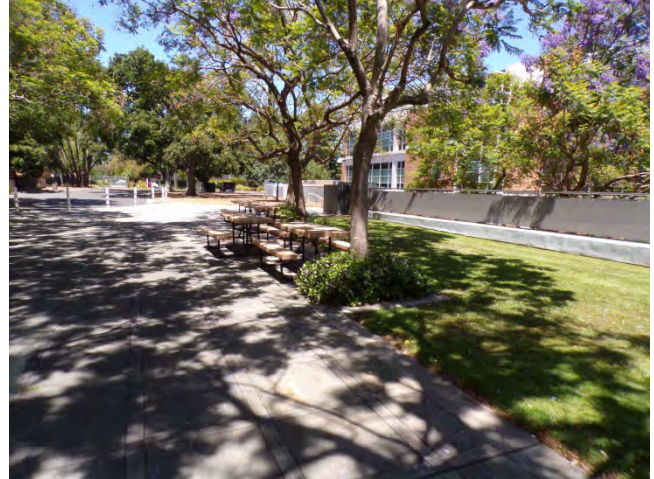
14. A small grass lawn is installed along the south side of the building.

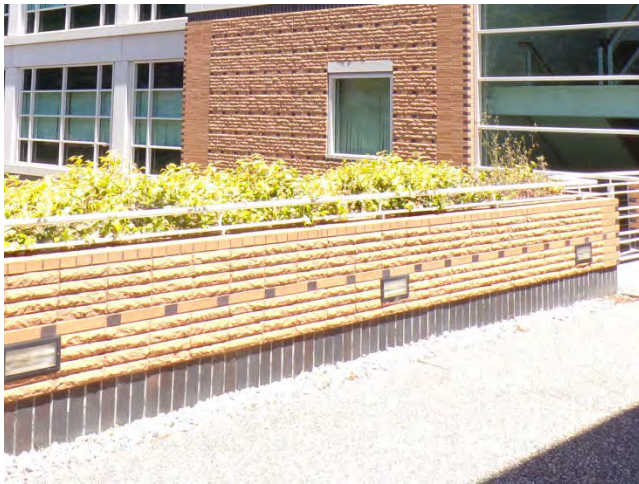
15. Landscaping at second floor level along walkway leading to main office/lab area entrance.

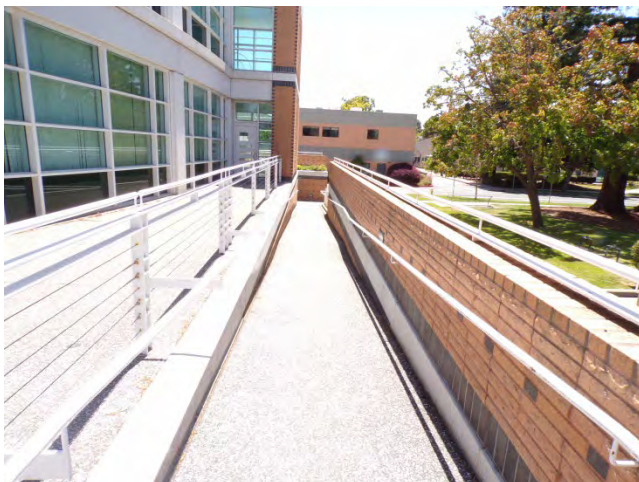
17. Concrete ramp along south elevation.

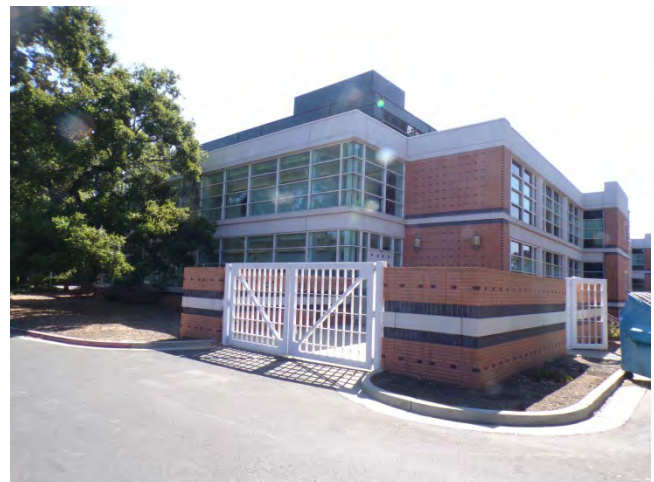
18. The loading dock area is located at the southwest corner of the building.

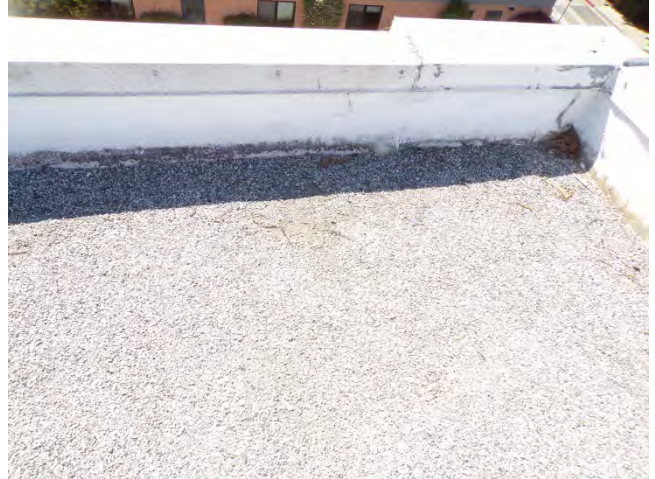
Building 365’s roofing systems appeared in “Good” to “Fair” condition. It appears a single-ply thermoplastic polyolefin (TPO) roofing system was installed time of original construction in 1995; the roofing membrane is covered with granite pea ballast. It appears that a modified bitumen roofing membrane was installed at the roof and overflow drain sump locations. However, ballast is not provided on the roof within the screen areas where mechanical equipment is located. No known, current leaks through the roofing system were reported. Owing to the roof’s 30-year age, replacement during the reserve term is recommended; the cost for this can be considered significant.

20. Granite pea ballast is broadcast over the underlying roofing membrane.

- Replace two sets of timber stairs along north elevation with fully code compliant stairs;
- Provide new tear-off TPO roofing systems on main roof and three lower roofs;

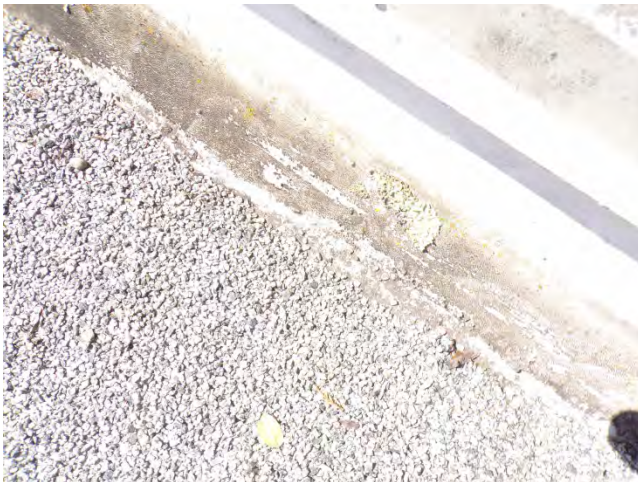
21. The roofing system appears to be a single-ply TPO membrane topped with ballast.

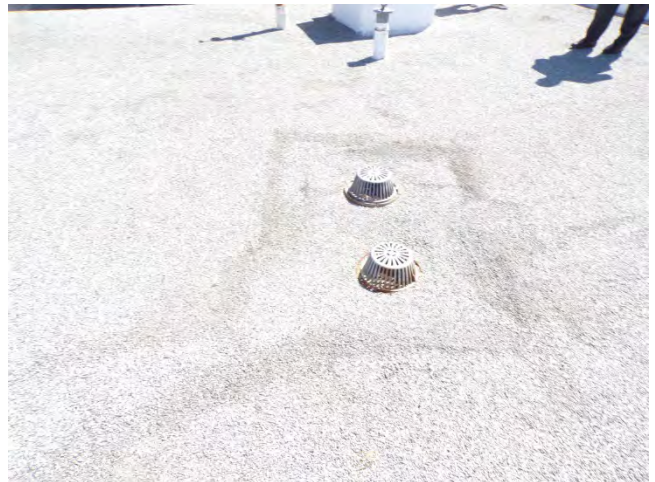
22. In the ballasted areas, roof and overflow drain combinations are installed within shallow sumps.

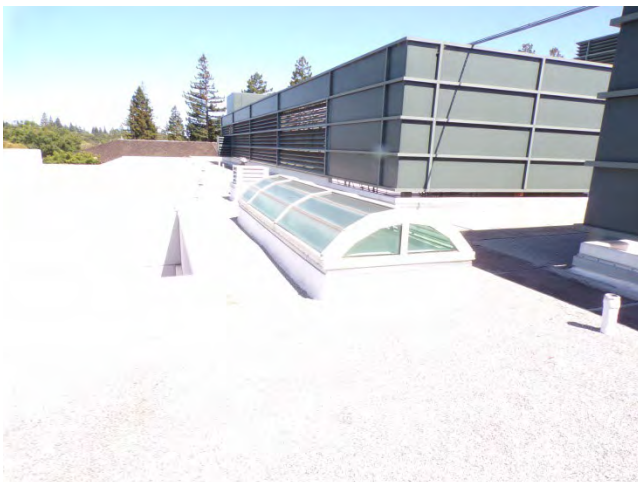
23. Seven skylights are installed.

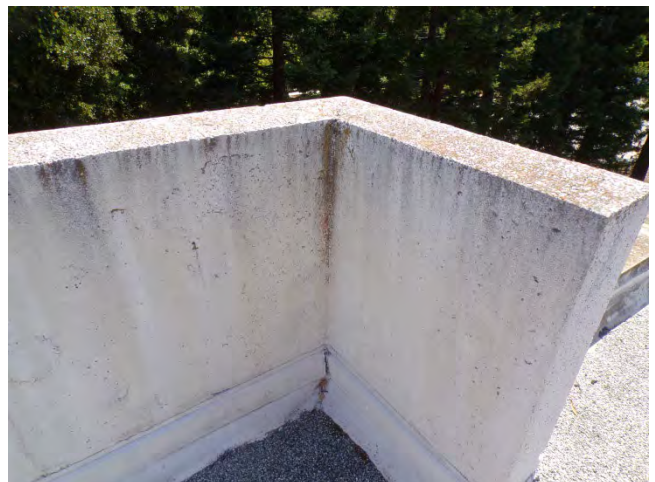
24. The precast concrete panels are also used for the parapets.

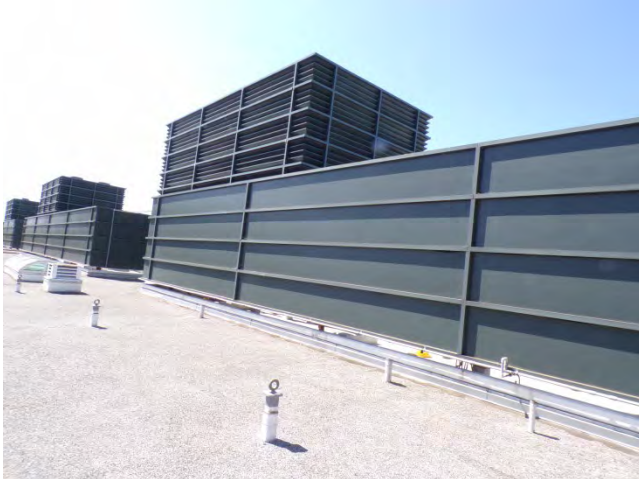
25. The mechanical equipment screens are steel-framed with painted fiberboard facings.

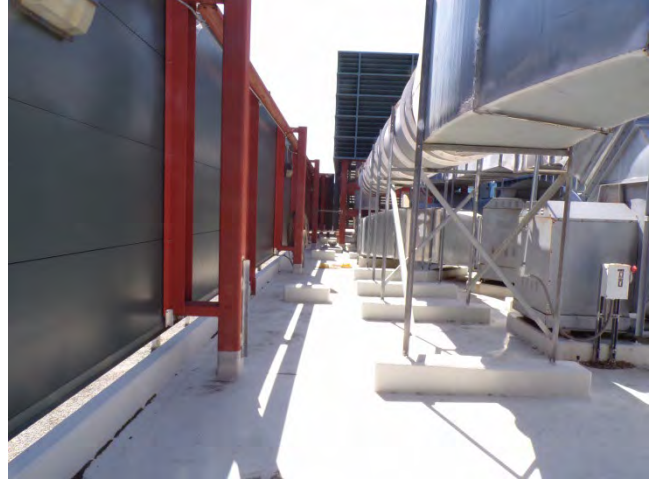
26. The gravel ballast is not applied within the equipment screened areas of the roof.

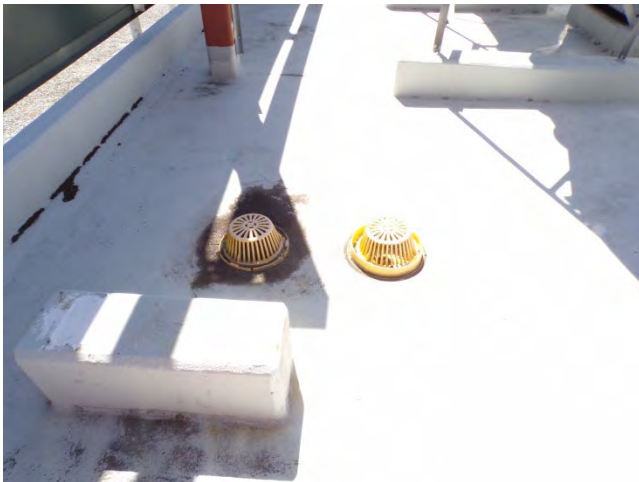
27. Within the screened areas, the roof and overflow drain combinations are not installed in shallow sumps.

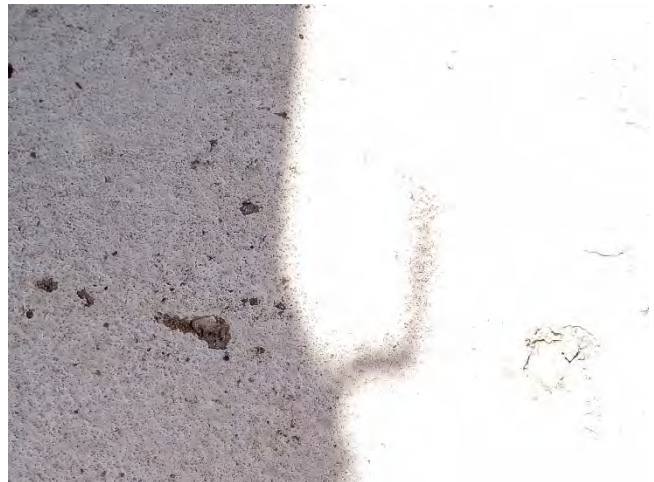
28. A coating has been applied on the roofing membrane within the screened areas.

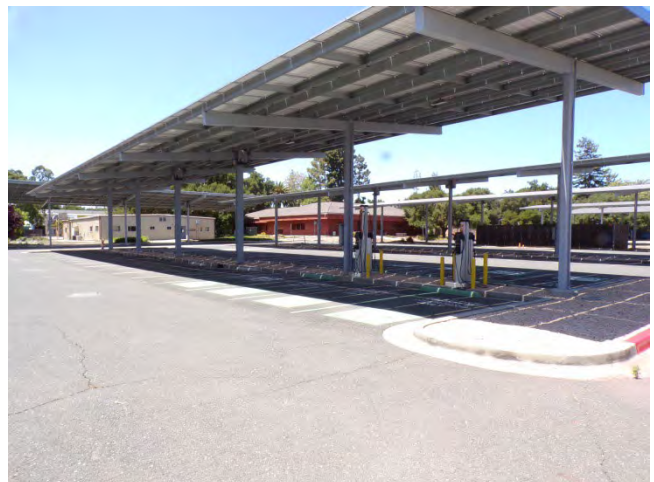
30. Canopies topped with solar arrays are installed in the main parking lot. The canopies/solar arrays are outside the scope of work for this project.

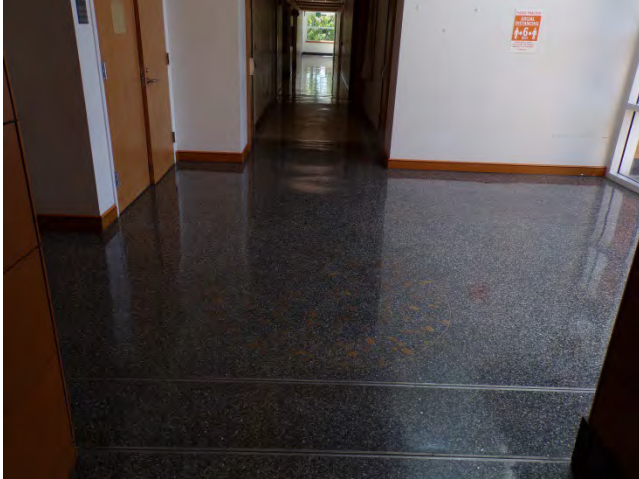
31. Interior finishes in lobbies and some corridor areas.

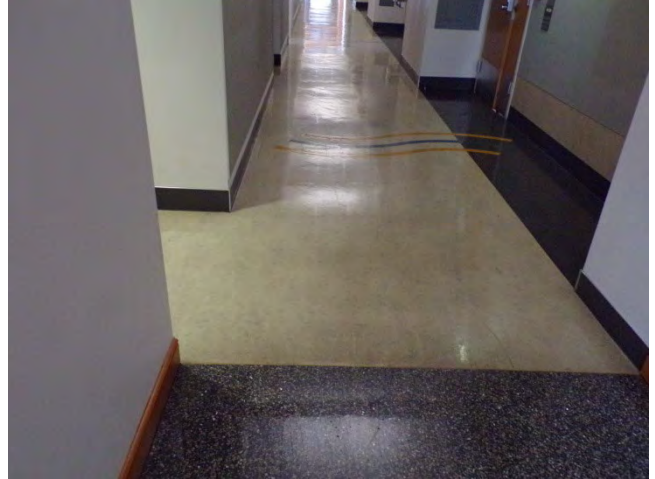
32. Interior finishes in corridor areas.

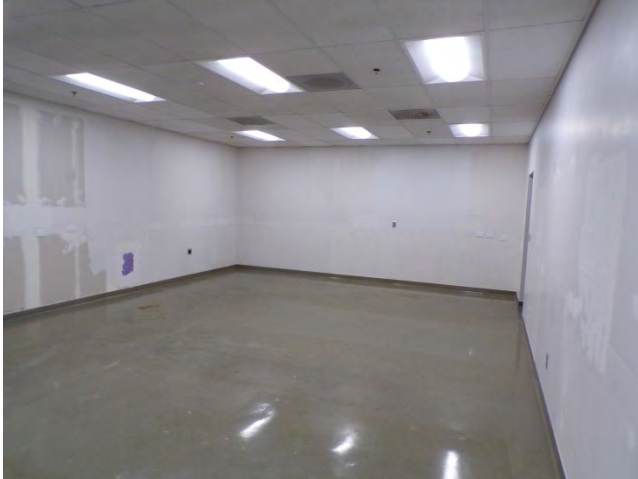
37. Interior finishes and fixtures in lab areas.

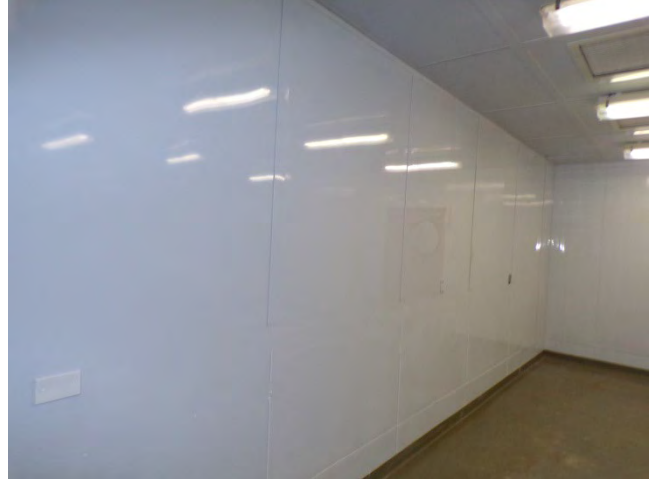
38. Interior finishes and fixtures in lab areas.

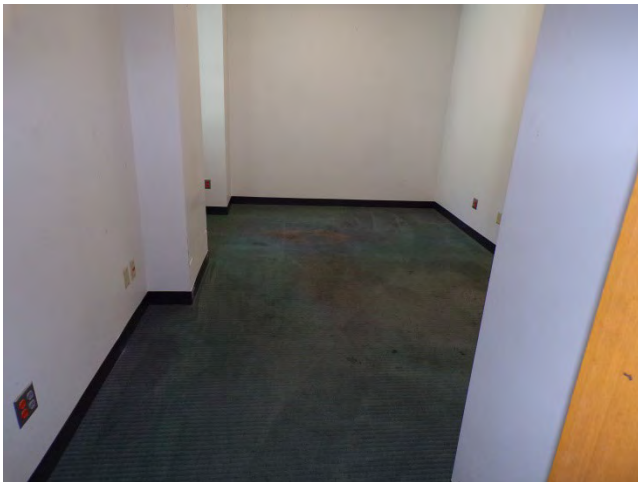
39. Interior finishes in office areas.

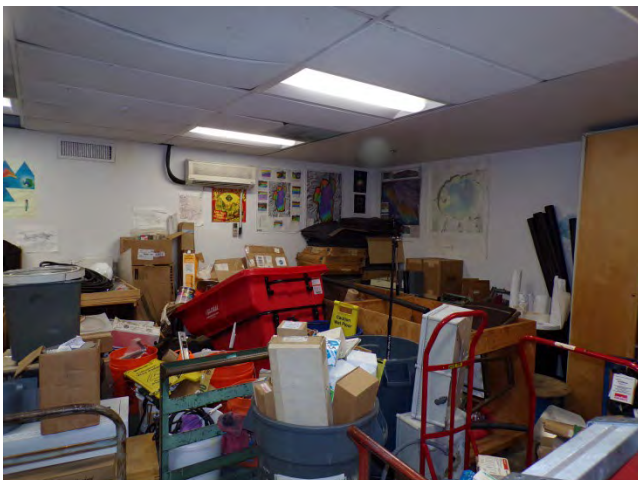
41. Interior finishes and fixtures in storeroom.

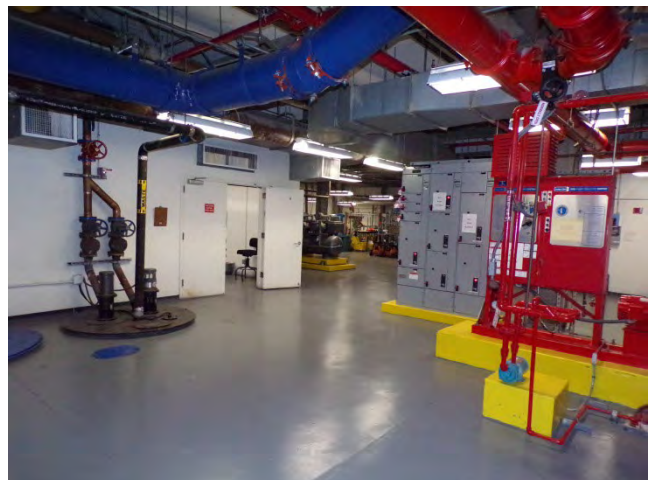
42. Interior finishes and fixtures in main mechanical room.

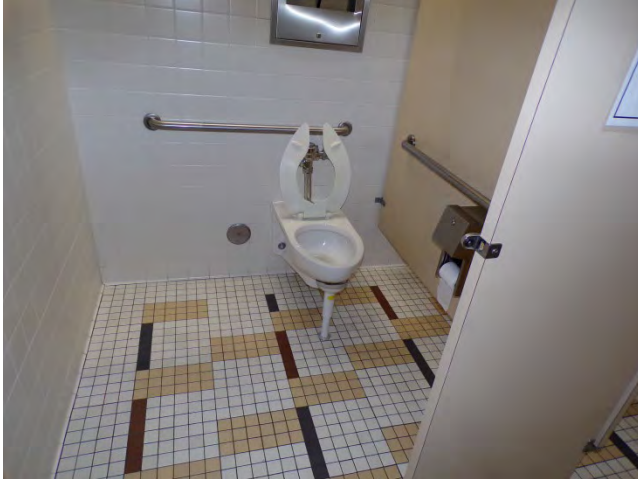
43. Interior finishes and fixtures in restrooms.

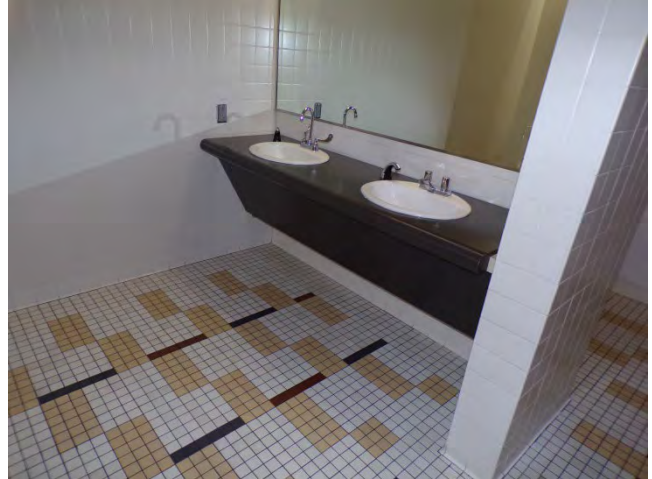
44. Interior finishes and fixtures in restrooms.

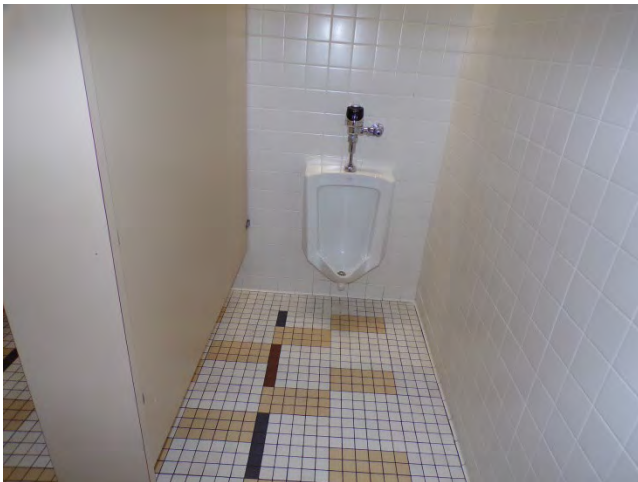
45. Interior finishes and fixtures in restrooms.

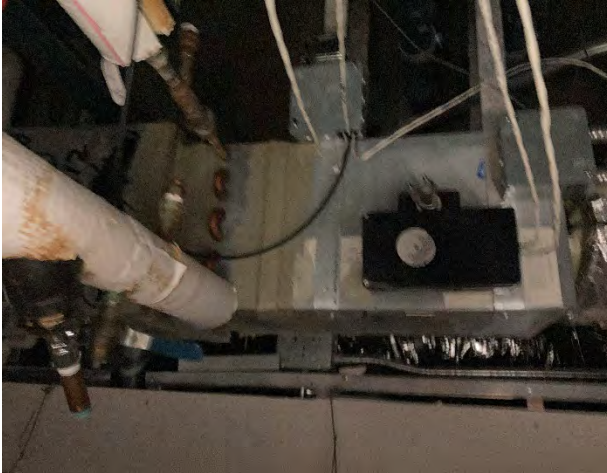
M-2. Four-pipe air handling unit.
