## PROPERTY CONDITION ASSESSMENT

2030 Harrison Street, San Francisco, CA 94110

PROJECT 26008.61  
May 1, 2026

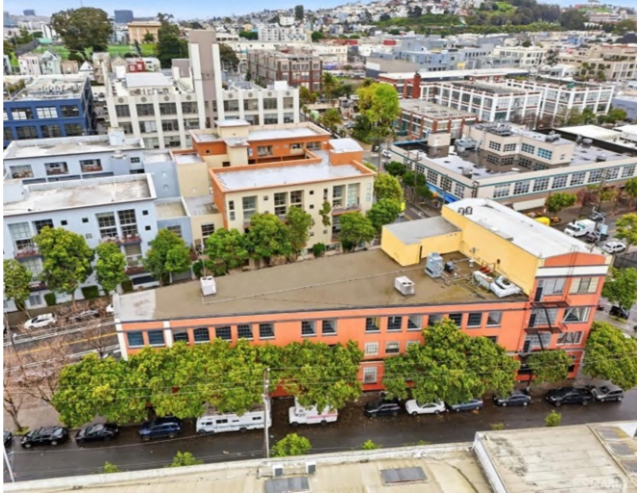
1. The building was constructed in 1907.

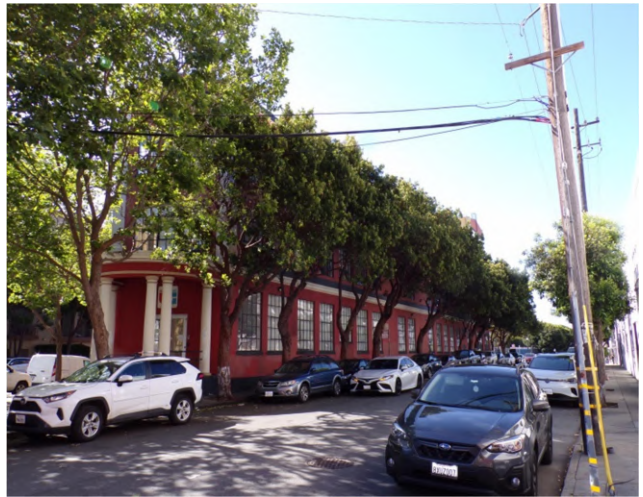
4. West elevation along Treat Avenue.

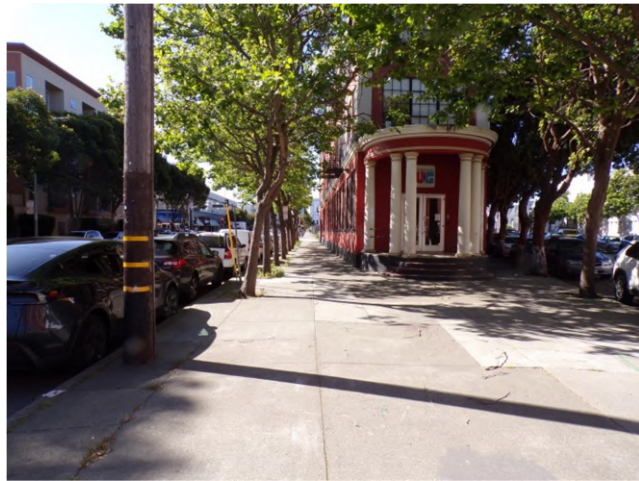
16. Public sidewalk at north end of site and along east elevation.

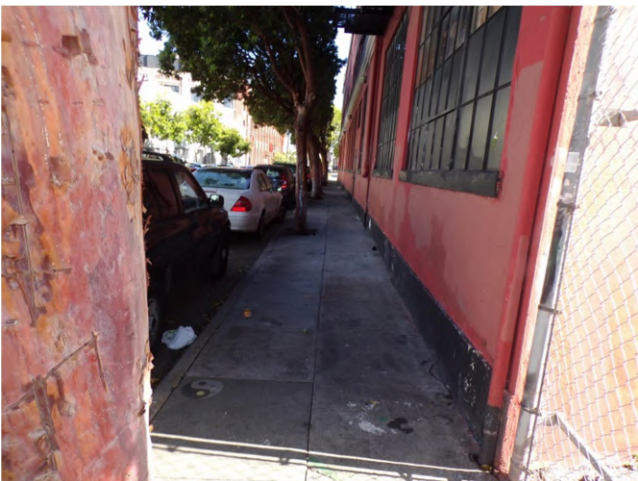
17. Public sidewalk along west elevation.

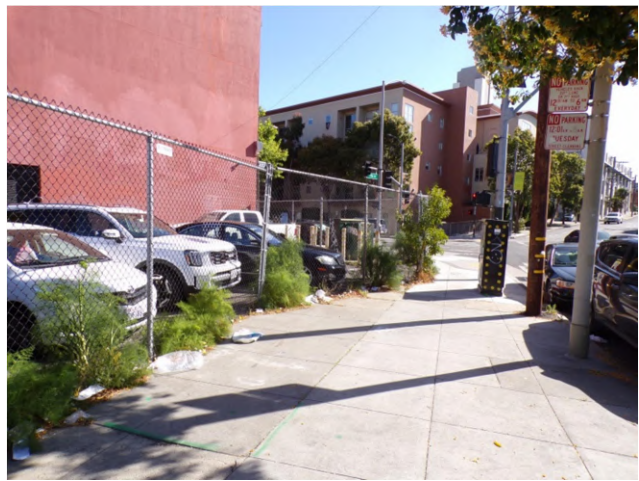
18. Public sidewalk at south end of site. Chain-link fencing also shown.

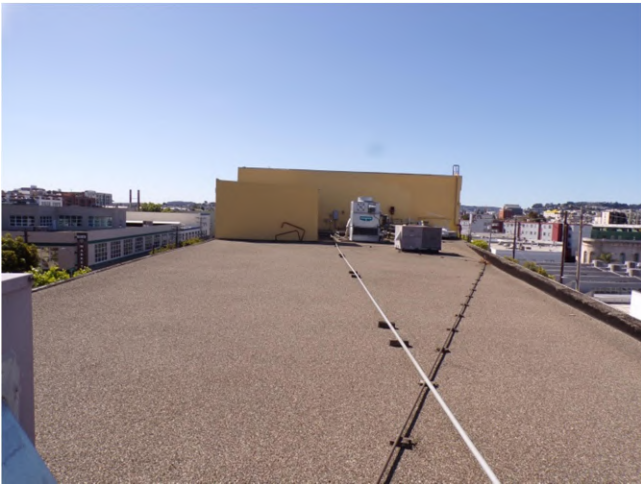
The roofing systems appeared in Fair to Poor condition with the bias towards Poor on the main portion of the roof.

21. Main roof: The BUR system has pea gravel ballast.

recommend that new, tear-off roofing systems be provided on all roof areas during the reserve term.

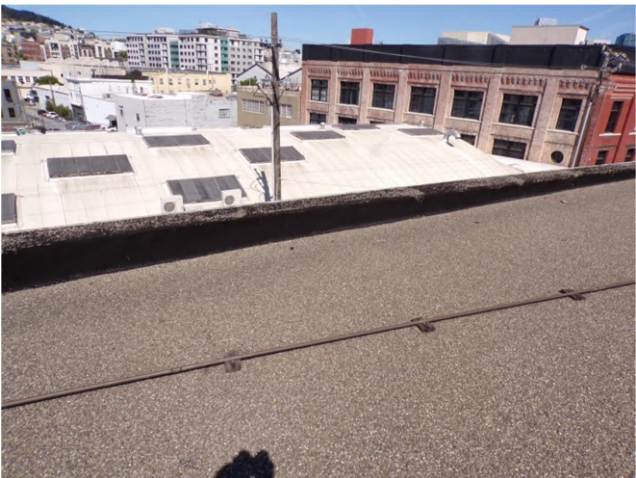
23. Main roof: Low parapets are provided.

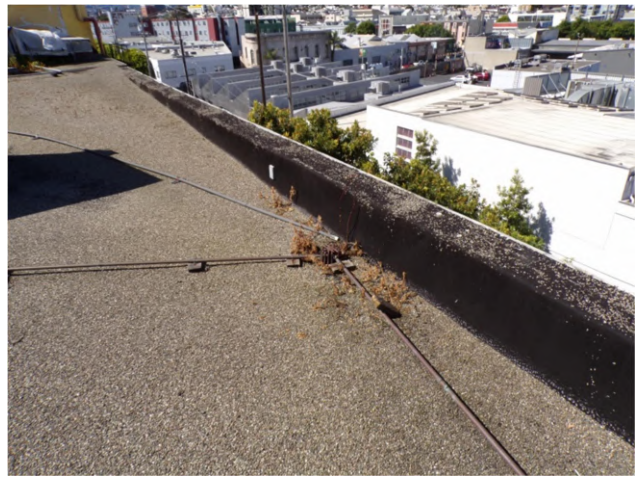
An area of longstanding ponded water was observed near the ventilation equipment at the foot of the north elevation of the fourth floor. There is no roof drain in the immediate vicinity of the ponded water and the make-up air (MUA) unit and the exhaust fan/duct complex serve as dams preventing water from flowing freely to the single roof drain on the main portion of the roof.

24. Main roof: Only one roof drain serves this level of the roof.

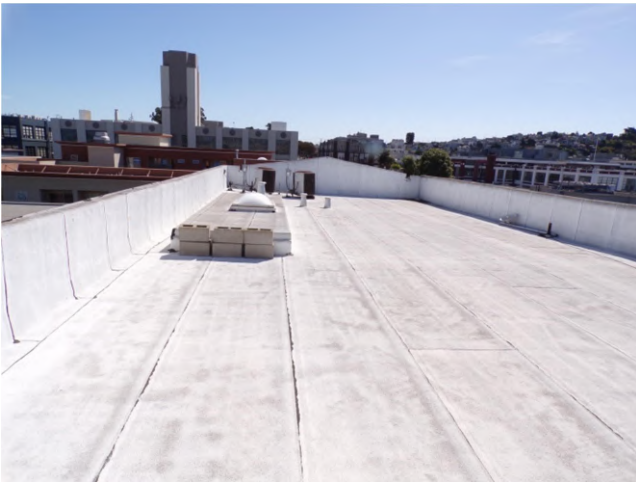
27. Fourth floor roof: The BUR system on this roof level does not have gravel ballast.

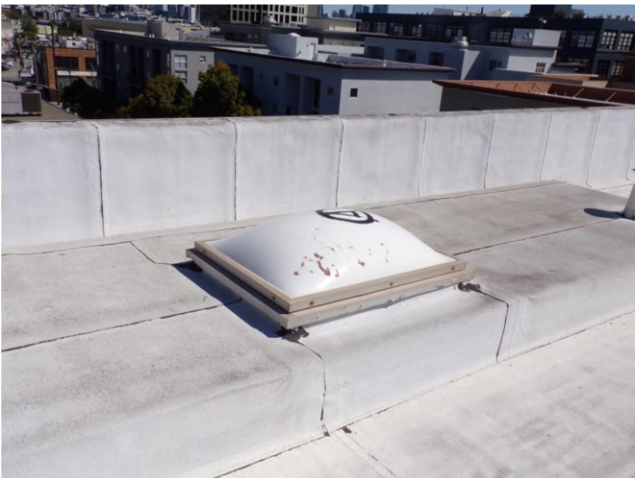
29. Fourth floor roof: Only one skylight is installed on this building.

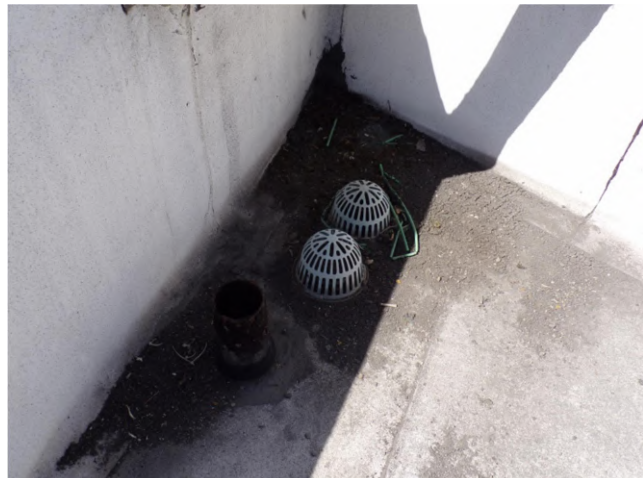
30. Fourth floor roof: A roof and overflow drain combination is provided.

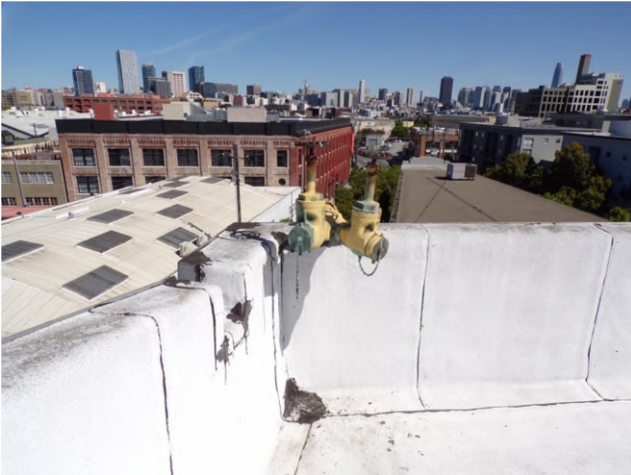
31. Fourth floor roof: Fire department connections. This roof level has taller parapets.

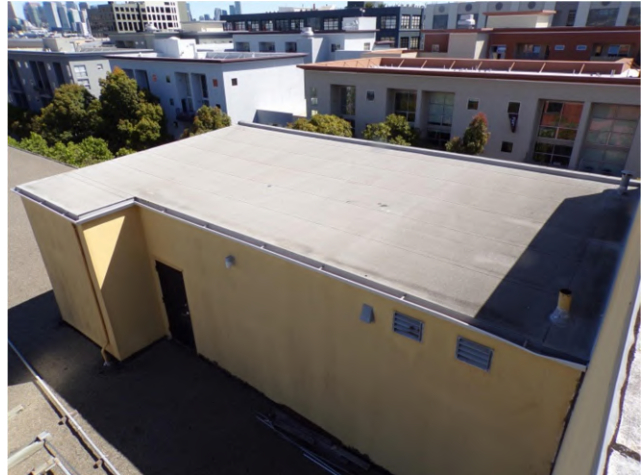
32. Penthouse: The BUR system on this roof level does not have gravel ballast.

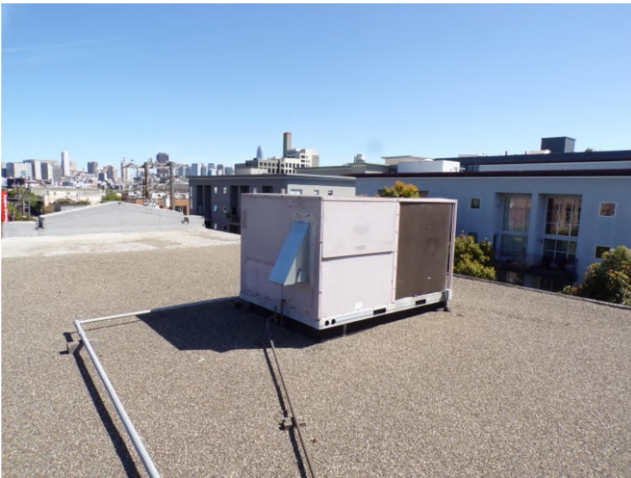
33. Two 12 ton Carrier packaged units are mounted on the main roof level.

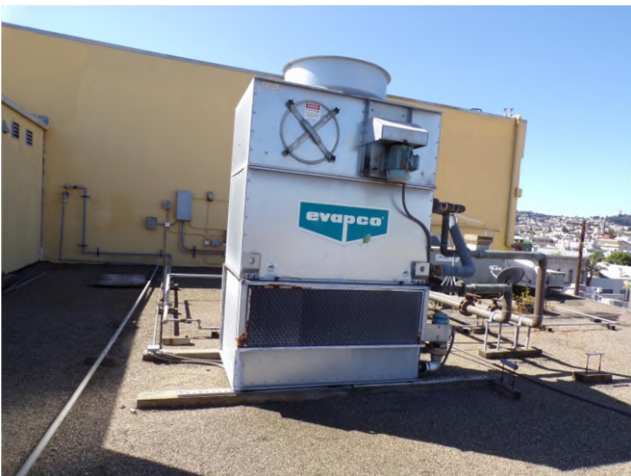
35. The Evapco cooling tower provides chilled water to the hydronic loop system.

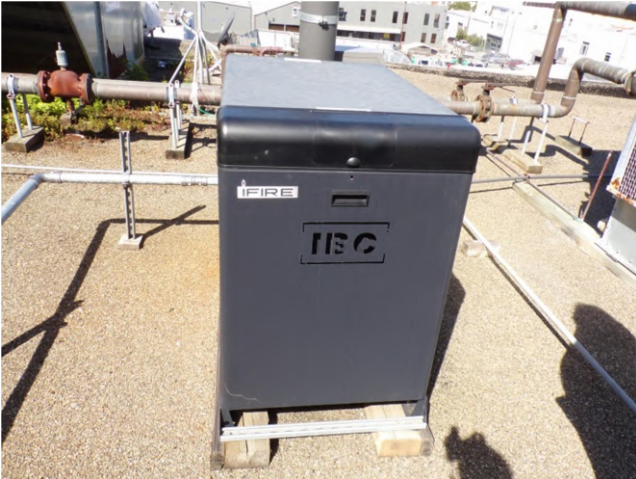
37. The IBC Technologies boiler provides hot water to the hydronic loop system.

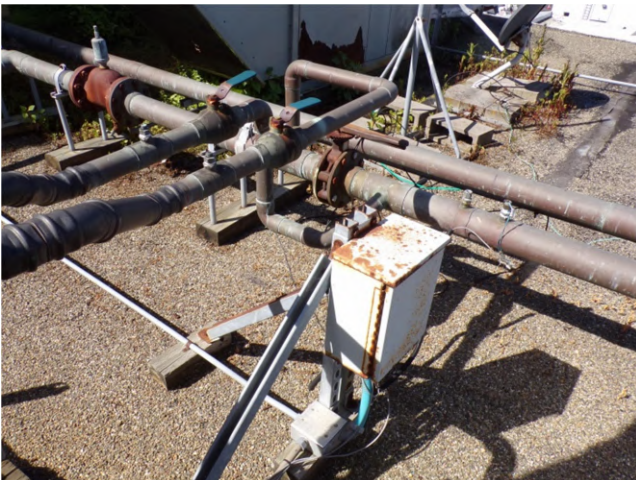
41. Rooftop piping for the hydronic loop system.

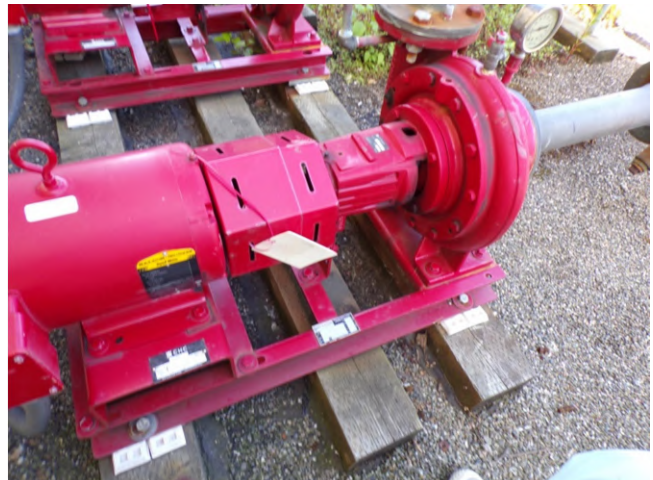
42. Two Bell & Gossett pumps serve the hydronic loop system.

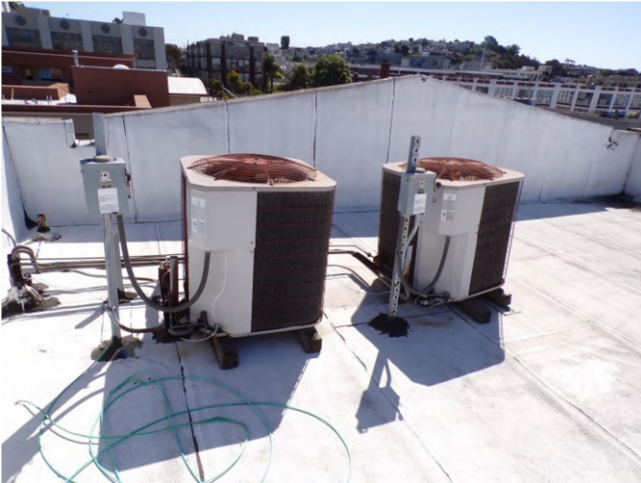
43. Two five ton Carrier splits systems are installed on the fourth floor roof.

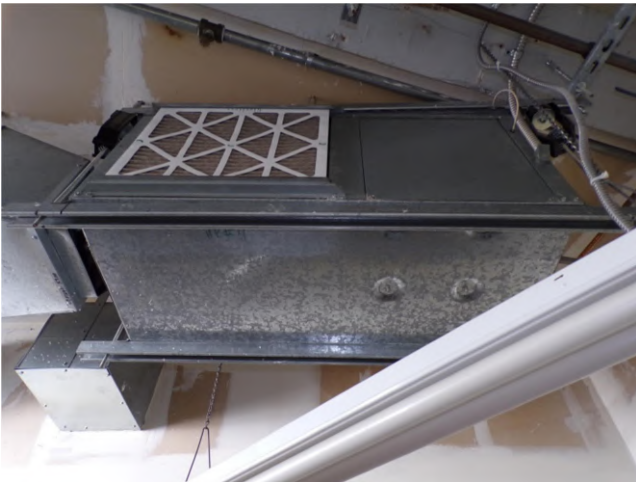
45. Seven water source heat pumps are installed in attic locations on the first and second floors.

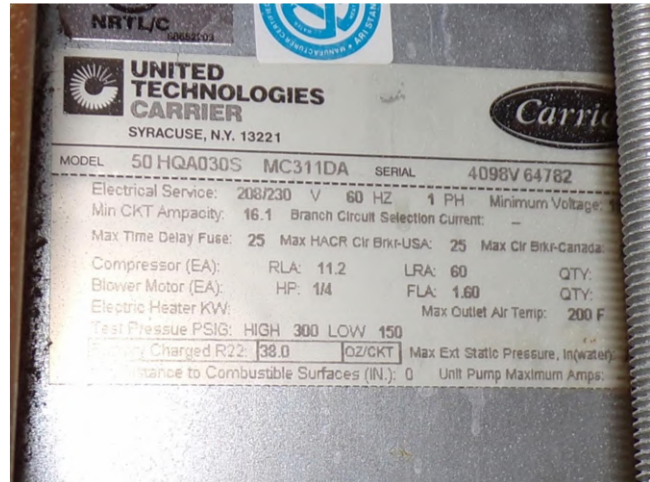
46. The six Carrier heat pumps were manufactured in 1998.

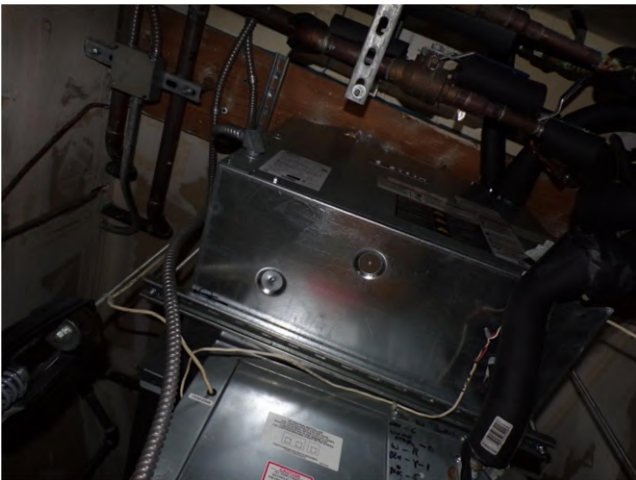
47. In 2022, a Bosch water source heat pump was installed atop an older Carrier unit.

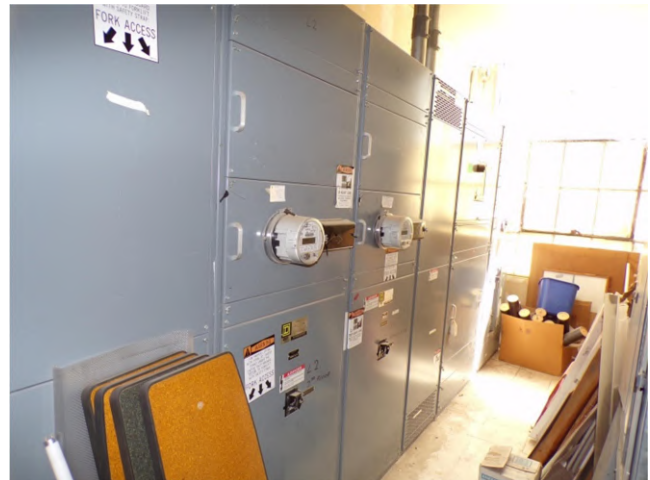
Pacific Gas & Electric (PG&E) provides 208Y/120 volt three-phase, four-wire service to the property. The main service entrance equipment and the main disconnect are both rated at 1,600 amps. Copper wire-in-conduit feeds handle power distribution. The main service entrance equipment was manufactured by Square D in 1998, as were the sub-panels we observed. The electrical equipment appeared in generally Good condition.

48. The 1,600 amp capacity main electrical service equipment was manufactured by Square D.

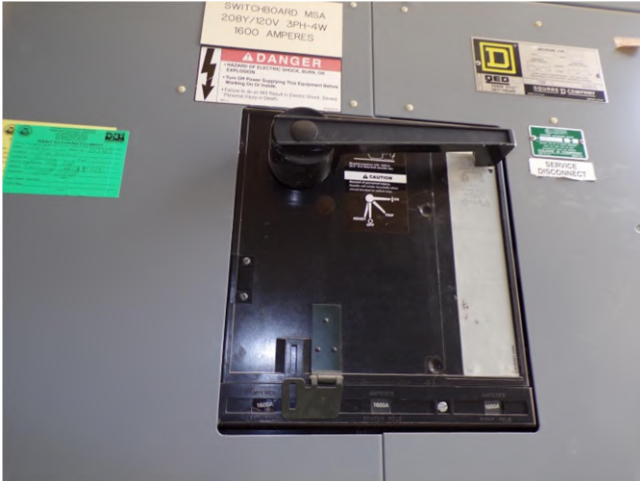
49. The 1,600 amp main disconnect.

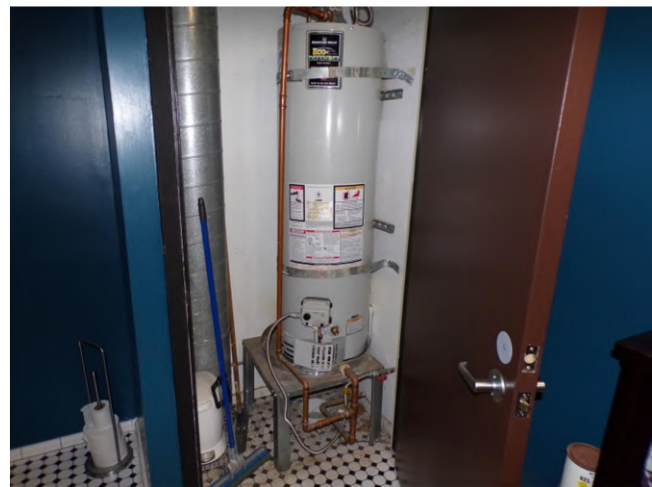
52. The natural gas-fired water heater is located in a service closet in a fourth floor restroom.

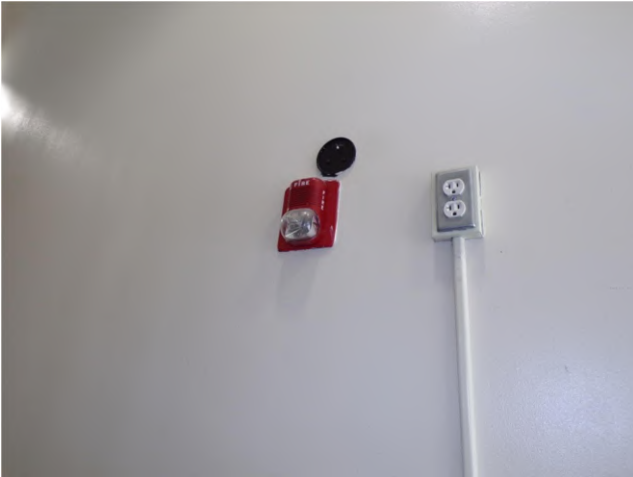
55. Fire alarm devices, such as the horn/strobe shown, are not provided in all required locations.

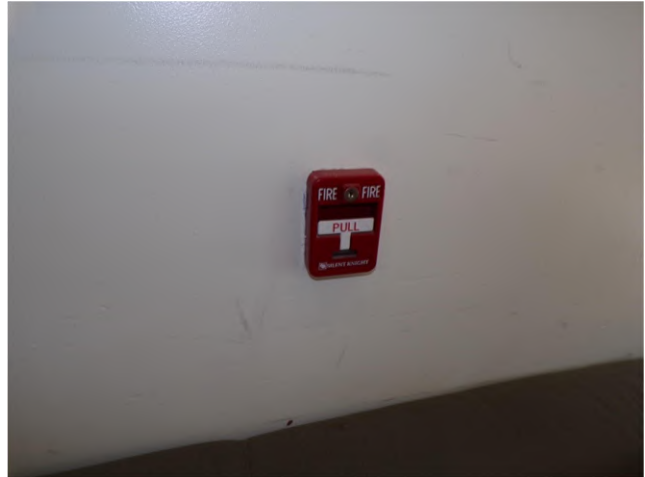
56. One manual pull station was observed.

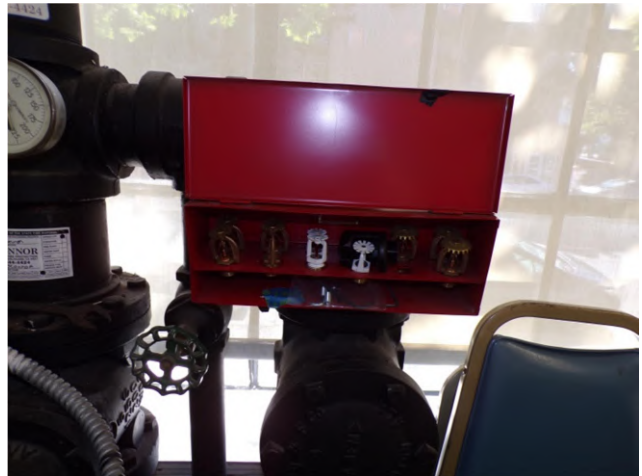
58. A box of spare sprinkler heads is provided.

| No | Sec | Photos | | Avg EUL (yr) | EFF AGE (yr) | Nominal RUL (yr) | Quantity | Unit | Cost Estimate Source | Unit Cost | Immediate Needs | Replacement Reserves | | | | | Years 1-5 Cumulative | Modernization Costs (Optional) | | | | | |
|---|---|---|---|---|---|---|---|---|---|---|---|---|---|---|---|---|---|---|---|--|--|--|--|
| 35 | L. | 58 | MODERNIZATION: Replace all older fire sprinkler heads. | N/A | N/A | N/A | 1 | LS | Allowance | \$50,000.00 | | | | | | | | | | | | | |

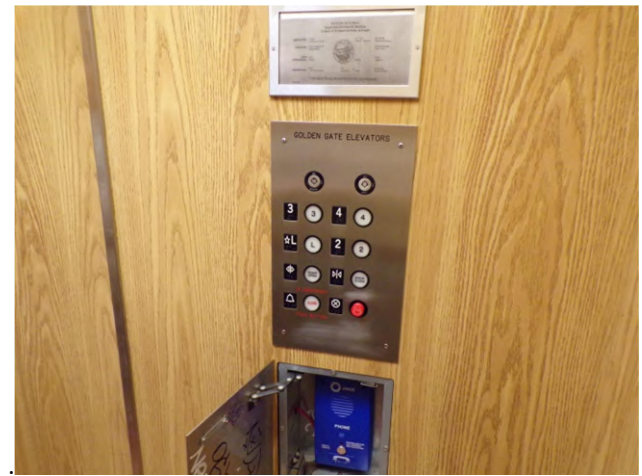
60. Elevator control panel in cab.

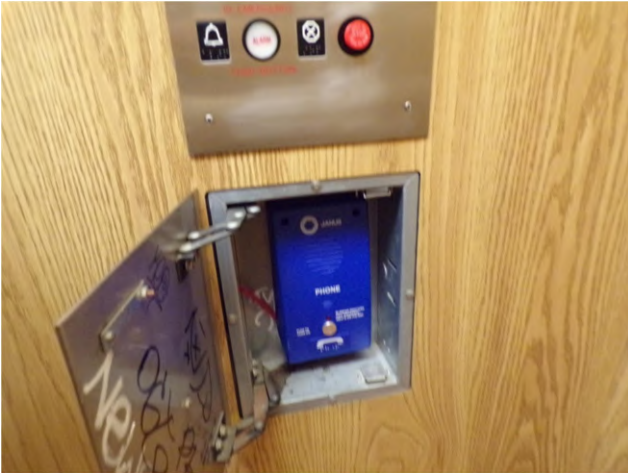
61. Hands-free communication device in elevator.

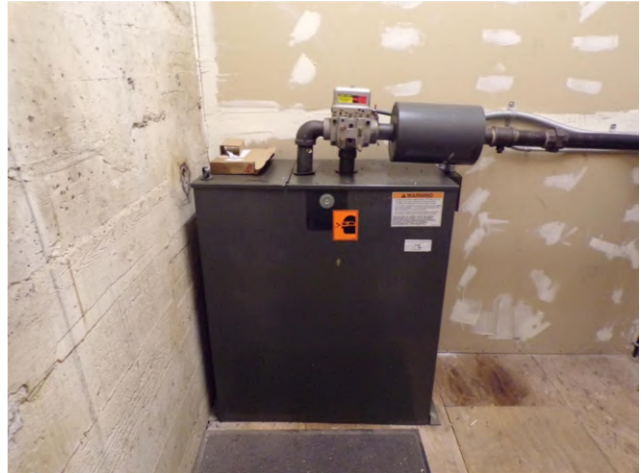
62. Hydraulic pump for elevator. The elevator and its hydraulic equipment date to 1998.

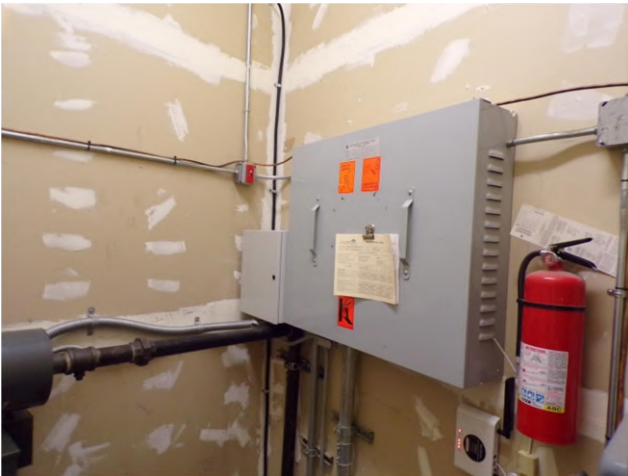
63. The digital control panel for elevator dates to 1998.

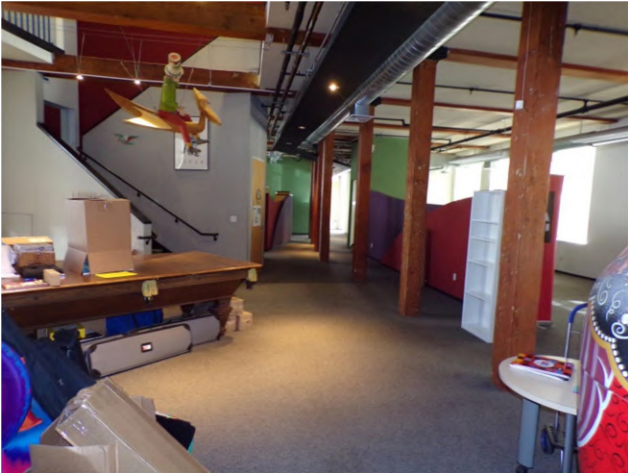
67. First floor: Interior finishes and fixtures in open office area.

| No | Sec | Photos | | Avg EUL (yr) | EFF AGE (yr) | Nominal RUL (yr) | Quantity | Unit | Cost Estimate Source | Unit Cost | Immediate Needs | Replacement Reserves | | | | | Years 1-5 Cumulative | Modernization Costs (Optional) | | | | | |
|---|---|---|---|---|---|---|---|---|---|---|---|---|---|---|---|---|---|---|---|--|--|--|--|
| 15 | G. | 67-94 | Allowance for performance of minor repairs and general renovation of interior finishes. | N/A | N/A | N/A | 1 | LS | Allowance | \$50,000.00 | | | | | | | | | | | | | |

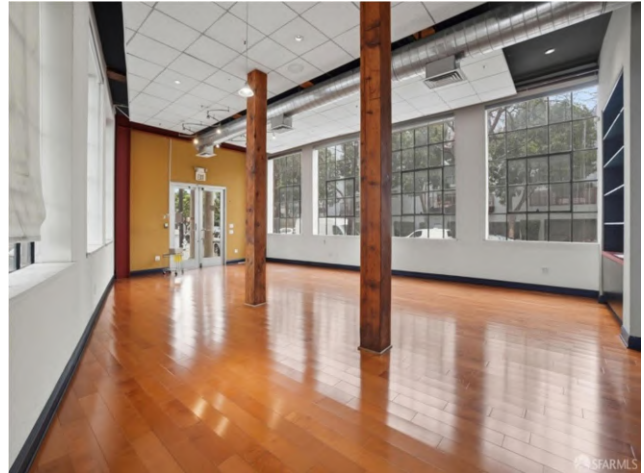
68. First floor: Interior finishes and fixtures in large foyer at main entrance.

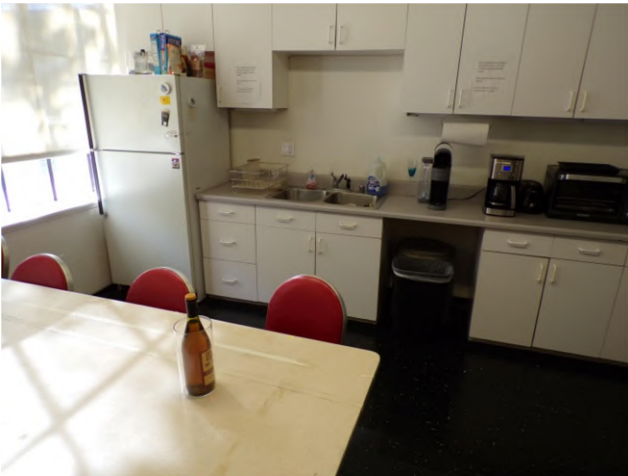
69. First floor: Interior finishes and fixtures in breakroom.

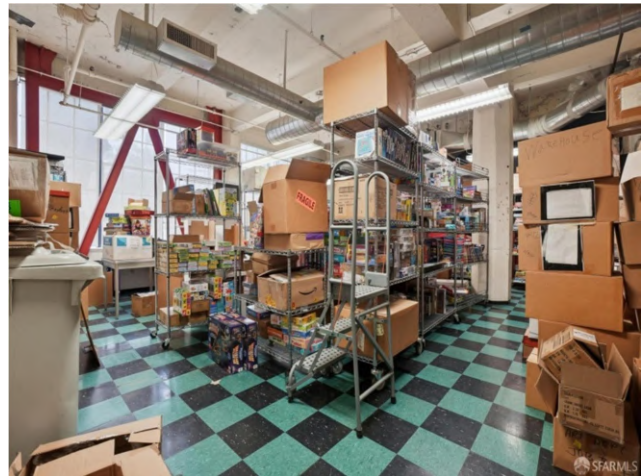
70. First floor: Interior finishes and fixtures in storage room.

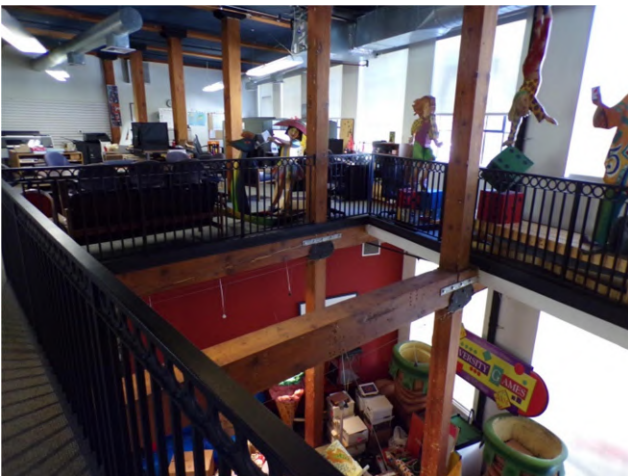
71. Second floor: Interior finishes and fixtures in open office area.

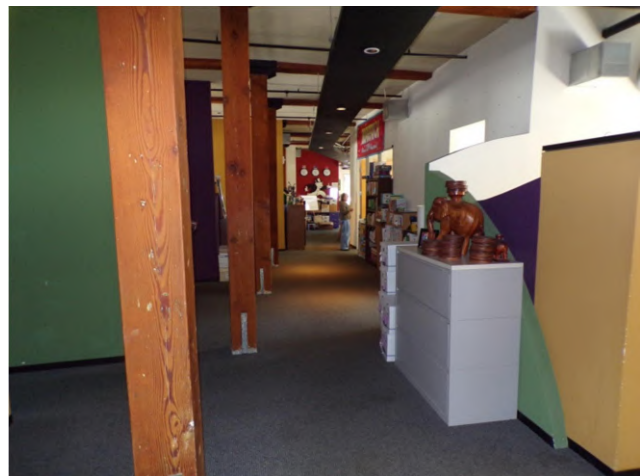
72. Second floor: Interior finishes and fixtures in open office area.

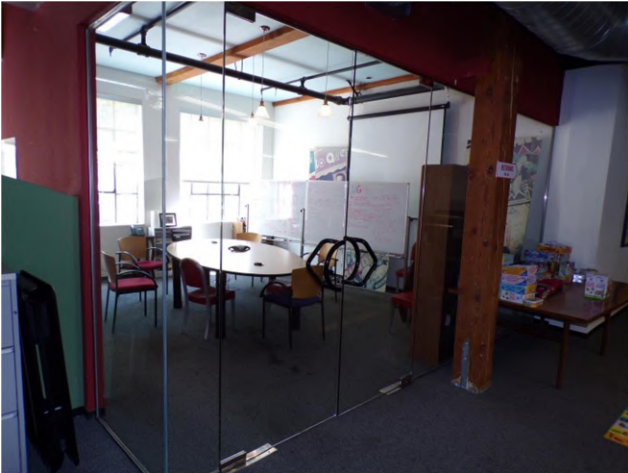
73. Second floor: Interior finishes and fixtures in conference room.

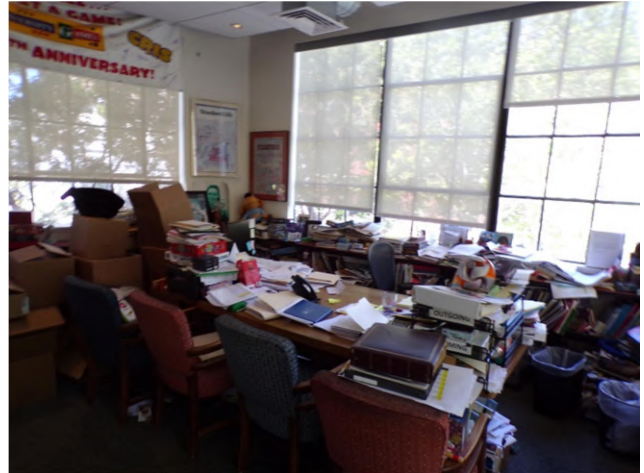
74. Second floor: Interior finishes and fixtures in private office.

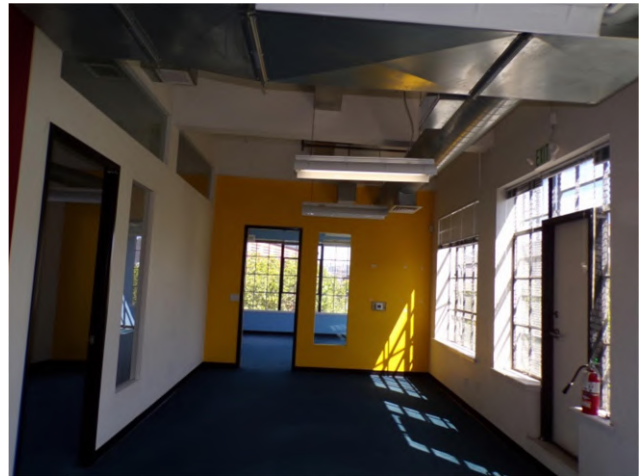
76. Third floor: Interior finishes and fixtures in private office.

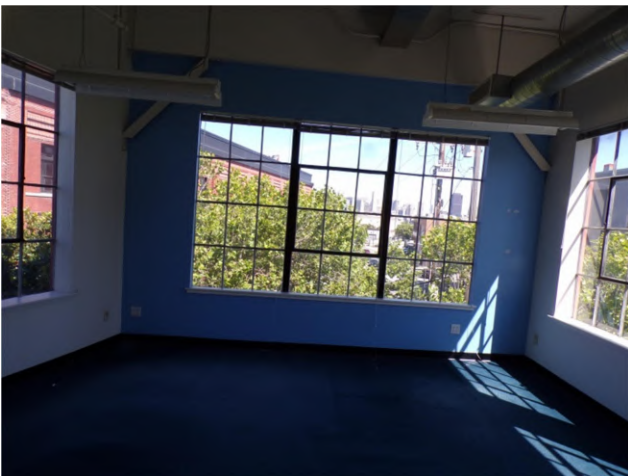
77. Third floor: Interior finishes and fixtures in private office.

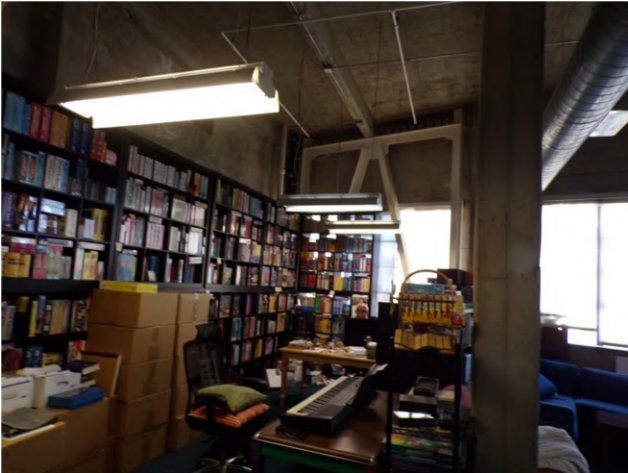
79. Fourth floor: Interior finishes and fixtures in private office.

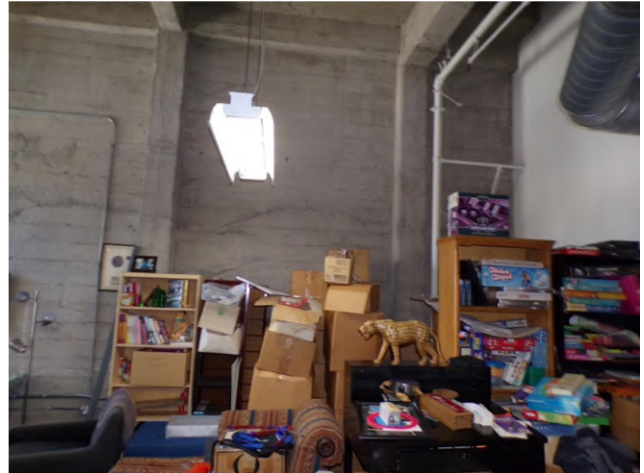
80. Fourth floor: Interior finishes and fixtures in private office.

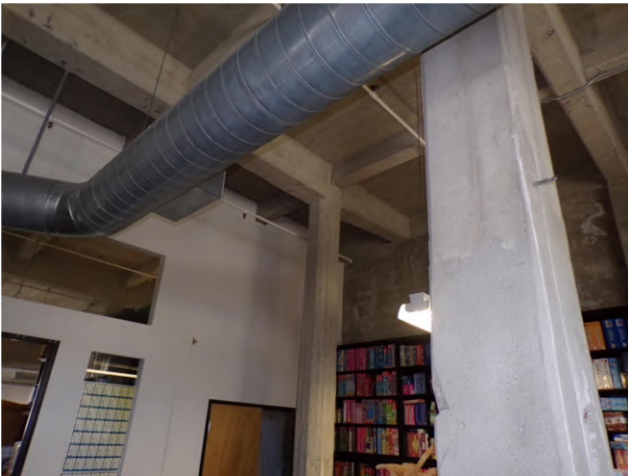
81. Fourth floor: Interior finishes and fixtures in private office.

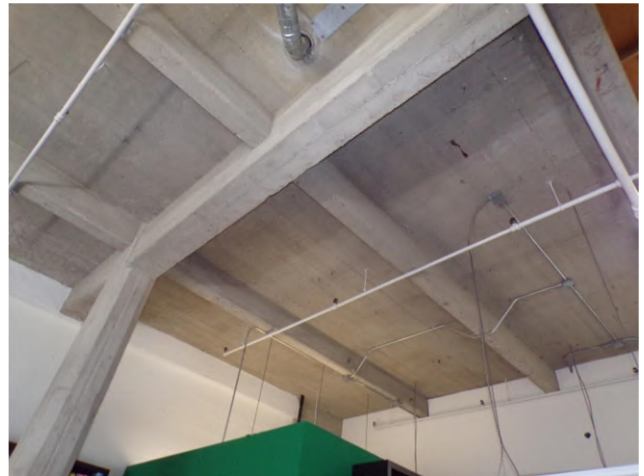
82. Fourth floor: Interior finishes in private office.

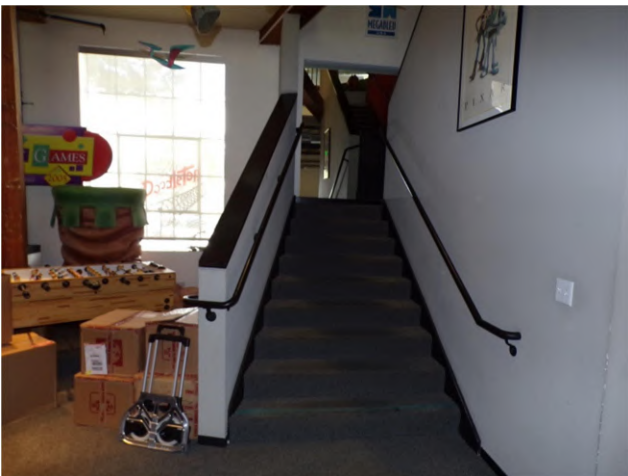
83. Formal stairs in open office area.

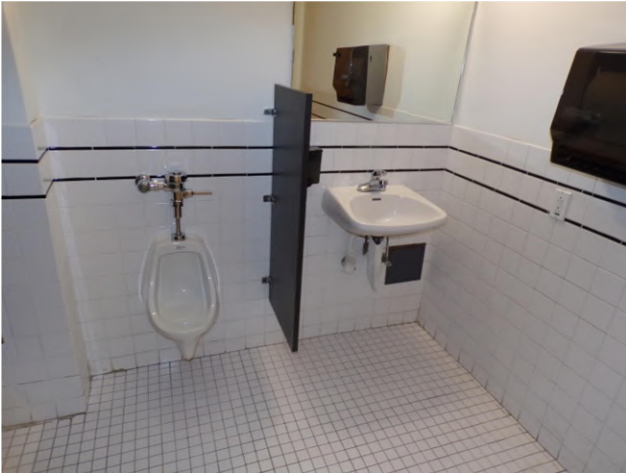
85. Interior finishes and fixtures in restrooms.

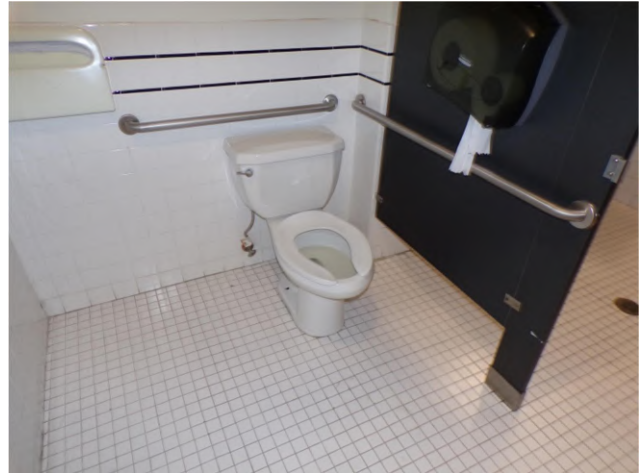
86. Interior finishes and fixtures in restrooms.

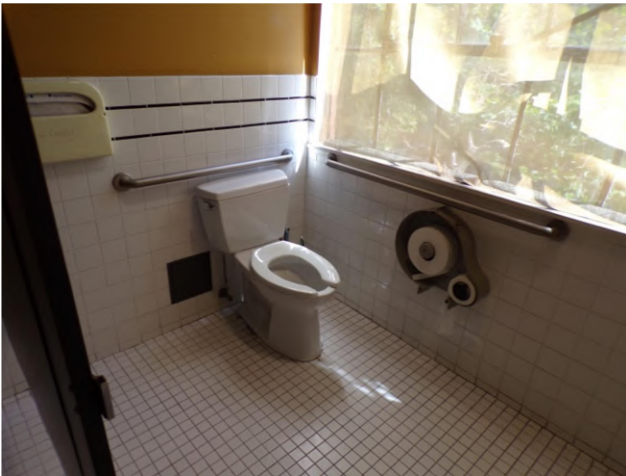
87. Interior finishes and fixtures in restrooms.

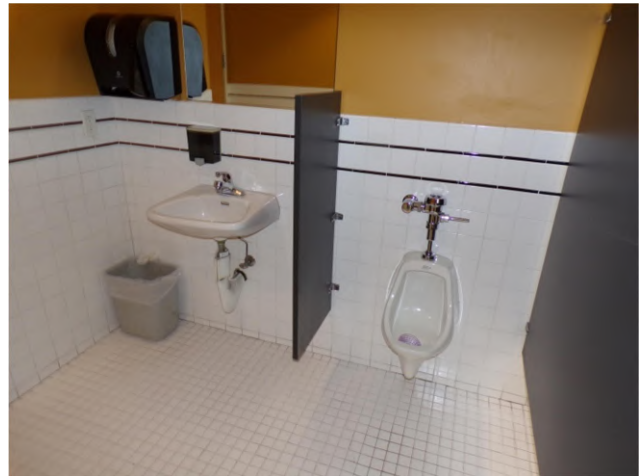
88. Interior finishes and fixtures in restrooms.

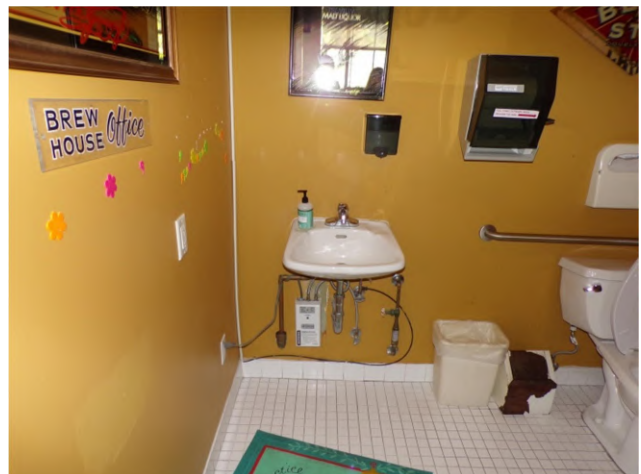
90. Interior finishes and fixtures in restrooms.

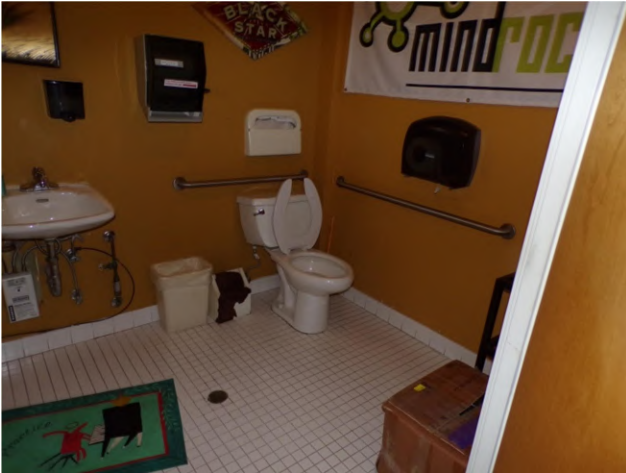
91. Interior finishes and fixtures in restrooms.

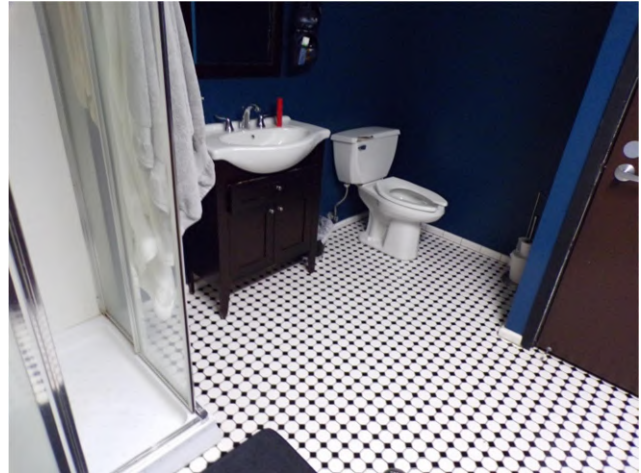
92. Interior finishes and fixtures in restrooms.

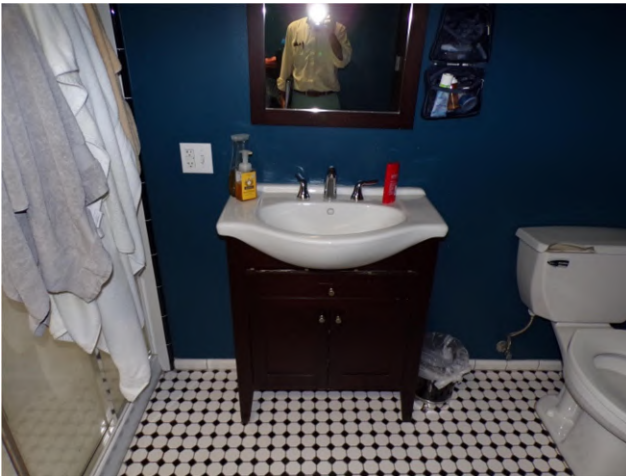
93. Interior finishes and fixtures in restrooms.

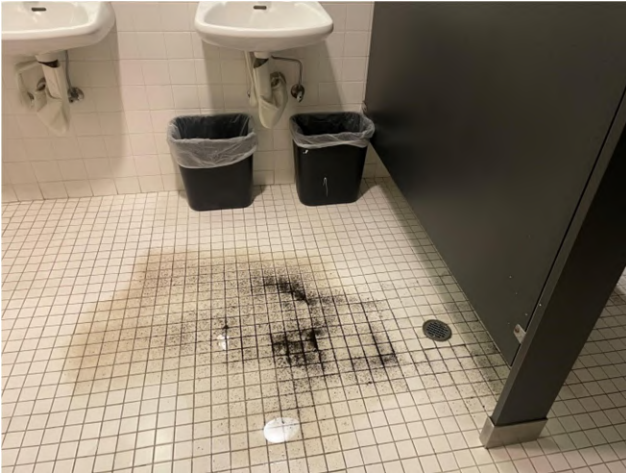
109. Earlier in the week of our site visit, minor flooding up through the floor drains occurred.

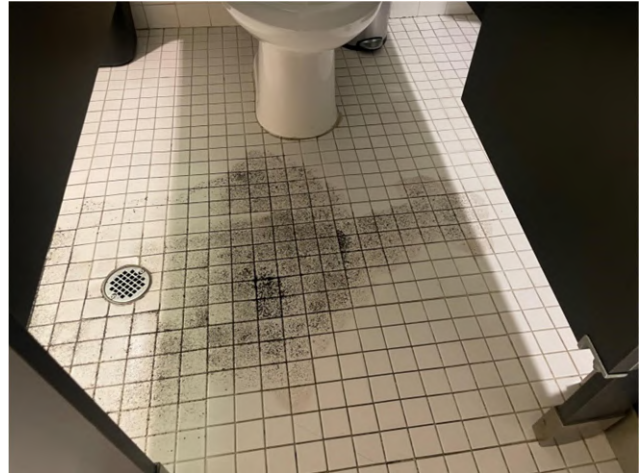
110. The San Francisco Public Utilities Commission has scheduled municipal sewer line replacements under Harrison Street.

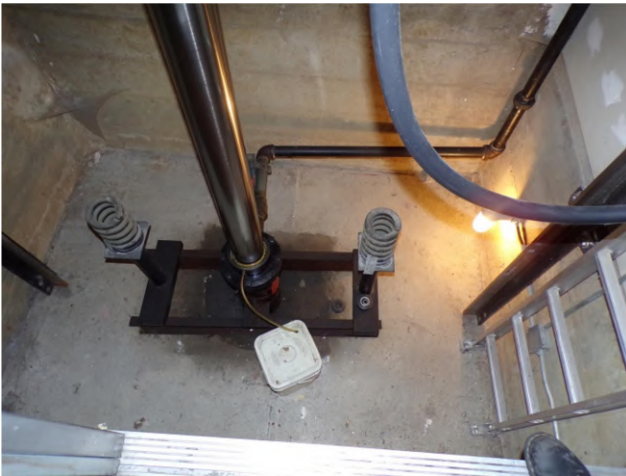
111. The elevator pit with hydraulic equipment.
