# AllWest Environmental

## PROPERTY CONDITION ASSESSMENT

**5601 & 5733 San Leandro Street, Oakland, California 94621**

**ALLWEST PROJECT 22183.60  
February 10, 2023**

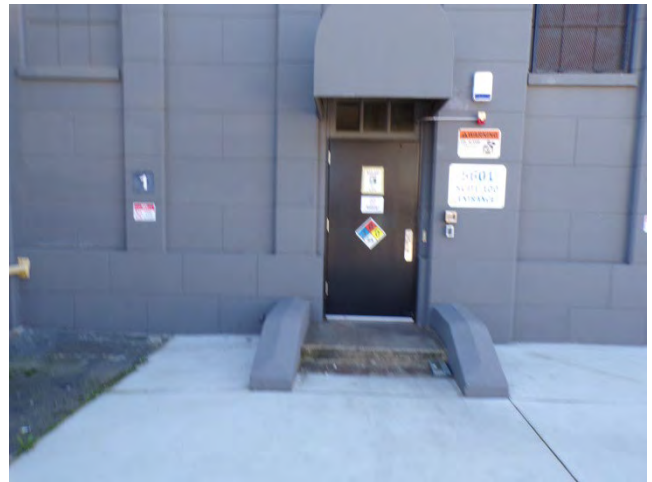
10. Bldg 5601E: Secondary entrance along San Leandro Street. Entrance is not wheelchair accessible.

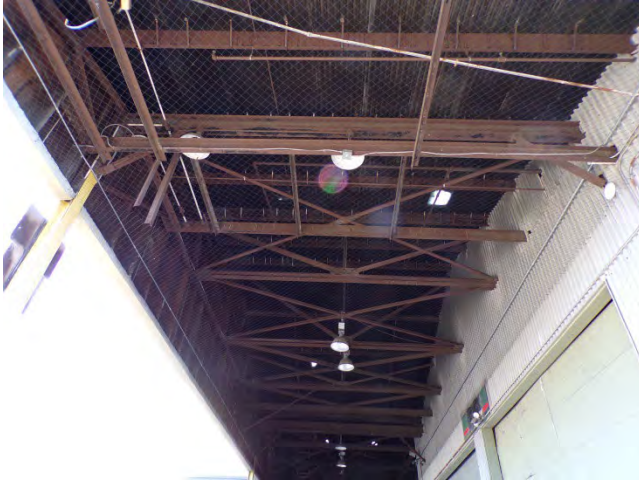
13. Bldg 5601W: Exposed steel structure should be repainted during the reserve term.

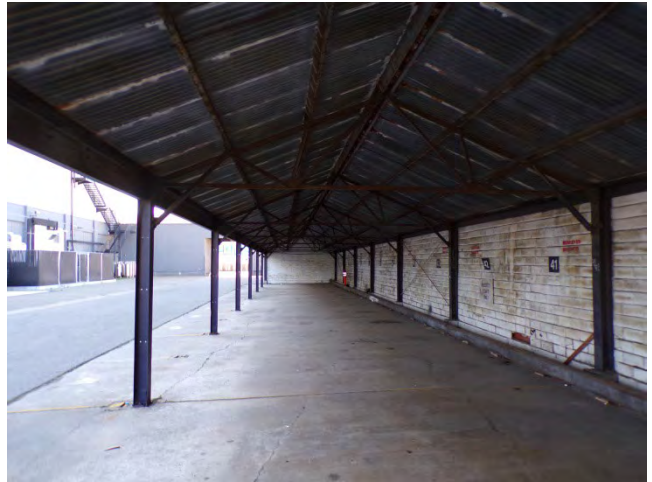
16. Bldg 5601E: Carport along north property line. Paint finishes in carport should be repainted during the reserve term.

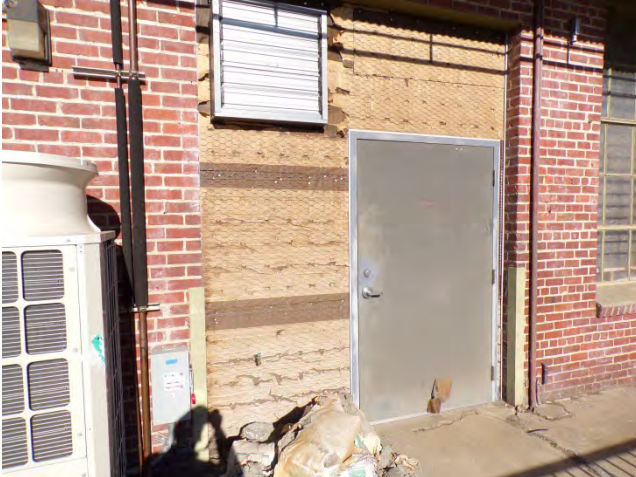
25. Bldg 5733E: Plywood has been installed in various locations along the south elevation.

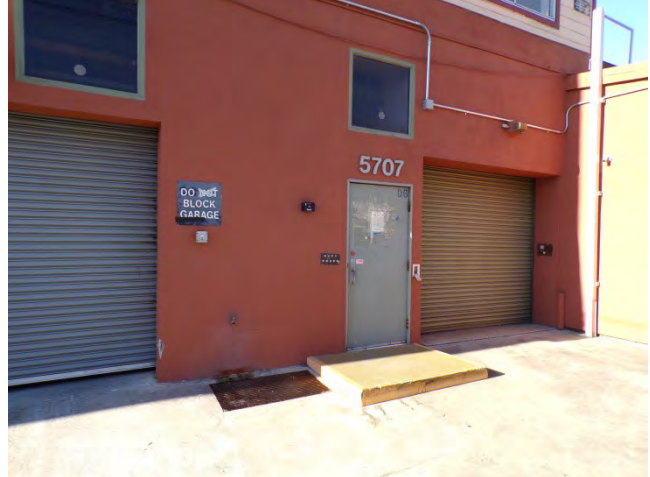
26. Bldg 5733E: Entrances into tenant spaces along the east elevation are not wheelchair accessible.

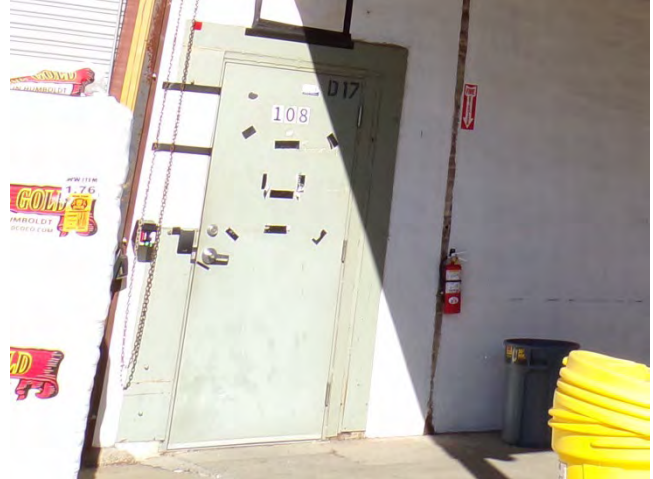
32. Bldg 5733W: Primary pedestrian entrance on south elevation. Door sill is not Accessibility compliant.

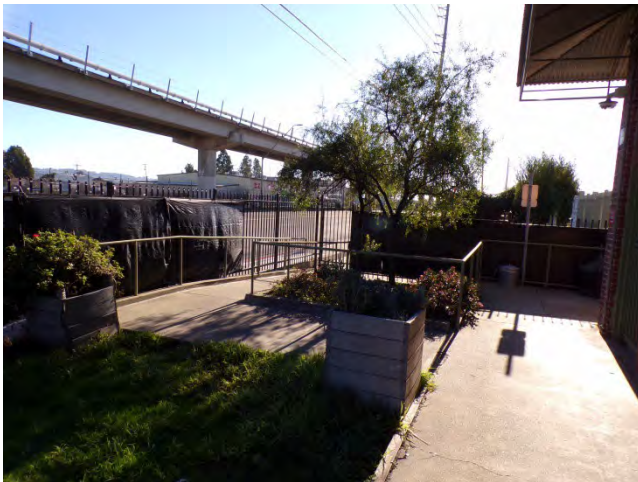
33. Bldg 5733E: Landscaping at the property is minimal.

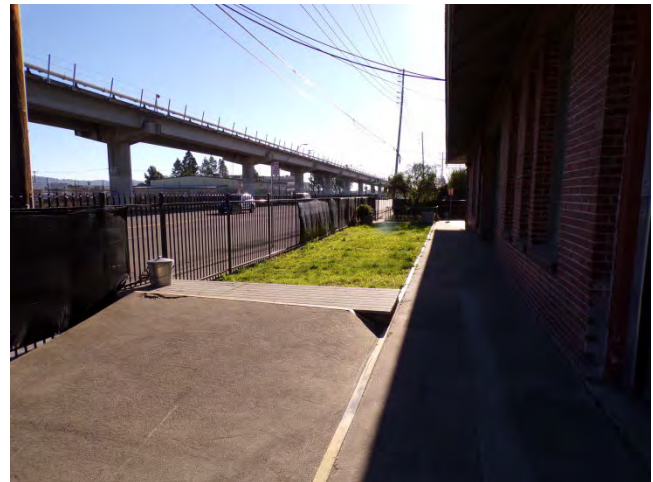
34. Bldg 5733E: Landscaping at the property is minimal.

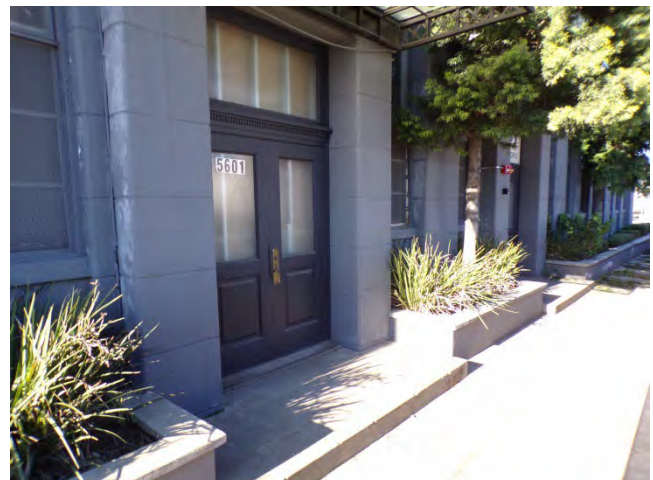
36. Bldg 5601E: Landscaping along east elevation.

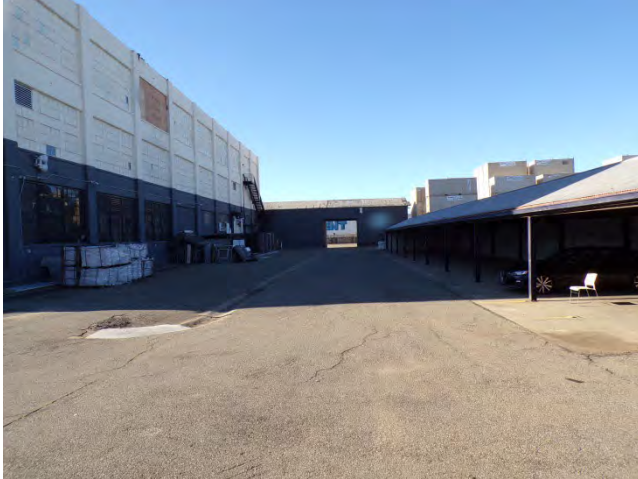
37. Bldg 5601E: Asphalt parking area on north side of building.

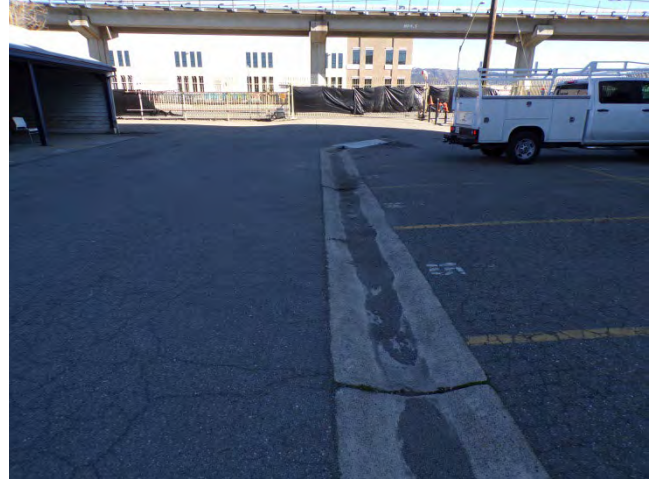
38. Bldg 5601E: Asphalt parking area on north side of building; concrete swale at center of photo.

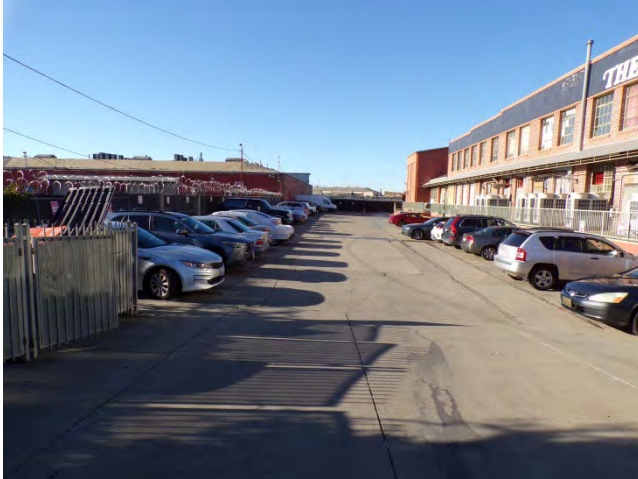
43. Bldg 5733E: Concrete-paved parking area on east side of site.

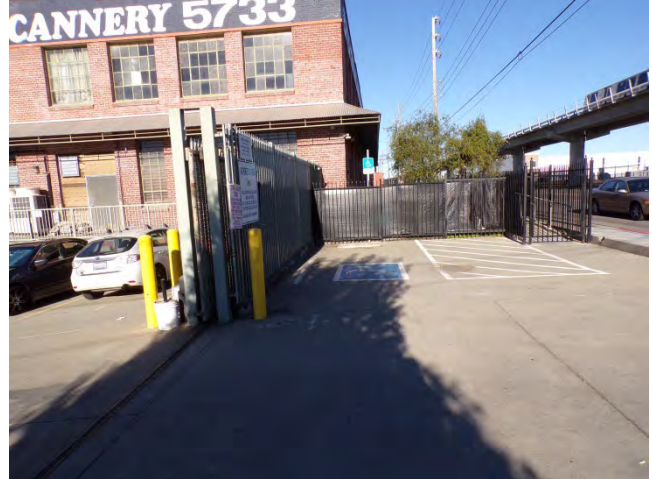
44. Bldg 5733E: One Van Accessible parking stall is provided at this building.

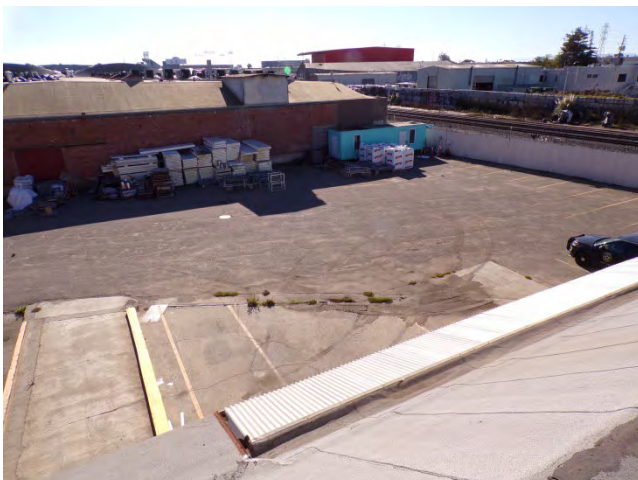
47. Bldg 5733W: Concrete and asphalt paving are provided on the south side of this building.

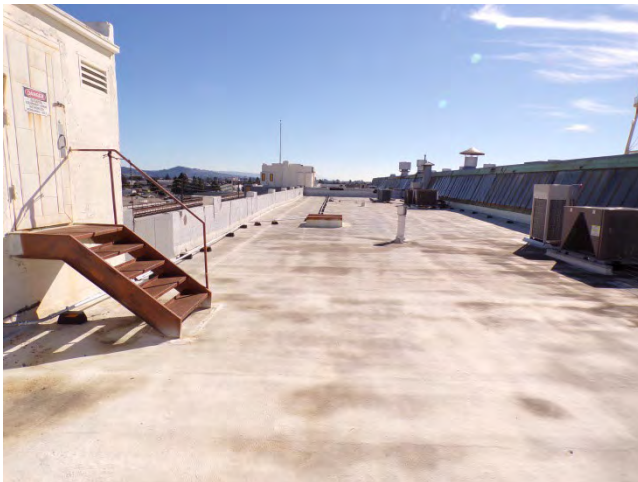
51. Bldg 5601E: The BUR roofing system on the east side of the building, looking south.

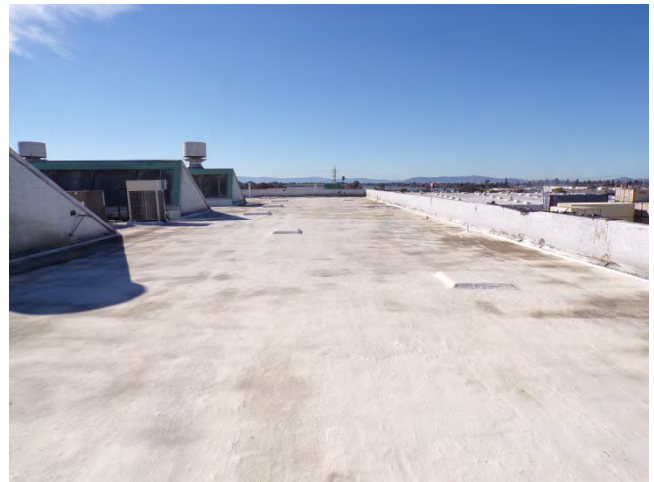
52. Bldg 5601E: The BUR roofing system on the north side of the building, looking west.

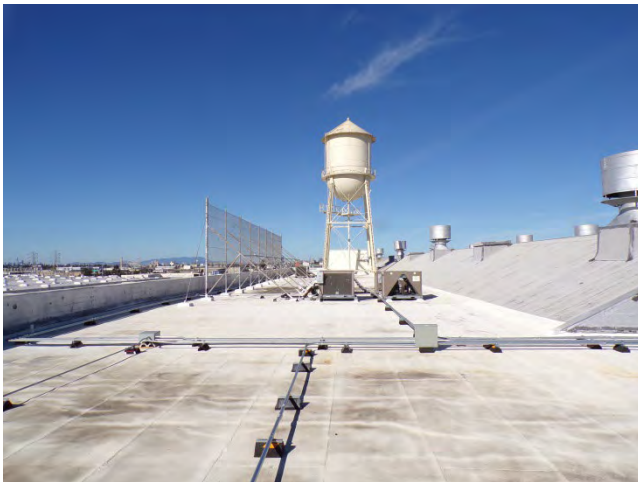
57. Bldg 5601E: The water tower is no longer in service.

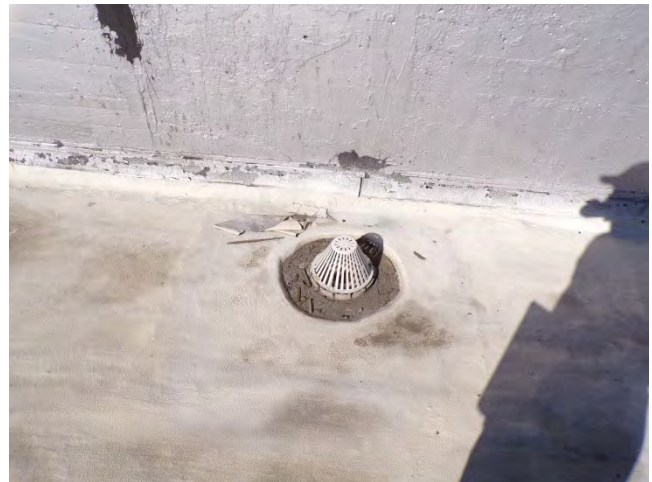
58. Bldg 5601E: Grated roof drains are installed; overflow protection is not provided.

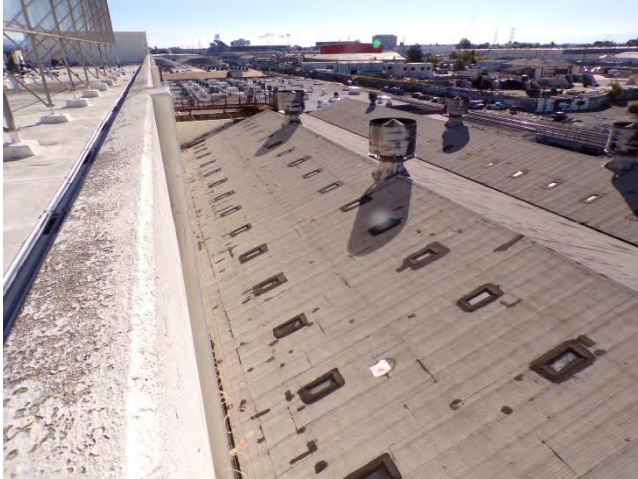
61. Bldg 5601W: The ribbed steel roof panels appear to have had a spray-on coating applied.

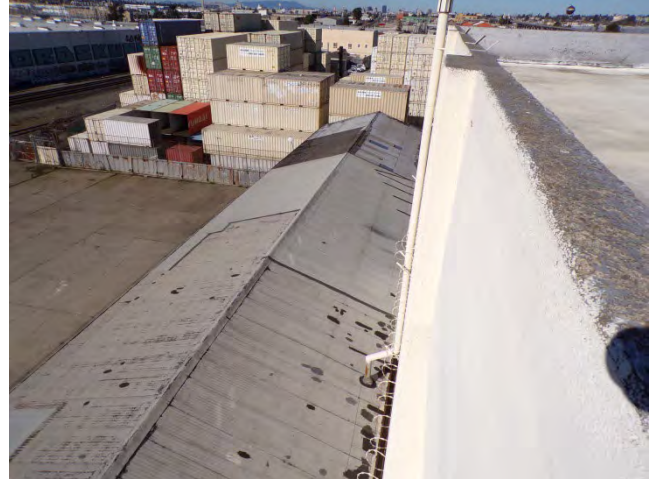
62. Bldg 5601W: The ribbed steel roof panels appear to have had a spray-on coating applied.

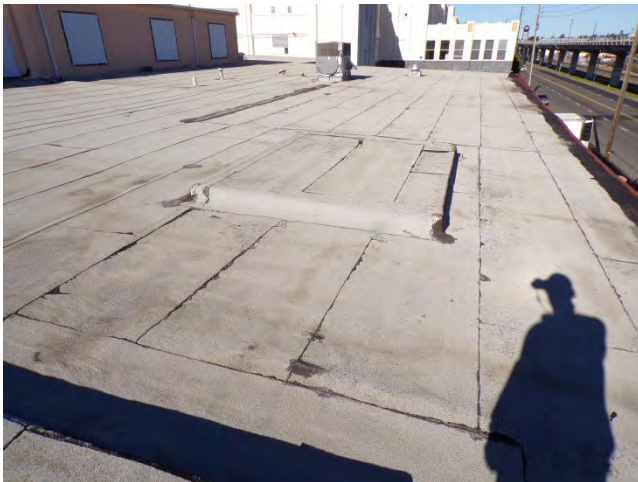
63. Bldg 5733E: The BUR roofing system on the east side of the building, looking north.

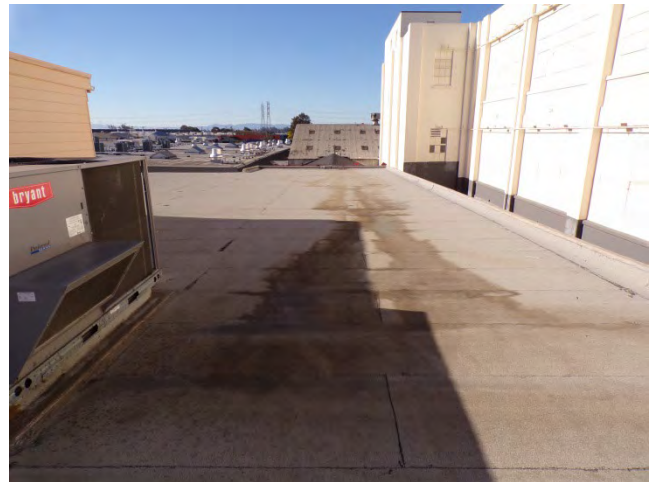
64. Bldg 5733E: The BUR roofing system on the north side of the building, looking west.

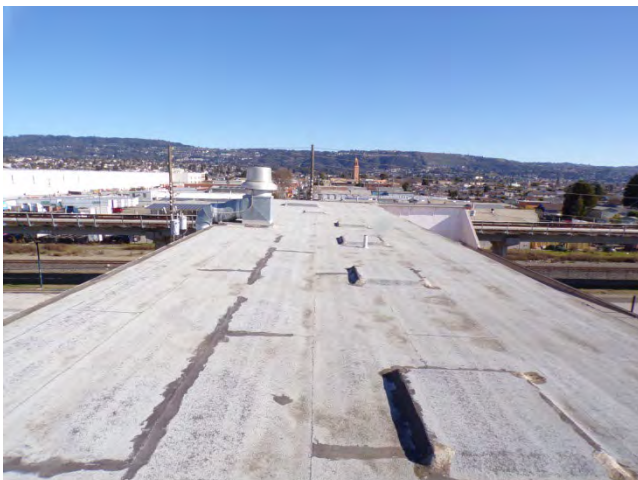
65. Bldg 5733E: The BUR roofing system on the second story portion of the building, looking east.

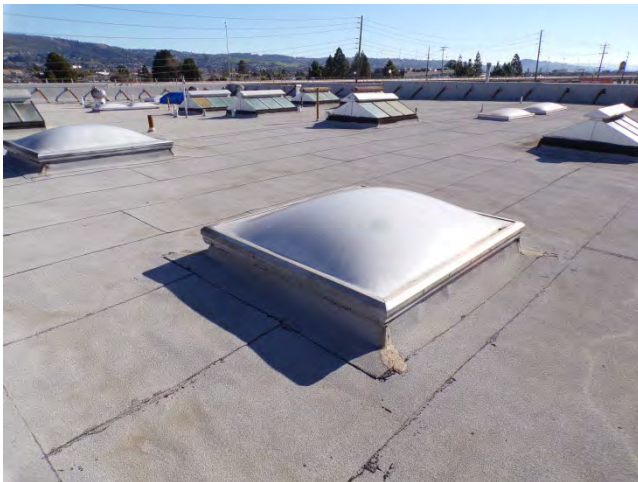
69. Bldg 5733E: Numerous skylights are installed.

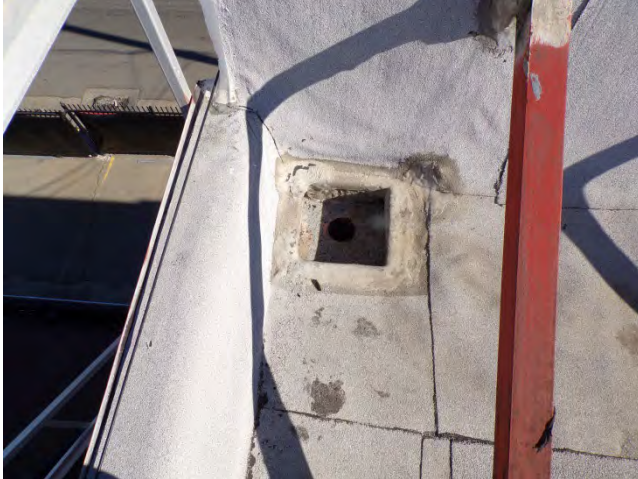
73. Some roof drains lack atrium grates or screens. Bldg 5733E shown.

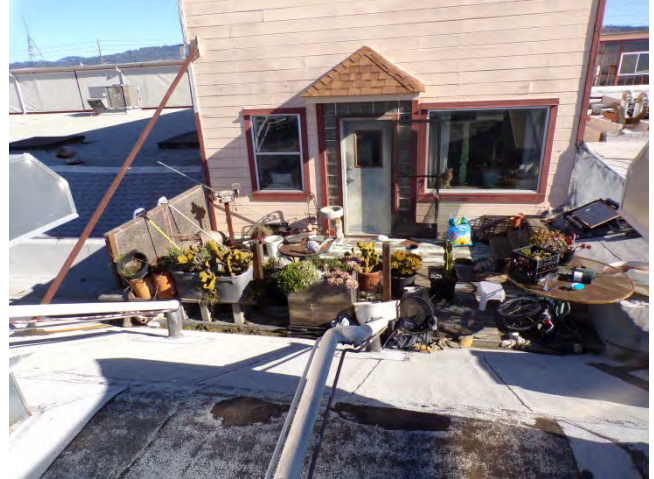
74. Bldg 5733E: A wood-framed roof terrace is installed on the west end of the two-story portion of this building.

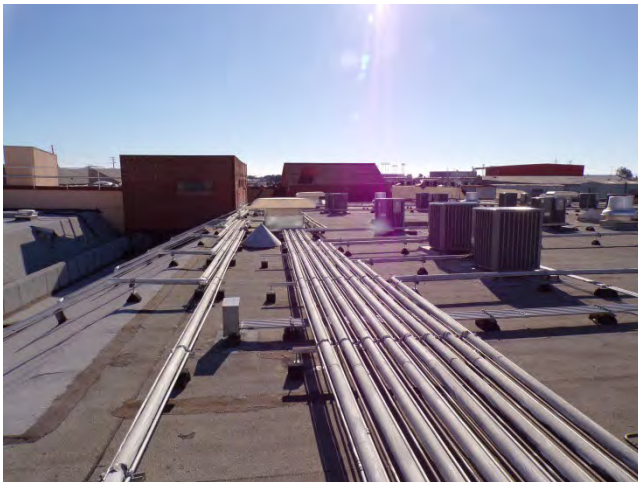
75. Bldg 5733W: The BUR roofing system on the east side of the building, looking south.

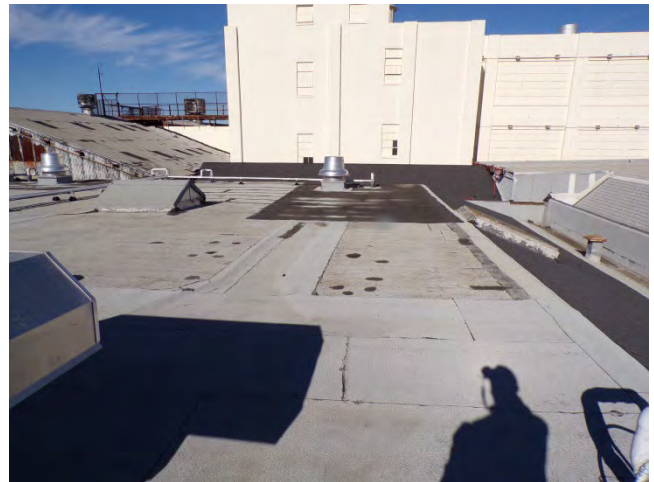
76. Bldg 5733W: The BUR roofing system on the east side of the building, looking north.

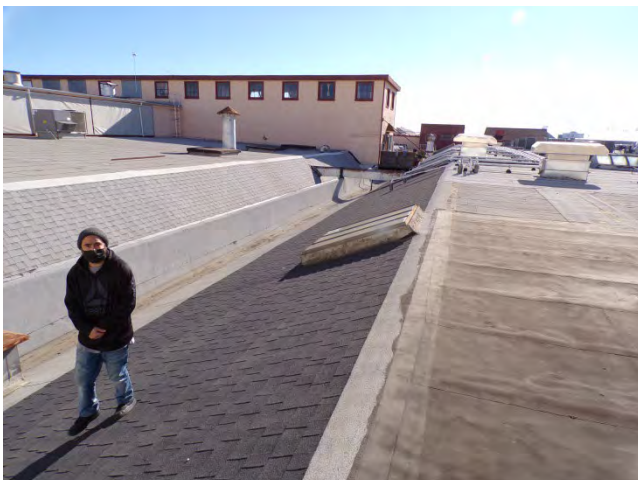
77. Bldg 5733W: Composite asphalt shingles are typically installed on the pitched roofs.

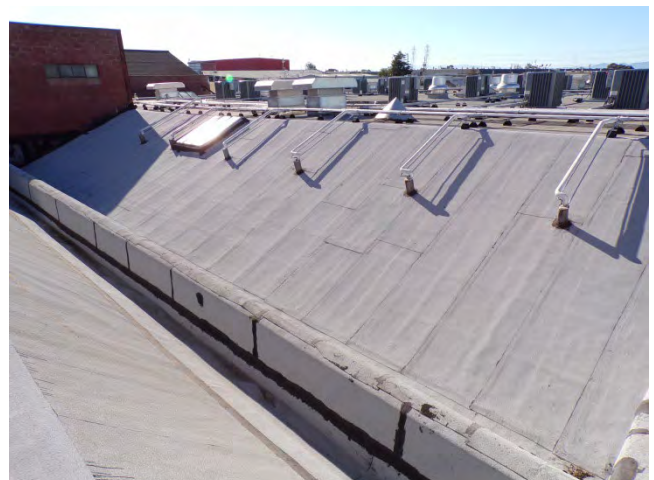
78. Bldg 5733W: BUR systems are also installed on some pitched roofs.

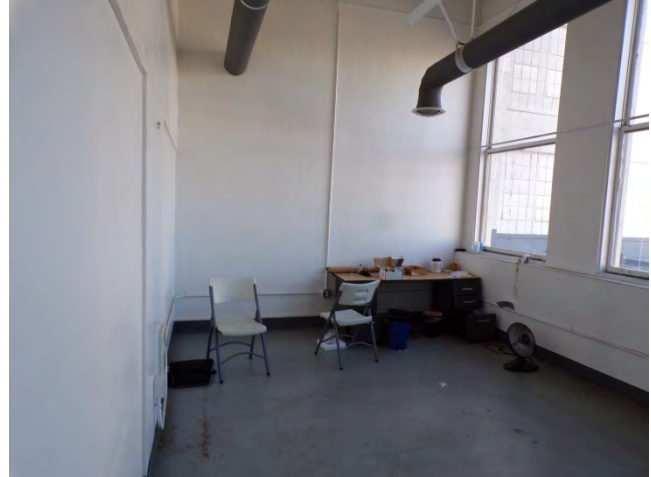
86. Bldg 5601E: Interior finishes and fixtures in office area.

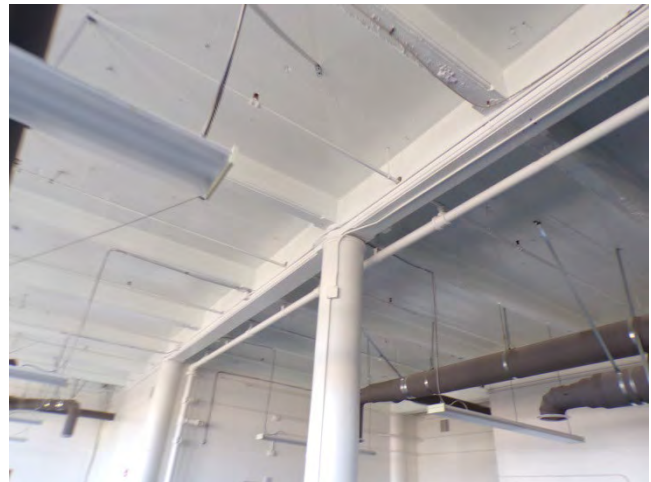
88. Bldg 5601E: Interior finishes and fixtures in office area.

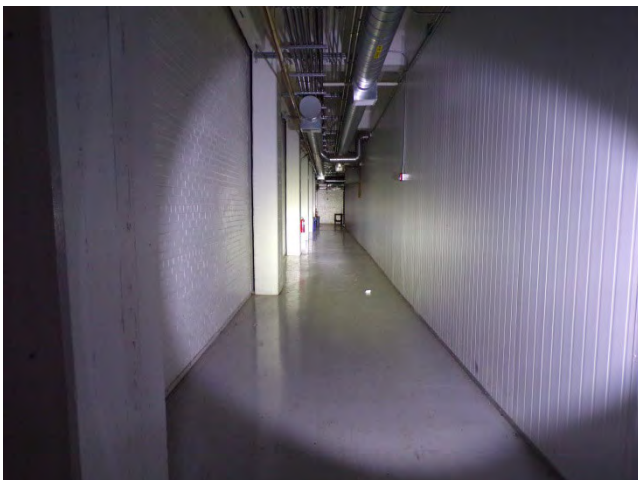
89. Bldg 5601E: Interior finishes and fixtures in circulation area of plant cultivation rooms.

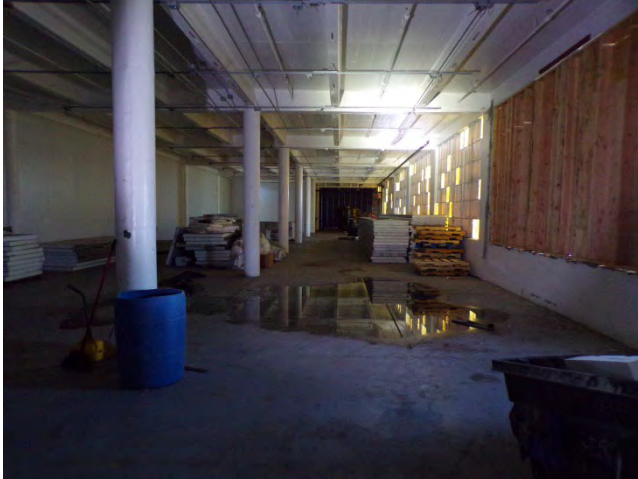
91. Bldg 5601E: Window opening at right is infilled with plywood. Water intrusion has occurred along the north elevation at third floor level.

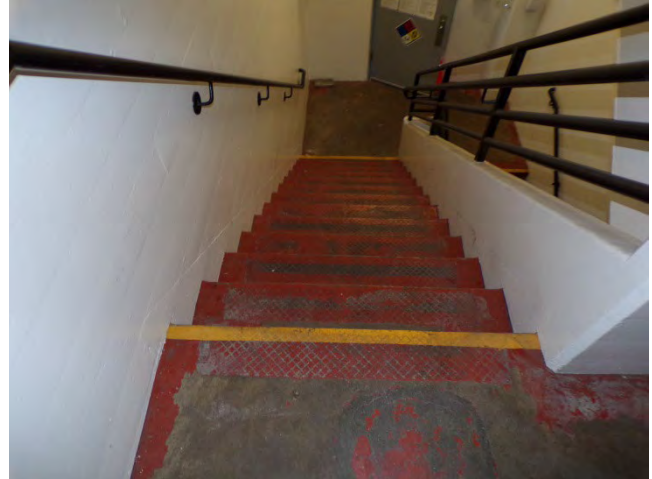
92. Space 5601E: Interior finishes in stairwells.

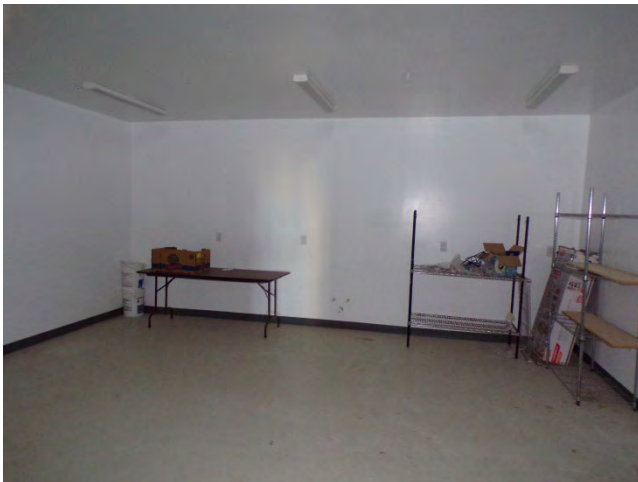
93. Bldg 5601W: Interior finishes and fixtures in office area.

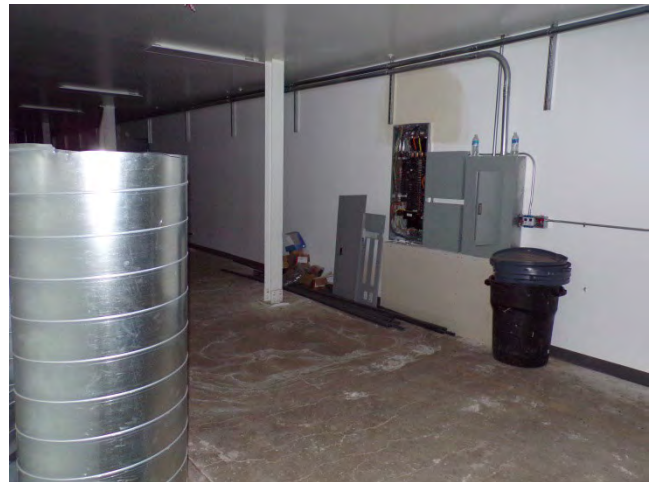
94. Bldg 5601W: Interior finishes, fixtures and equipment in circulation area of plant cultivation rooms.

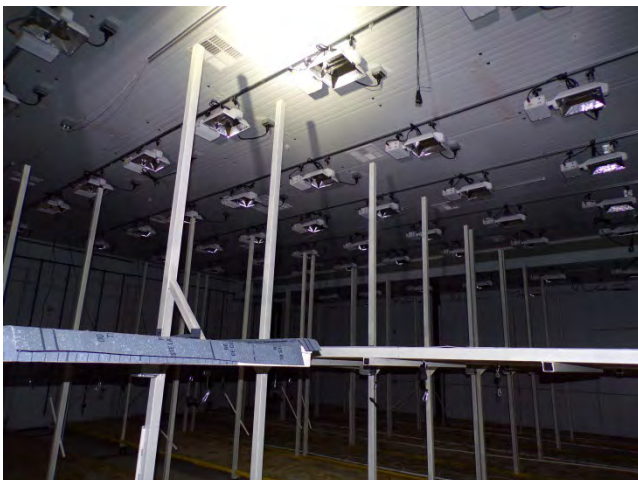
95. Bldg 5601W: Interior finishes, fixtures and equipment in plant cultivation rooms.

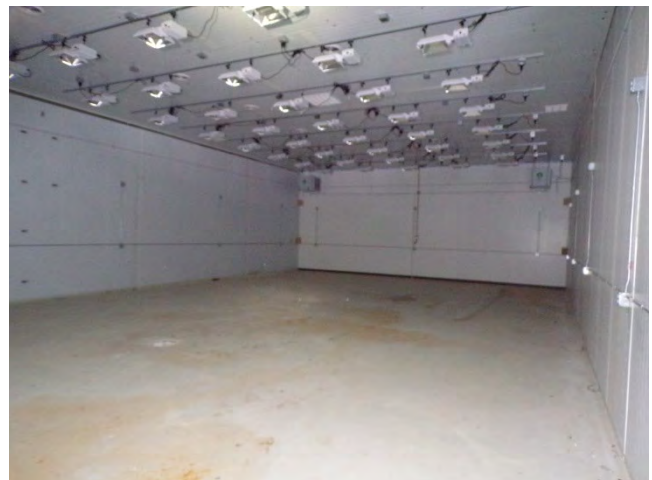
96. Bldg 5601W: Interior finishes, fixtures and equipment in plant cultivation rooms.

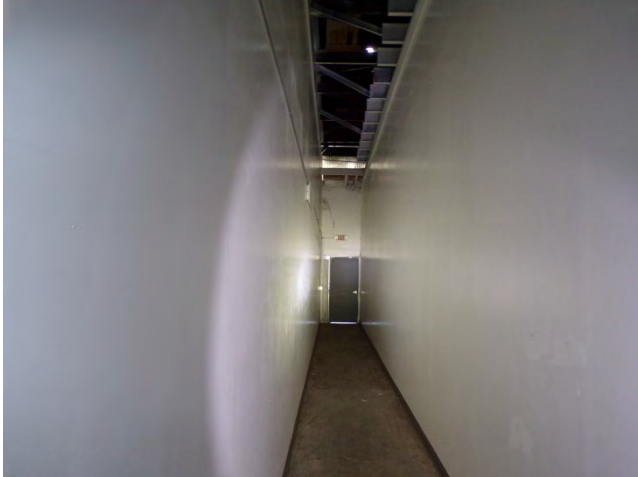
97. Bldg 5601W: Interior finishes and fixtures in circulation area of plant cultivation rooms.

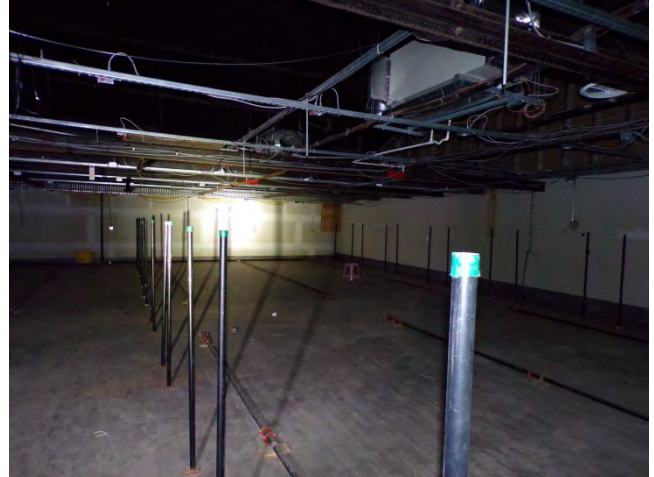
98. Bldg 5601W: Interior finishes, fixtures and equipment in attic room.

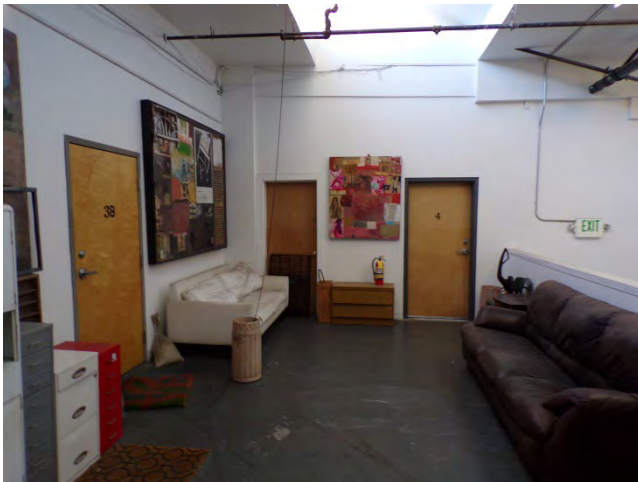
99. Bldg 5733E: Interior finishes and fixtures in common area of apartment portion of building.

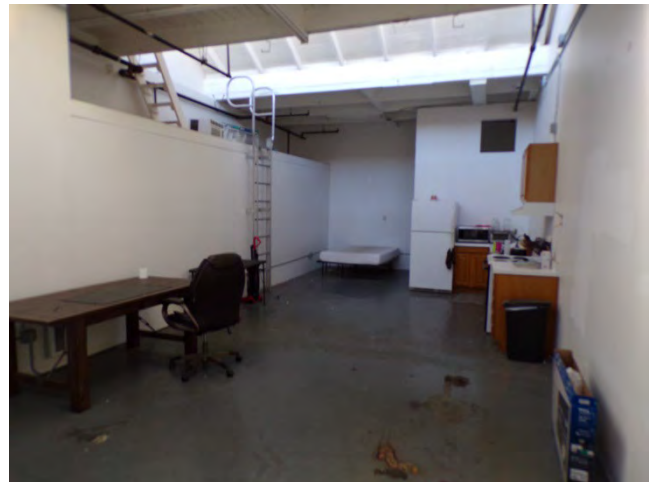
100. Bldg 5733E: Interior finishes, fixtures, and equipment in apartments.

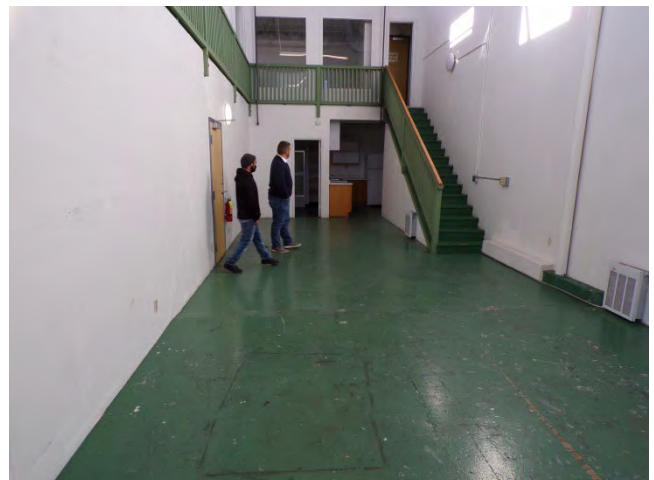
101. Bldg 5733E: Interior finishes, fixtures, and equipment in apartments.

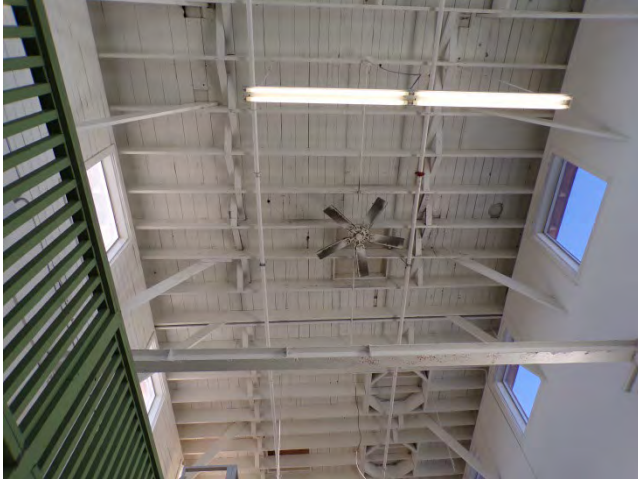
102. Bldg 5733E: Interior finishes and fixtures in apartments.

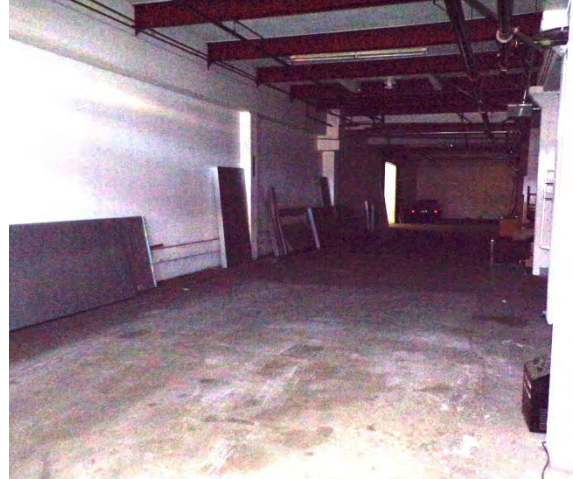
103. Bldg 5733E: Interior finishes and fixtures in apartments.

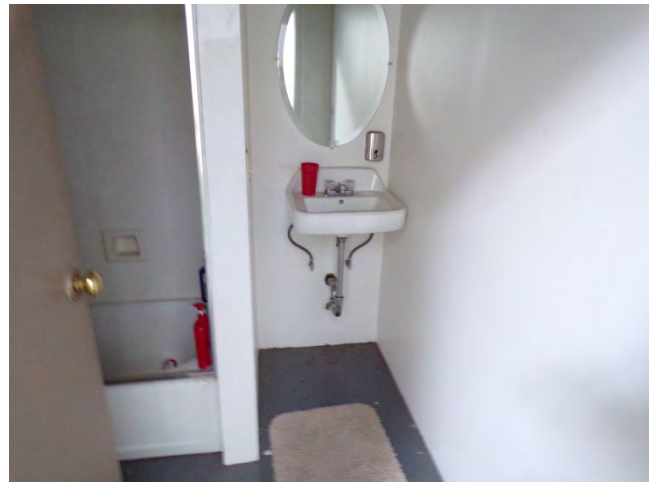
105. Bldg 5733E: Interior finishes and fixtures in apartment bathrooms.

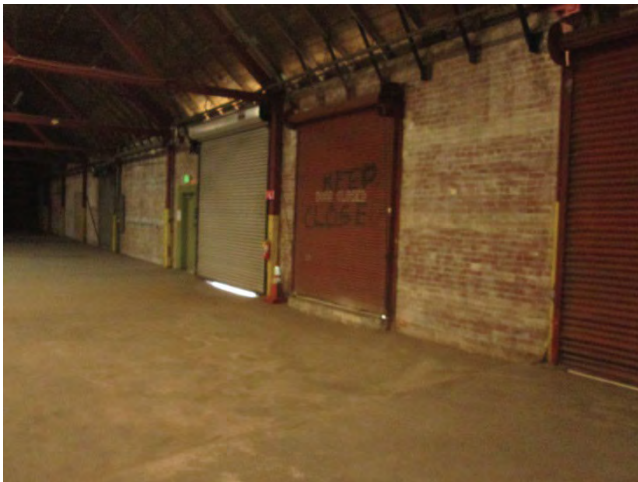
110. Bldg 5733E: Interior finishes and fixtures in warehouse areas. (Photo from 2017 PCA.)

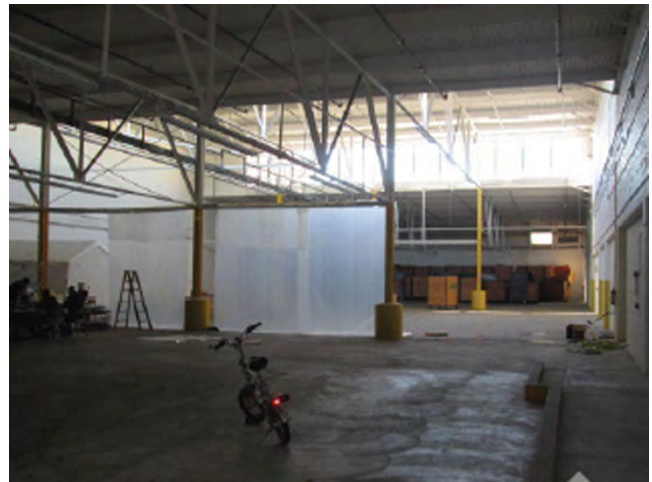
111. Bldg 5733E: Interior finishes in warehouse areas. (Photo from 2017 PCA.)

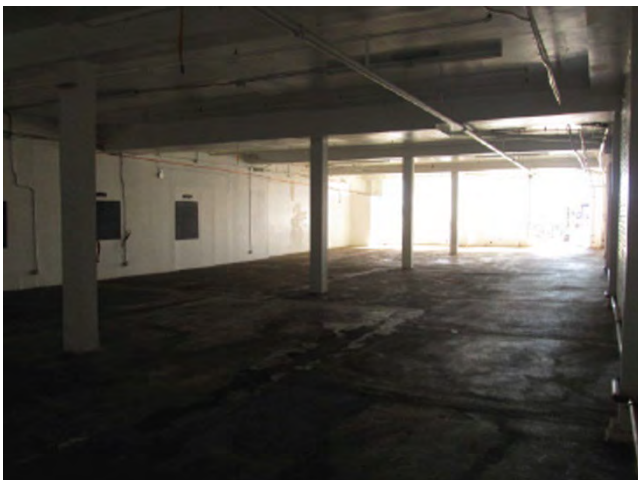
112. Bldg 5733W: Interior finishes and fixtures in warehouse areas. (Photo from 2017 PCA.)

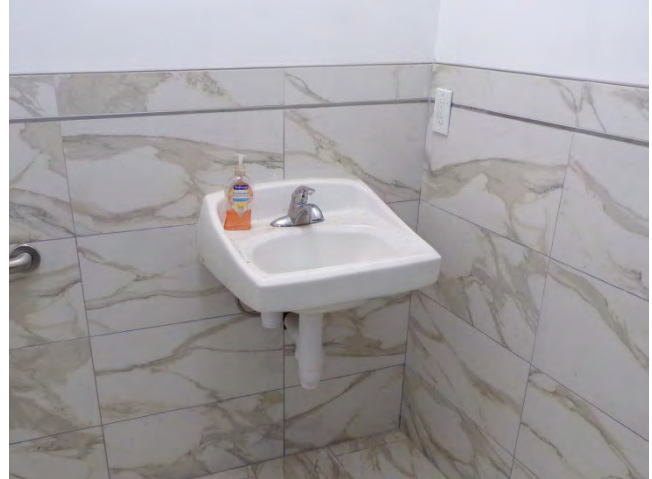
115. Bldg 5601E: Interior finishes and fixtures in restrooms.

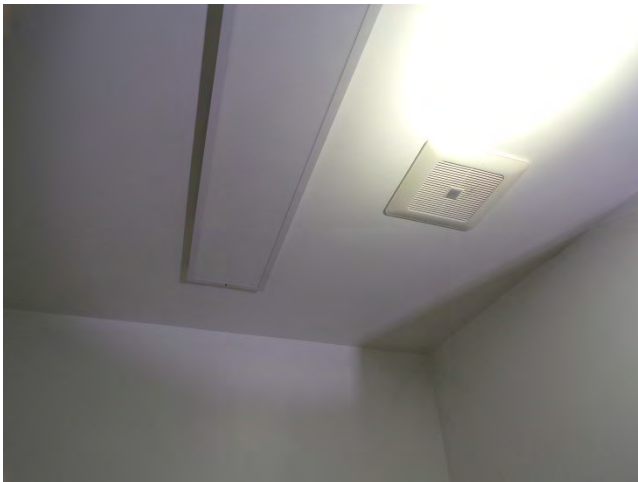
116. Bldg 5601E: Interior finishes and fixtures in restrooms.

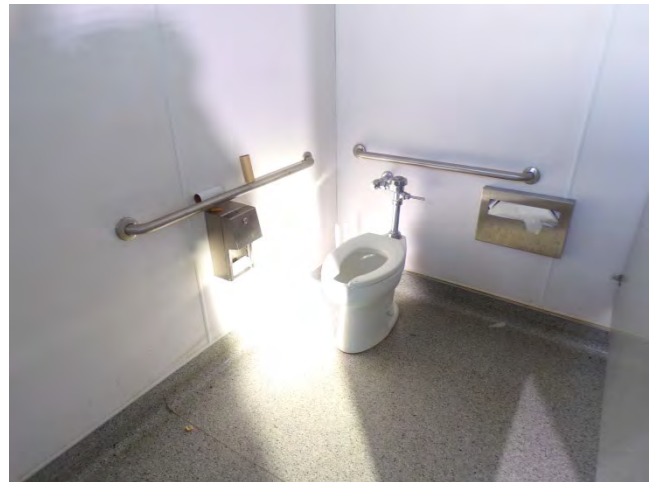
117. Bldg 5601E: Interior finishes and fixtures in restrooms.

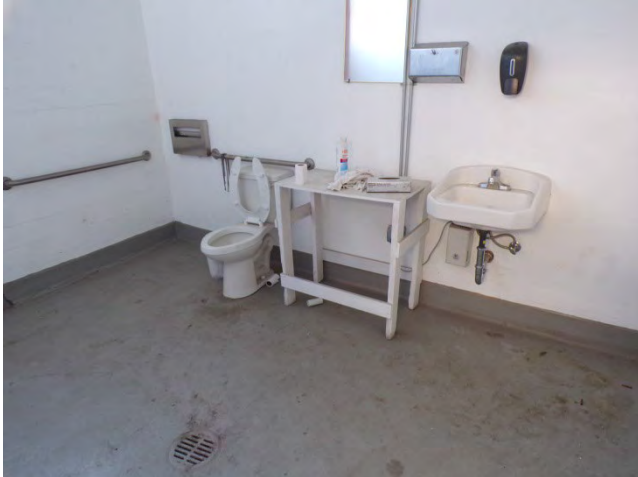
120. Bldg 5601E: Interior finishes and fixtures in restrooms.

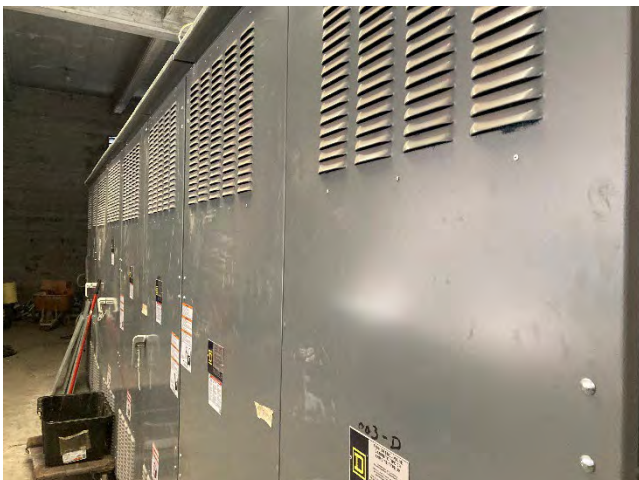
M-4. Bldg 5733E: Main electrical switchgear.

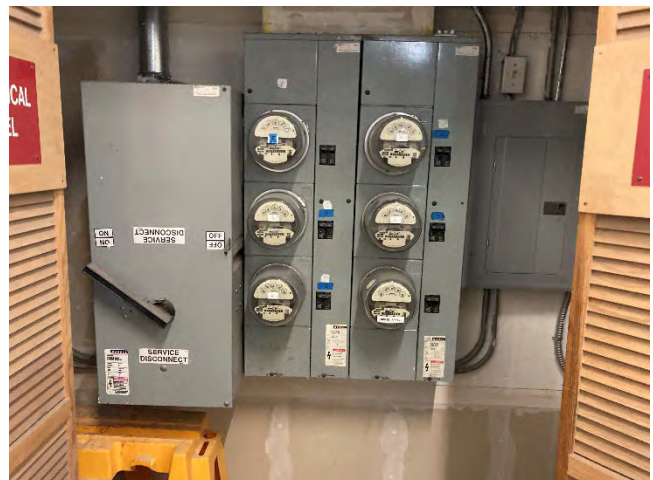
M-5. Bldg 5601E: Main electrical switchgear.

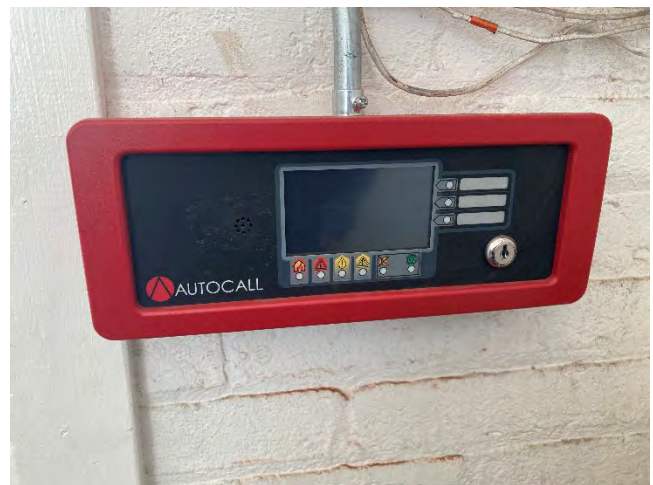
M-16. Bldg 5733E: Fire alarm panel.

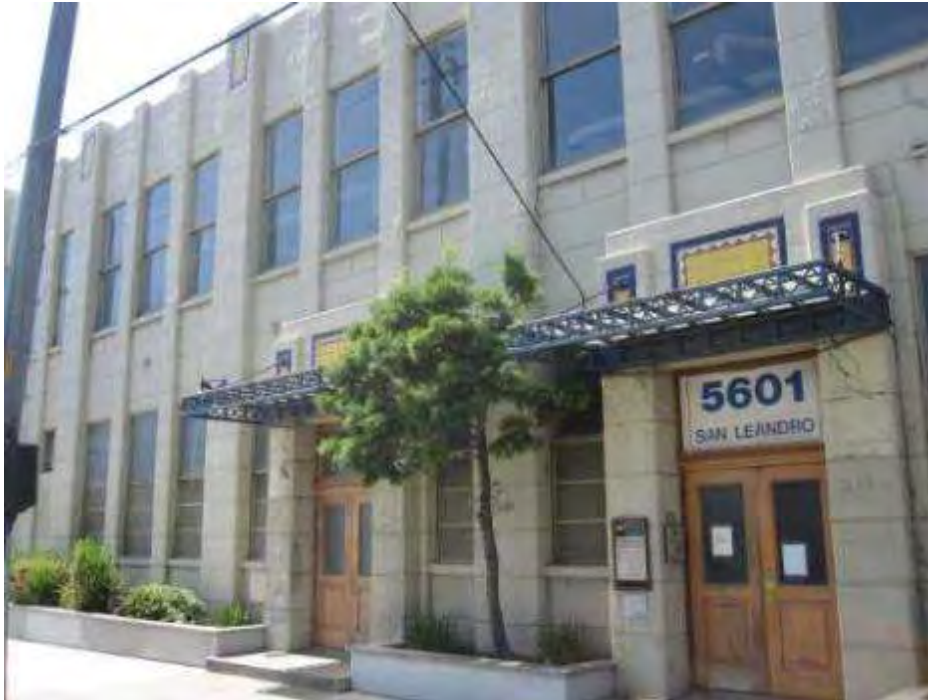
1. The single, two- and three-story, 5601 San Leandro Street, front elevation.

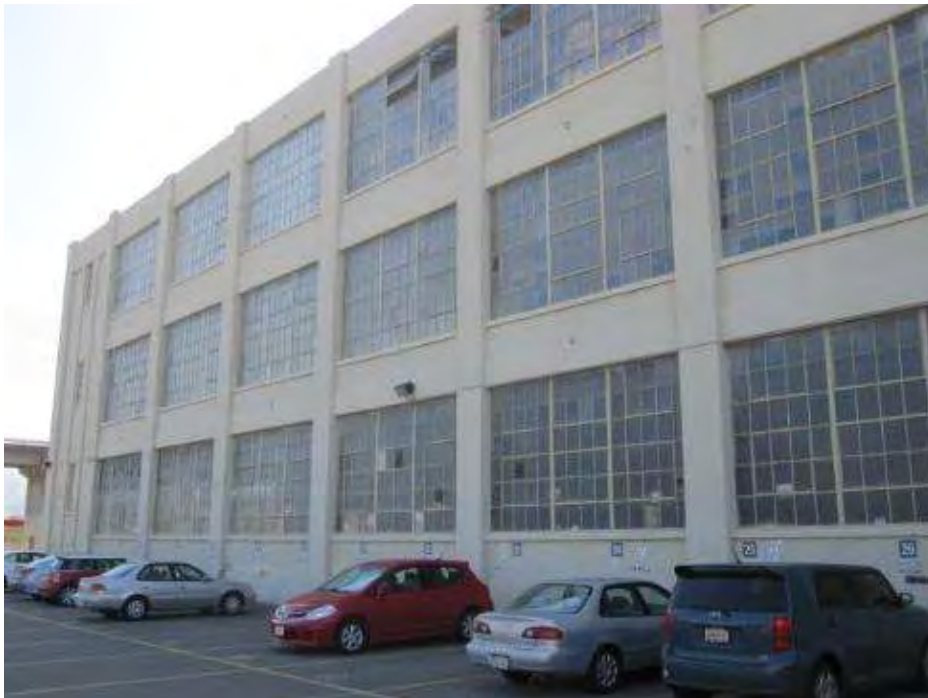
2. The three-story reinforced concrete frame, side elevation.

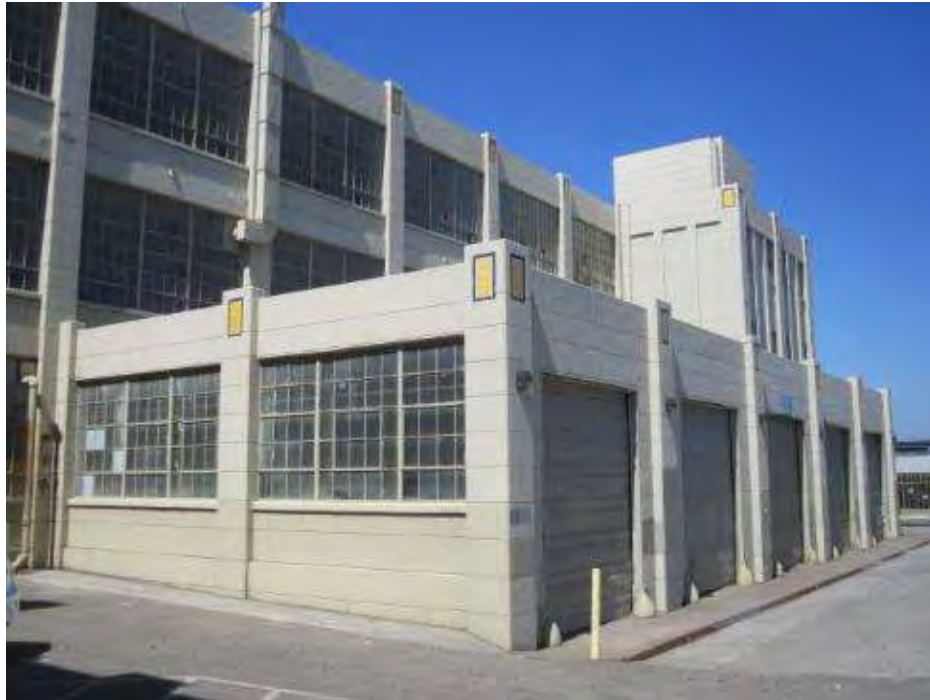
3. The single- and three-story reinforced concrete frame main portion of the building, partial front elevation.

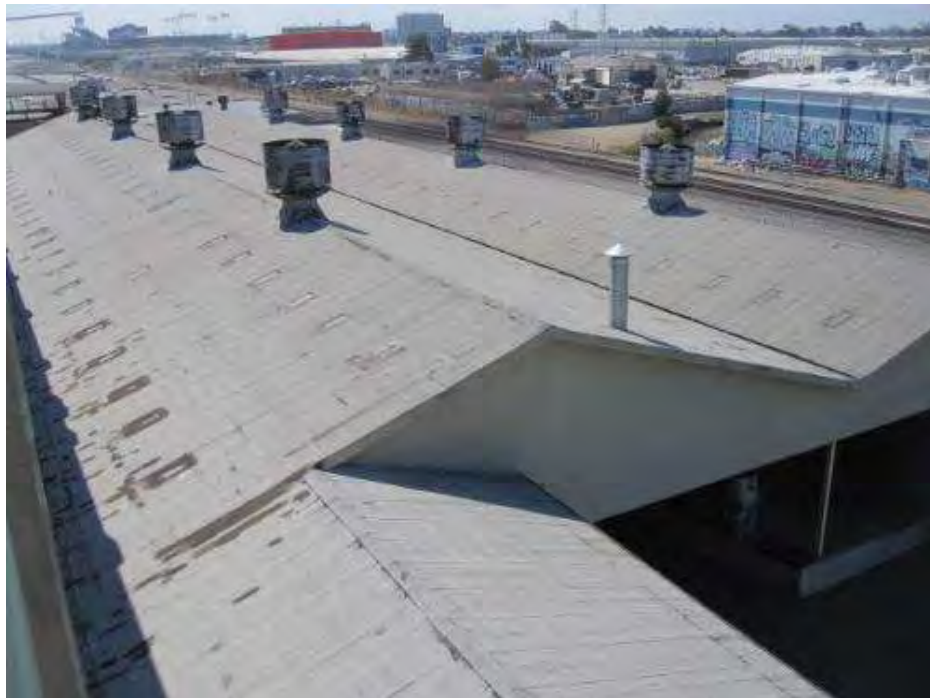
4. The single-story steel framed warehouse portion of the building.

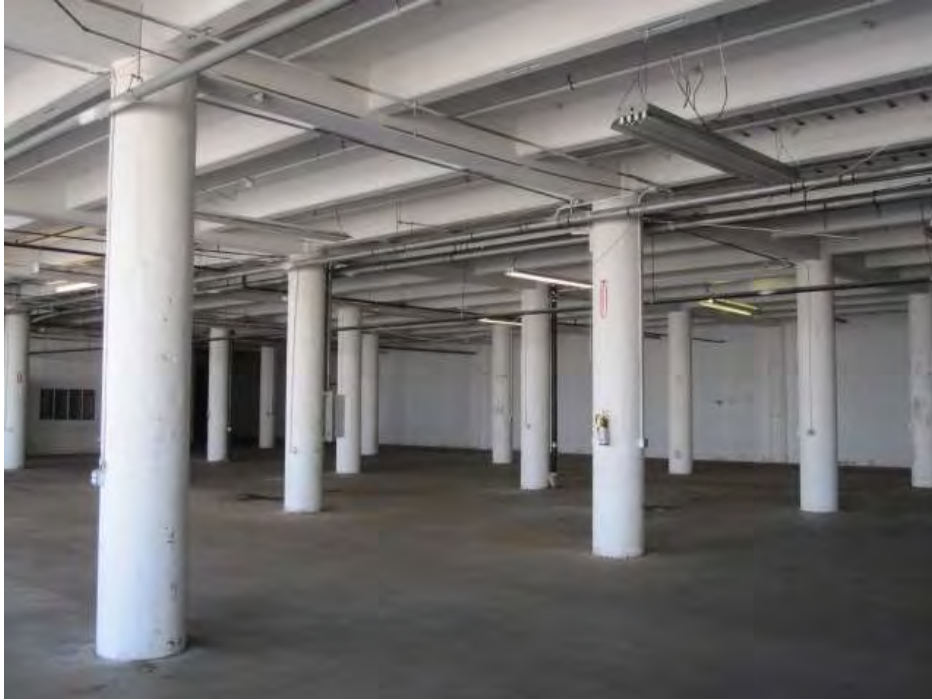
The higher PML assessment values reflect the fact that the pre-code reinforced concrete moment-resisting frames are potentially weak and non-ductile and could potentially be vulnerable when subjected to the defined earthquake scenario event. In addition, there is a potentially active earthquake fault within 2.4 miles of the property.

5. The reinforced concrete slabs, joists, beams and supporting columns in the main portion of the building.

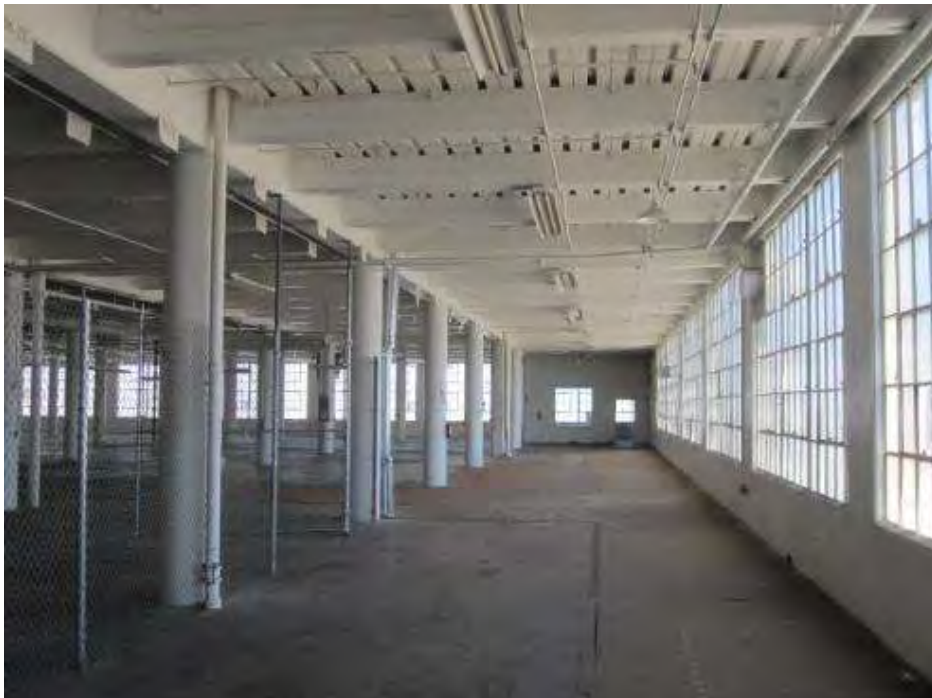
6. The corrugated metal decking, concrete slabs, joists, beams, columns and supporting exterior bearing walls in the main portion of the building.
