# AllWest Environmental

## PROPERTY CONDITION ASSESSMENT

**5601 & 5733 San Leandro Street, Oakland, California 94621**

**ALLWEST PROJECT 22183.60  
February 10, 2023**

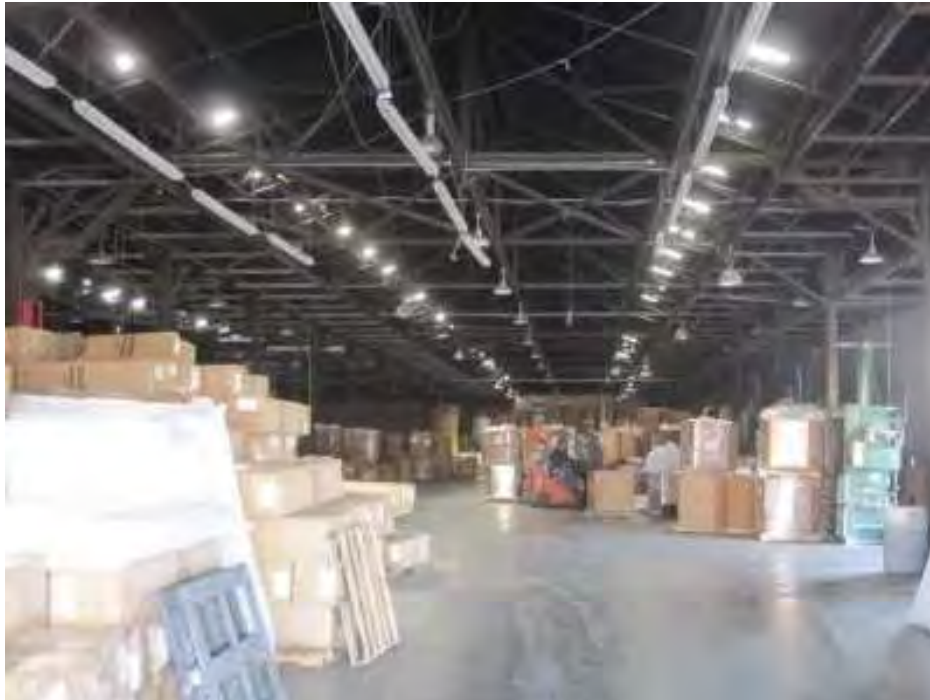
7. The warehouse open-web steel trusses and supporting columns.
