## PROPERTY CONDITION ASSESSMENT

870 Santa Cruz Avenue, Menlo Park, CA 94025

ALLWEST PROJECT 24117.60  
October 11, 2024

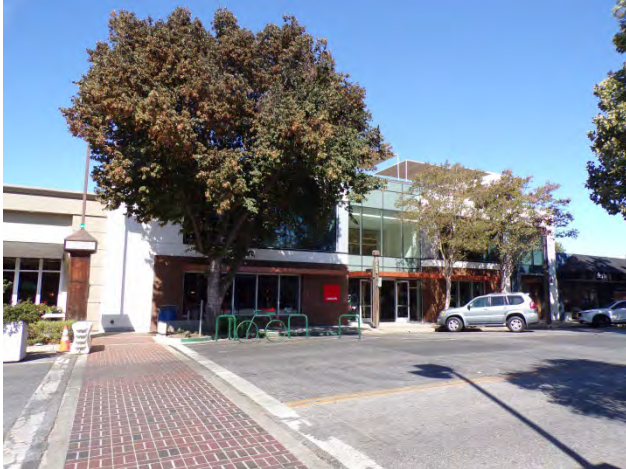
1. East elevation along Santa Cruz Avenue.

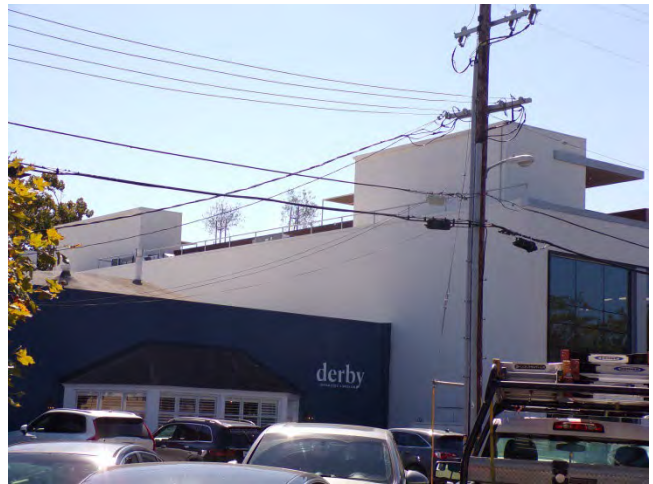
4. North elevation (white CMU wall) above adjacent building.

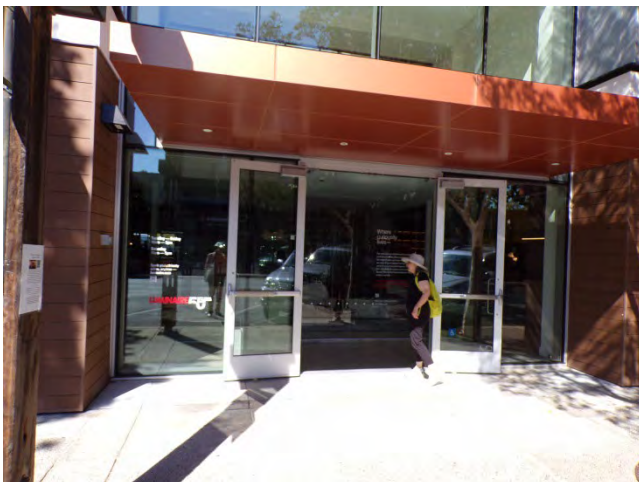
5. Clear anodized aluminum storefront window and door assemblies are installed along the Santa Cruz Avenue elevation (shown) and on the west elevation.

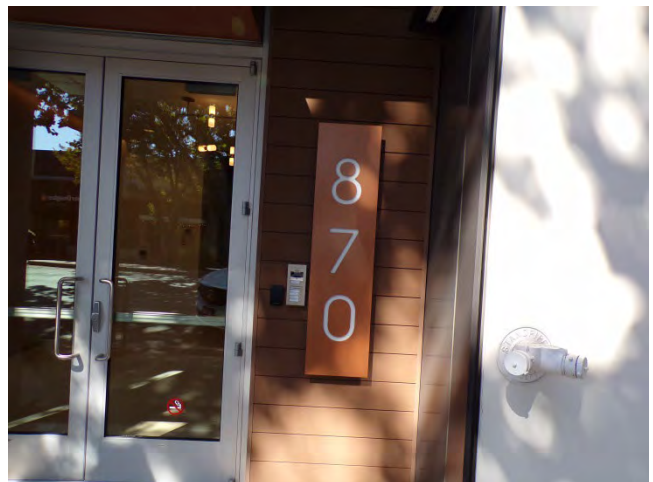
6. Primary address signage at northeast corner of building. FDC shown at right.

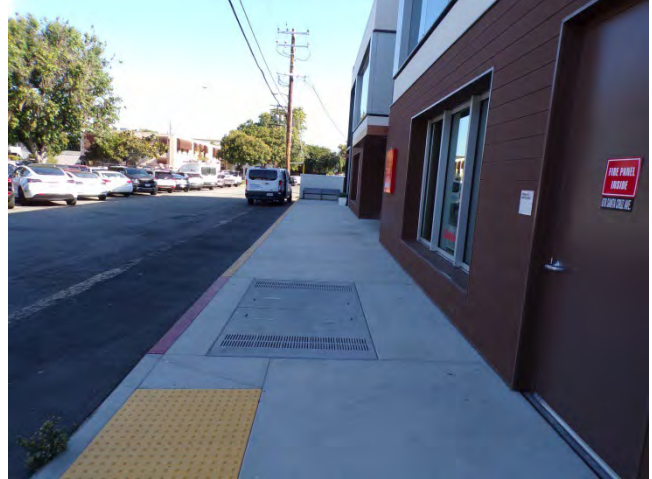
8. View along west elevation walkway, looking north. The large vault is for the PG&E transformer.

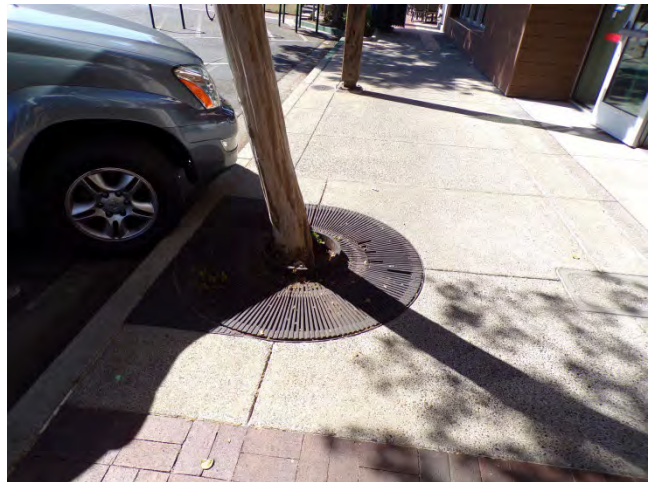
10. Three street trees along Santa Cruz Avenue are the only live landscaping elements.

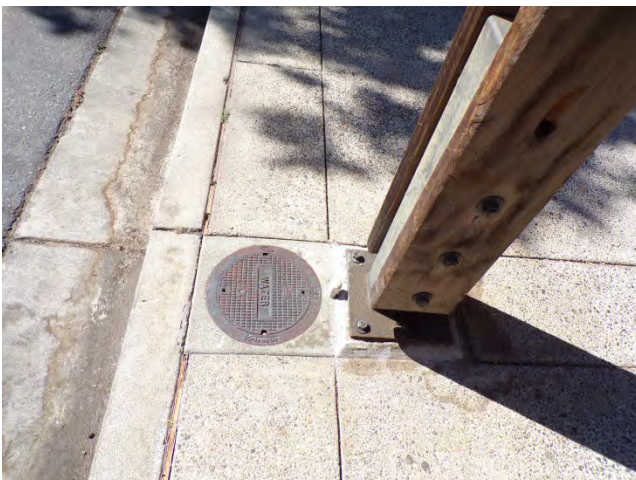
11. Various vaults are located in the sidewalk along Santa Cruz Avenue. A sewer clean-out vault is shown.

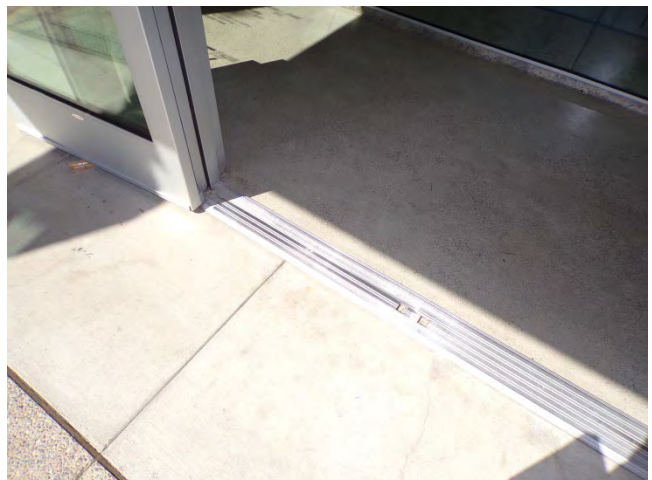
12. Threshold plate and new concrete pour at main entrance along Santa Cruz Avenue into first floor tenant space.

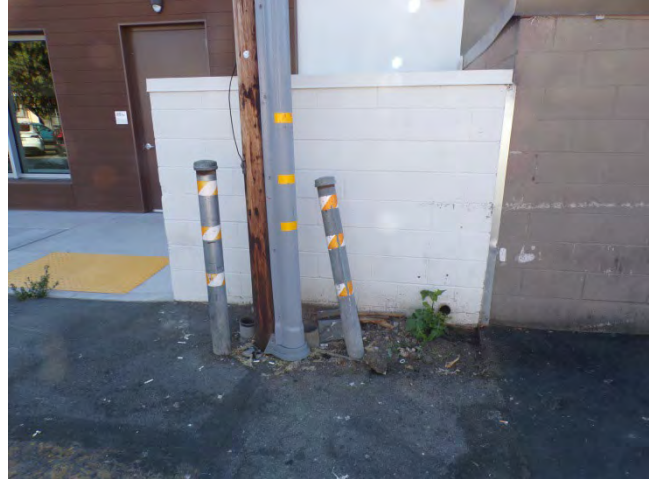
14. The bollards in the parking lot are presumed to be the responsibility of the City. The CMU enclosure behind the bollards contains the gas meter for the subject property.

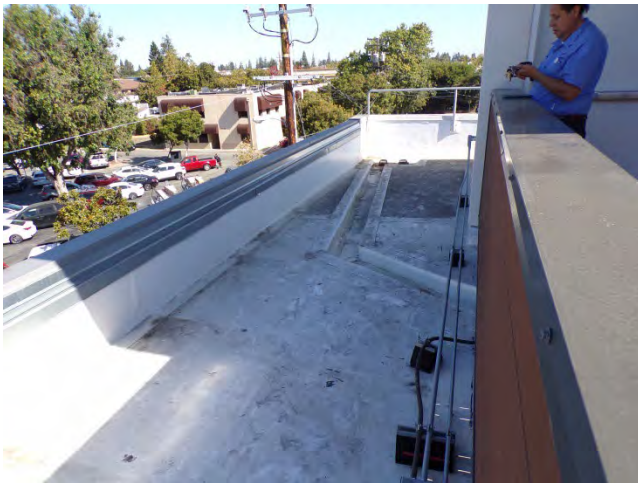
15. The PVC roofing system was installed in November and December of 2020.

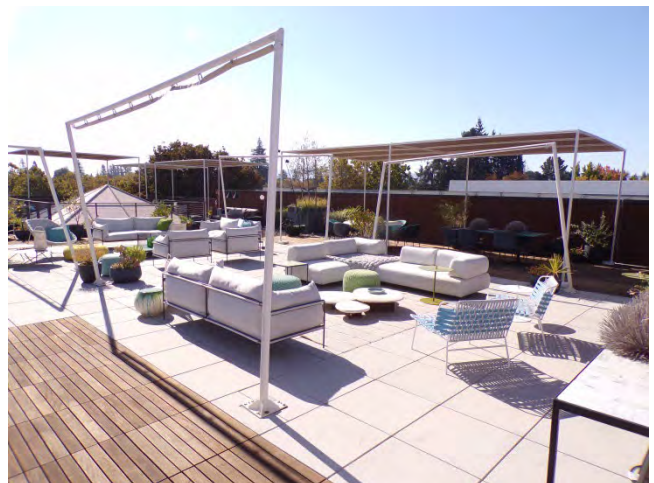
18. Most of the roof is covered with a pedestal flooring system upon which outdoor furniture is displayed.

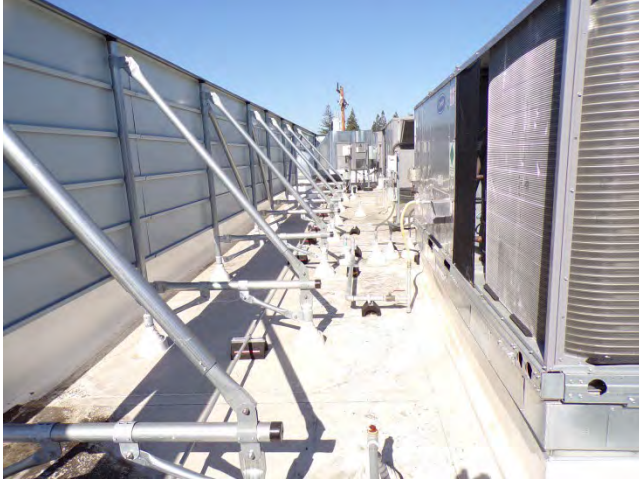
19. The inner face of the mechanical equipment roof screens is shown at left.

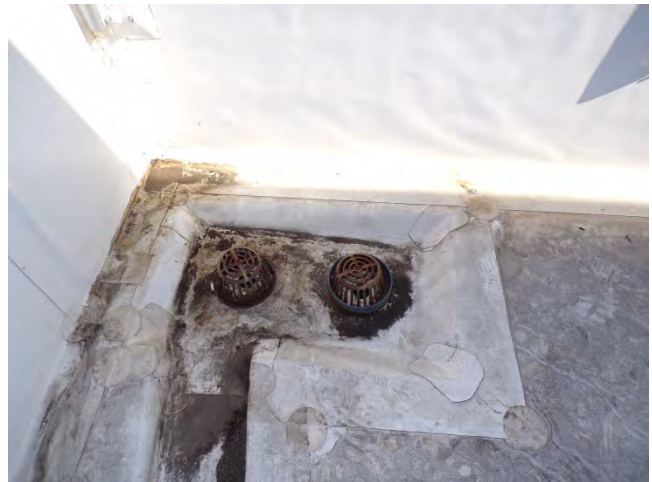
22. Roof and overflow drain combinations are located near the four corners of the building.

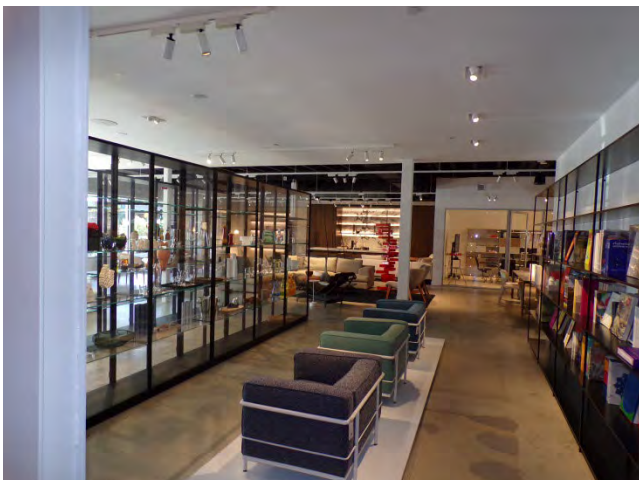
23. First floor: Interior finishes and fixtures in showroom area of tenant space.

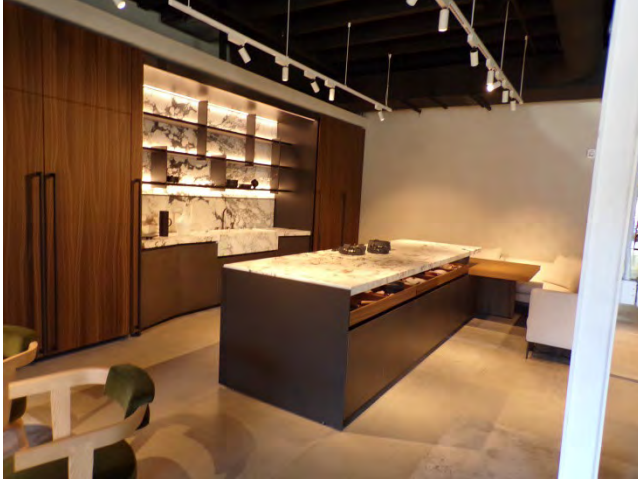
25. First floor: Interior finishes and fixtures in showroom area.

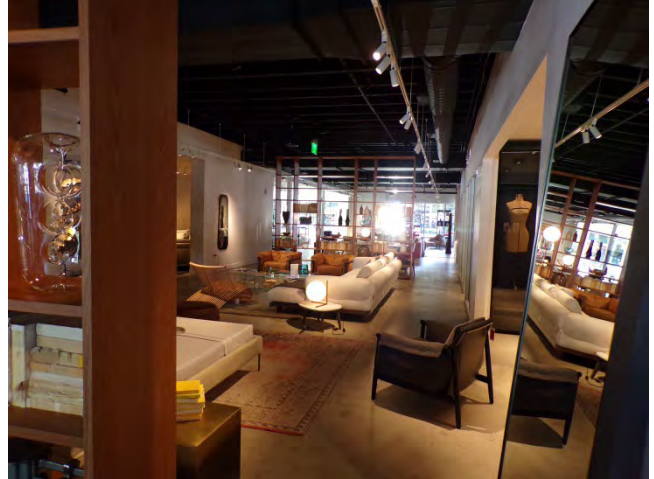
26. First floor: Interior finishes and fixtures in showroom area.

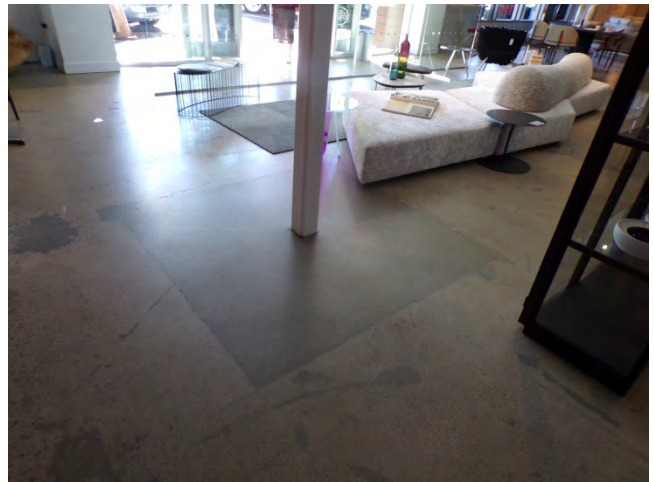
28. First floor: Interior finishes in showroom area. The outline of the enlarged column footing can be seen.

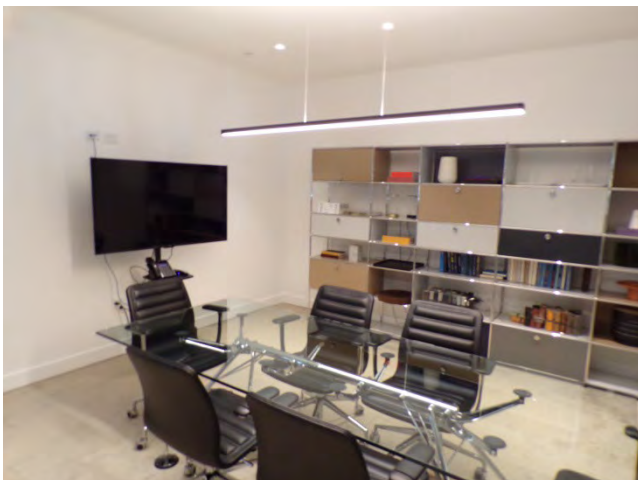
29. First floor: Interior finishes and fixtures in showroom area.

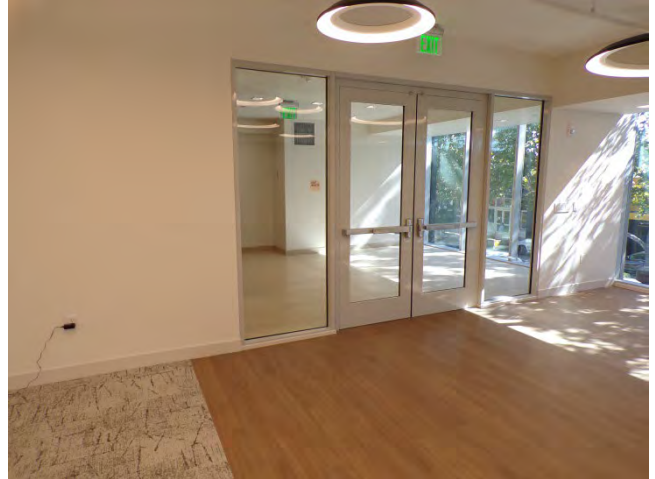
32. Suite 201: Interior finishes and fixtures.

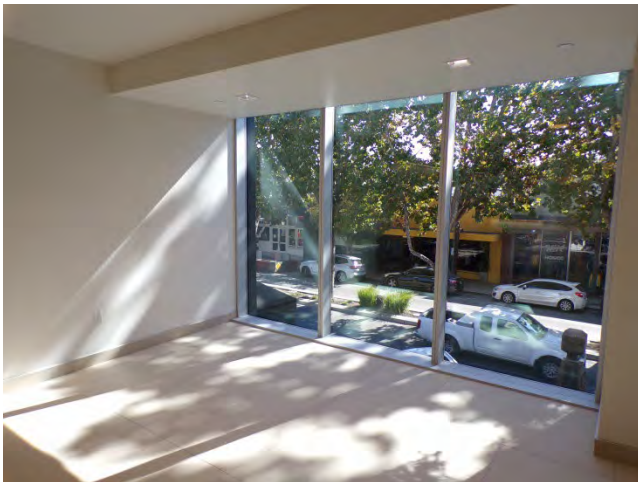
33. Suite 201: Interior finishes and fixtures.

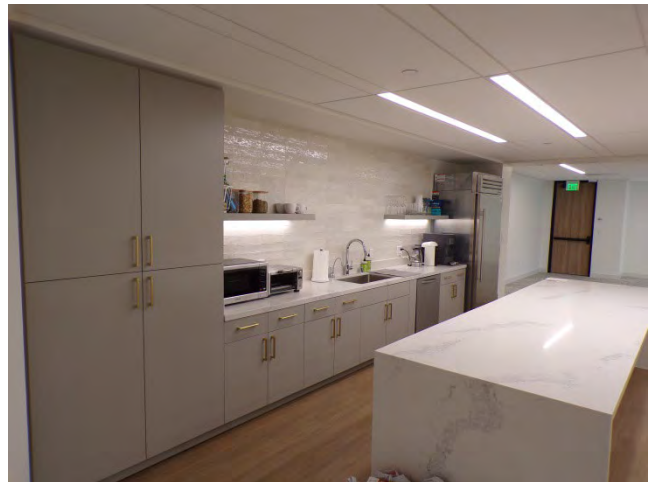
34. Suite 201: Interior finishes and fixtures in kitchenette.

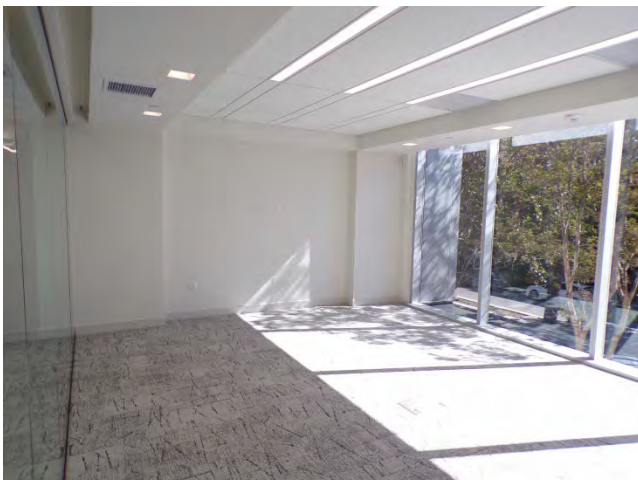
35. Suite 201: Interior finishes and fixtures.

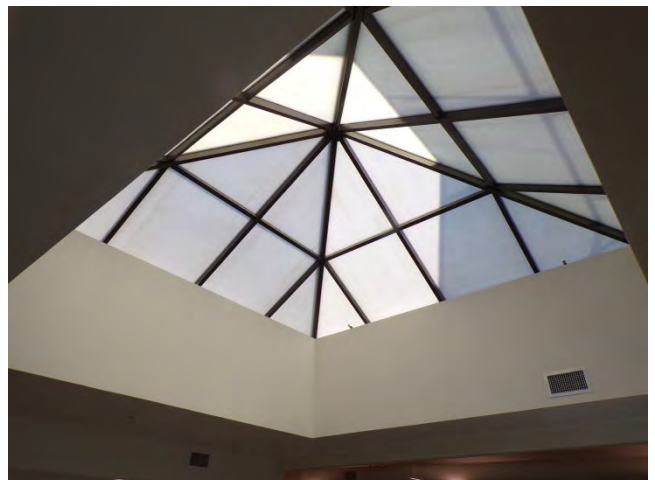
36. Suite 201: Interior finishes, skylight and fixtures.

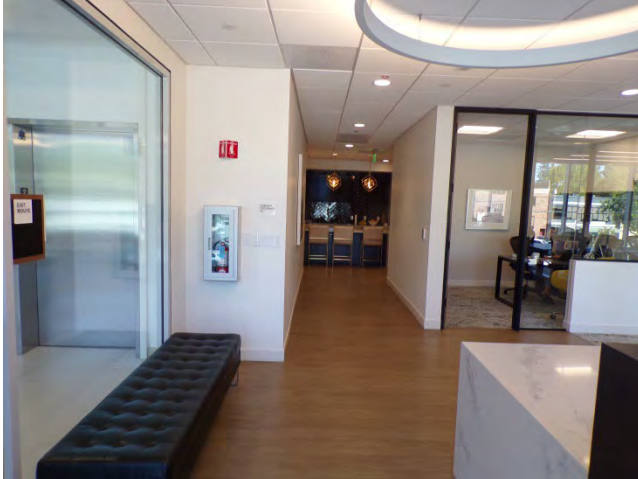
37. Suite 202: Interior finishes and fixtures.

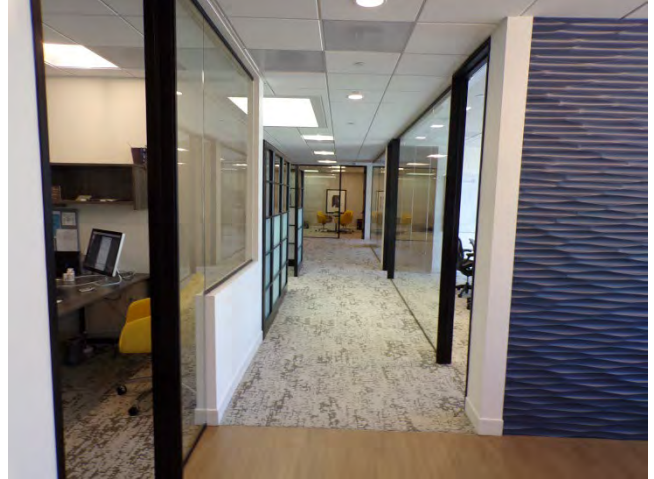
38. Suite 202: Interior finishes and fixtures.

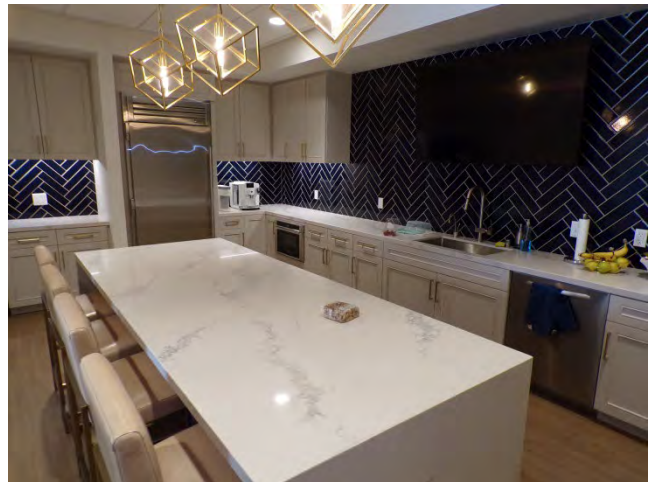
40. Suite 202: Interior finishes and fixtures in kitchenette.

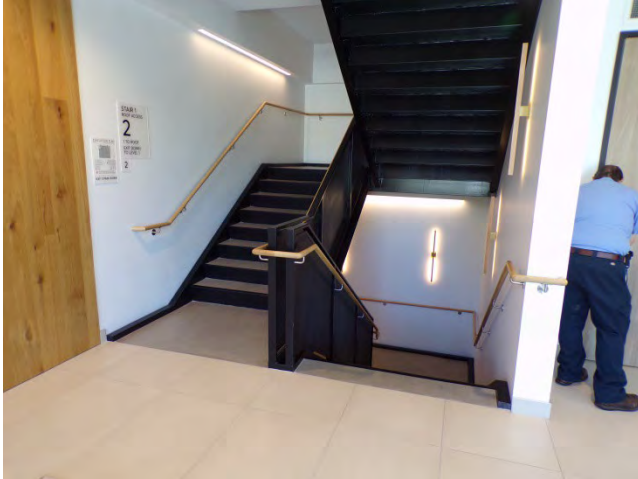
43. Two sets of interior stairs are provided.

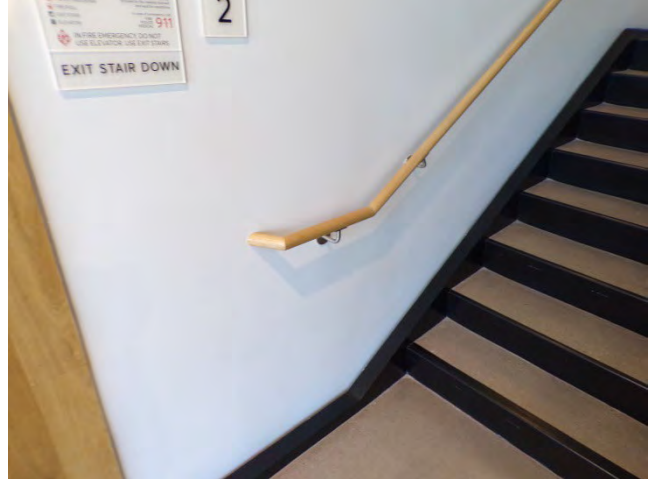
44. Both sets of stairs appeared compliant with current Accessibility requirements.

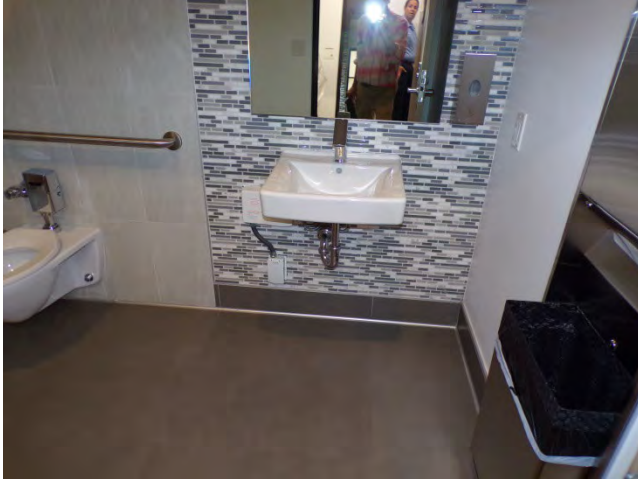
49. Second floor: Interior finishes and fixtures in restrooms. This sink drainpipe lacks required insulation.

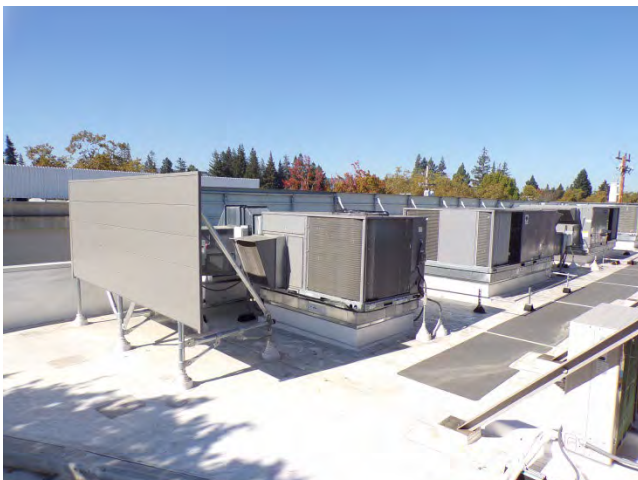
53. Four Carrier packaged units are located on the south side of the roof. Screens for HVAC equipment also shown.

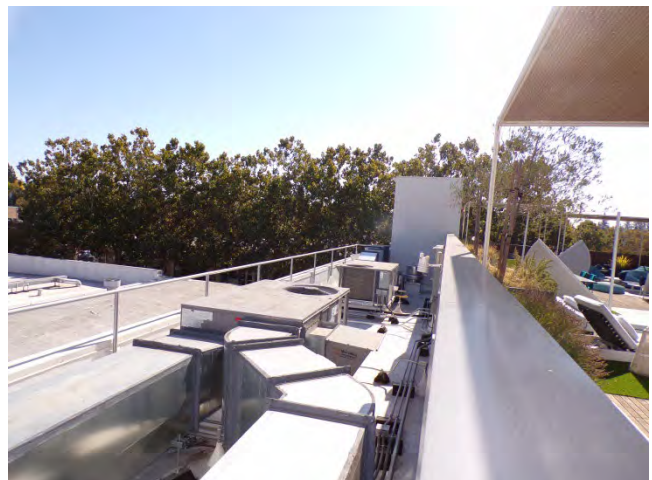
54. Two Carrier packaged units are located on the north side of the roof.

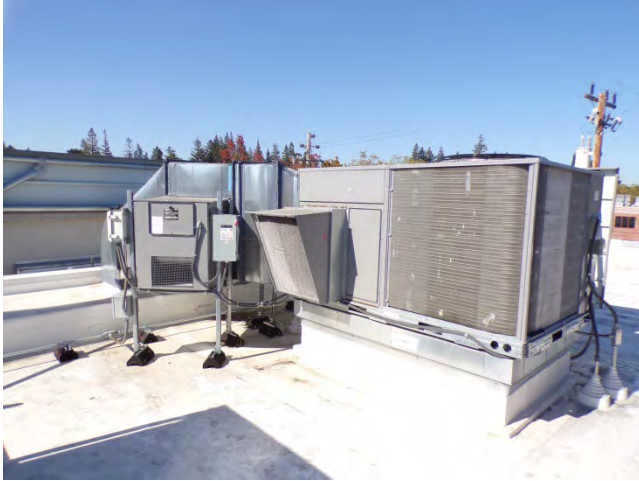
55. The *Carrier* packaged units were installed in 2022 and appeared in "Good" condition.

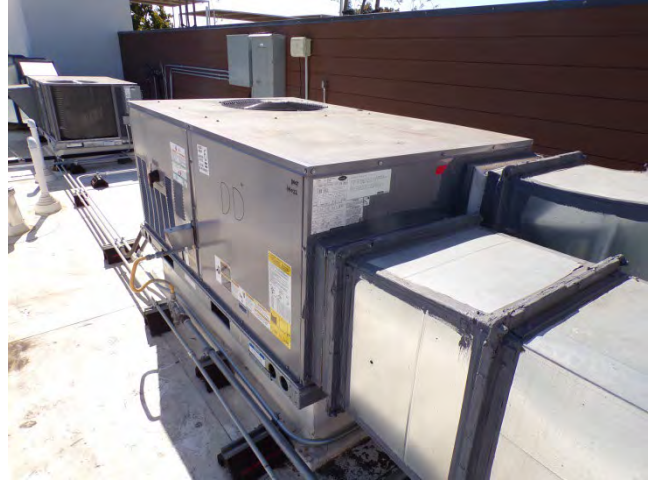
56. All six rooftop furnaces have flexible gas line connections.

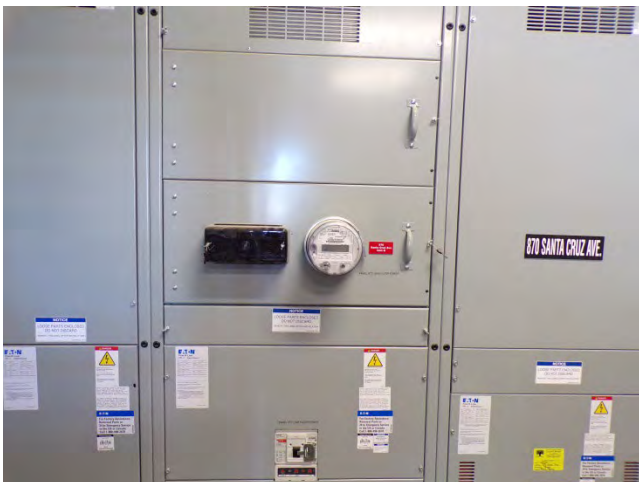
59. The main service entrance panel is rated at 600 amps. It is located in the main service room near the southwest corner of the building.

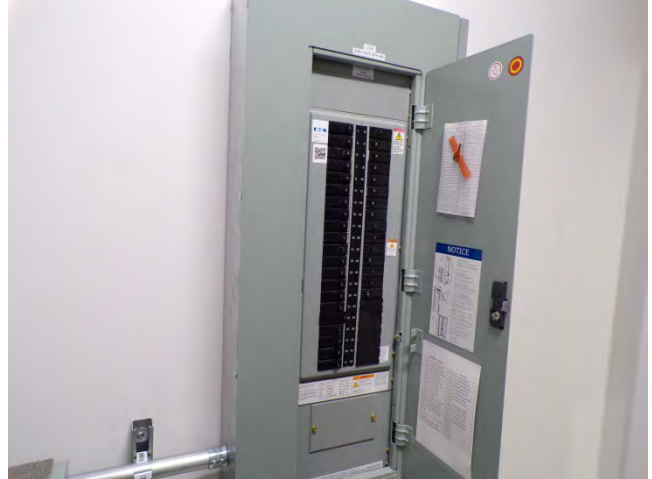
62. No evidence of infrared scanning of the electrical distribution equipment was observed.

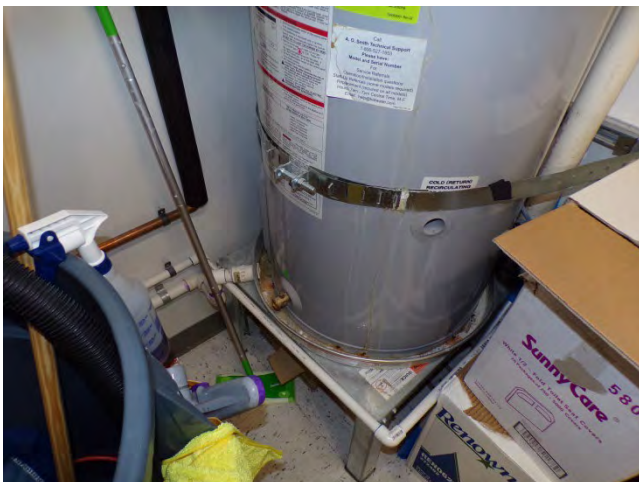
65. The water heater has compliant seismic strapping.

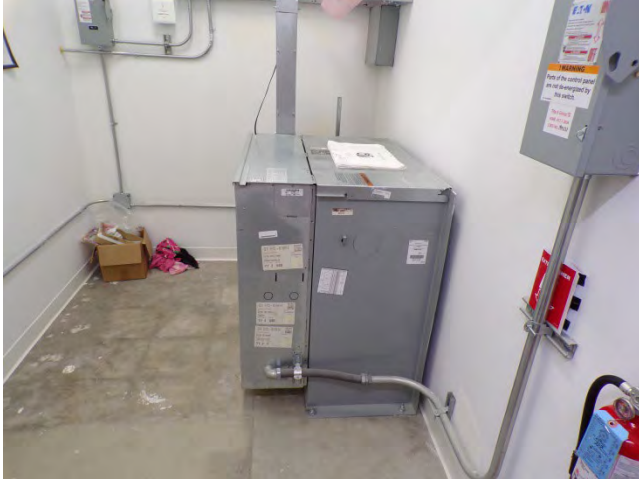
73. The elevator hydraulic load test was last conducted on January 22, 2024.

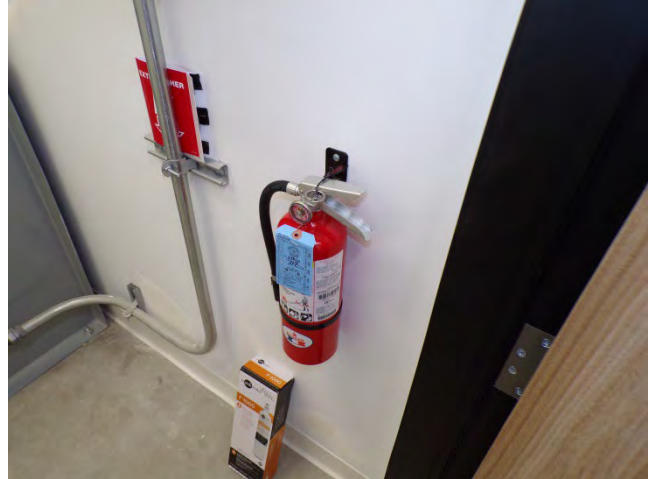
74. All observed fire extinguisher inspection tags were current, dated May 8, 2024.

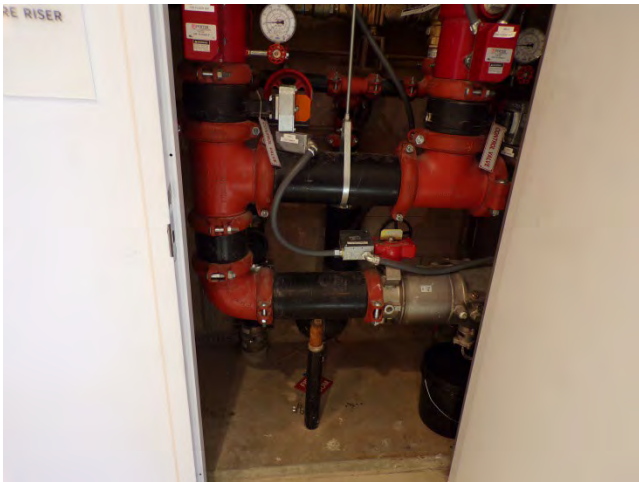
75. The two 6" fire sprinkler risers are located in a service closet near the northeast corner of the building.
