### PROPERTY CONDITION ASSESSMENT

## 2 & 8 Medical Plaza Drive, Roseville, CA 95661

**PROJECT 26006.60**  
**April 13, 2026**

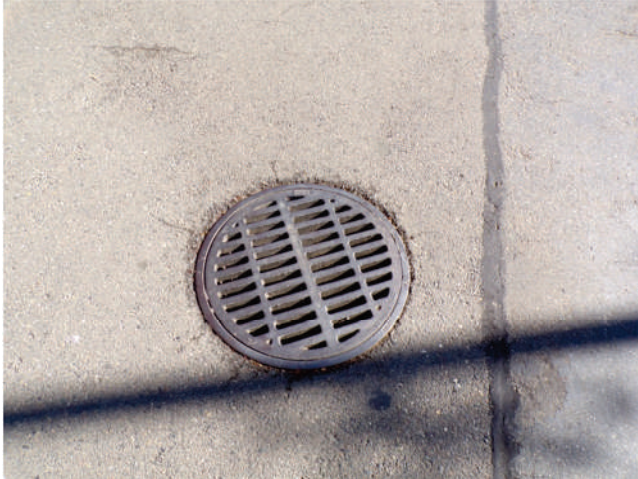
25. MOB 2: Drain inlets are located in several locations in the parking lot.

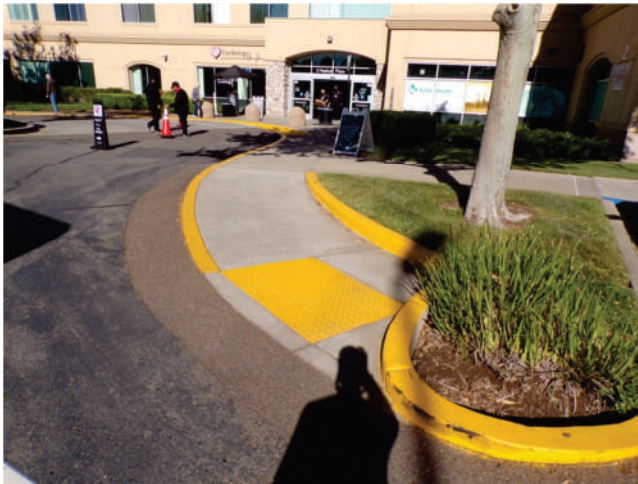
39. MOB 2: Concrete site walkways appeared in generally "Good" condition. Truncated domes are located in required locations.

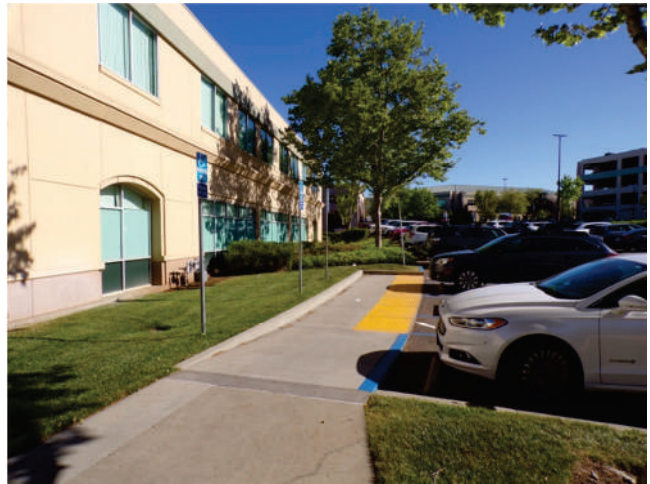
40. MOB 2: Concrete site walkways appeared in generally "Good" condition. Truncated domes are located in required locations.

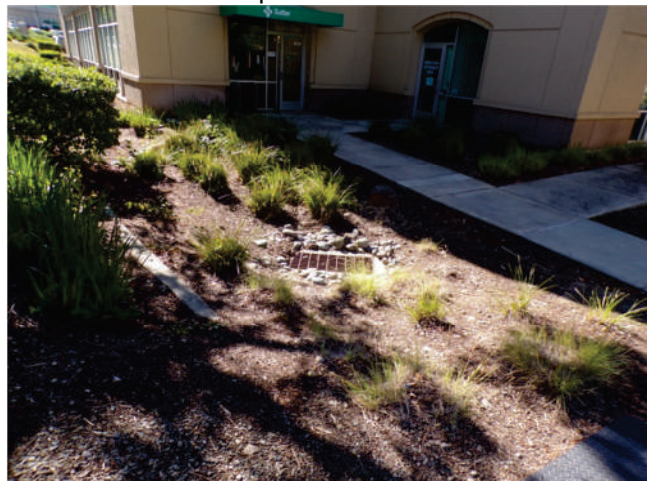
42. MOB 2: Drain inlets are also located in landscaped areas.

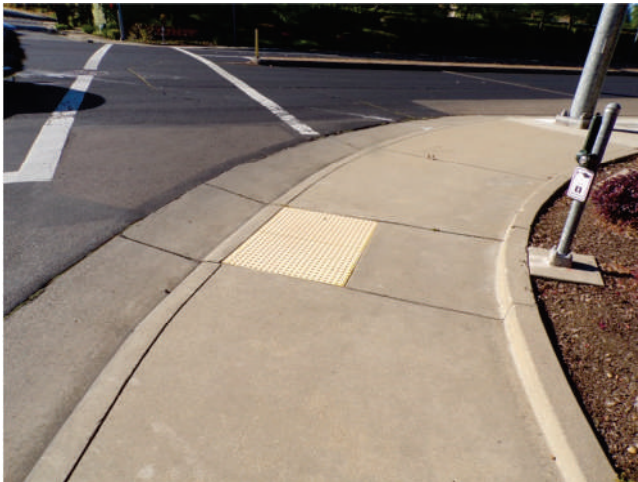
45. MOB 2: Truncated domes are located in required locations.

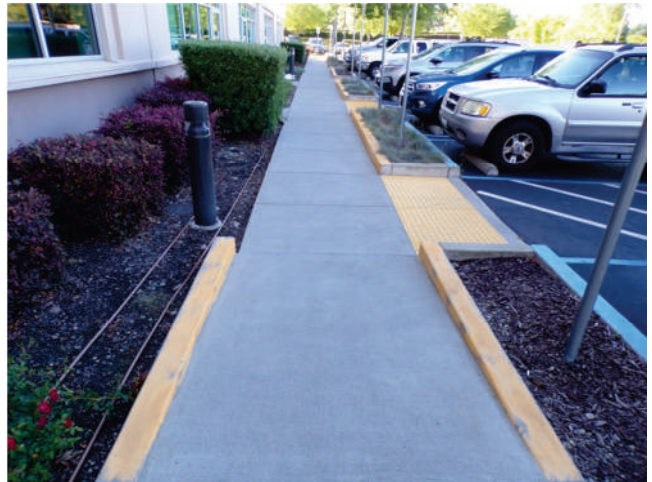
46. MOB 2: Concrete site walkways appeared in generally "Good" condition. Truncated domes are located in required locations.

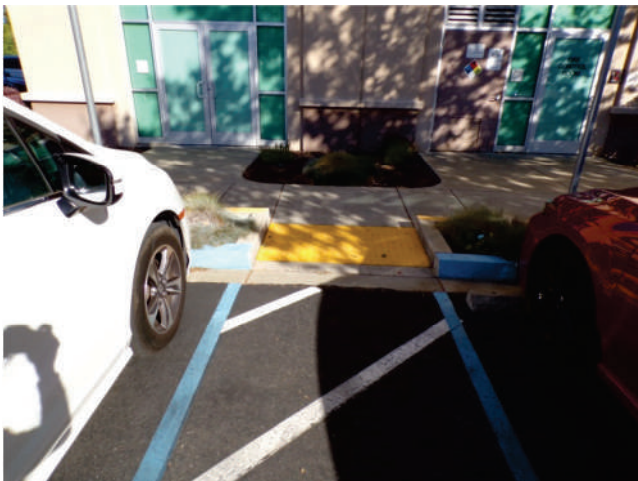
47. MOB 2: Truncated domes are located in required locations.

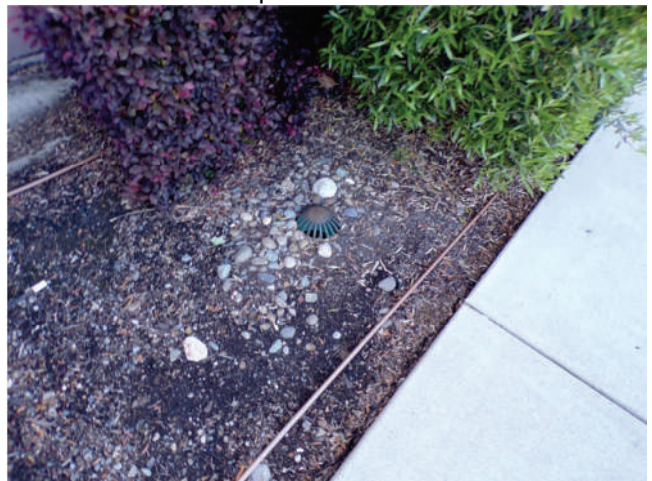
48. MOB 8: Drain inlets are also located in landscaped areas.

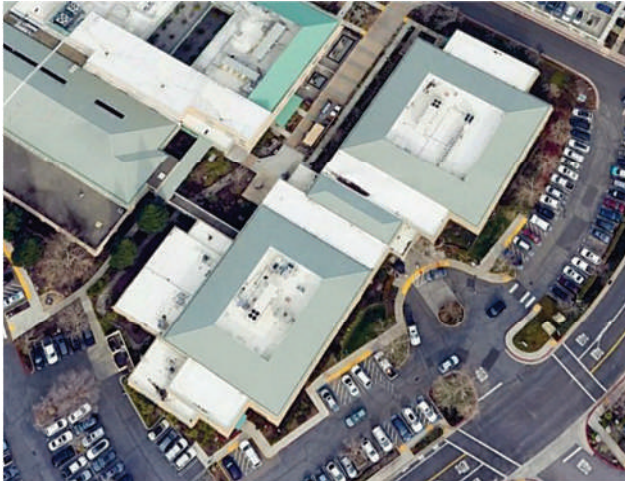
49. MOB 2 has a complex roofing configuration.

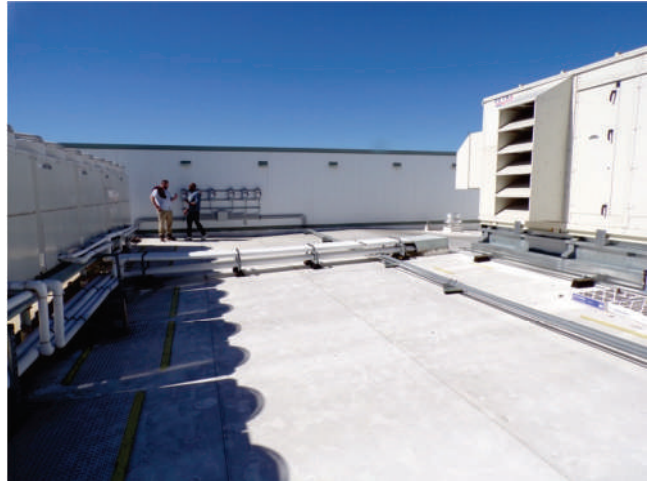
50. MOB 2, south wing: The TPO roofing system was installed in 2018.

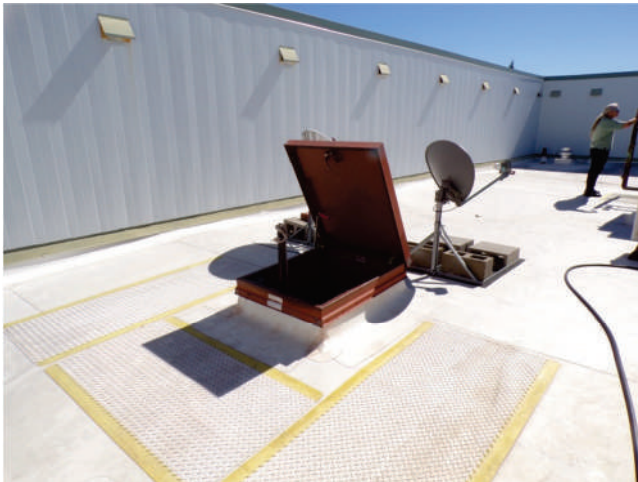
51. MOB 2, south wing: A roof hatch provides access to the flat roof equipment well of this wing.

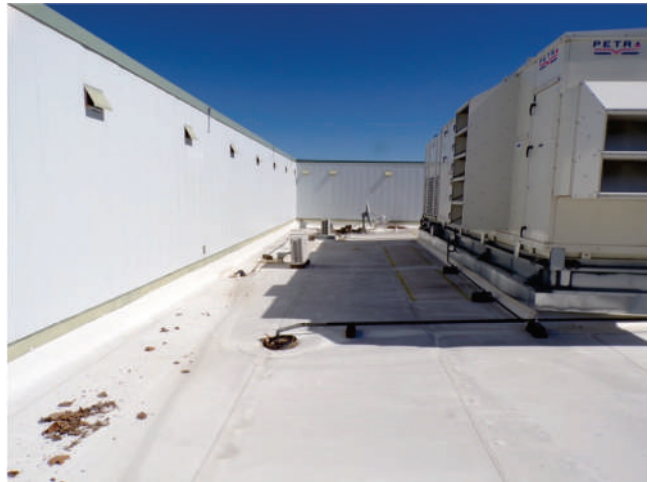
52. MOB 2, south wing: The roofing system appeared in generally "Good" condition.

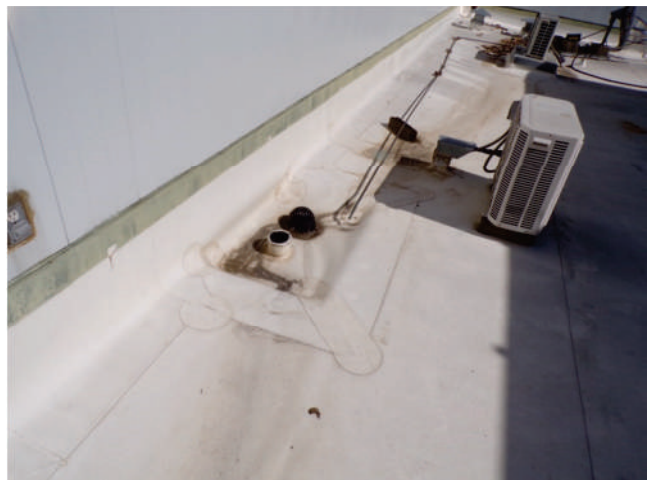
54. MOB 2, south wing: Roof and overflow drains are located in shallow sumps.

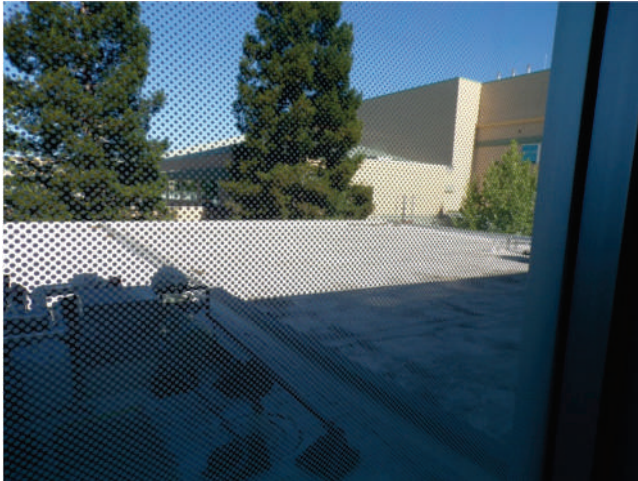
55. MOB 2, south wing: Direct physical access was not possible on the secondary flat roof areas of this building.

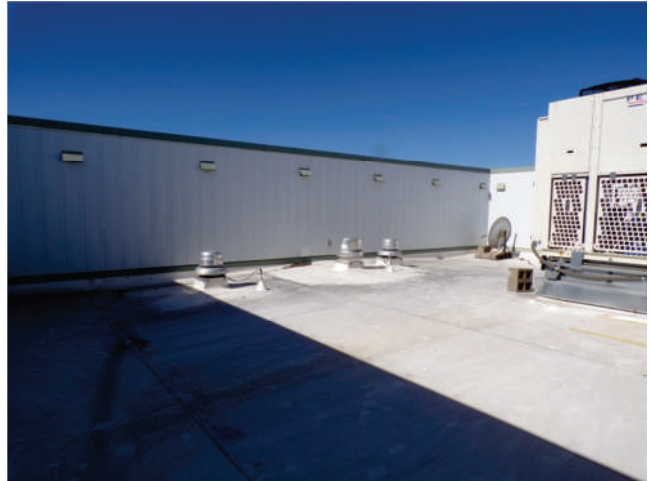
56. MOB 2, north wing: The TPO roofing system was installed in 2018.

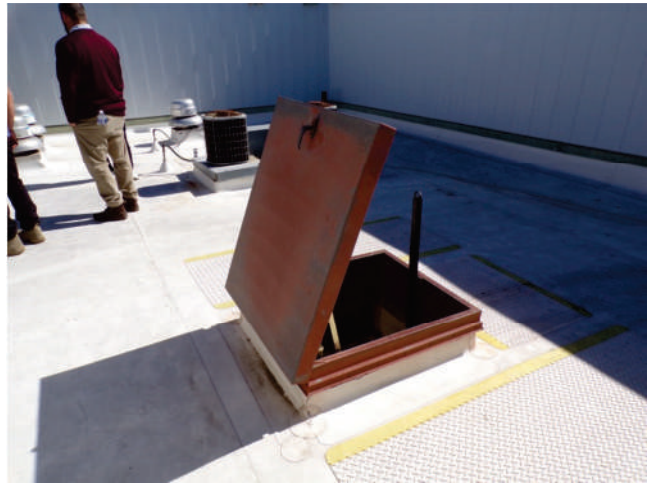
58. MOB 2, north wing: A separate roof hatch provides access to the flat roof area of this wing.

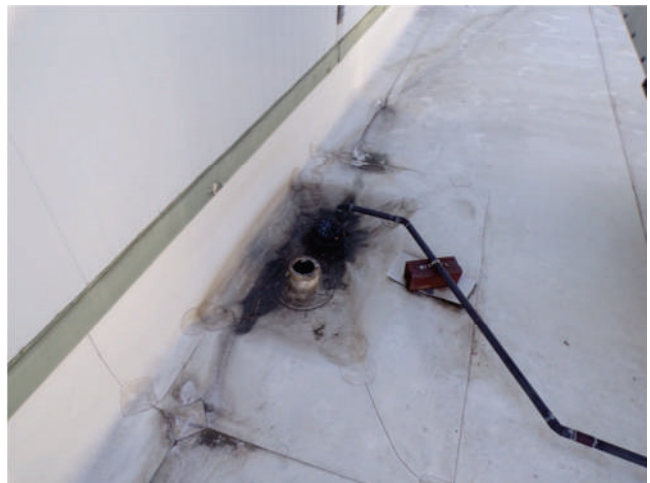
60. MOB 2, north wing: Roof and overflow drains are located in shallow sumps. Accumulation of grime in sumps is typical.

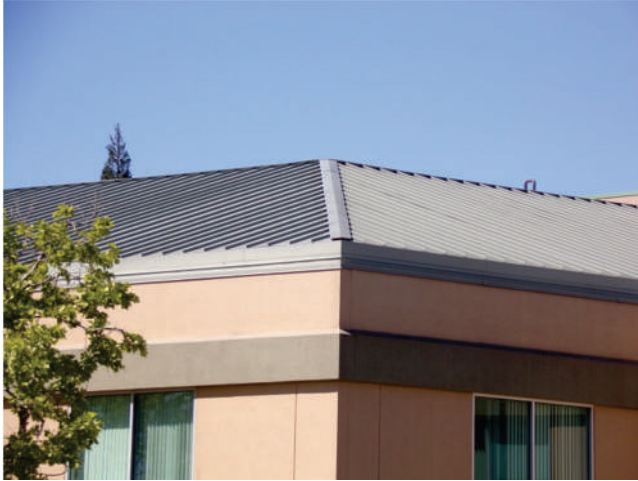
61. MOB 2: The pitched roof mansards on this building could only be observed from grade.

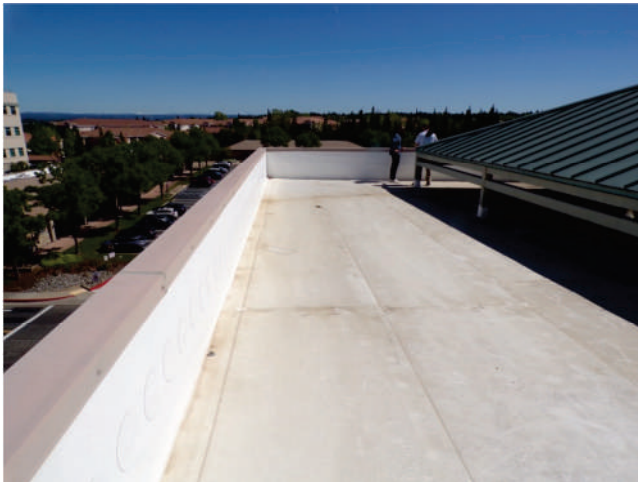
63. MOB 8: The TPO roofing system was installed in 2016 at the time of original construction.

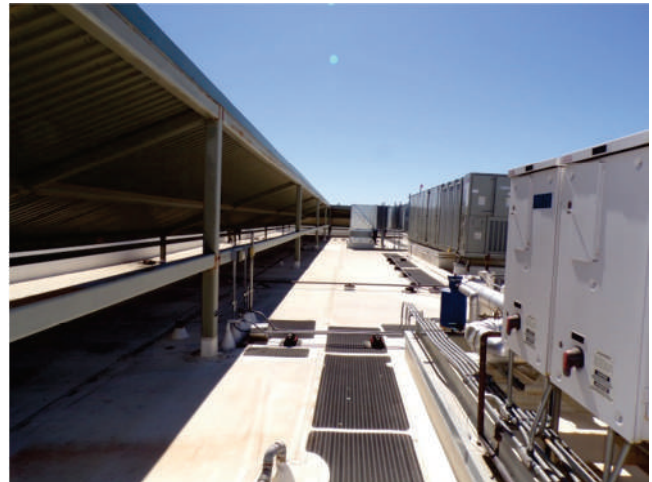
64. MOB 8: The TPO roofing system appeared in generally "Good" condition.

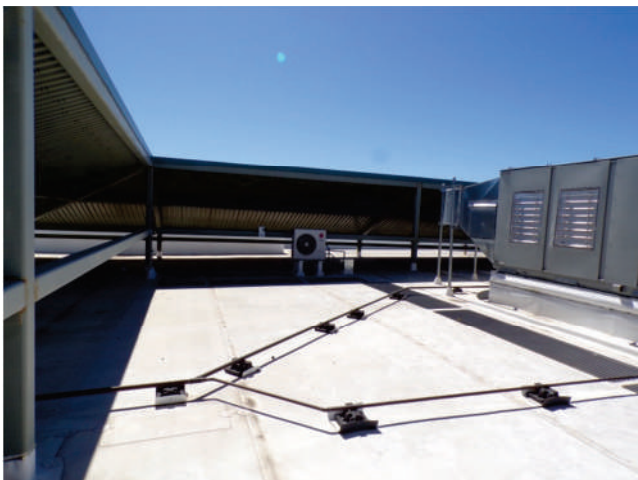
65. MOB 8: The TPO and metal roofing systems both appeared in generally "Good" condition.

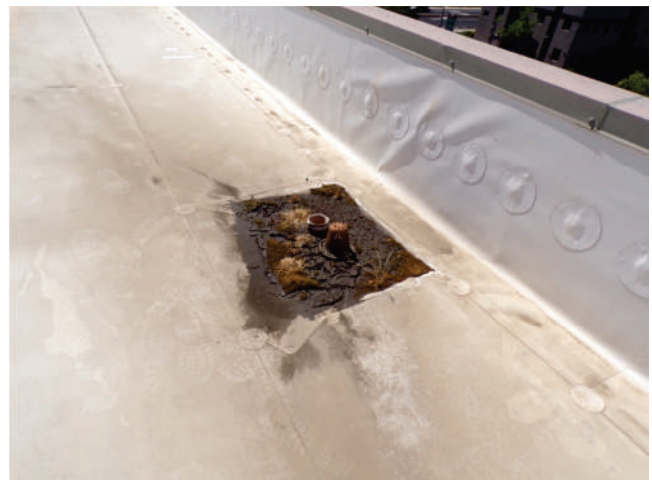
66. MOB 8: Roof and overflow drains are located in shallow sumps. Accumulation of grime in sumps is typical.

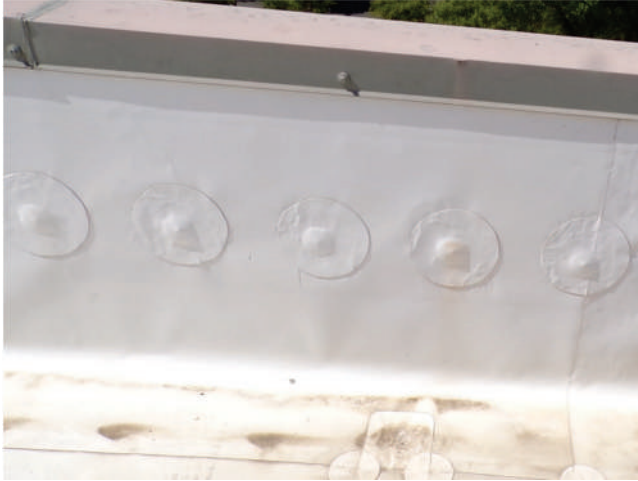
67. MOB 8: The TPO membrane turns up at the parapets and terminates under the parapet cap.

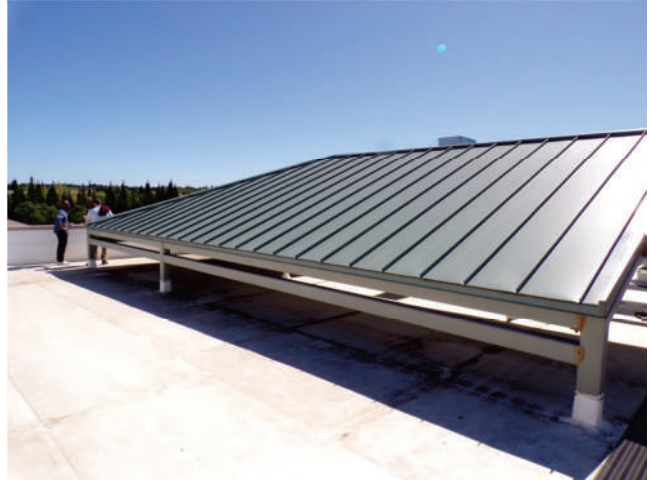
68. MOB 8: The mansards were directly observable from adjacent flat roof areas on this building.

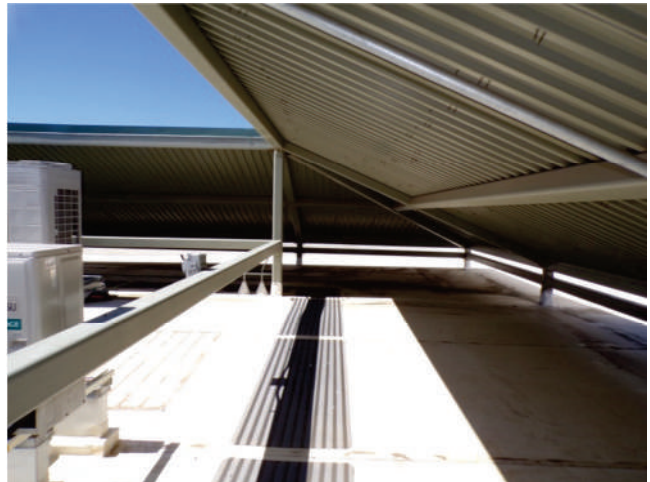
70. MOB 2: The mansards on this building do not function as true roofs in the sense that they do act as a weatherseal for the interior areas beneath them.

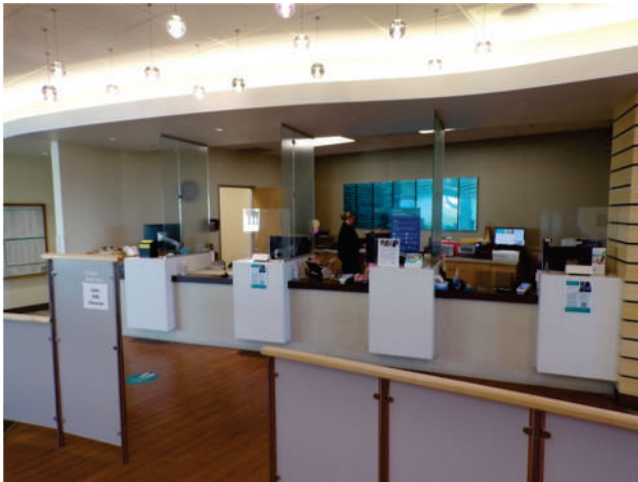
93. MOB 8: Interior finishes and fixtures at nurse's stations.

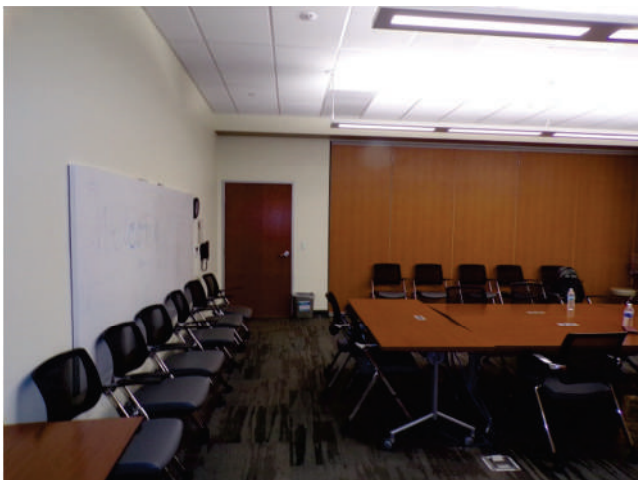
95. MOB 8: Interior finishes and fixtures in conference rooms.

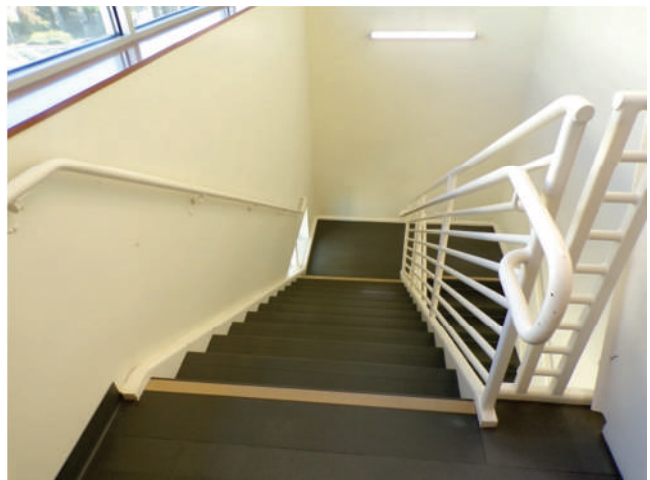
96. MOB 8: Interior finishes and fixtures in fire stairs.

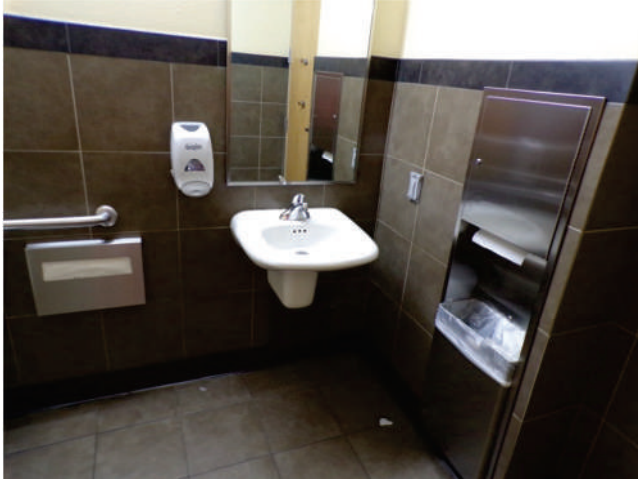
97. MOB 2: Interior finishes and fixtures in remodeled restrooms.

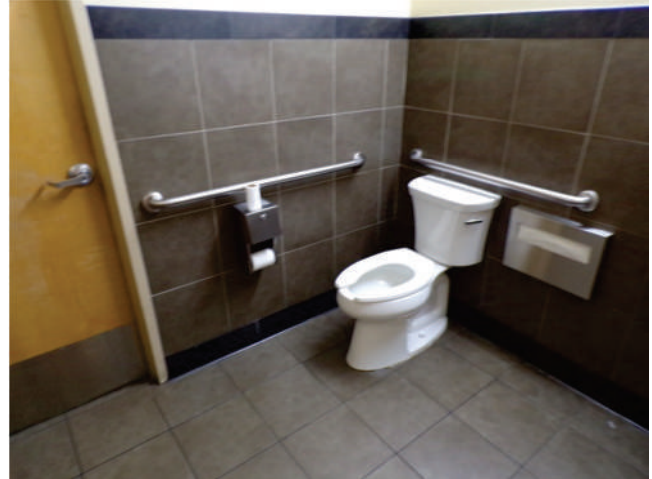
98. MOB 2: Interior finishes and fixtures in remodeled restrooms.

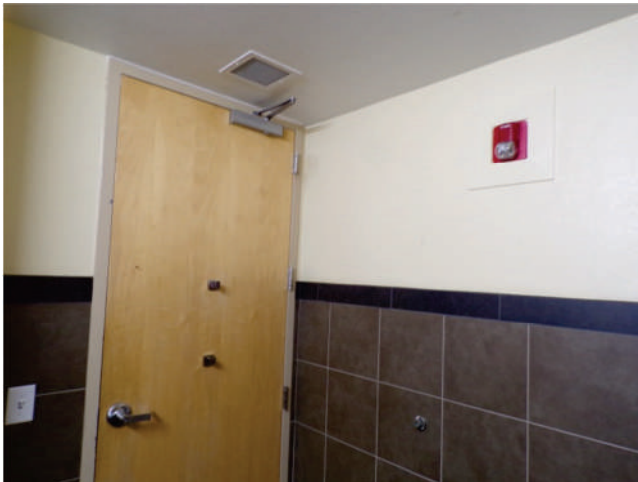
99. MOB 2: Interior finishes and fixtures in remodeled restrooms. Horn/strobe alarm devices are installed in these newer restrooms.

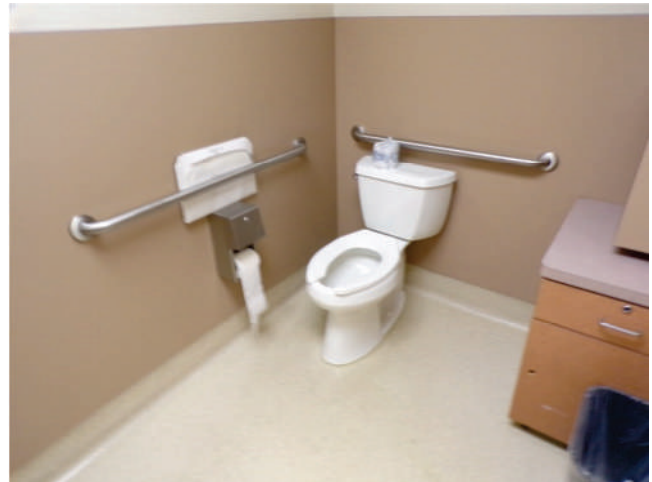
100. MOB 2: Interior finishes and fixtures in older restrooms.

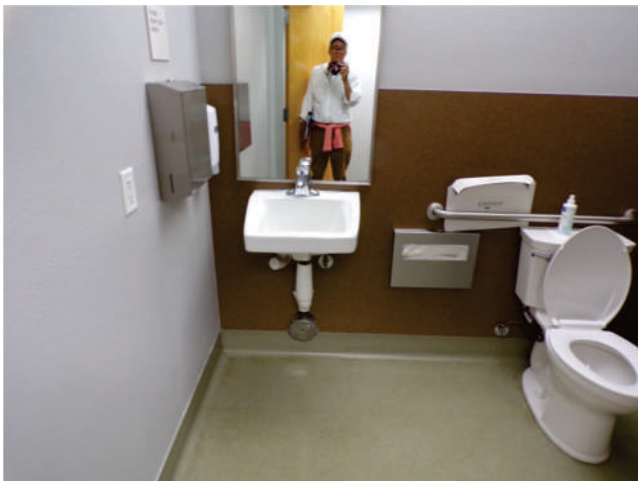
101. MOB 2: Interior finishes and fixtures in older restrooms. Horn/strobe alarm devices are not installed in these restrooms.

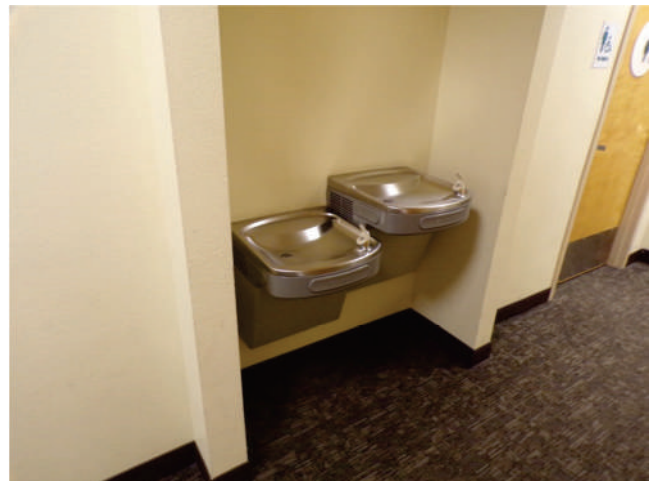
102. High-low water fountain combinations are installed in both subject buildings. MOB 2 shown.

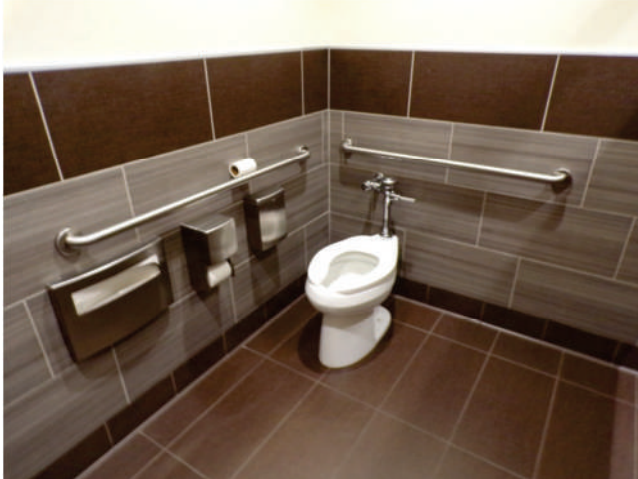
103. MOB 8: Interior finishes and fixtures in restrooms.

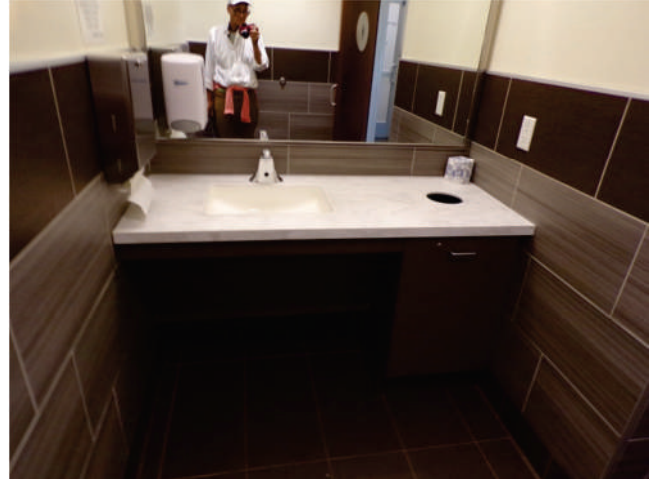
104. MOB 8: Interior finishes and fixtures in restrooms.

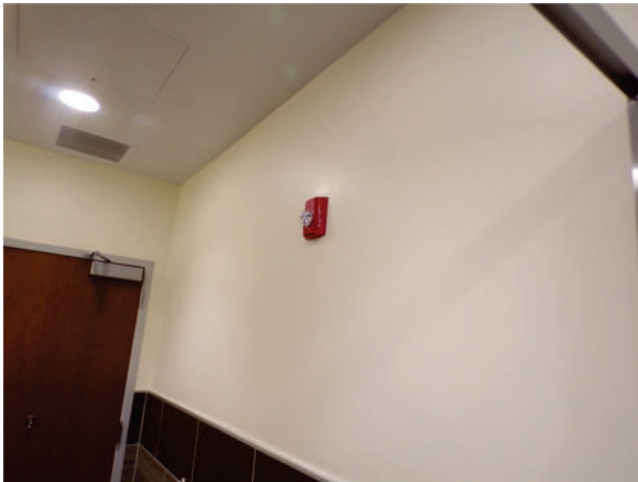
105. MOB 8: Interior finishes and fixtures in restrooms. Horn/strobe alarm devices are installed in all observed restrooms in this building.

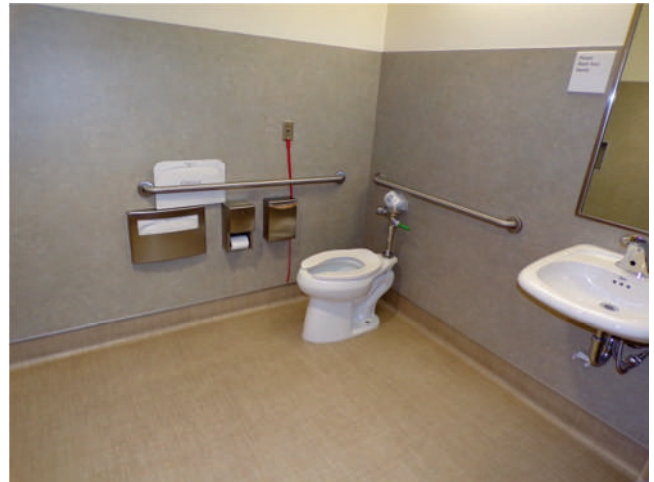
106. MOB 8: Interior finishes and fixtures in patient area restrooms.

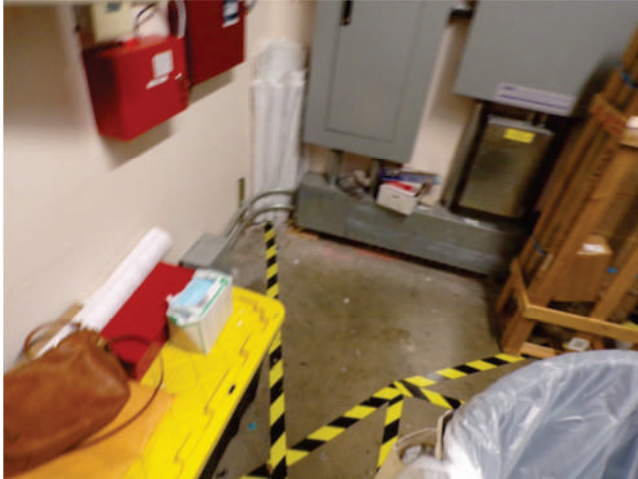
109. MOB 2: Interior finishes and fixtures in service rooms.

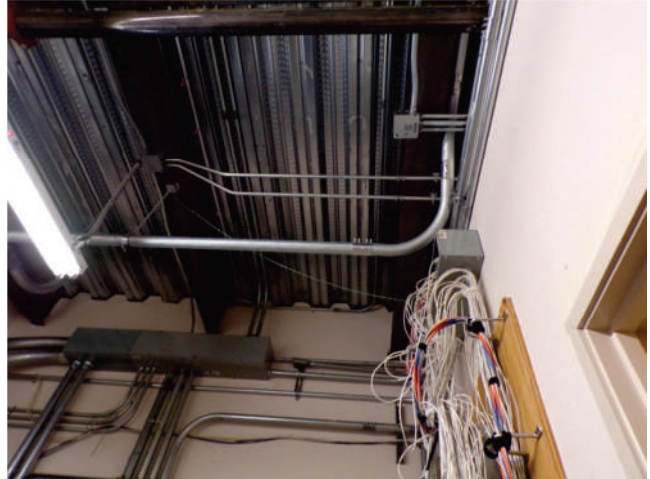
110. MOB 2: Interior finishes and fixtures in service rooms.

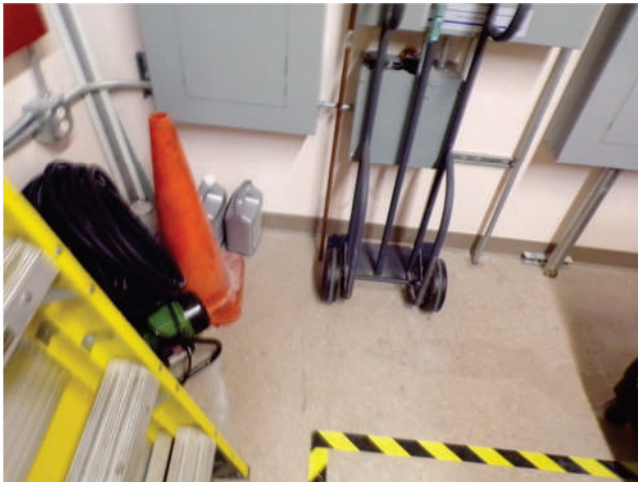
111. MOB 2: Interior finishes and equipment in service rooms.

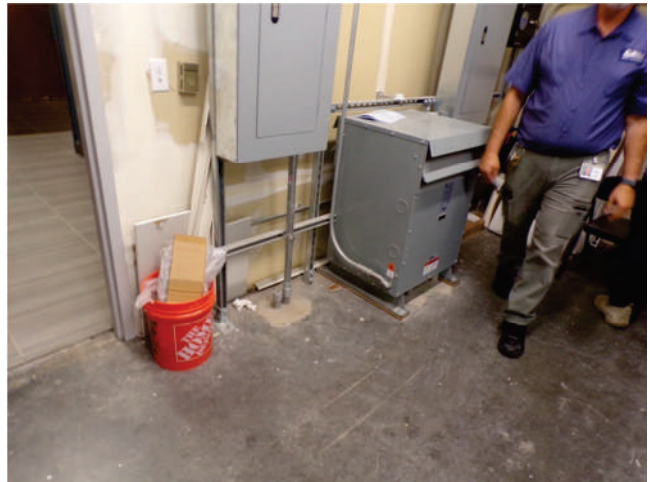
112. MOB 8: Interior finishes and equipment in service rooms.

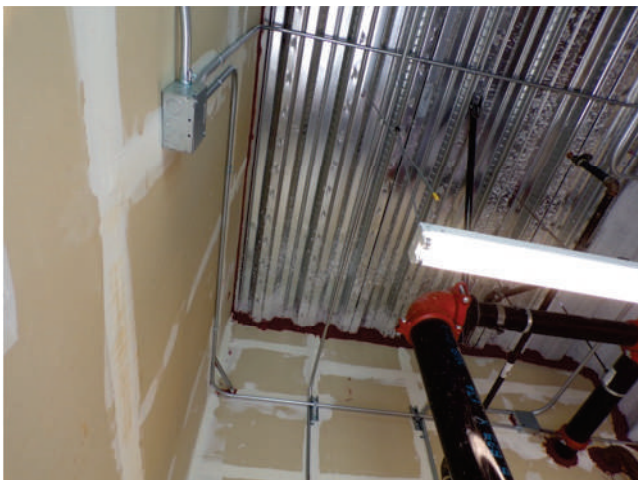
113. MOB 8: Interior finishes and fixtures in service rooms.

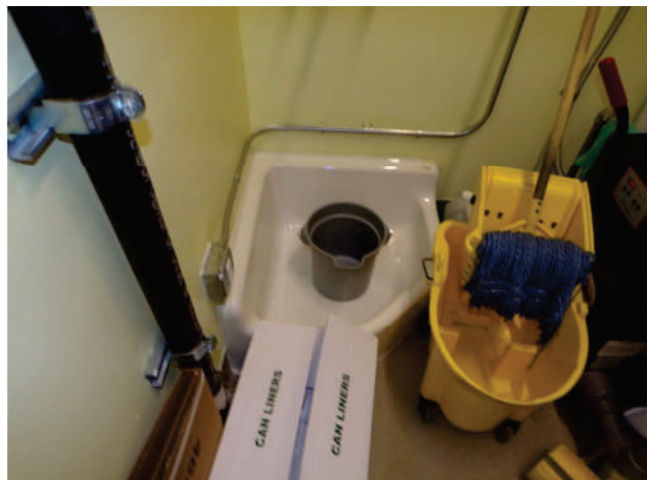
114. MOB 8: Interior finishes and fixtures in service rooms.

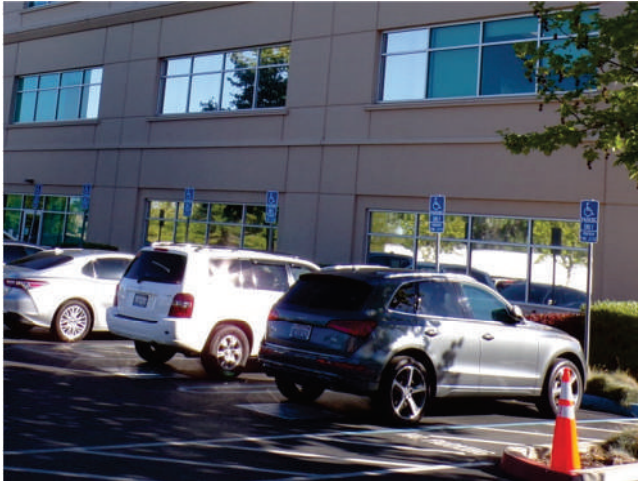
115. MOB 8: Sixteen Accessible parking stalls are provided at this building.

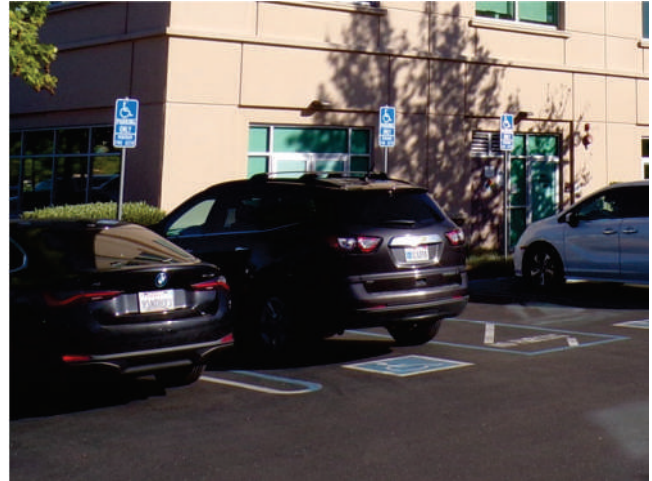
116. MOB 8: Accessible parking stalls are located in proximity to the primary pedestrian entrances.
