## PROPERTY CONDITION ASSESSMENT

La Bahia Hotel & Spa, 215 Beach Street, Santa Cruz, CA 95060

ALLWEST PROJECT 26004.60  
February 6, 2026

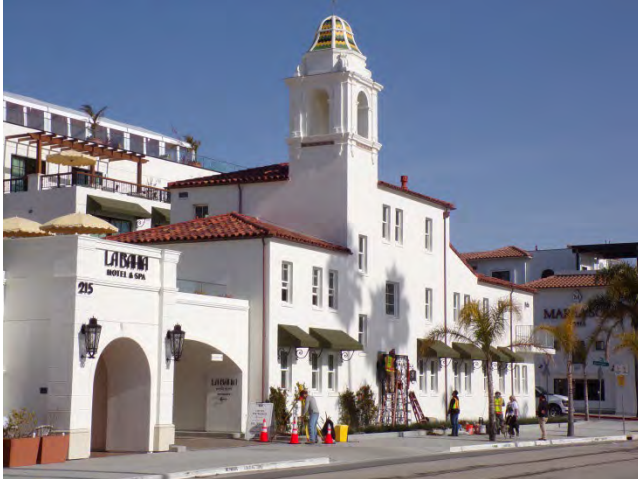
7. Tower Bldg: South elevation at center of shot.

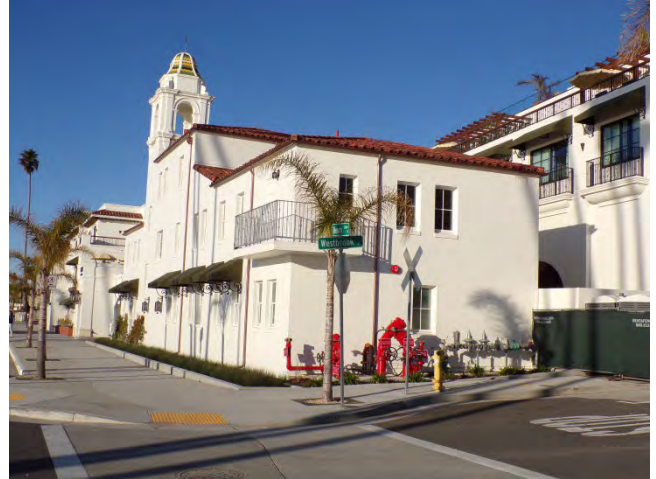
8. Tower Bldg: East elevation at center of shot.

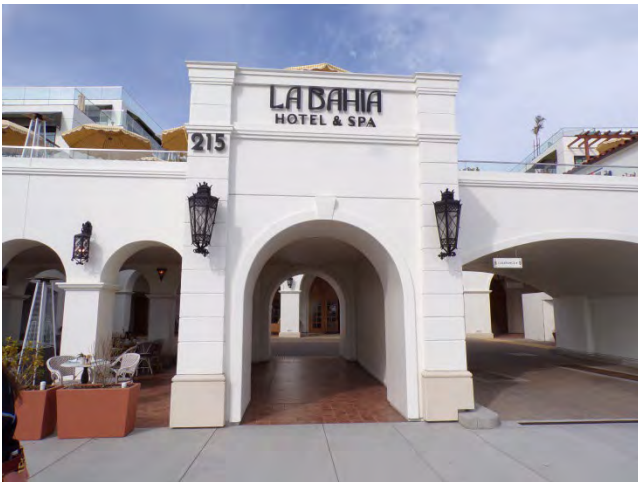
9. Primary pedestrian entrance along Beach Street.

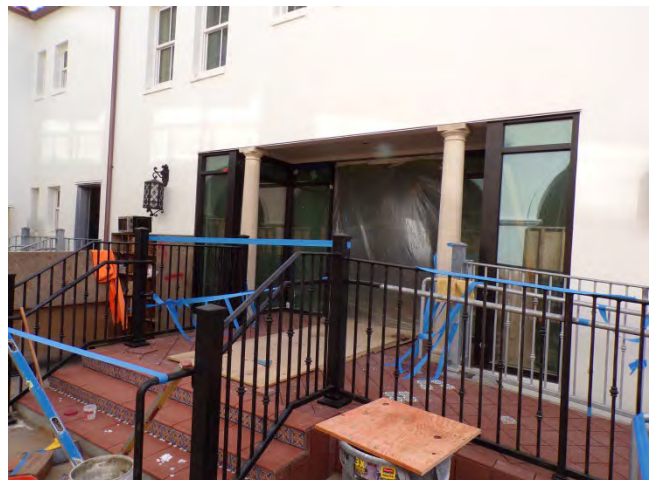
12. Tower Bldg: Primary pedestrian entrance.

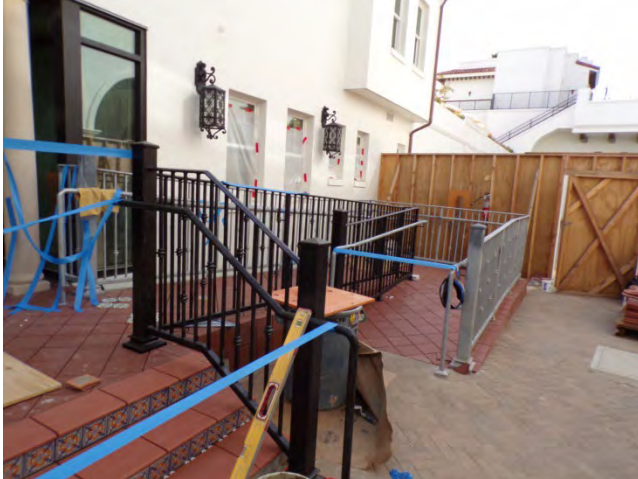
13. Tower Bldg: Wheelchair ramp along north elevation.

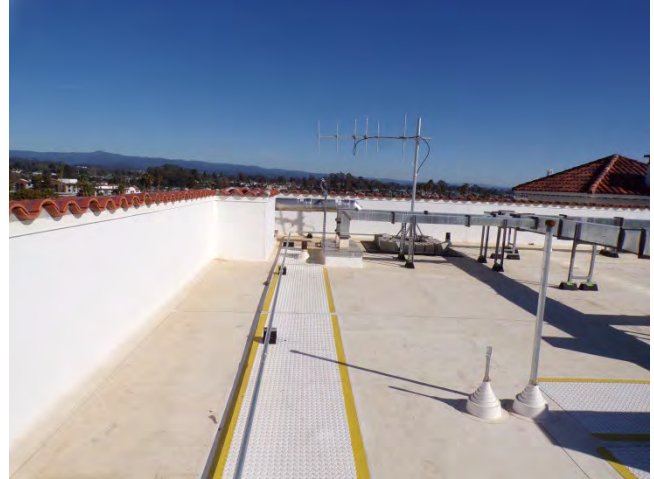
The roofing systems are evaluated as in "Excellent" to "Good" condition. On the Main Bldg, a single-ply thermoplastic polyolefin (TPO) roofing system is installed; it is date stamped February 2024. The Main Bldg roof is flat with minimal slopes. Red terra cotta barrel tiles are provided as accents, typically at the tops of parapets. Green roofs, with plantings of low-growing grasses, cover approximately 25% of the roof area of the Main Bldg. On the pitched roofs of the Tower Building, a new, red terra cotta barrel tile roofing system was installed in August 2025 as part of the current renovation project.

14. Main Bldg: The TPO roofing system is date stamped February 2024.

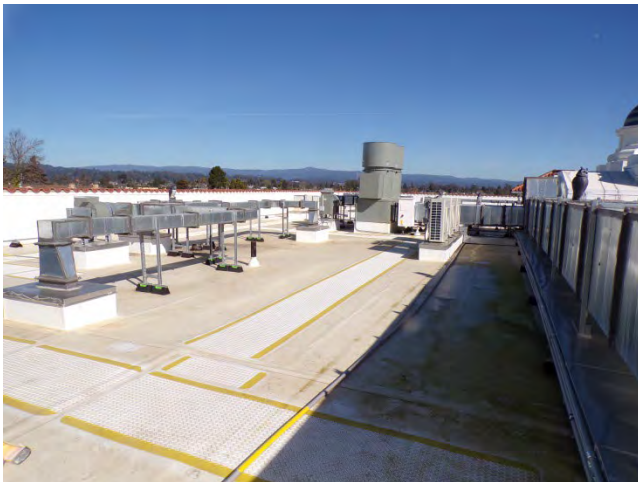
15. Main Bldg: The TPO roofing system is date stamped February 2024.

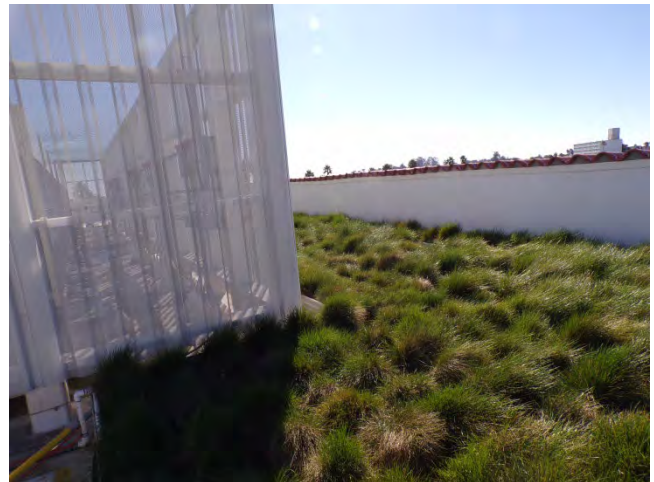
16. Main Bldg: Green roofing systems are installed over approximately 25% of the roof area.

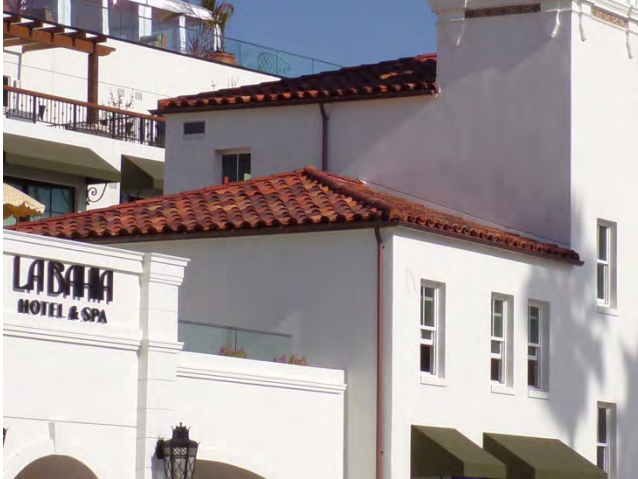
19. Tower Bldg: The red barrel tile roofing system was reportedly installed in August 2025.

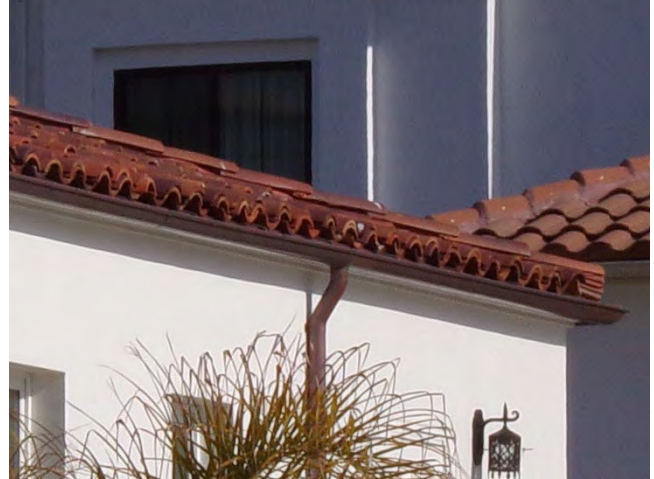
20. Tower Bldg: Gutters and downspouts provide roof drainage.

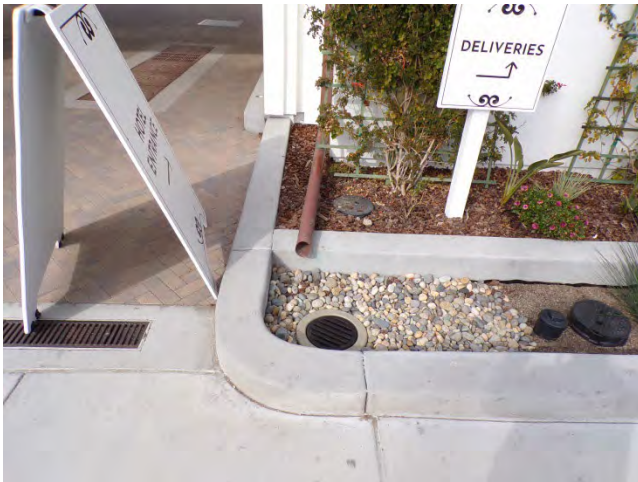
21. Tower Bldg: Downspouts discharge at slightly above grade to nearby drain inlets.

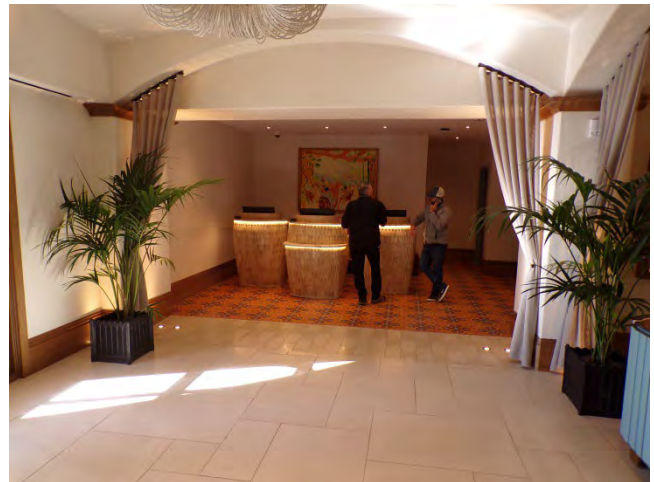
22. Main Bldg: Interior finishes and fixtures at reception desk in main lobby.

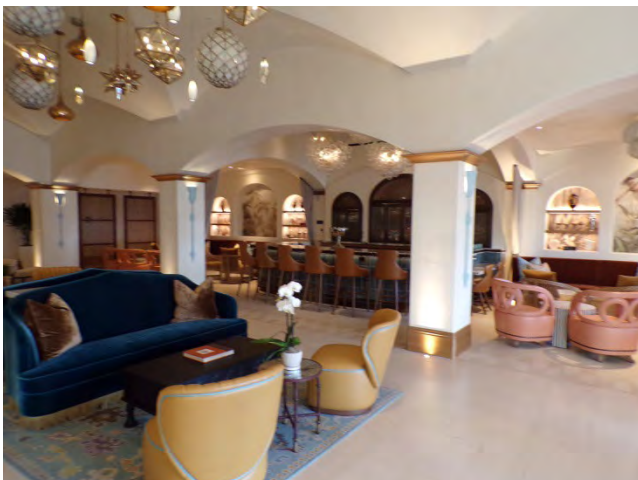
23. Main Bldg: Interior finishes and fixtures in main lobby with bar in background.

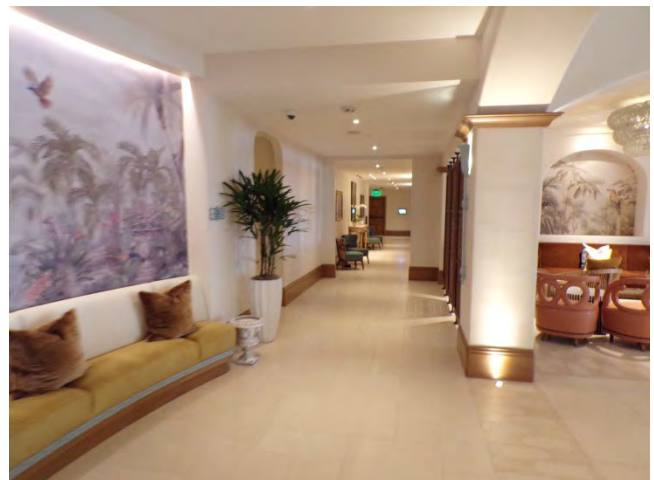
24. Main Bldg: Interior finishes and fixtures in main lobby corridor.

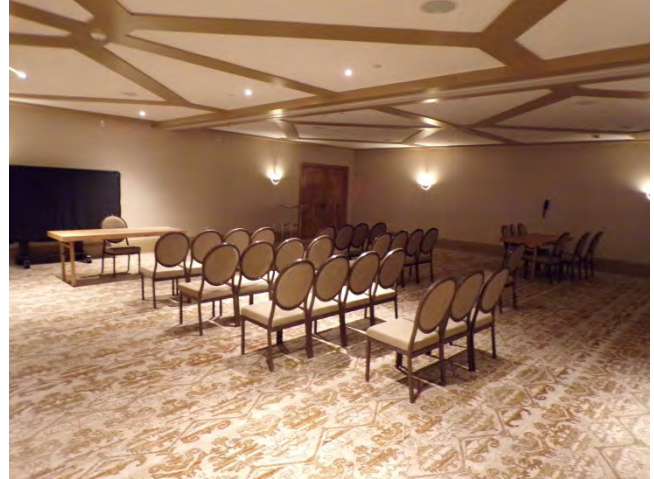
26. Main Bldg: Interior finishes and fixtures in conference room.

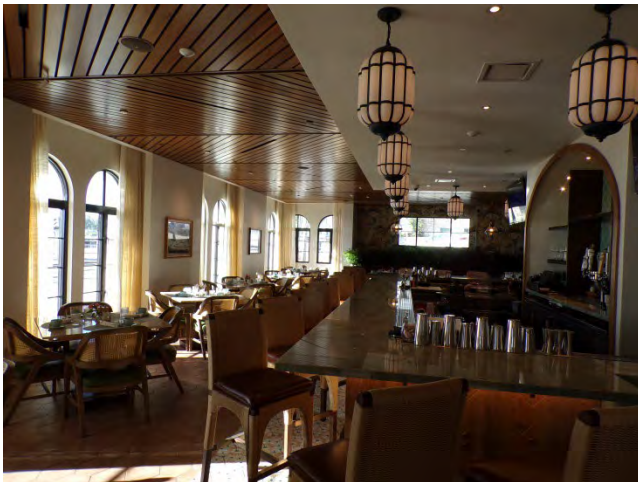
27. Main Bldg: Interior finishes and fixtures in first floor restaurant.

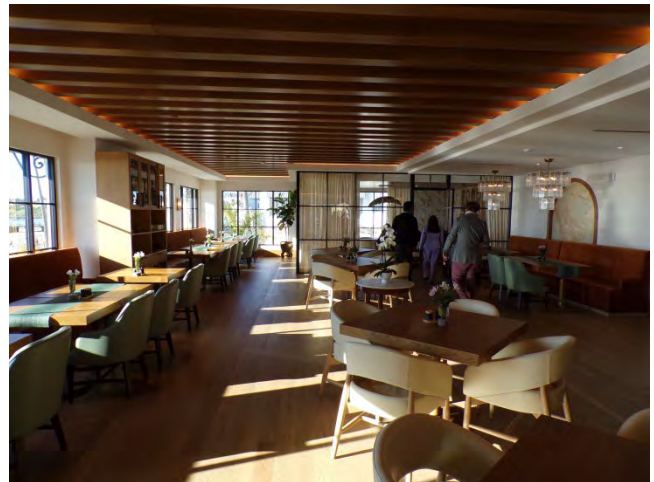
28. Main Bldg: Interior finishes and fixtures in second floor restaurant.

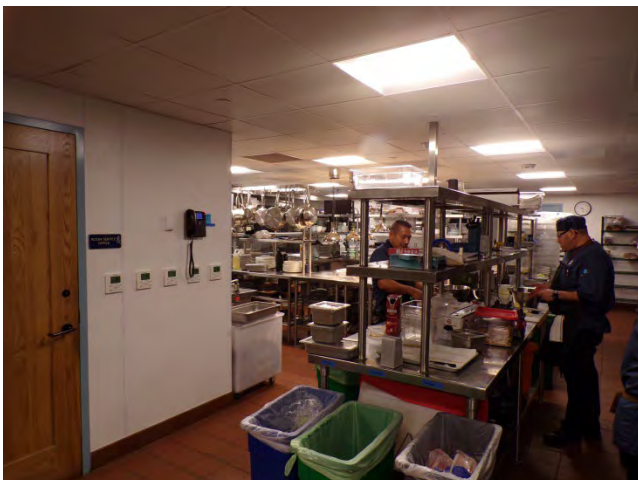
29. Main Bldg: Interior finishes and fixtures in kitchens.

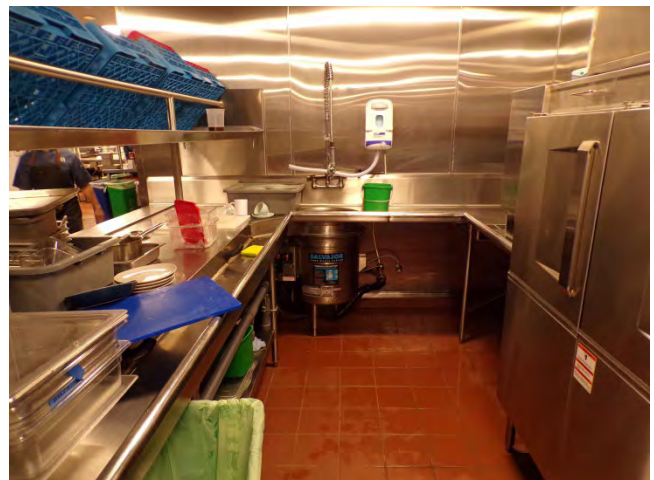
30. Main Bldg: Interior finishes and fixtures in kitchens.

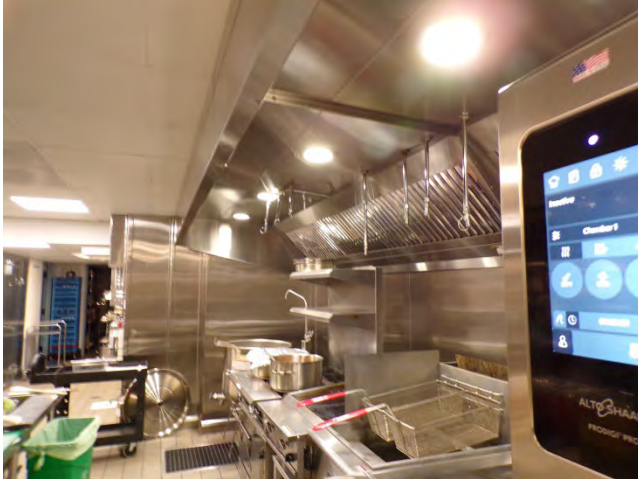
31. Main Bldg: Interior finishes and fixtures in kitchens. ANSUL fire suppression systems are installed above cooktops.

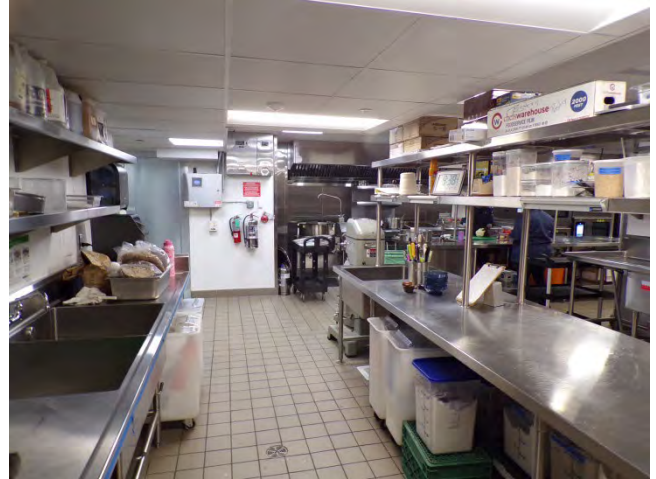
32. Main Bldg: Interior finishes and fixtures in kitchens.

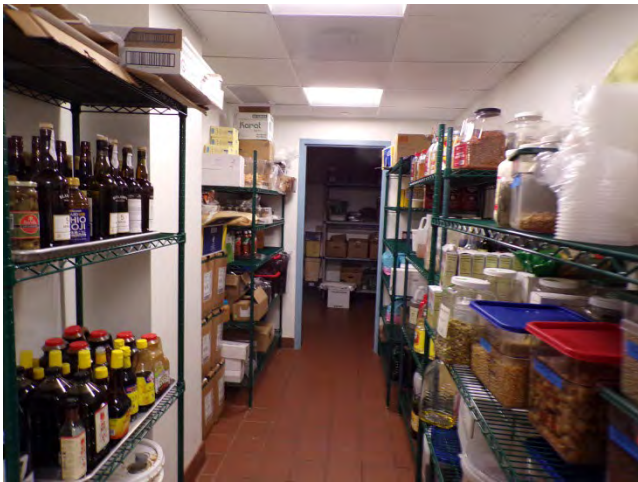
33. Main Bldg: Interior finishes and fixtures in kitchens.

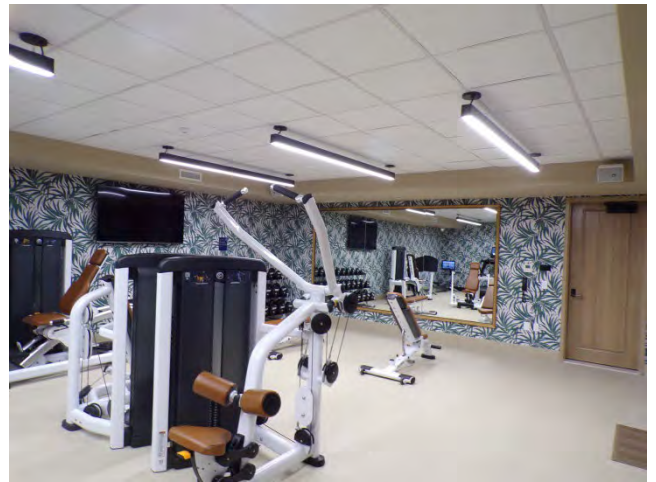
34. Main Bldg: Equipment and interior finishes and fixtures in fitness room.

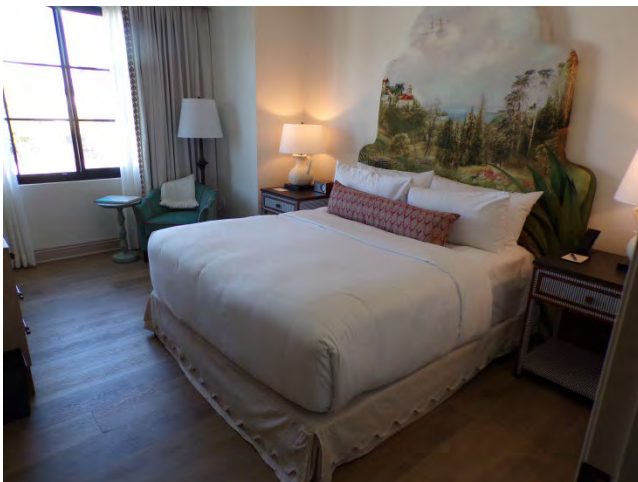
35. Main Bldg: Interior finishes and fixtures in guestrooms.

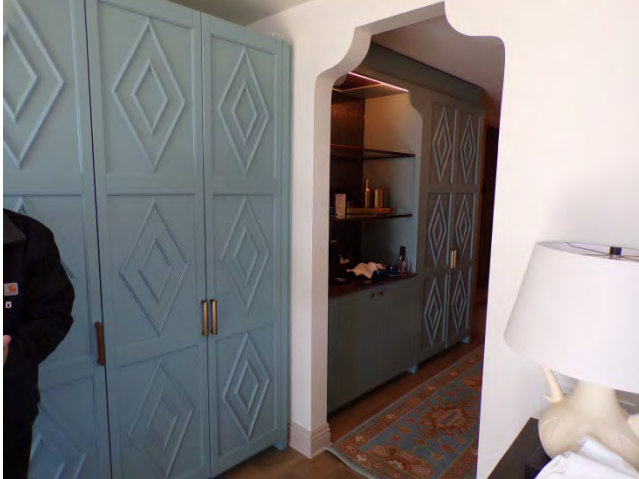
36. Main Bldg: Interior finishes and fixtures in guestrooms.

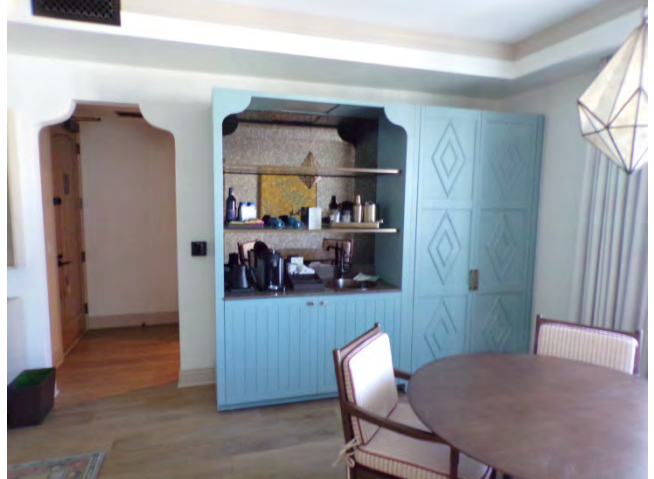
37. Main Bldg: Interior finishes and fixtures in guestrooms.

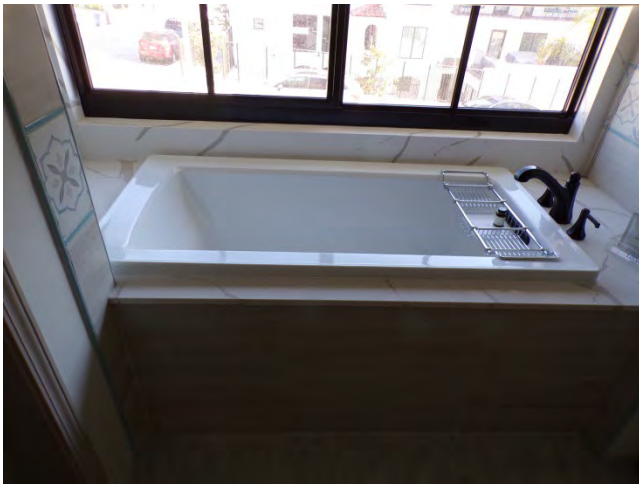
38. Main Bldg: Interior finishes and fixtures in guestrooms.

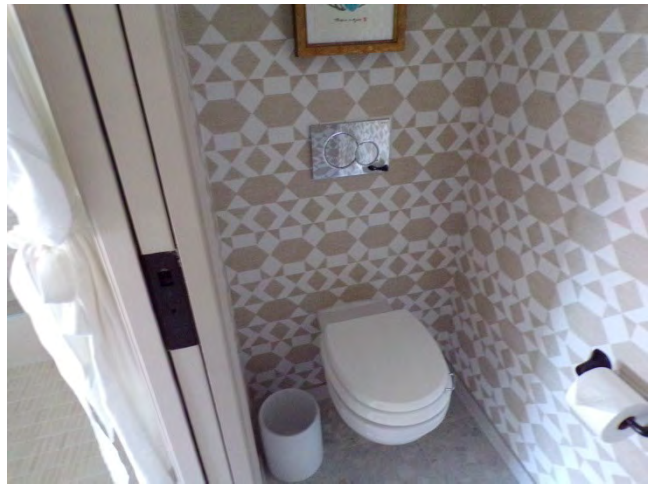
39. Main Bldg: Interior finishes and fixtures in guestroom bathrooms.

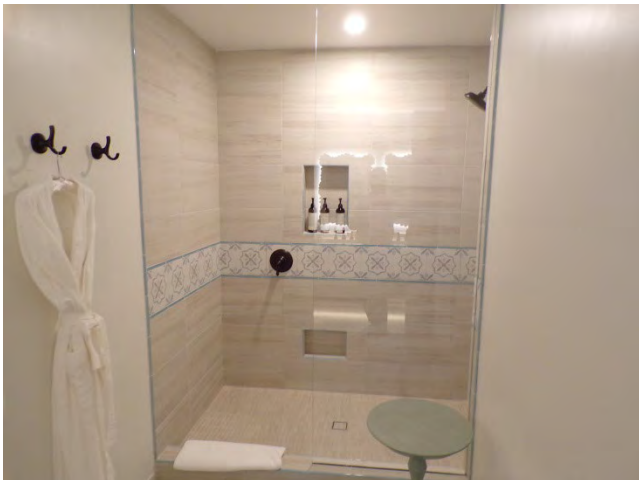
40. Main Bldg: Interior finishes and fixtures in guestroom bathrooms.

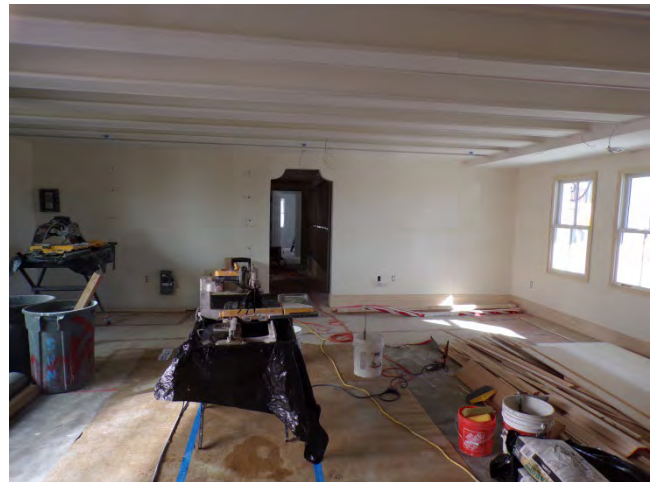
45. Tower Bldg: Interior finishes and fixtures. Construction was underway at the time of our site visit.

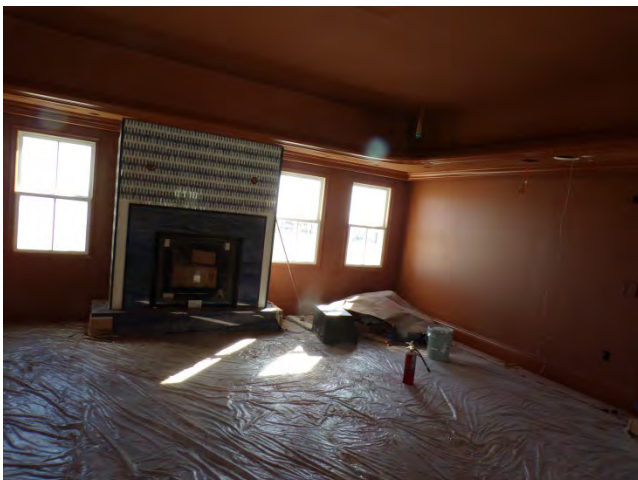
46. Tower Bldg: Interior finishes and fixtures.

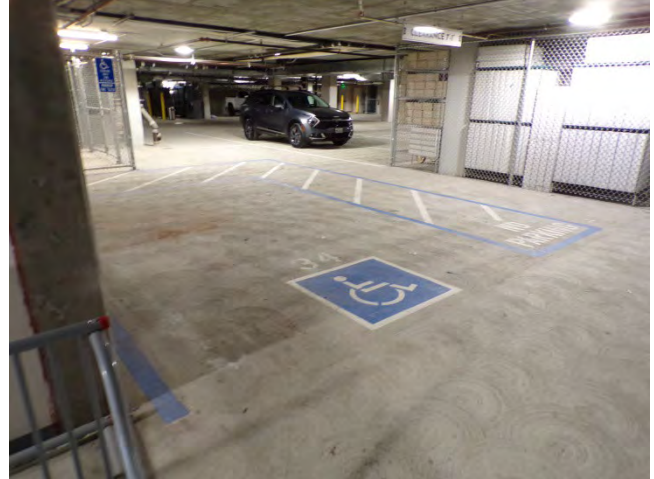
49. Main Bldg: The parking garage is located on the basement level (shown) and on the first and second floors.

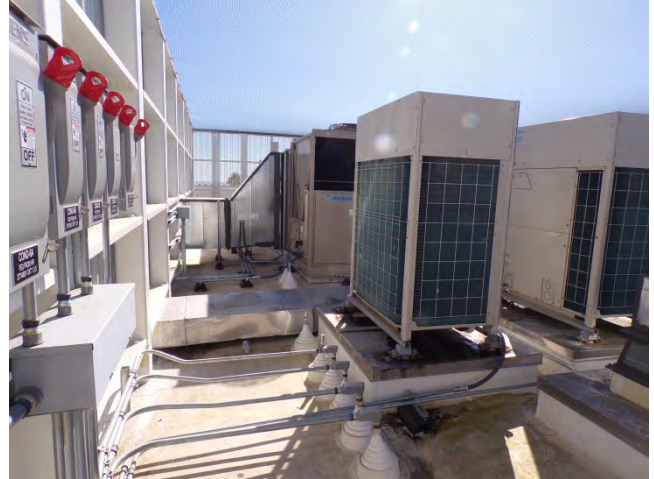
55. Main Bldg: *Daikin* split-system heat pumps.

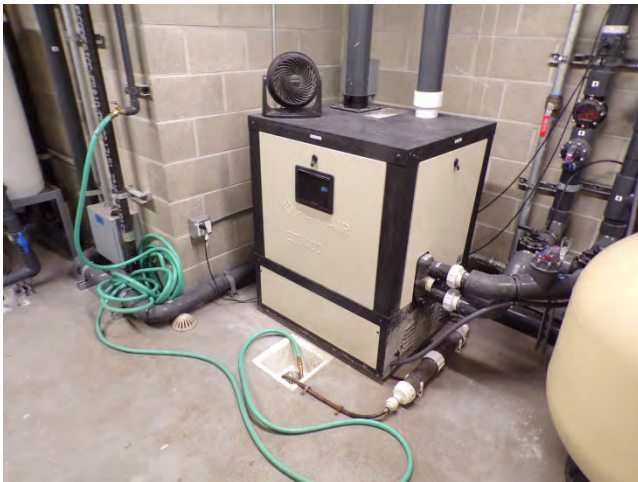
68. Main Bldg: The pool equipment is located in a dedicated service room.

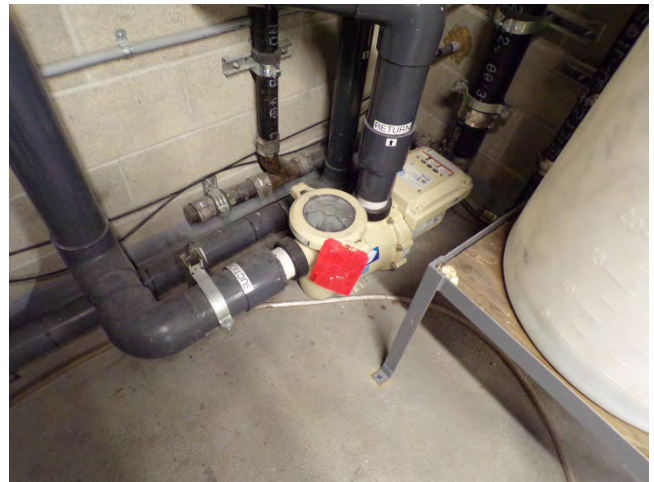
69. Main Bldg: Two *Pentair* ETi 400 natural gas-fired pool heaters are provided as are filtering equipment and two pumps. One pool water heater serves the swimming pool; the other serves the spa pool.

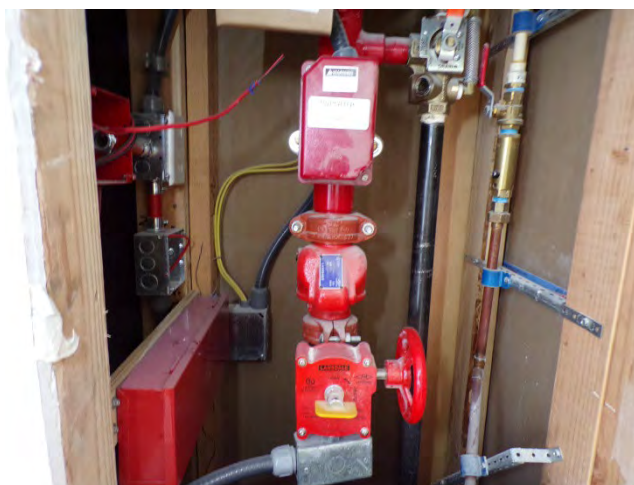
75. Main Bldg: Sprinkler riser.

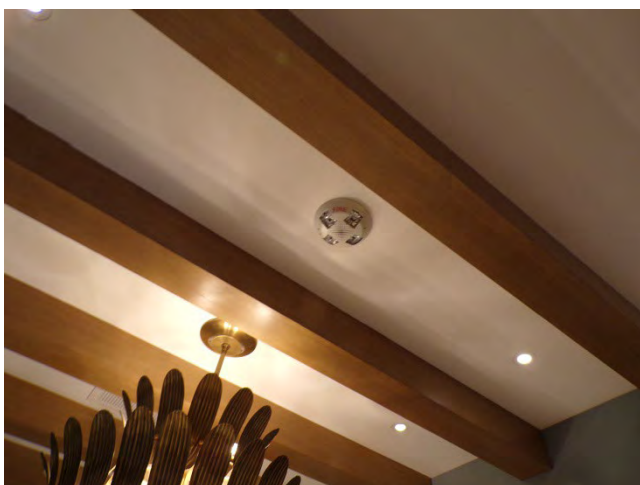
77. Horn/strobe alarm device placements appeared compliant with current Accessibility codes.

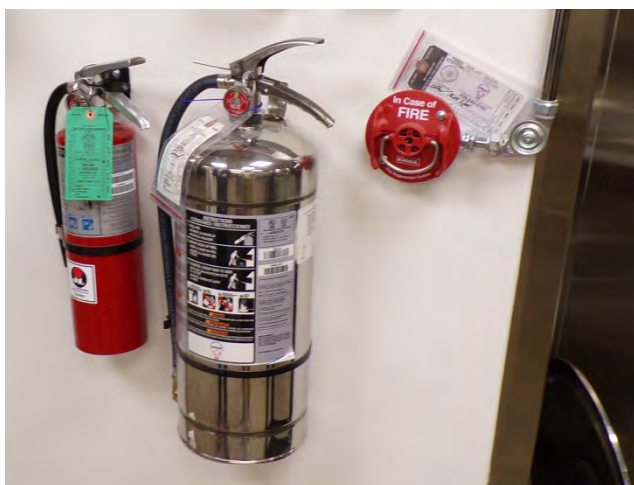
78. Manual pull stations were observed in a few locations. The silver fire extinguisher is a 10 lb. Class K-type, which are provided in the kitchens.

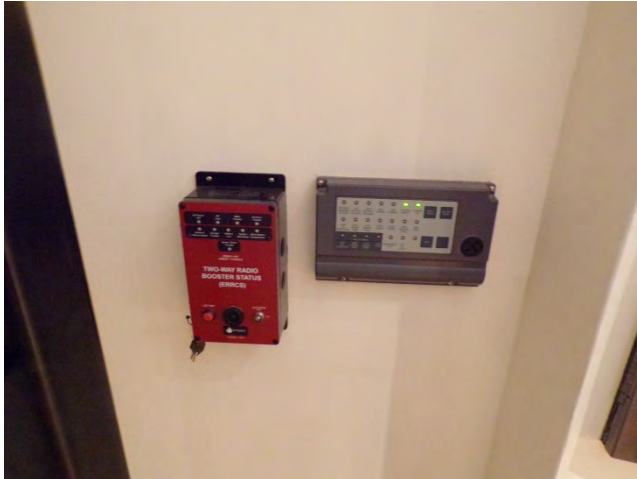
79. An ERRCS system is installed.

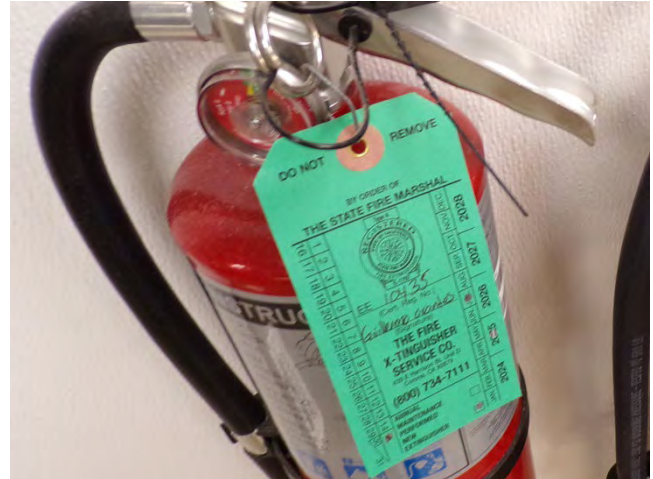
80. Five lb. ABC-type dry chemical fire extinguishers are installed throughout. All observed fire extinguishers had current inspection tags.

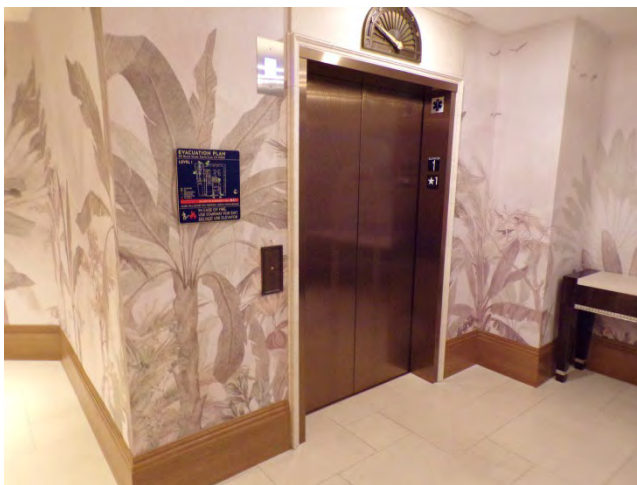
81. Main Bldg: Three Otis passenger elevators are installed.

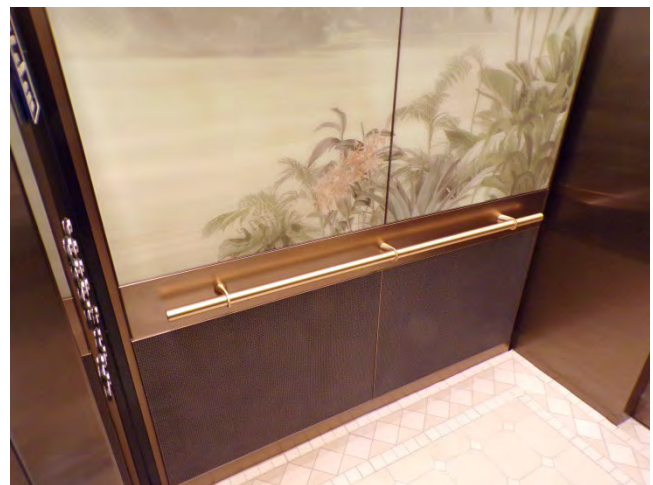
82. Main Bldg: Interior finishes and handrail in passenger elevators.

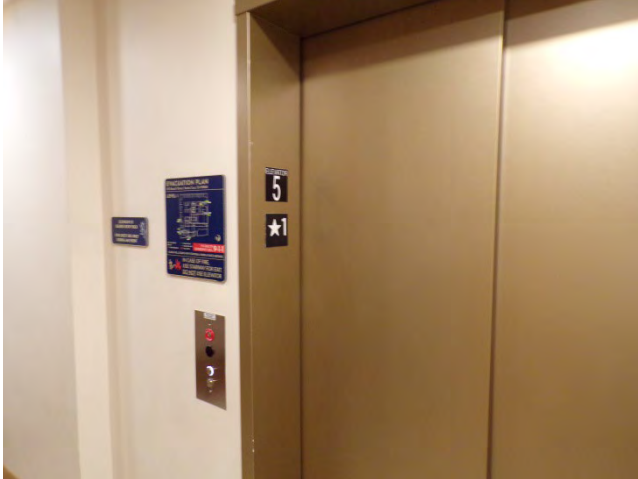
85. Main Bldg: Two Otis freight elevators are installed.

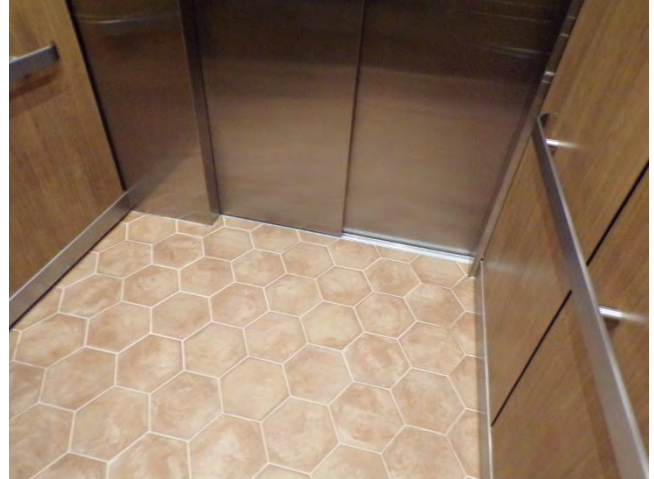
86. Main Bldg: Interior finishes and handrails in freight elevators.

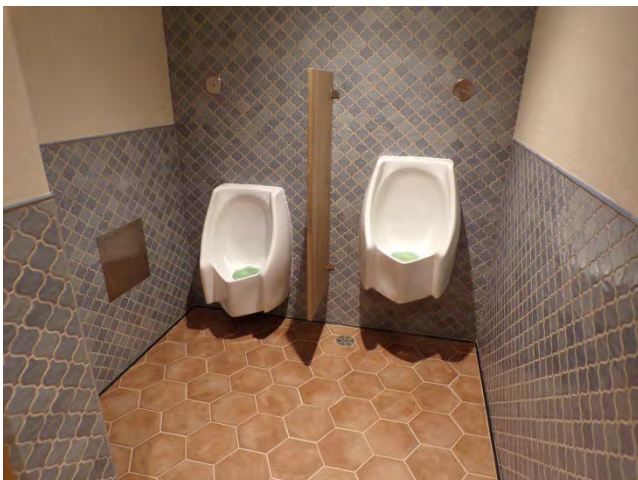
89. Main Bldg: Interior finishes and fixtures in restrooms. Waterless urinal are installed.

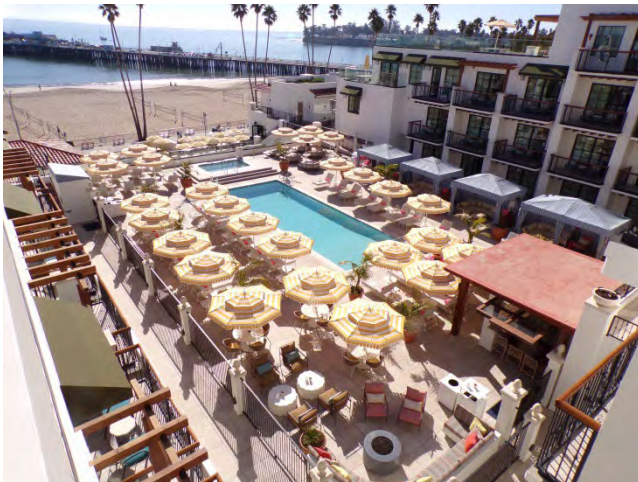
93. Main Bldg: The swimming pool is at third floor level.

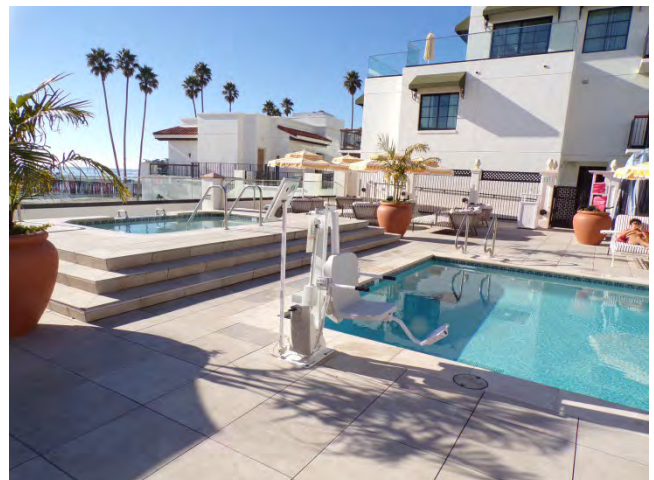
96. Main Bldg: An anchored pool chair lift is installed near the swimming pool. The portable lift was not observed.

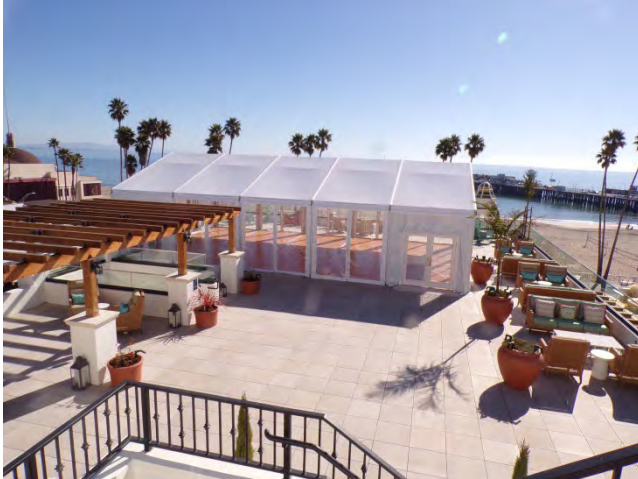
97. Main Bldg: The tent structure is a temporary installation, only used in cold weather months.

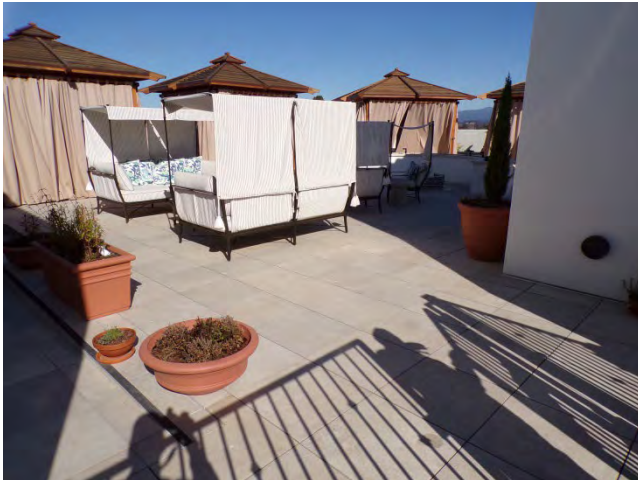
99. Main Bldg: Cabanás and outdoor seating for the spa area are provided on a roof terrace at sixth floor level.

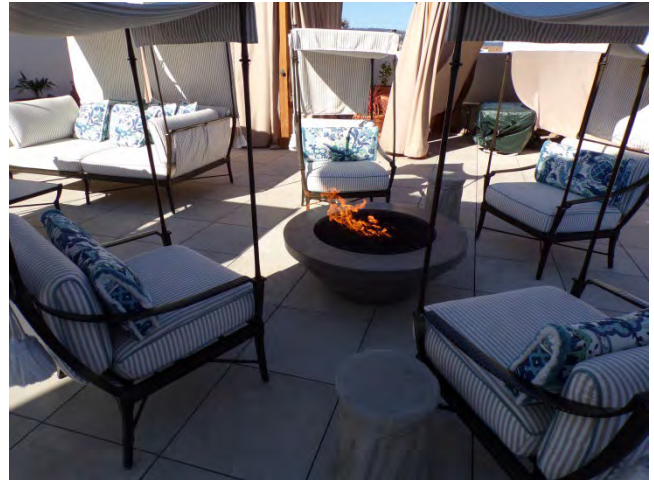
100. Main Bldg: A fire pit is installed near the cabanás.
