## PROPERTY CONDITION ASSESSMENT

**Sonoma Country Day School, 4400 Day School Place  
Santa Rosa, CA 95403**

**ALLWEST PROJECT 22088.60  
November 9, 2022**

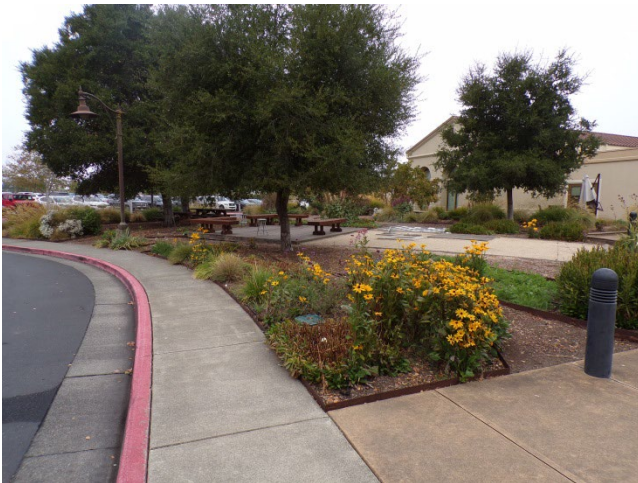
9. Main Bldg: Portion of south elevation at southwest corner of building. Landscaping at the property is attractive and well maintained.

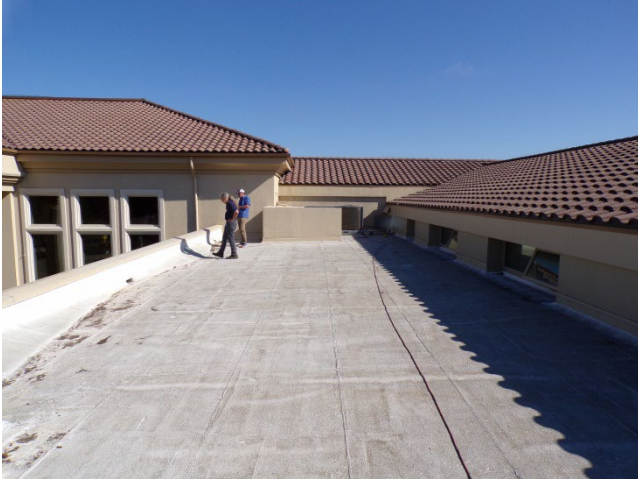
37. Main Bldg: Southeast wing BUR roof. This is the only BUR roofing system remaining on Main Bldg. Concrete barrel tiles shown on adjacent pitched roof areas.

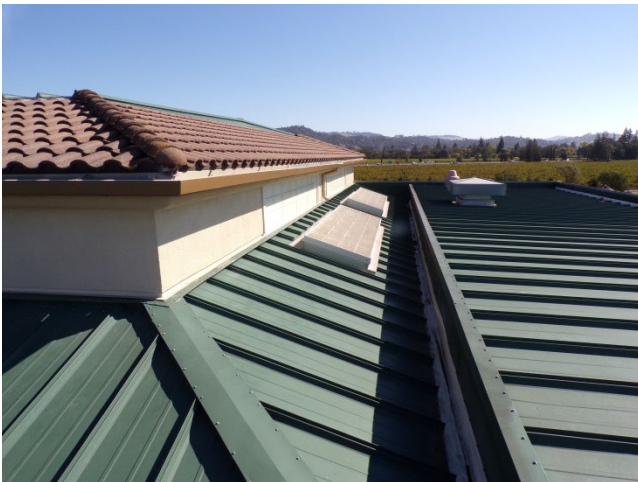
39. Gym: Standing seam metal roof with raised basketball court roof to left, looking south. Clerestory windows with translucent fiberglass panels shown.

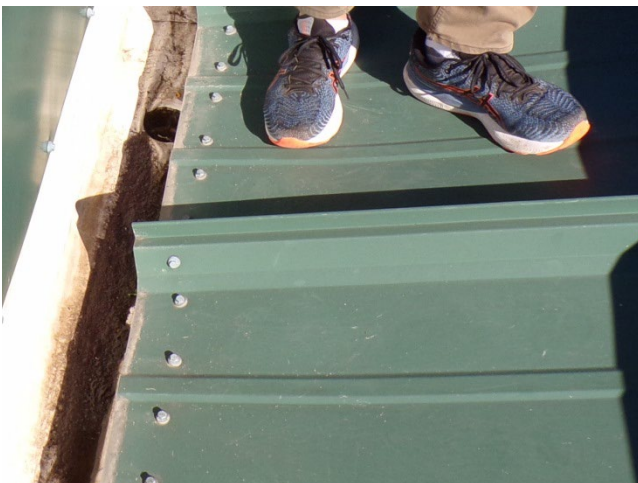
41. Gym standing seam metal roof showing TPO lined interior gutter, at left.

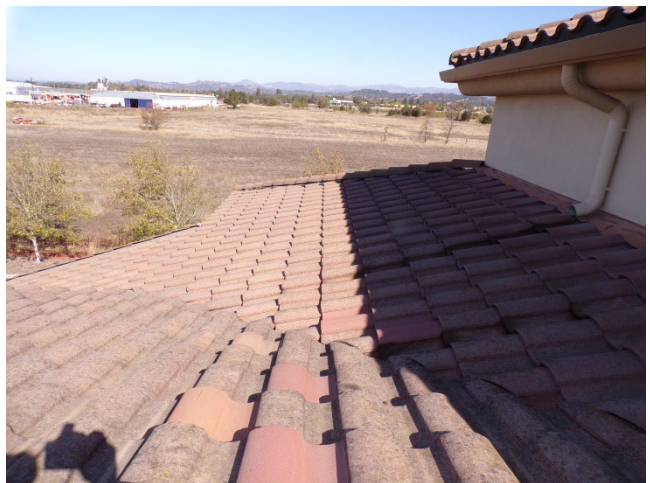
42. Gym: Concrete barrel tile roofing systems.

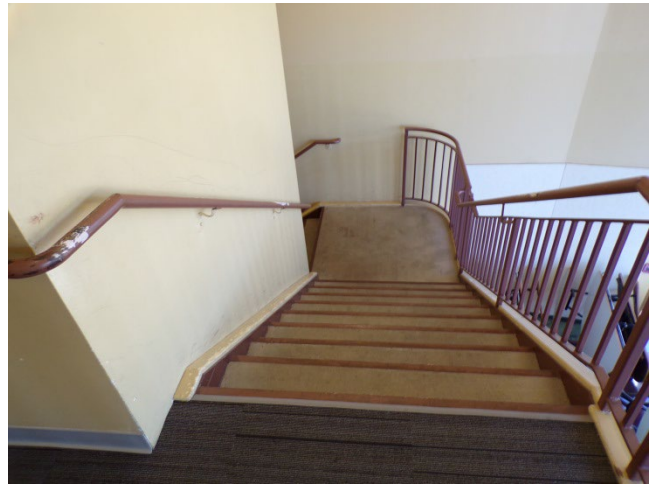
58. Gym: Entrance lobby unenclosed staircase. Minor damage to some paint finishes shown.

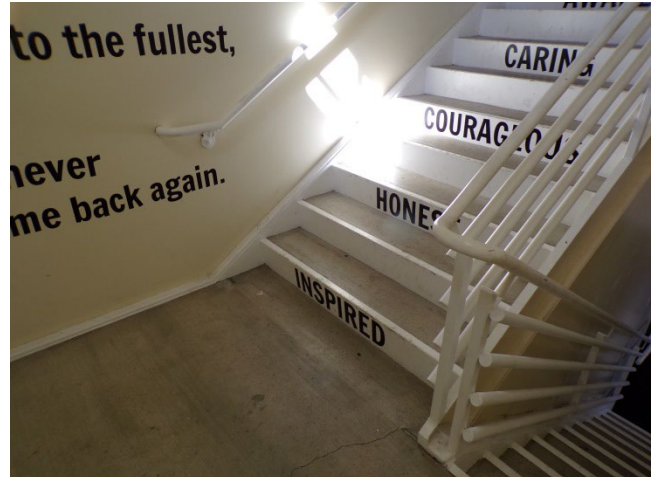
62. Gym: Stairs lack compliant visually contrasting striping at top and bottom treads.

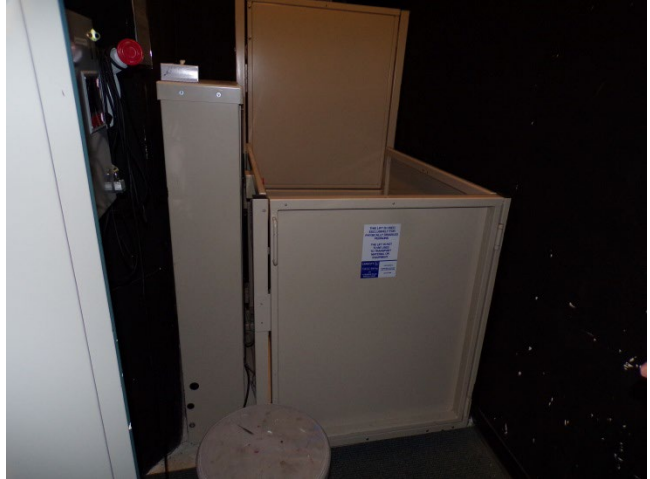
68. Main Bldg: Stage lift at auditorium provides access from seating area level to stage level.

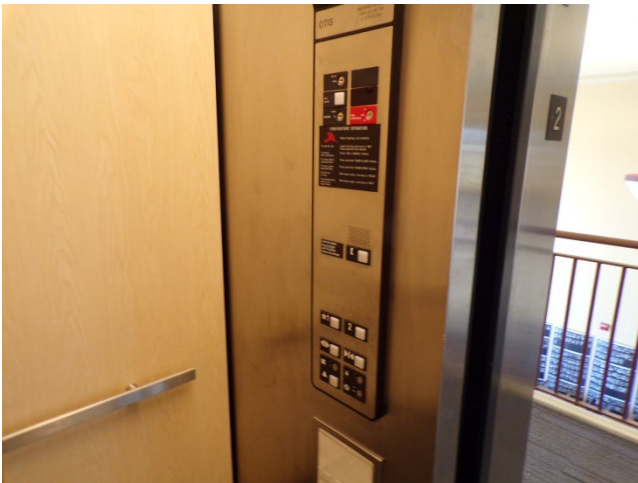
69. Gym: The elevator generally appears to meet Accessibility requirements.

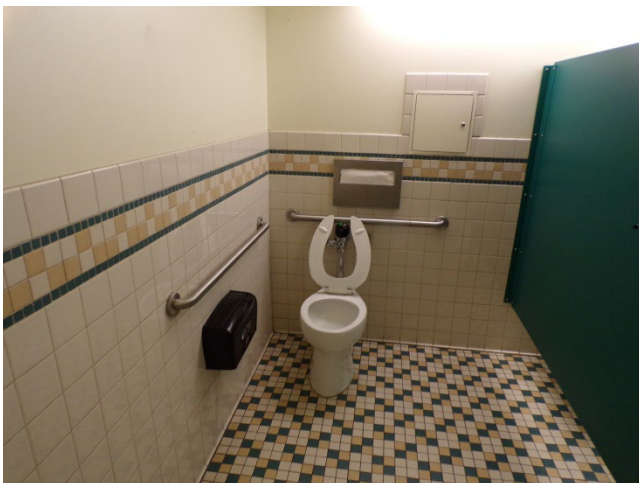
71. Accessible toilet stalls generally meets code requirements; Main Bldg restroom shown.

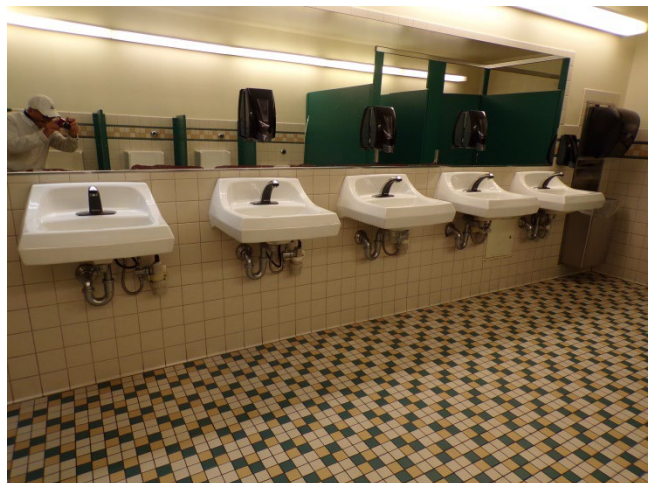
72. Typical sink and accessories generally meet Accessibility requirements, though many sinks lack drain pipe insulation; Main Bldg restroom shown.

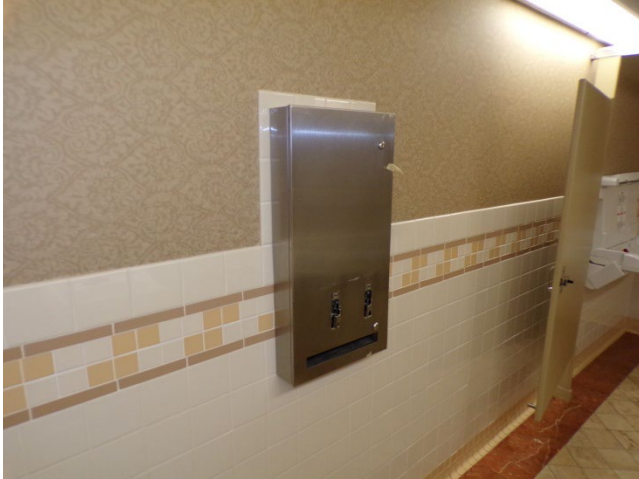
73. Main Bldg. The sanitary napkin dispenser in the adult women's restroom is not Accessibility compliant.

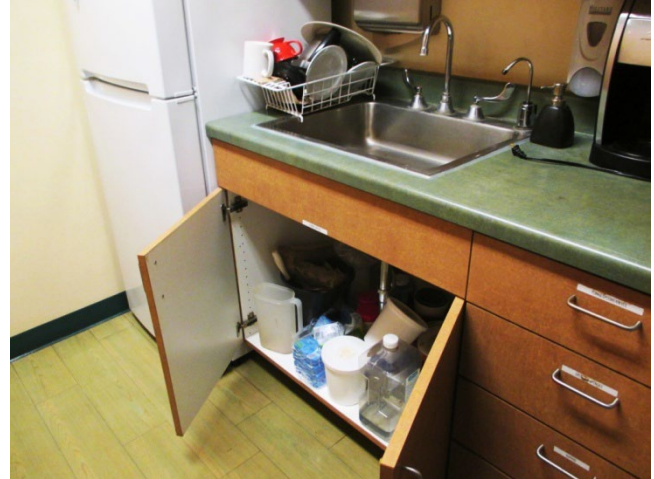
74. Main Bldg: Service sinks at several locations are inaccessible to a wheelchair occupant. Administarion area break room shown.

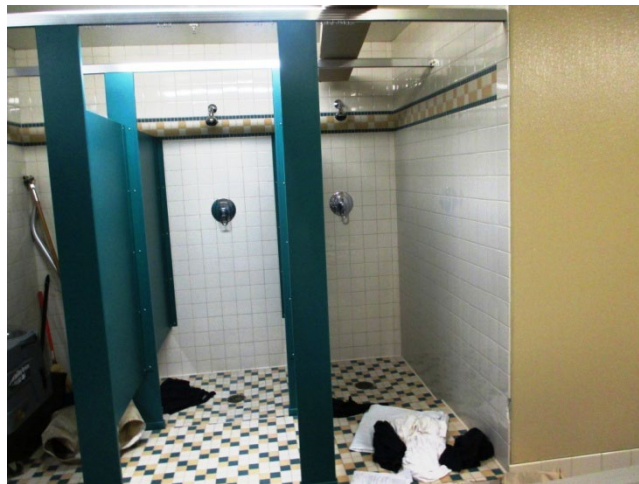
75. Gym showers do not meet Accessibility requirements.

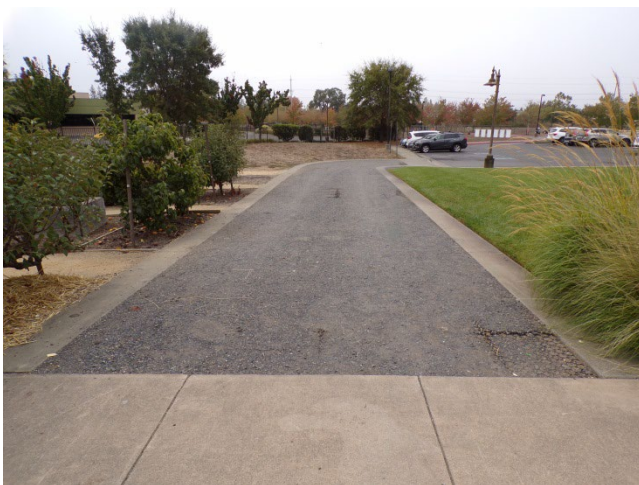
77. The short drive near the southeast corner of he Main Bldg requires gravel replenishment.

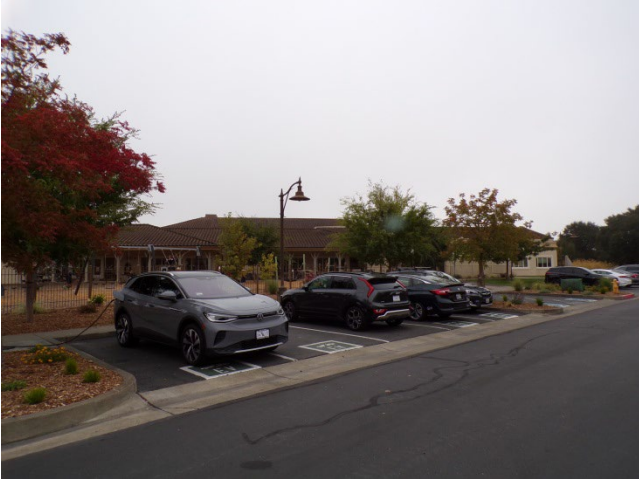
79. Four EV charging stalls are provided on the west side of the Main Bldg.

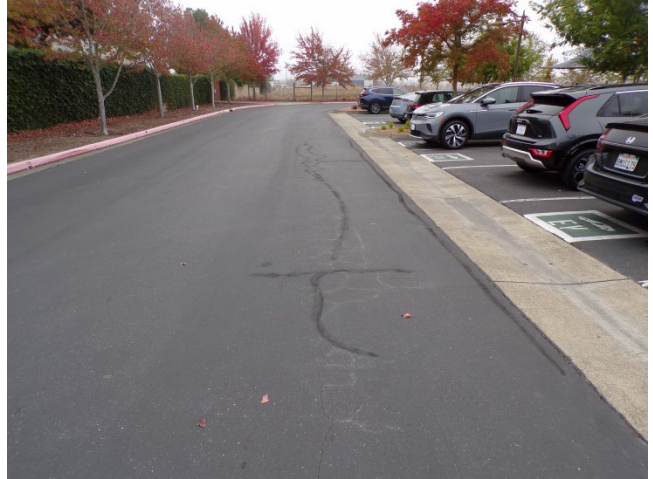
80. Minor repairs to asphalt paving can be anticipated during the reserve term.

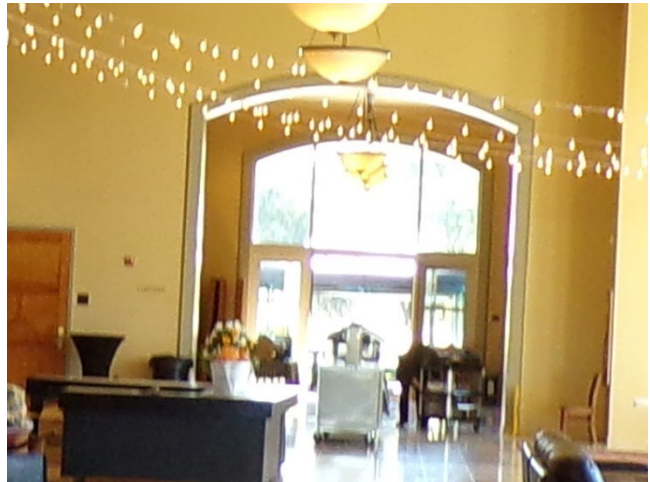
93. Main Bldg: West gallery of main entrance area.
