## PROPERTY CONDITION ASSESSMENT

**Our Lady of Loretto Church & School, 1806 Novato Boulevard  
Novato, CA 94947**

**ALLWEST PROJECT 23017.60  
February 27, 2023**

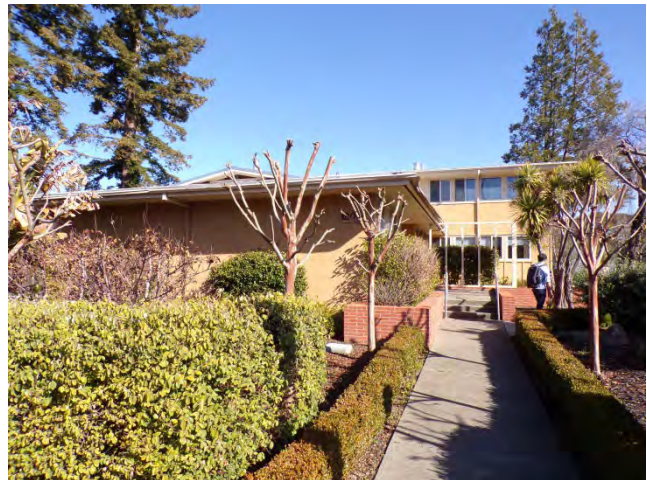
4. Rectory: South elevation.

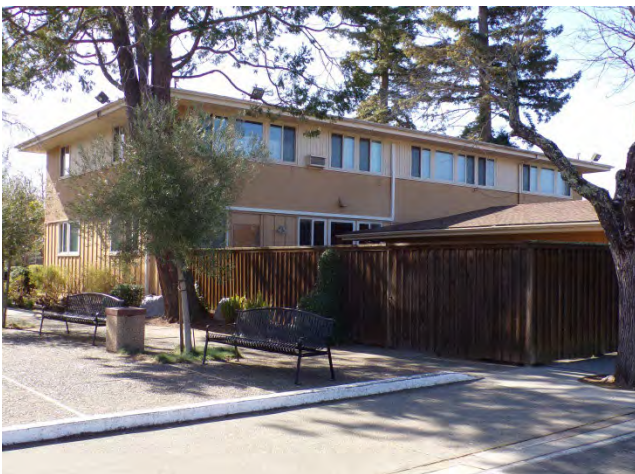
5. Rectory: Portion of west elevation at center; north elevation at far left. The roof of the Garage is at right.

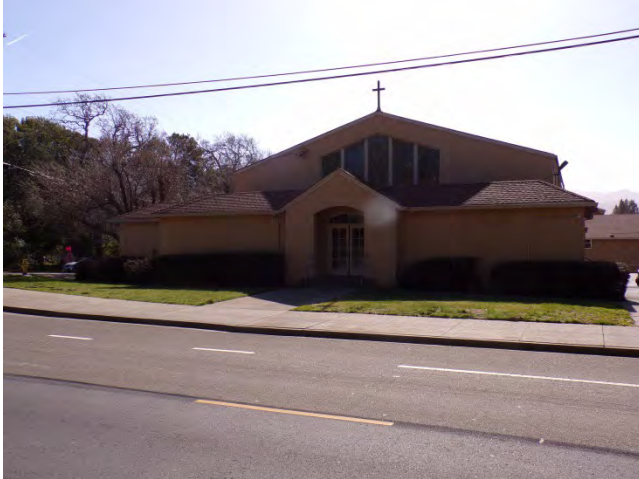
7. Hall Bldg: North elevation along Virginia Avenue.

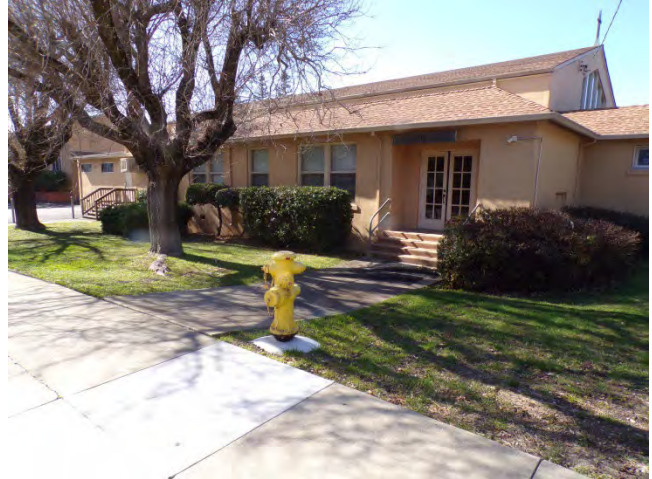
8. Hall Bldg: East elevation along Grant Avenue.

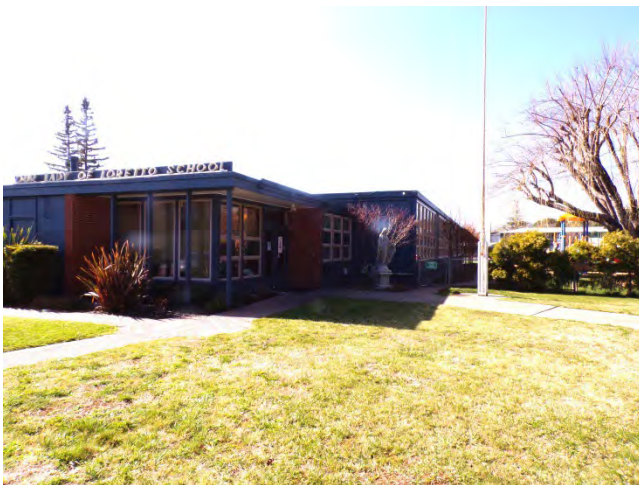
9. School: Primary entrance at center of photo. North elevation at right-center.

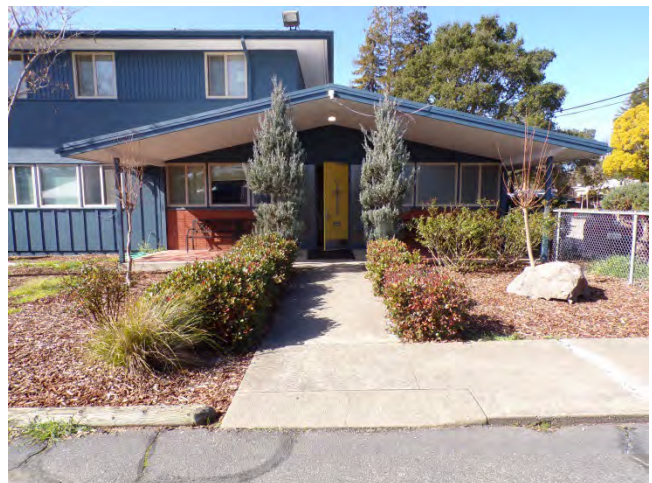
12. Convent: The primary entrance is on the east elevation.

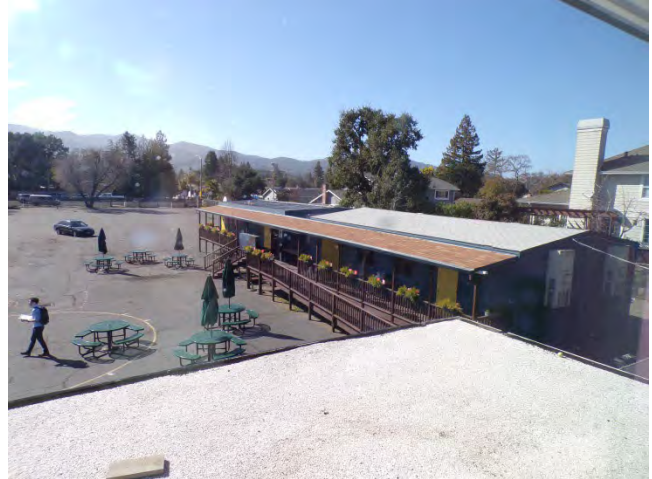
14. Mod Bldg N has an asphalt composite roofing system. Mod Bldg S has a ribbed steel panel roofing system.

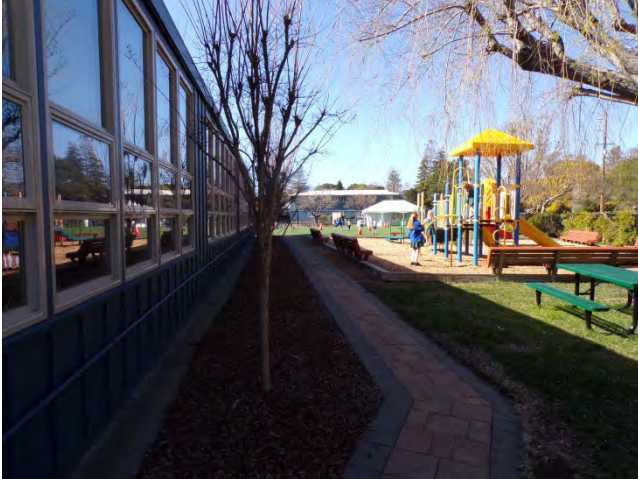
25. Playground equipment is installed along the north elevation of the School.

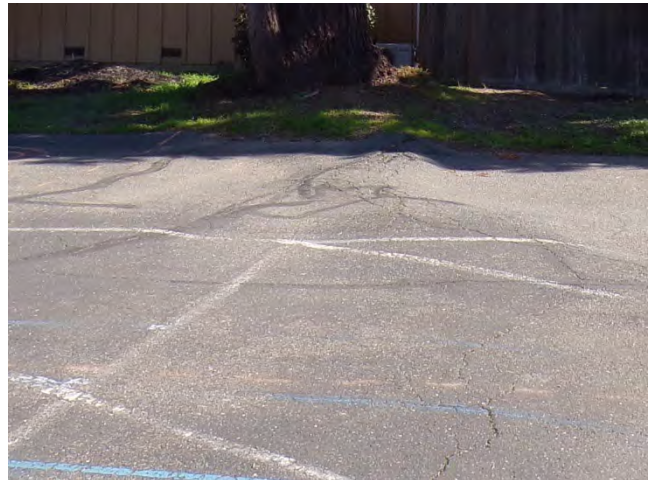
30. Upheavals and depressions in asphalt paving.

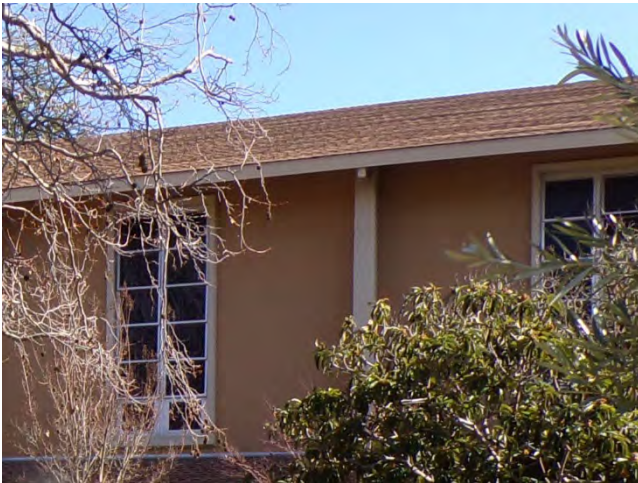
33. Church: An asphalt composite roofing system is installed.

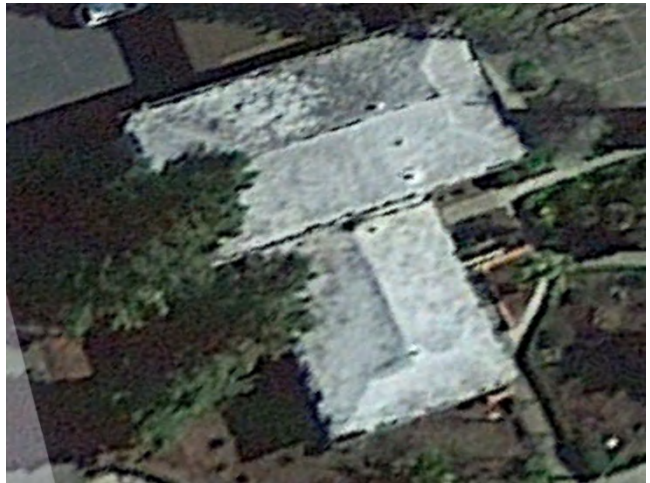
34. Rectory: A modified bitumen roofing system with white gravel ballast is installed.

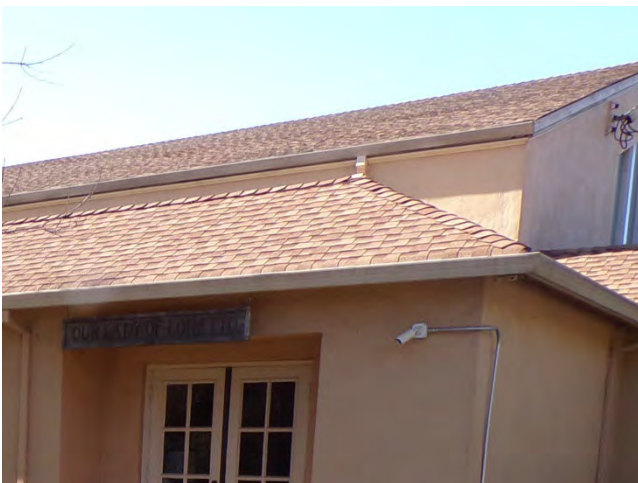
35. Hall Bldg: An asphalt composite roofing system is installed.

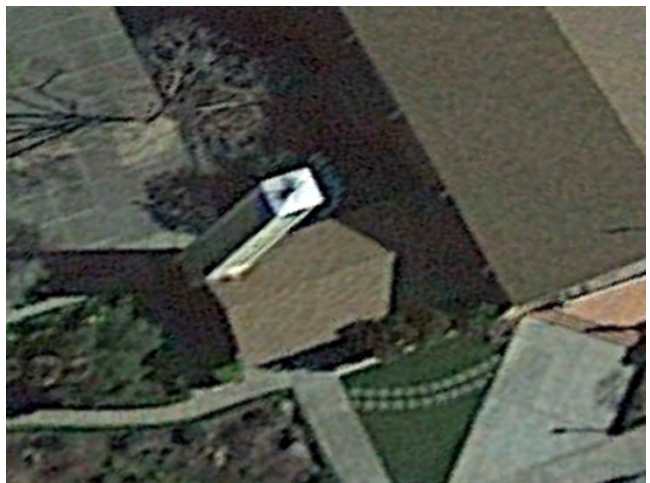
36. Bell Tower: The roofing system was not visible from grade. An unknown type of roofing system is installed.

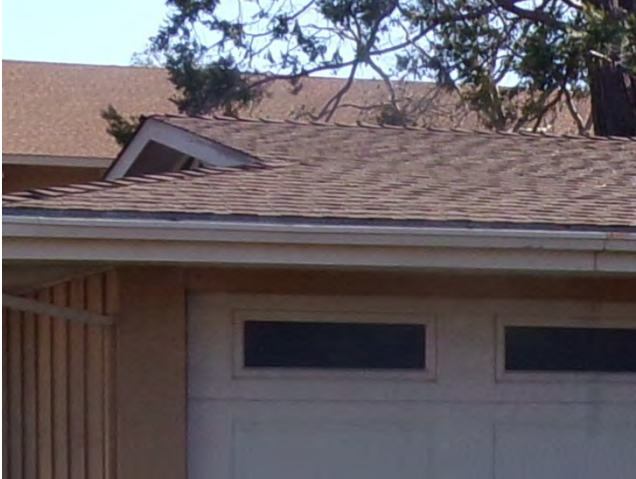
37. Garage: An asphalt composite roofing system is installed.

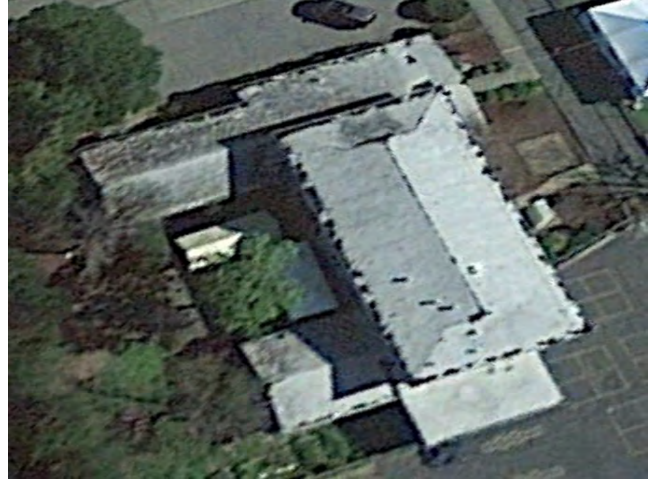
38. Convent: A modified bitumen roofing system with white gravel ballast is installed.

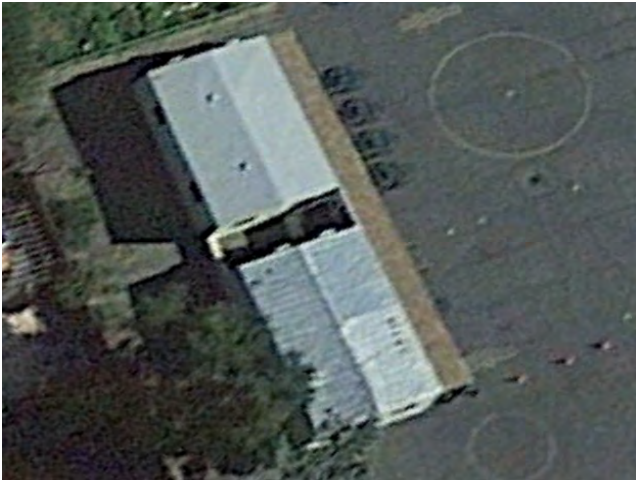
39. Mod Bldg N (at top) has an asphalt composite roofing system. Mod Bldg S (at bottom) has a ribbed steel panel roofing system.

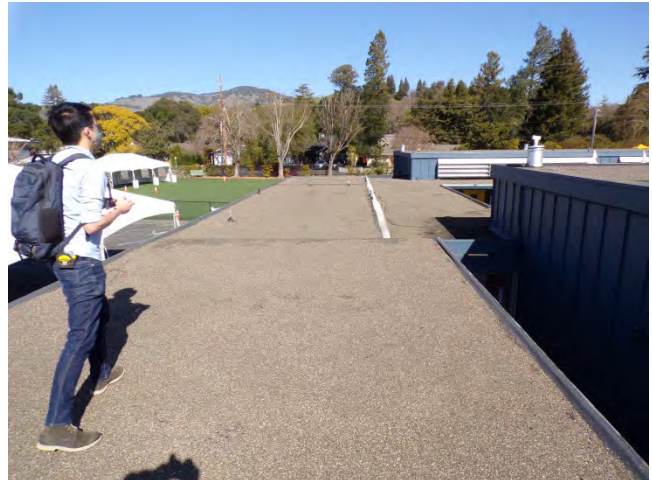
40. School: A modified bitumen roofing system with pea gravel ballast is installed.

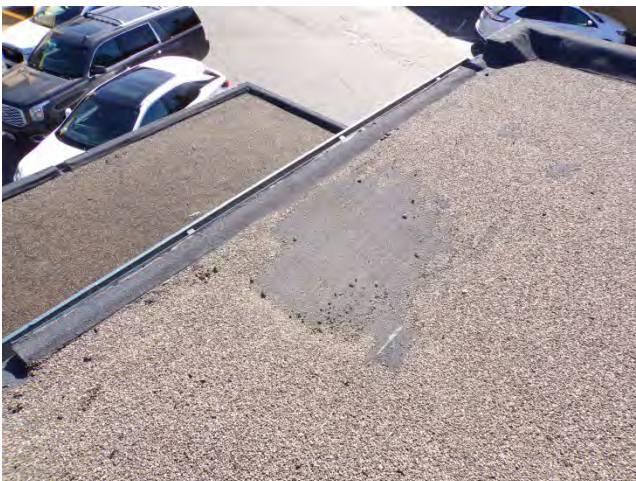
41. School: A modified bitumen roofing system with pea gravel ballast is installed. Area where ballast is absent shown.

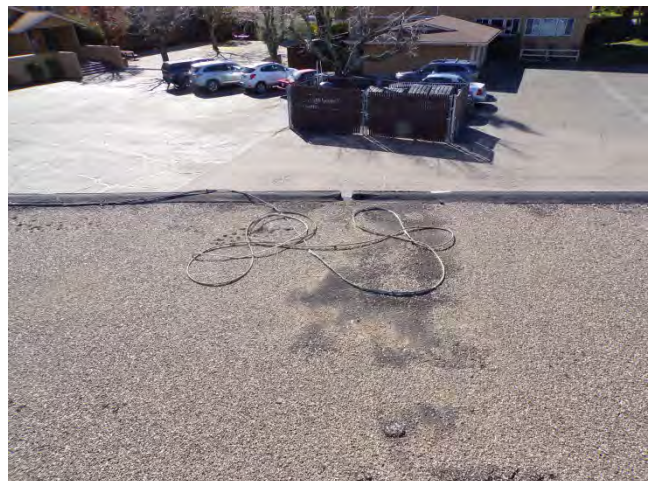
42. School: A modified bitumen roofing system with pea gravel ballast is installed. Area where ballast is absent shown.

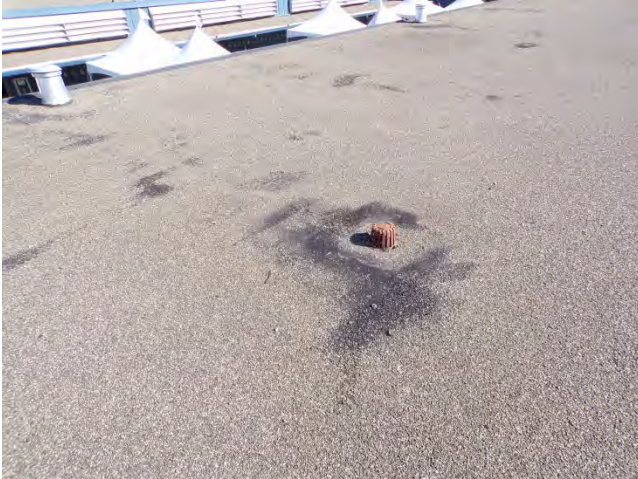
43. School: Atrium grated roof drains are installed.

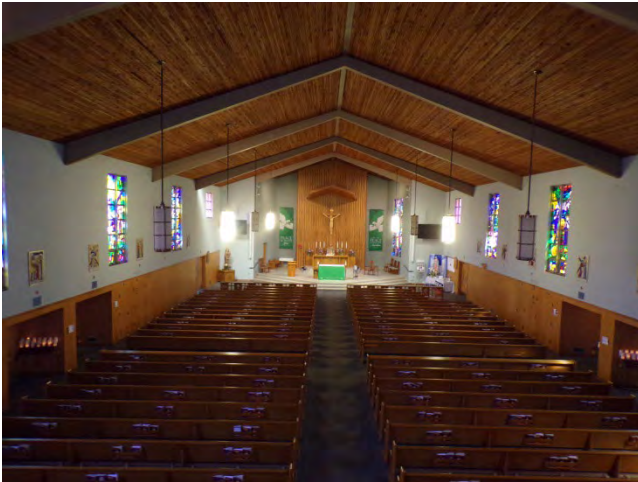
45. Church: Interior finishes and fixtures in nave (foreground) and chancel (background).

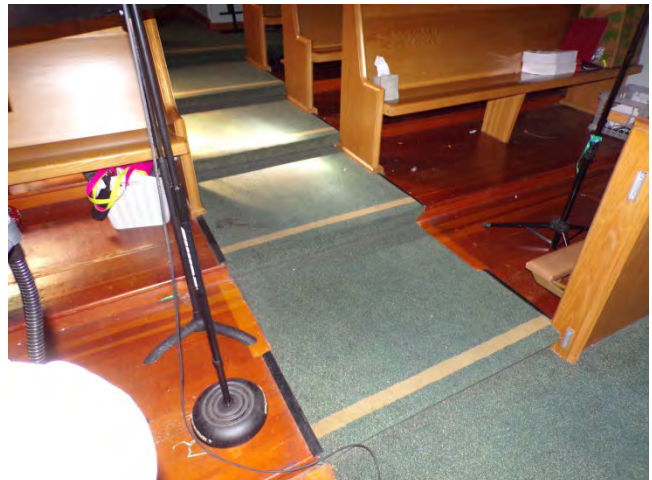
48. Church: Interior finishes and fixtures in choir loft

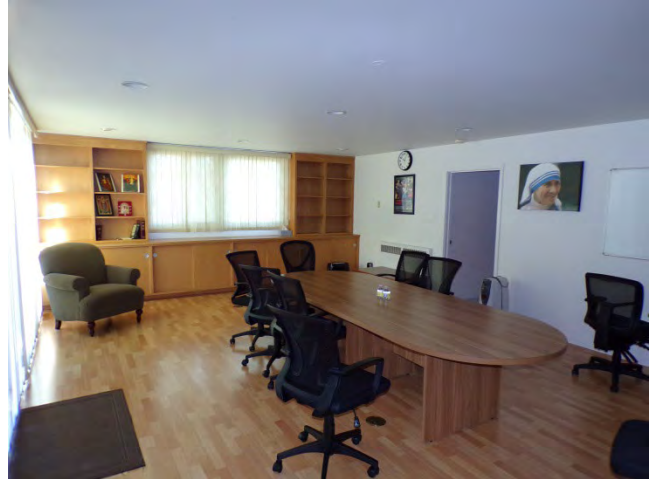
50. Rectory: Interior finishes and fixtures in conference room.

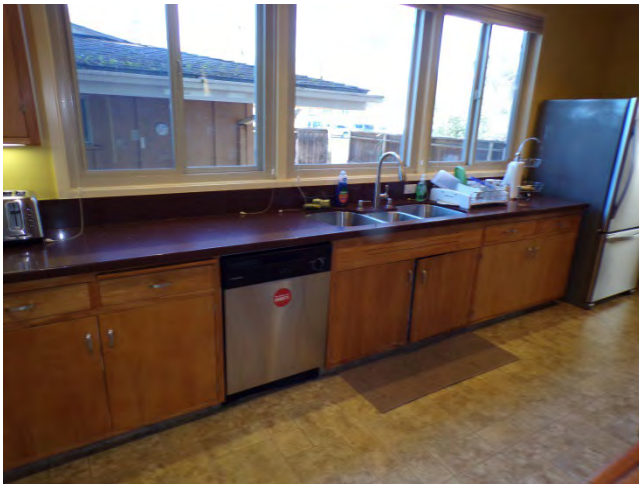
51. Rectory: Interior finishes and fixtures in kitchen

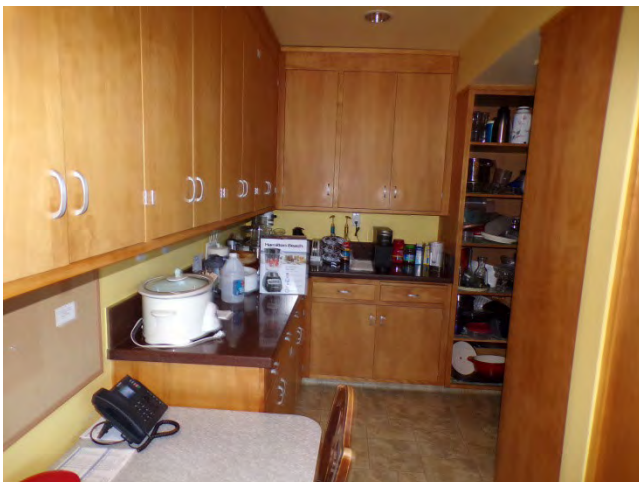
53. Rectory: Interior finishes and fixtures in break room.

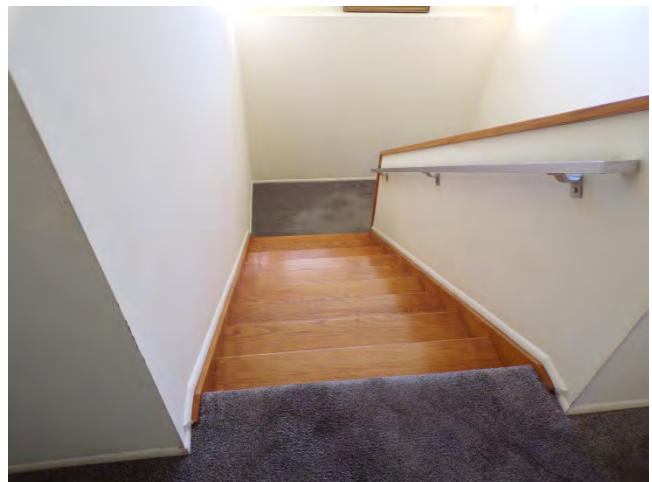
54. Rectory: Two sets of interior stairs are provided. Stairs lack compliant visually contrasting striping at top and bottom treads. Non-compliant handrails are installed.

AllWest recommends that remedial measures be taken to address the deficiencies for Accessibility in each of the bullet items listed above.

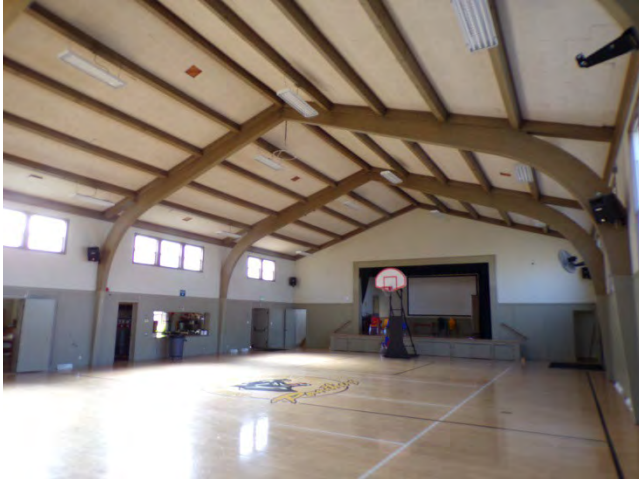
55. Hall Bldg: Interior finishes and fixtures in basketball court.

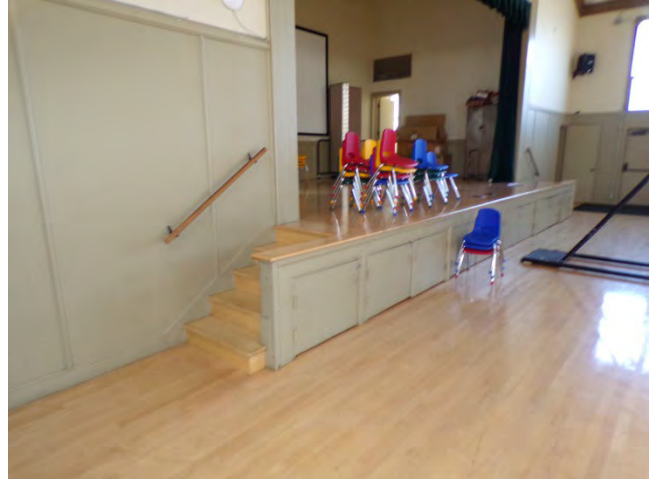
56. Hall Bldg: Interior finishes and fixtures at stage area.

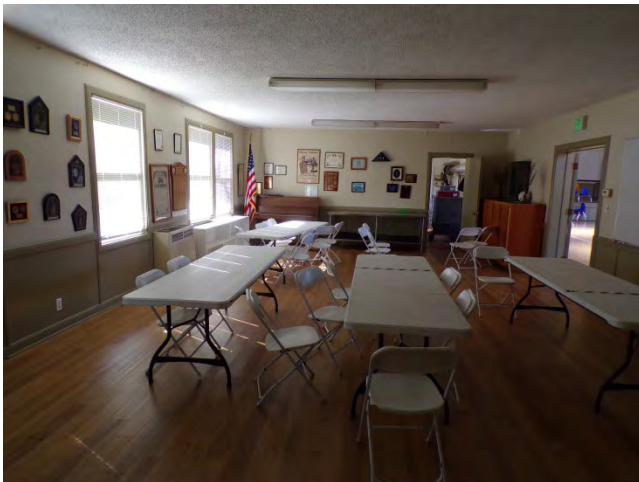
57. Hall Bldg: Interior finishes and fixtures in meeting room.

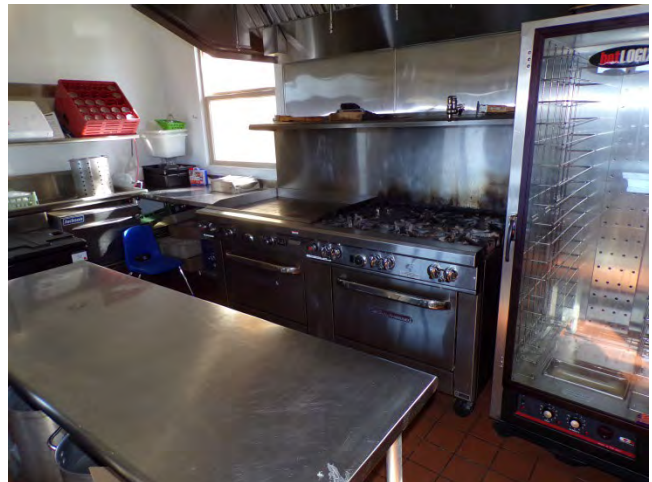
58. Hall Bldg: Interior finishes and fixtures in kitchen.

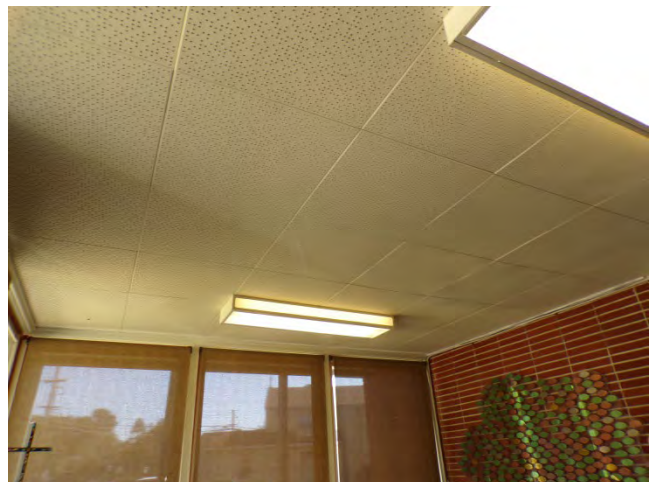
60. School: Interior finishes and fixtures in office area. Adhesive-applied acoustic ceiling tiles shown.

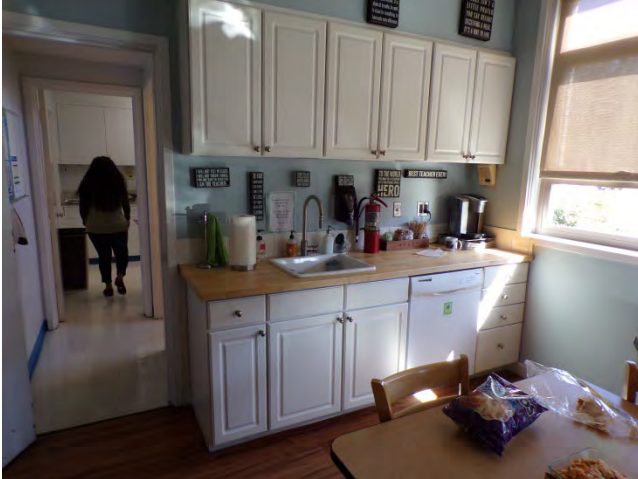
61. School: Interior finishes and fixtures in breakroom of office area.

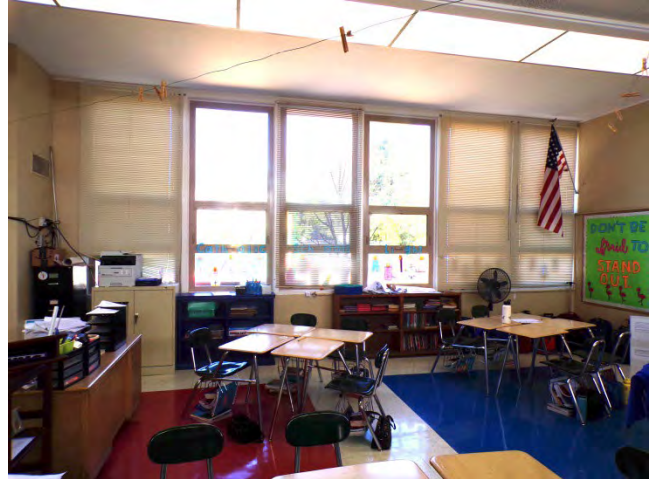
62. School: Interior finishes and fixtures in classrooms.

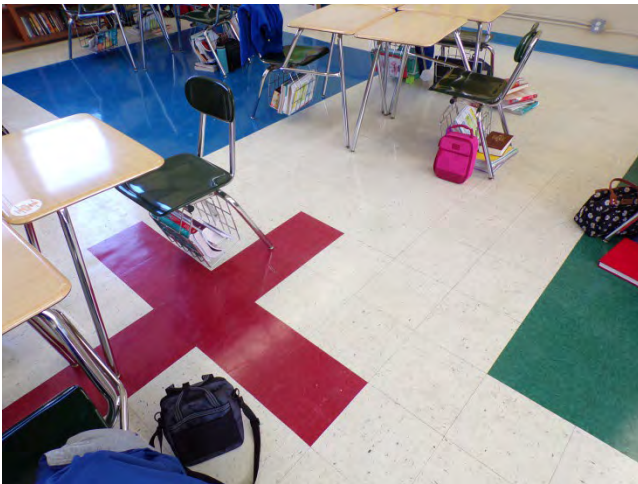
63. School: Interior finishes and fixtures in classrooms.

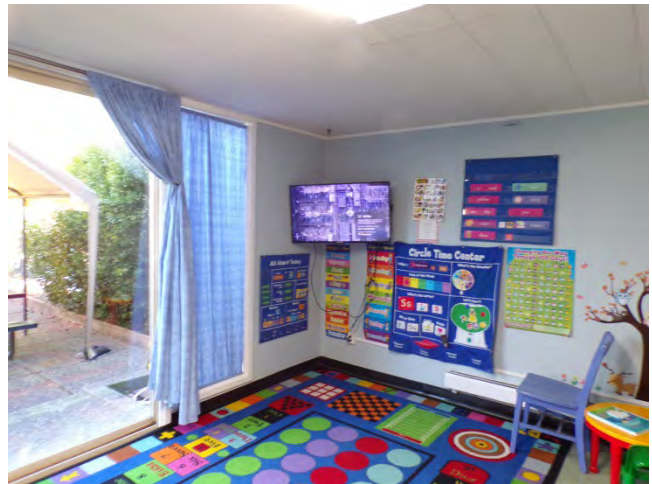
64. Convent: Interior finishes and fixtures in classrooms.

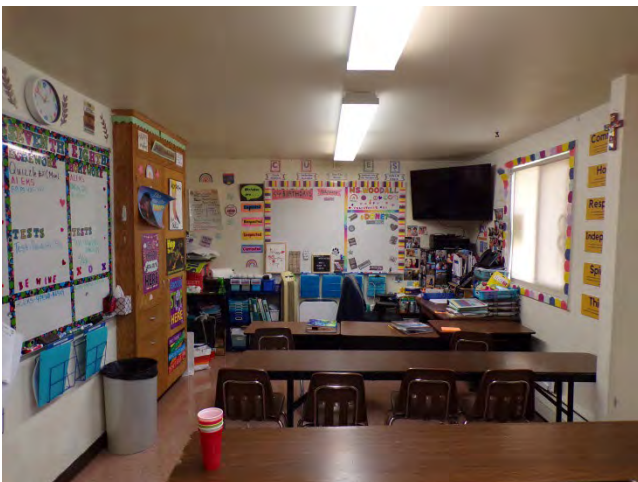
65. Convent: Interior finishes and fixtures in classrooms.

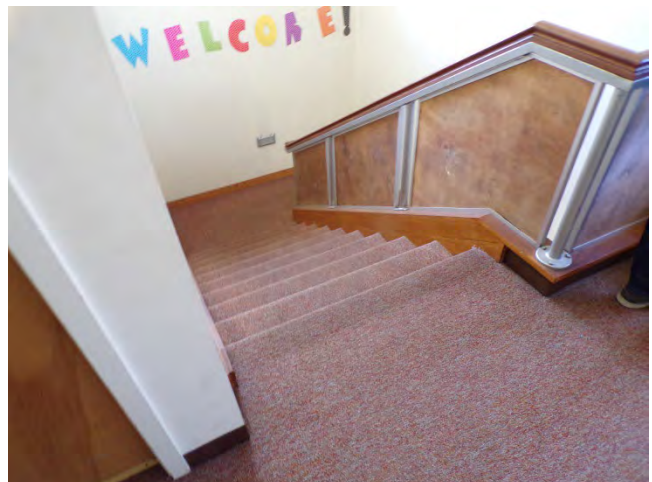
66. Convent: Two sets of interior stairs are provided. Stairs lack compliant visually contrasting striping at top and bottom treads. Compliant handrails are not provided.

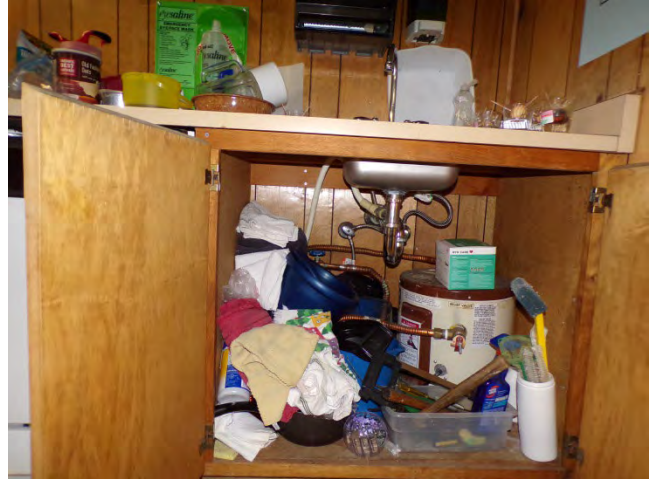
68. Mod Bldg N: An electric water heater of unknown age is installed in this modular building.

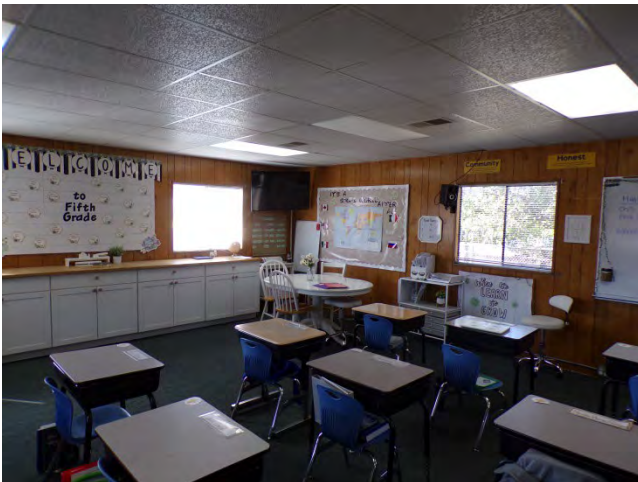
69. Mod Bldg S: Interior finishes and fixtures in classroom.

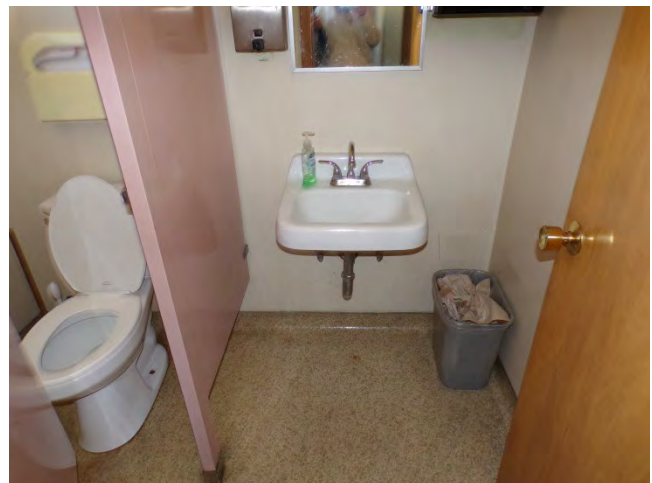
72. Church: Finishes and fixtures in older restroom.

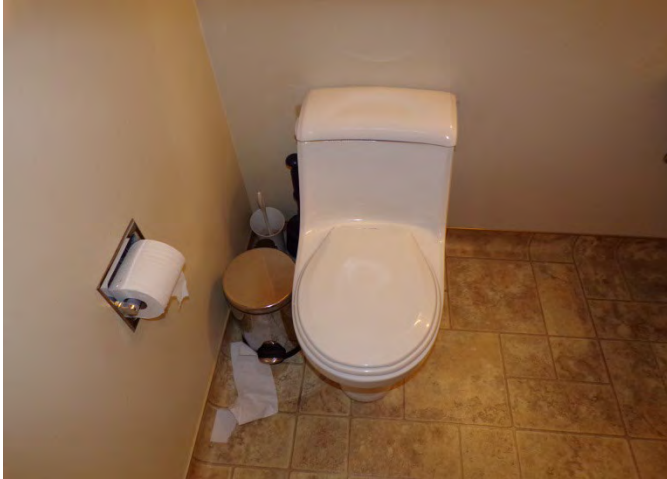
73. Rectory: Finishes and fixtures in office area restroom.

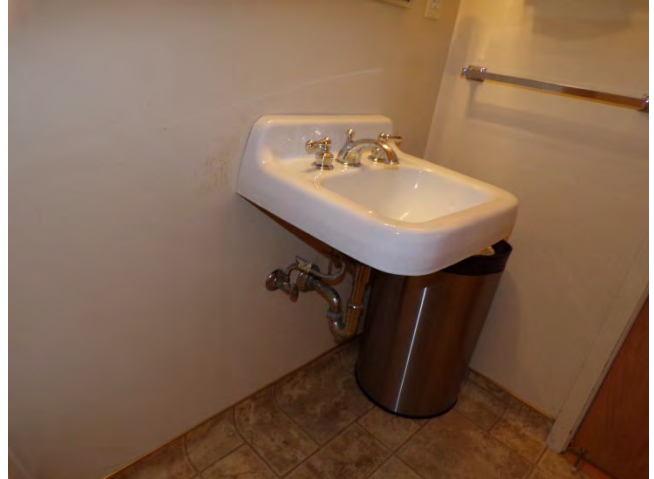
74. Rectory: Finishes and fixtures in office area restroom.

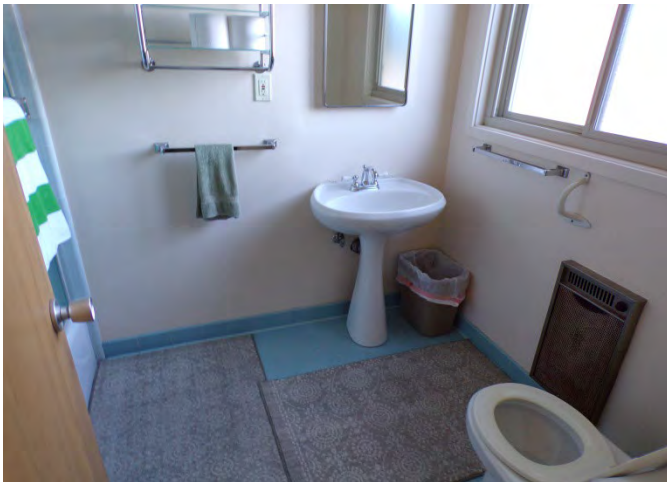
75. Rectory: Finishes and fixtures in residential unit bathroom.

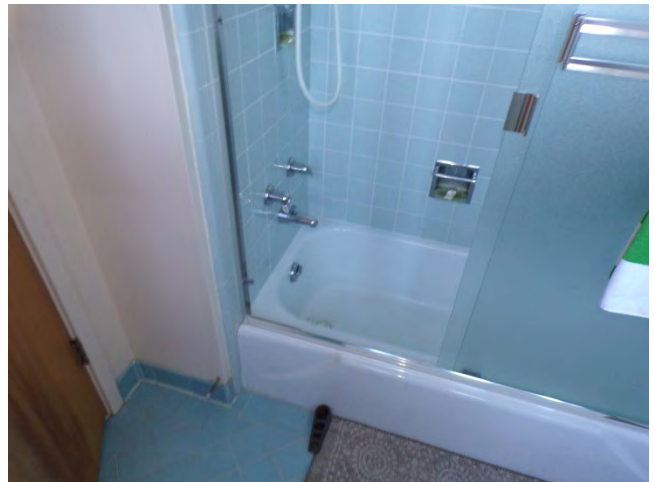
76. Rectory: Finishes and fixtures in residential unit bathroom.

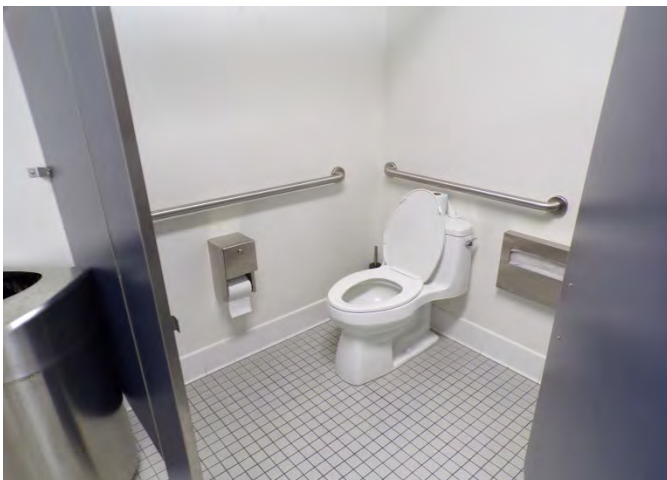
77. Hall Bldg: Finishes and fixtures in remodeled restroom.

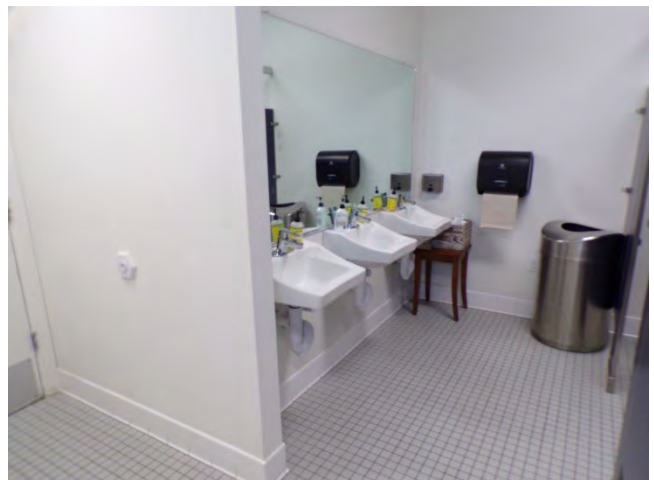
78. Hall Bldg: Finishes and fixtures in remodeled restroom.

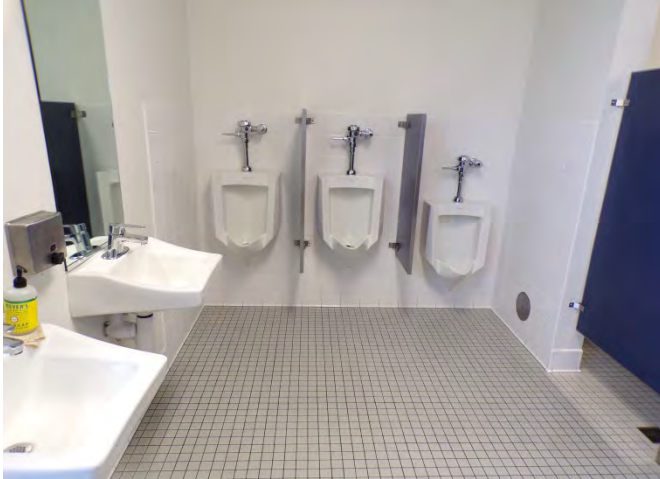
79. Hall Bldg: Finishes and fixtures in remodeled restroom.

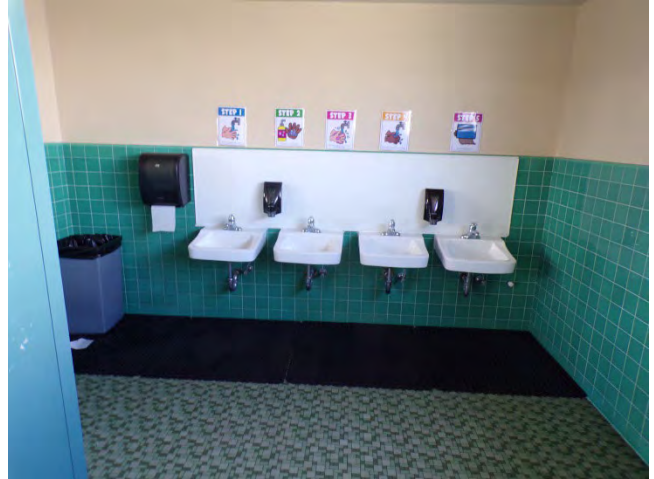
80. School: Finishes and fixtures in children's restroom.

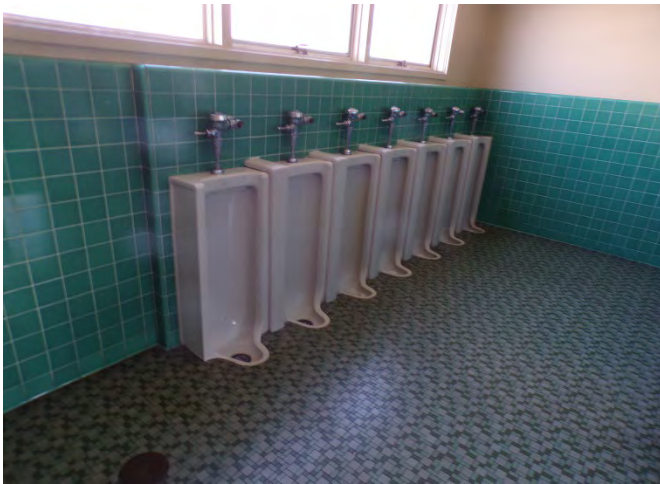
81. School: Finishes and fixtures in children's restroom.

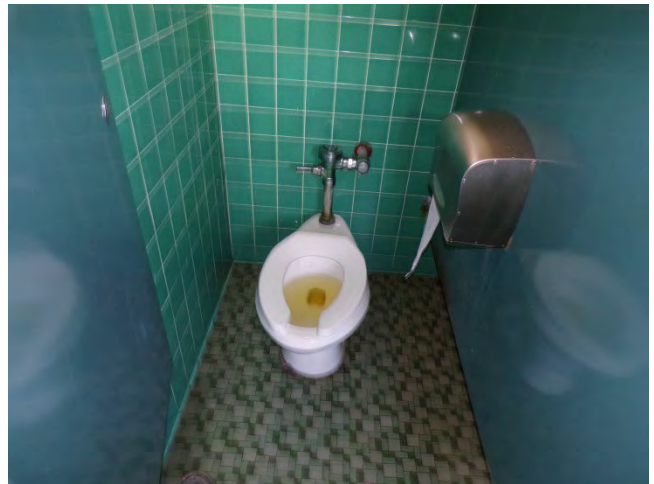
82. School: Finishes and fixtures in children's restroom.

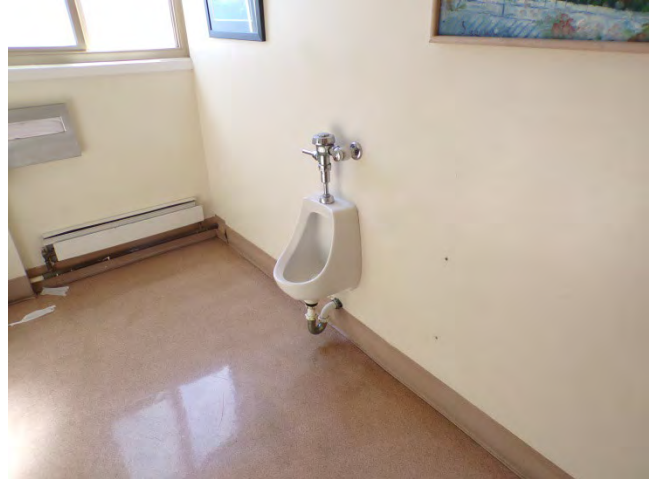
86. Rectory: Finishes and fixtures in restroom.

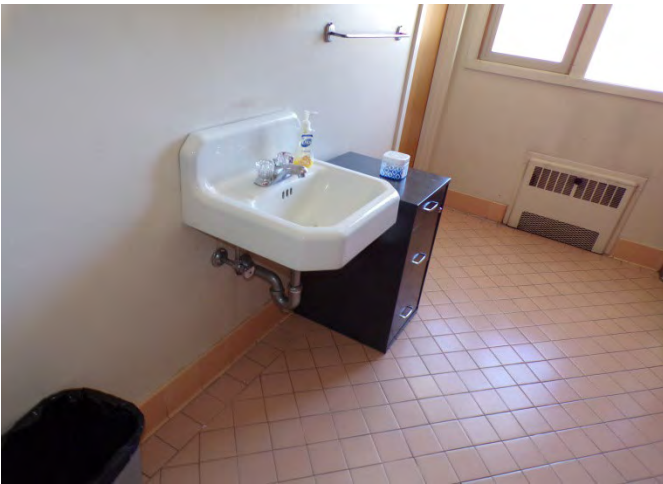
87. Rectory: Finishes and fixtures in restroom.

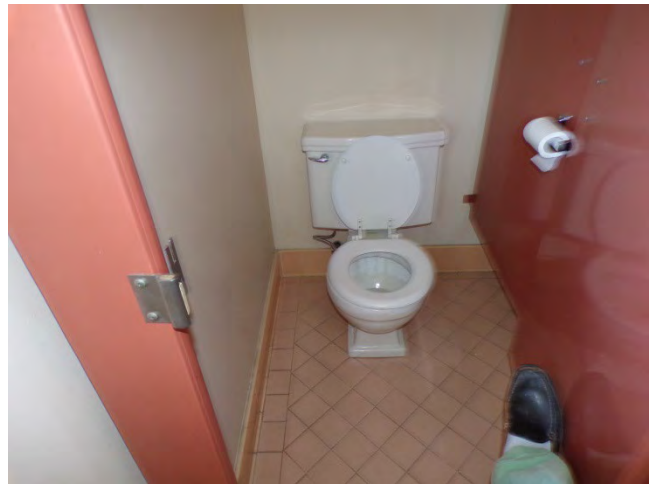
88. Rectory: Finishes and fixtures in restroom.

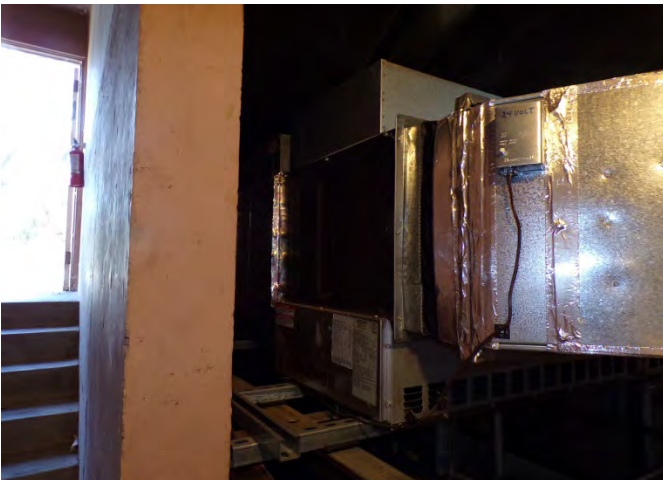
89. Church: Two Reznor natural gas-fired furnances, manufactured in November of 2011, provide heat.

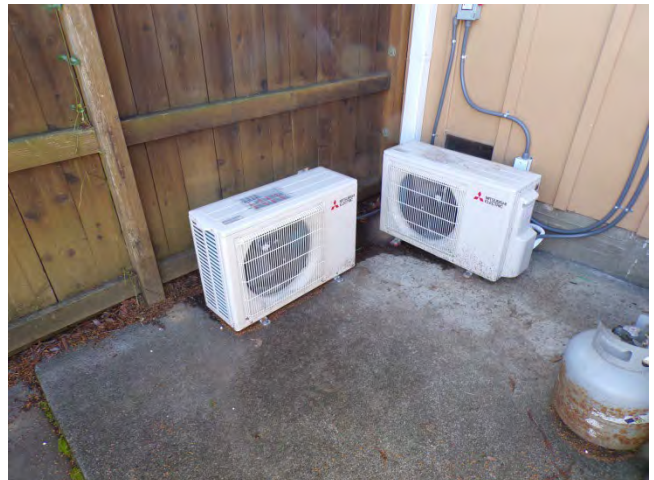
90. Rectory: Three split-system heat pumps were manufactured by Mitsubishi in 2022 (two shown). They provide heated and cooled air.

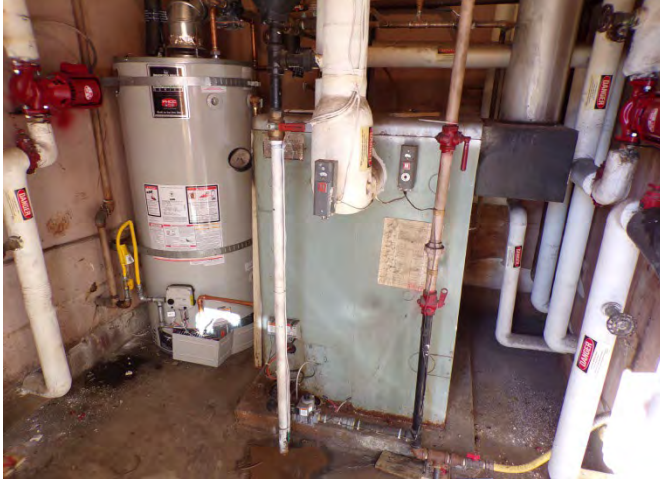
91. Rectory: A natural gas-fired boiler provides hot water to a hydronic loop heating system. The boiler has a rigid gas line connection.

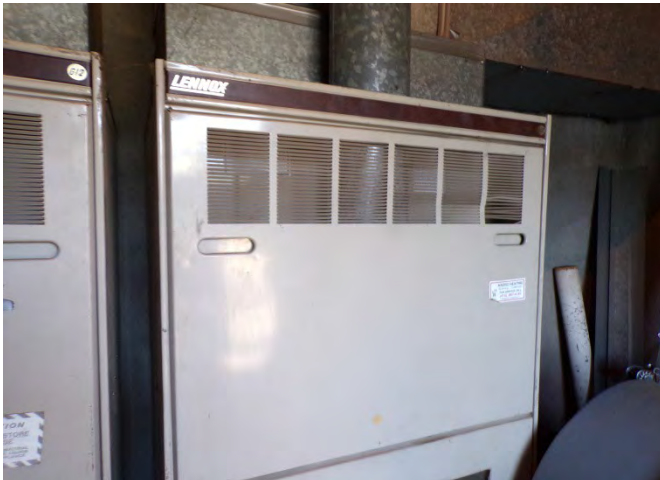
93. Hall Bldg: Two Lennox natural gas-fired furnaces provide heat.

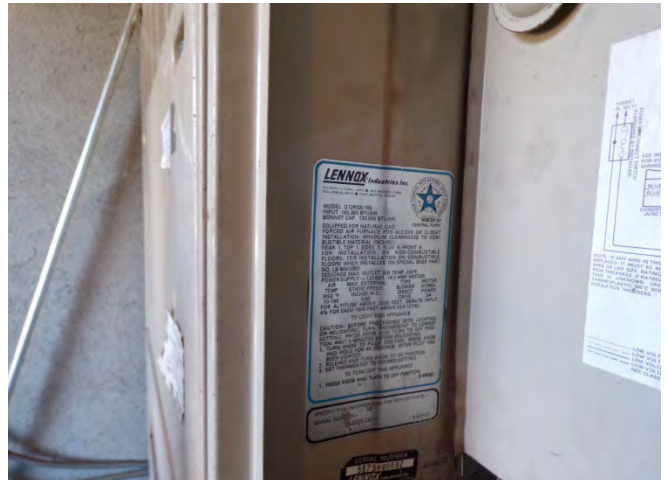
94. Hall Bldg: The Lennox furnaces were manufactured in October of 1975.

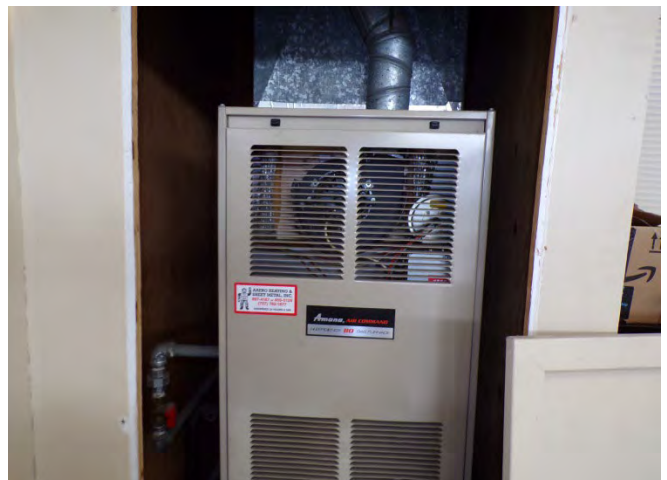
96. School: Each of the eight classrooms has a natural gas-fired furnace for space heating.

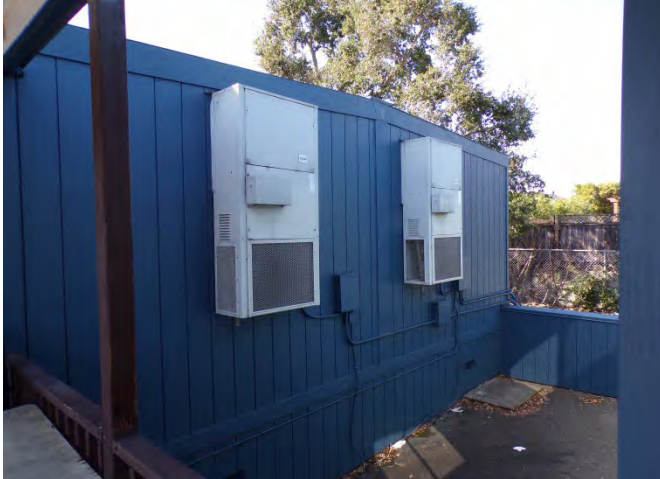
97. Mod Bldgs: Each Mod Bldg has two ZoneAir electric furnaces. Age and heating capacity are unknown.

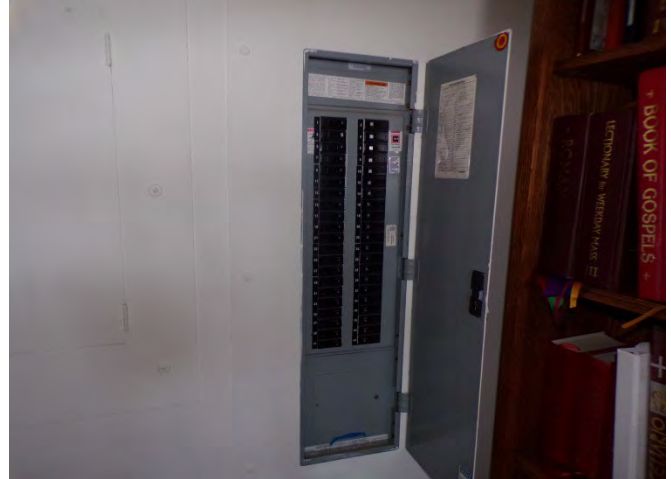
98. Church: The main electrical service entrance panel is rated at 225 amps.

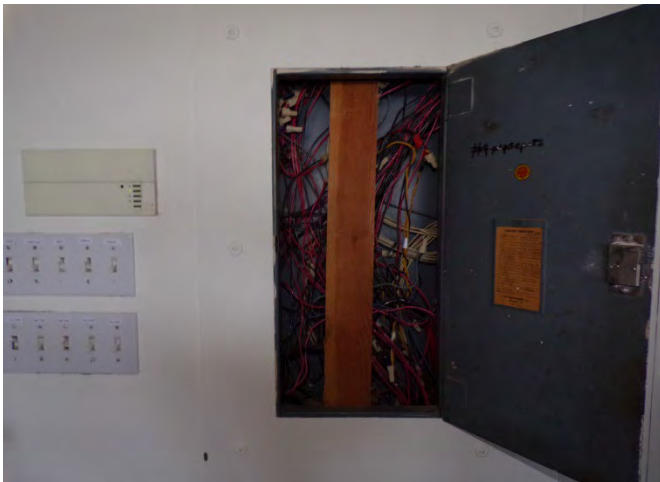
99. Church: This electrical panel is lacking an interior cover plate.

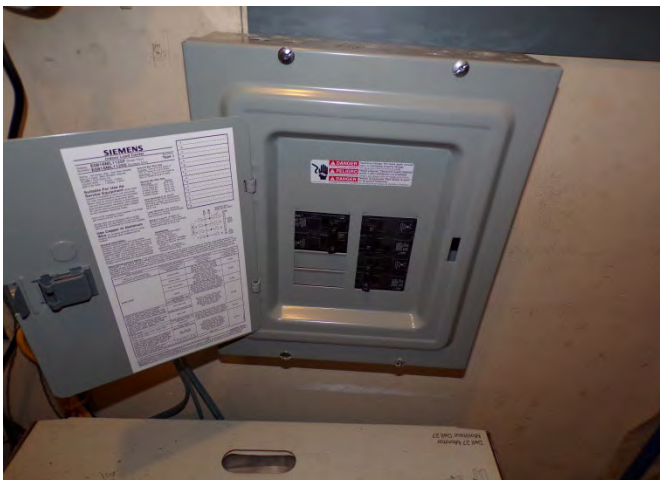
101. Rectory: A sub-panel rated at 125 amps is also installed in this building.

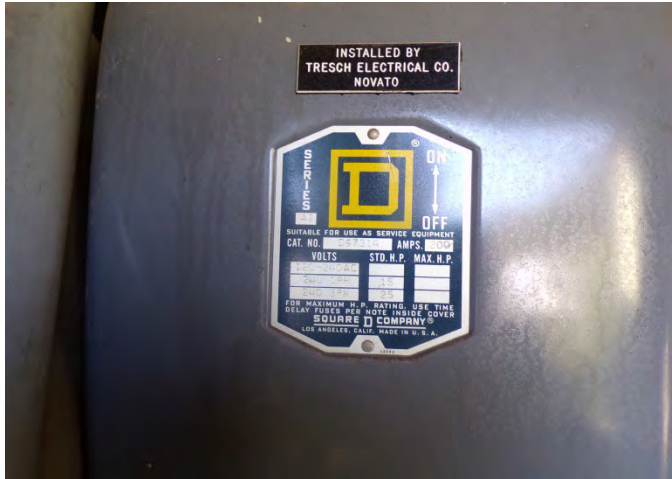
103. School: The main electrical service entrance panel is rated at 200 amps.

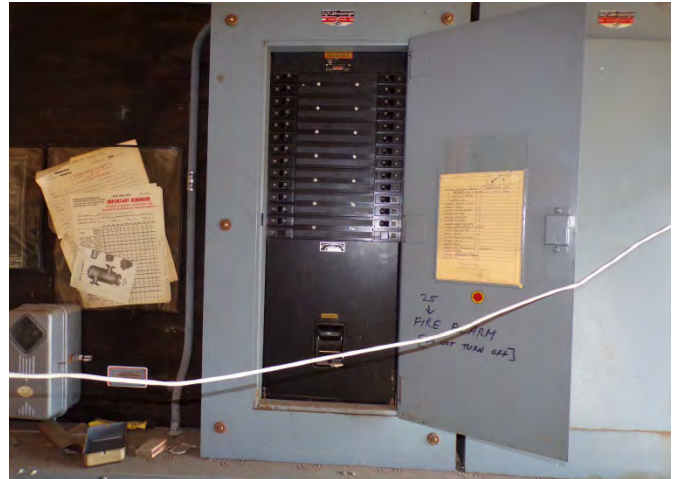
104. Convent: The main electrical service entrance panel is rated at 200 amps.

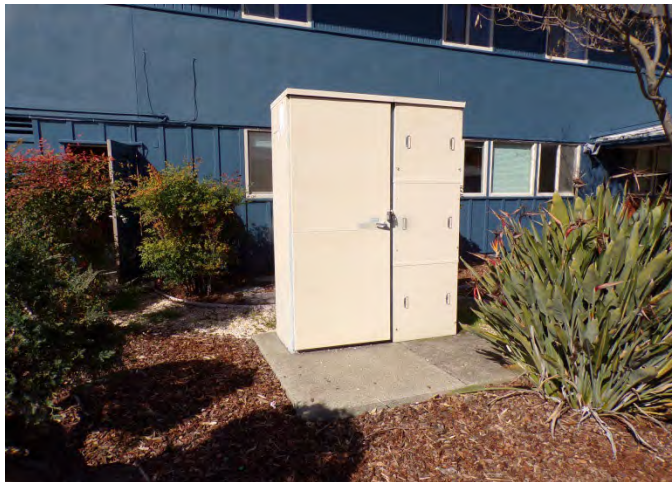
105. Convent: A locked PG&E enclosure near this building presumably contains the main electrical switchgear for the property.

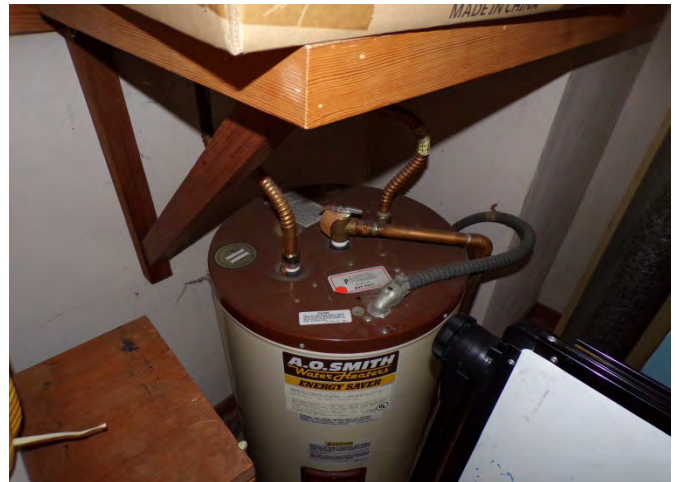
106. Church: The 20-gallon electric water heater has seismic strapping. This unit was manufactured in December of 1995.

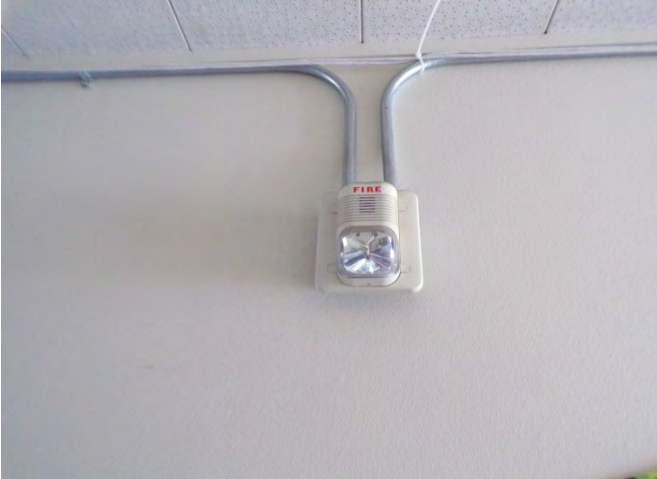
109. Convent: Horn/strobe alarm devices are installed in this building.

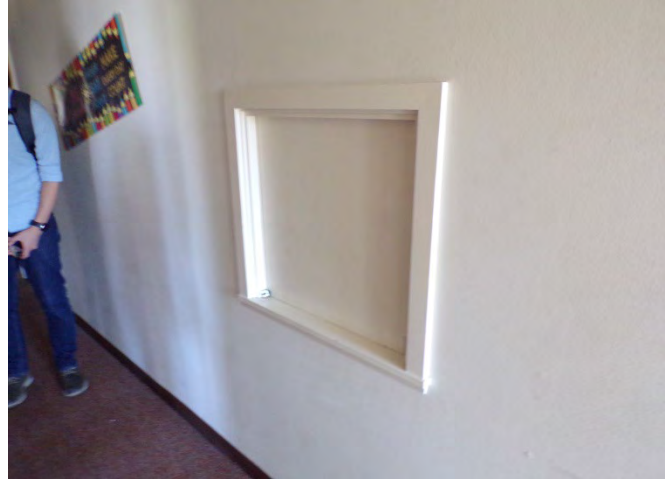
110. Dumbwaiters, which have been taken out of service, are installed in the Convent (shown) and the Rectory.
