## PROPERTY CONDITION ASSESSMENT

**Our Lady of Loretto Church & School, 1806 Novato Boulevard  
Novato, CA 94947**

**ALLWEST PROJECT 23017.60  
February 27, 2023**

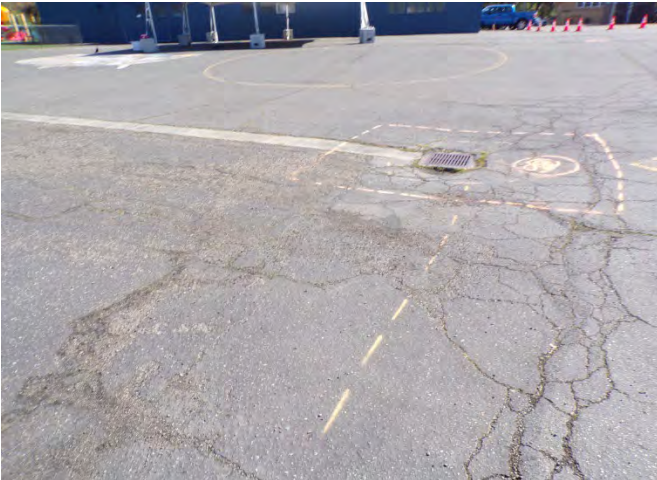
111. Flooding in the parking lot was reported during recent heavy rains at this area drain.

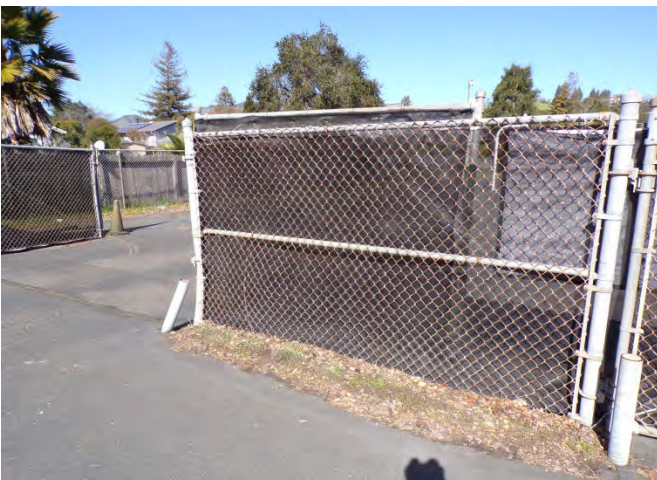
113. The perimeter chain-link fencing is in a degraded condition. Bent pole and rusted chain-link shown.
