**PROPERTY CONDITION ASSESSMENT**

**Tiburon Baptist Church  
445 Greenwood Beach Road  
Tiburon, California 94920**

**June 26, 2023**

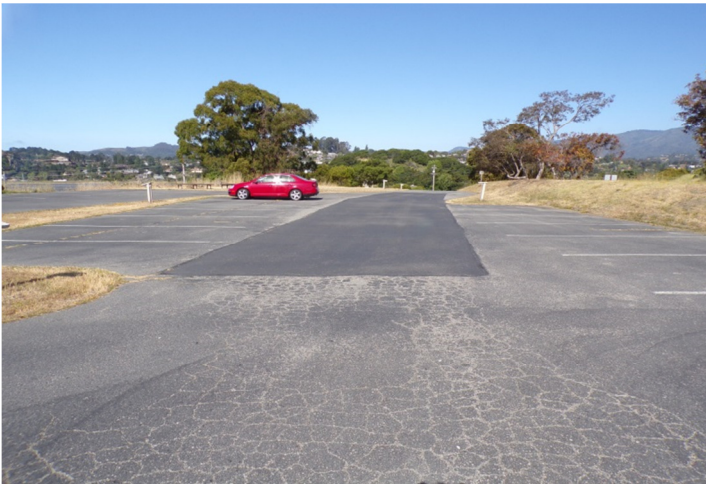
9. Typical view of parking lot, looking west. Large area of repair at center (darker asphalt). Alligator cracking in foreground.

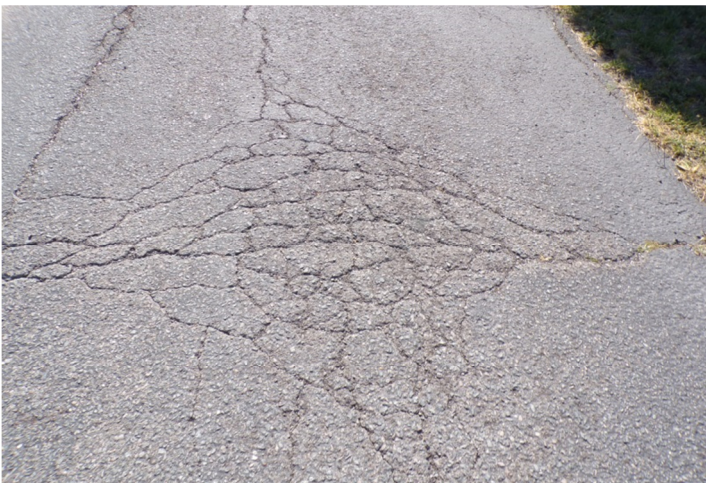
11. Degraded condition of asphalt surface of parking lot and drive aisles.

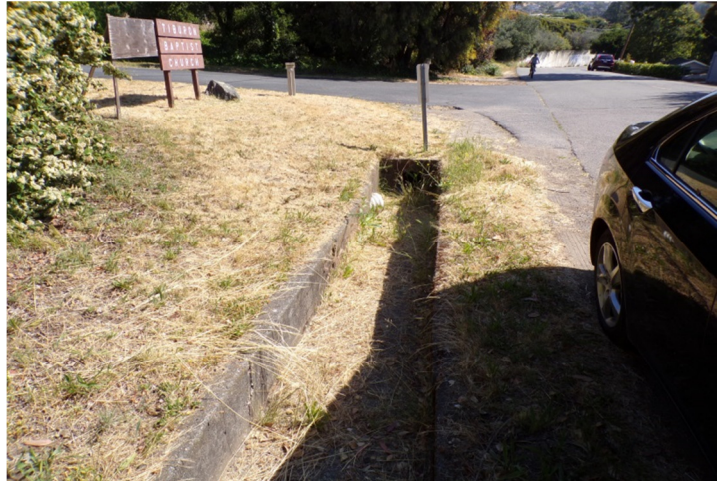
14. Typical untended landscaping along Greenwood Beach Road at south side of site with concrete swale shown. East site entrance in background.

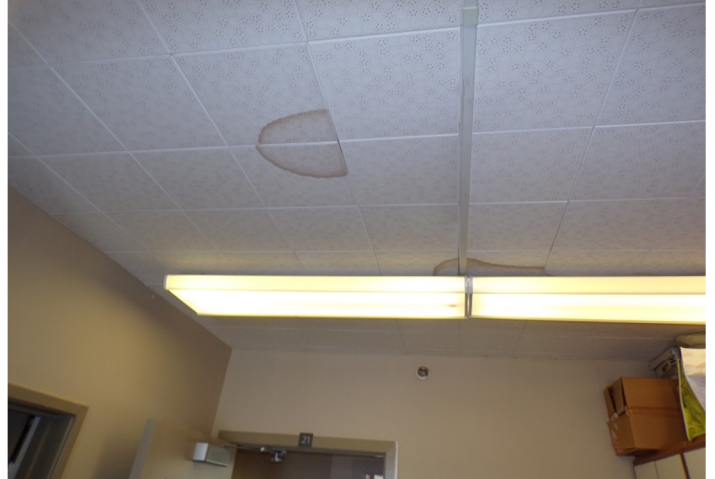
32. Water stained ceiling tiles were observed in a few locations.

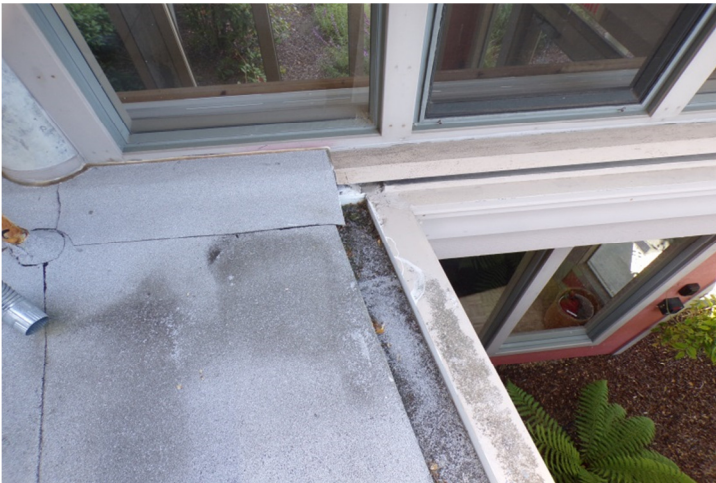
39. New BUR roofing systems were installed in September 2017. Mineral granule separation has already occurred.

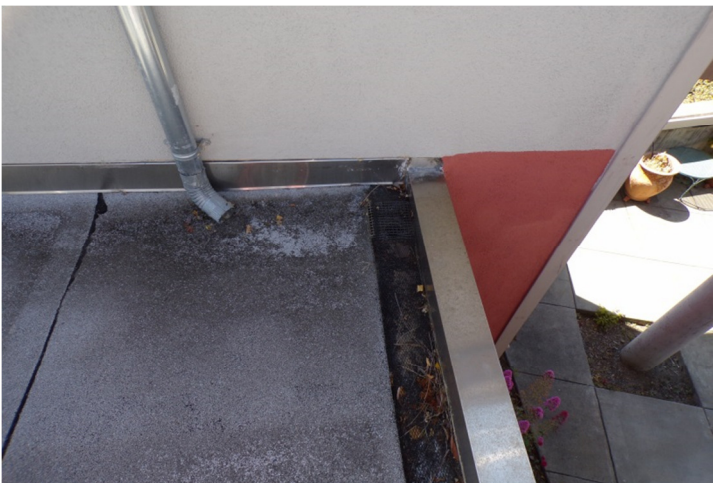
41. A drainage problem was described at this location adjacent to the elevator shaft (in background).

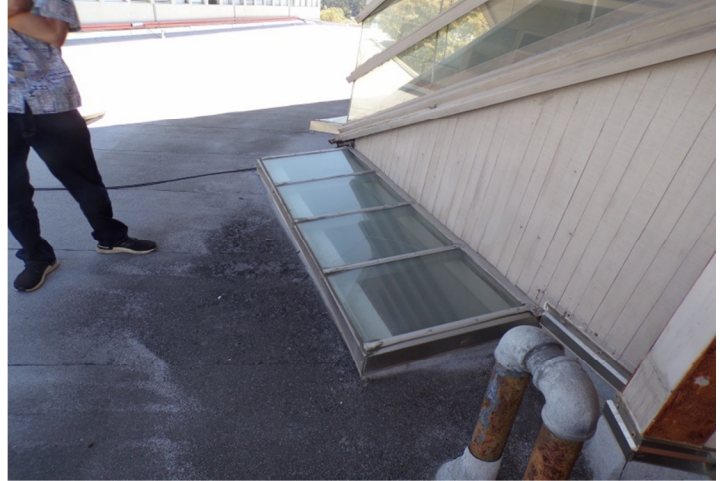
44. Two sets of aluminum framed skylights are installed in the vicinity of the Sanctuary on the roof above the main floor. Second pane from bottom is cracked.

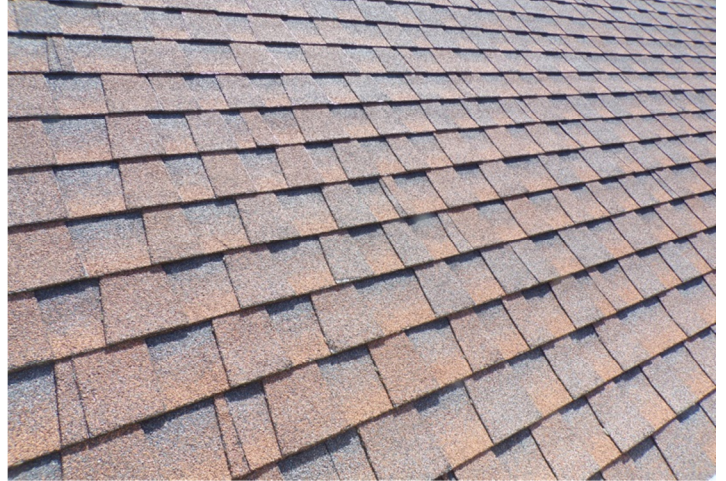
50. The shingles above the Sanctuary are in better condition than those on the lower-sloped pitched roofs.

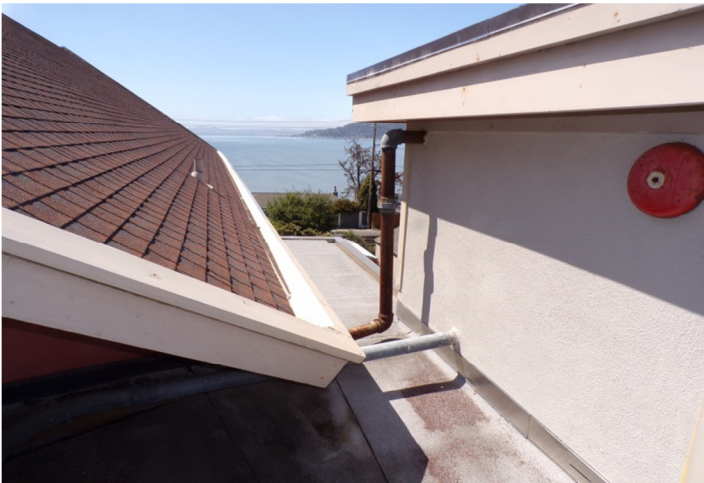
51. The asphalt composite shingles above the Sanctuary may have an EUL which extends beyond the 10-year term of analysis.

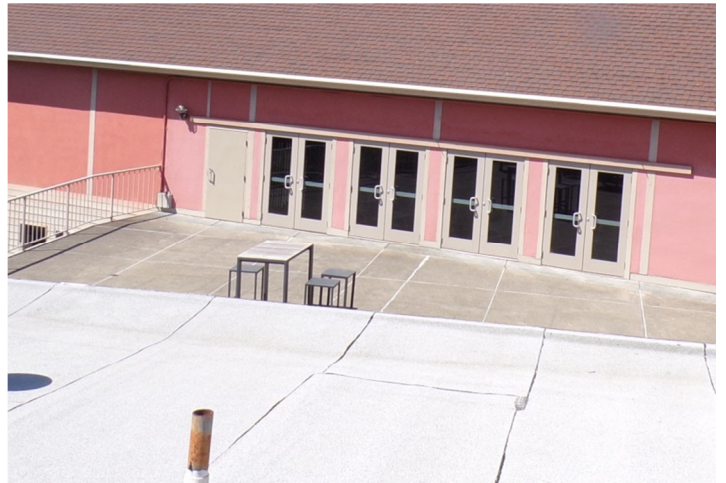
52. A concrete deck is provided on east side of the Sanctuary.

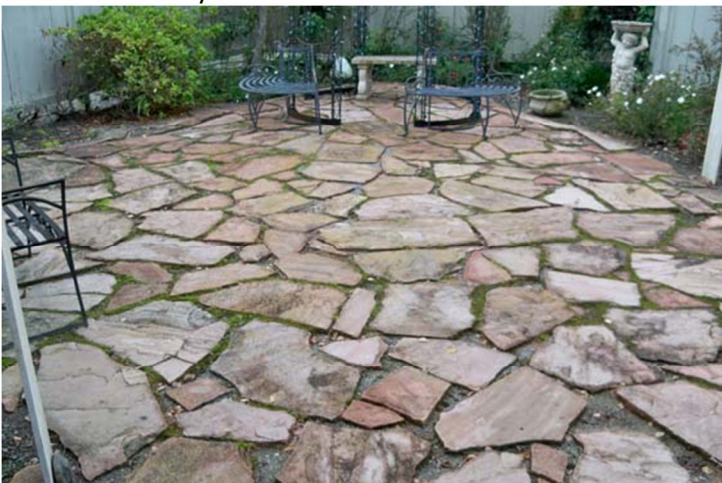
53. Tripping hazards were observed in flagstone paved courtyard (2016 photo).

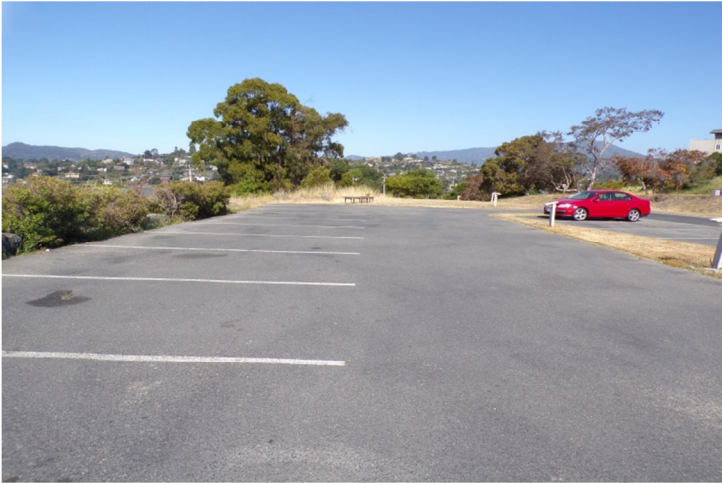
55. Non-Accessible parking stalls will require restriping during the reserve term.

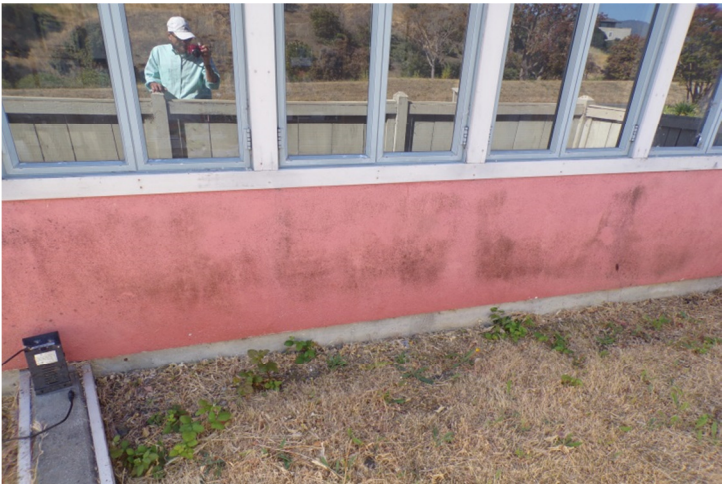
57. Exterior paint finishes will require repainting during the reserve term.

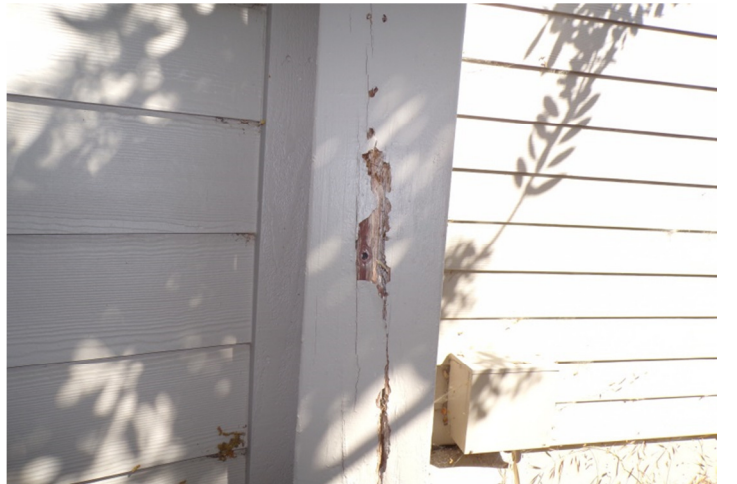
58. Rotten exterior wood building elements, such as the glulam columns pictured here, require repair or replacement.

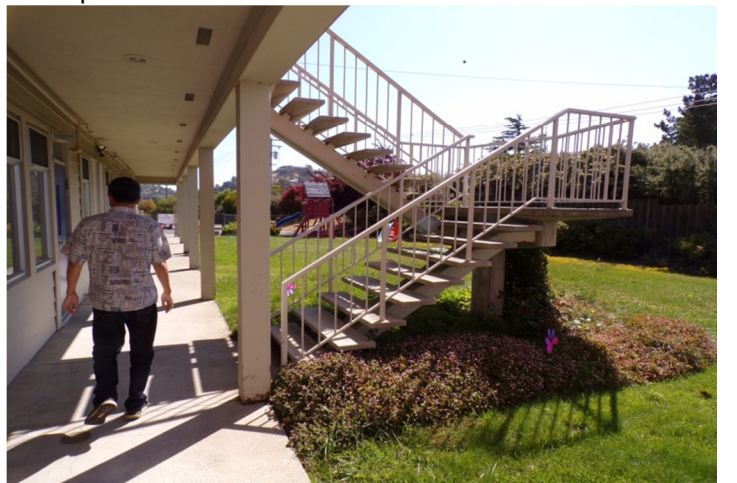
60. Both sets of exterior concrete stairs no longer comply with current building and Accessibility codes.

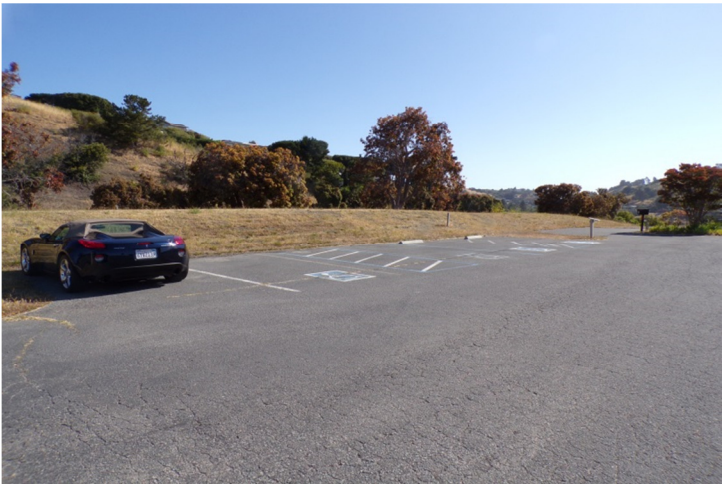
63. Path of travel pavement markings from north Accessible parking stall are lacking.

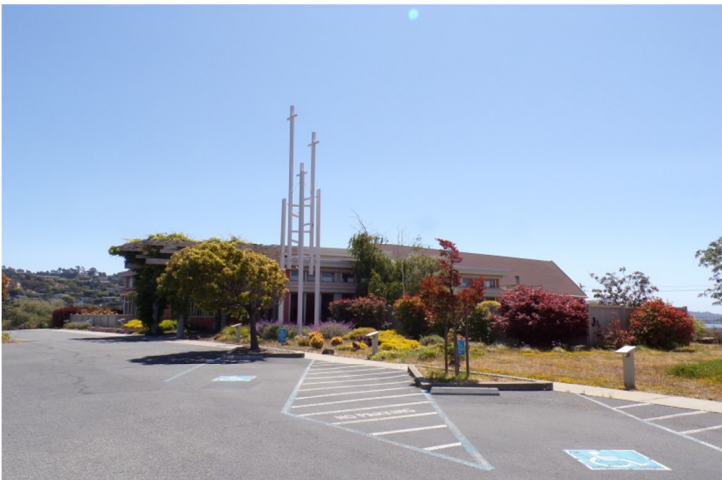
65. Truncated domes are not installed in any required location at the subject property.

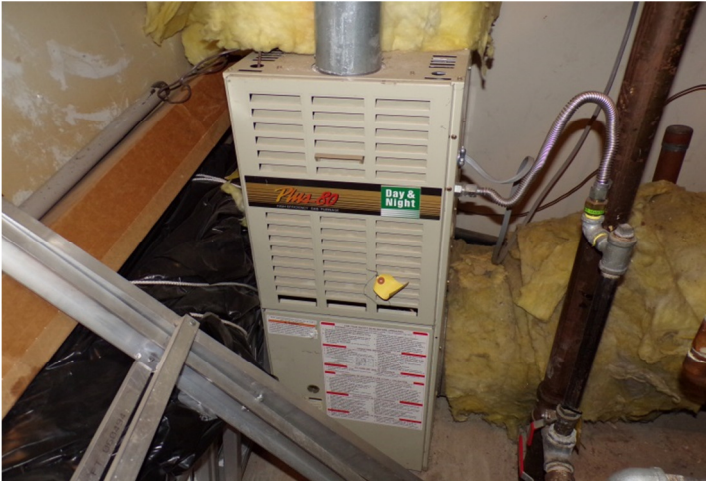
67. The older *Day & Night* furnace dates to 1996.

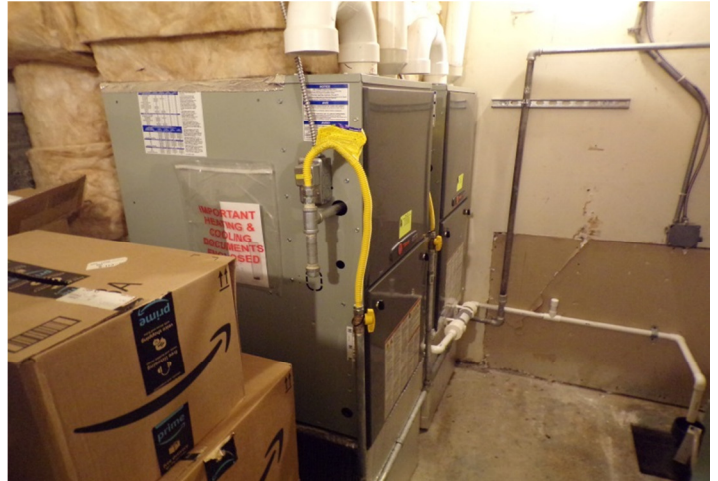
68. Two 100,000 BTU/hr Trane furnaces were installed in 2017 in an interior utility room on the lower floor.

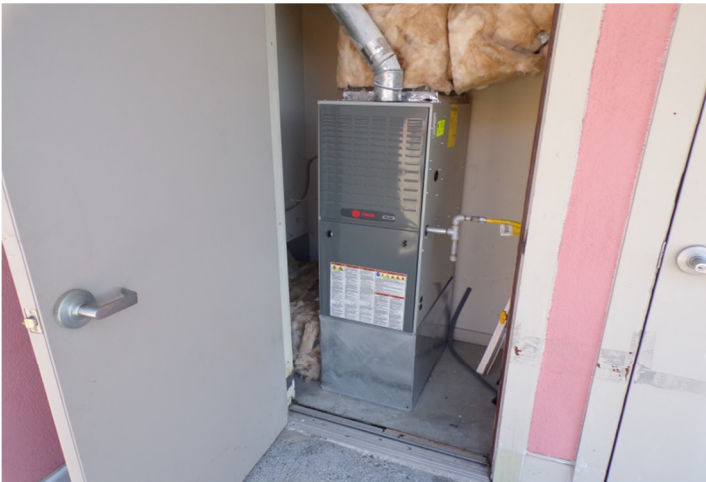
69. One 60,000 BTU/hr Trane furnace was installed in an exterior service closet in 2017.

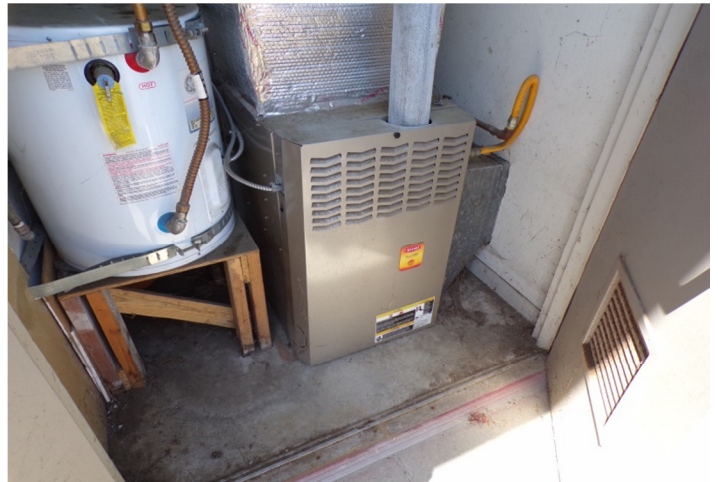
70. The older Bryant furnace dates to 2005.

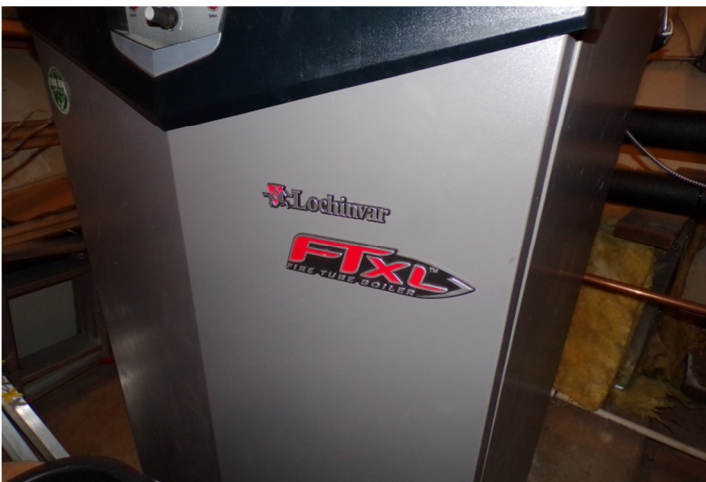
71. The *Lochinvar* boiler was installed in the main level mechanical room in 2017.

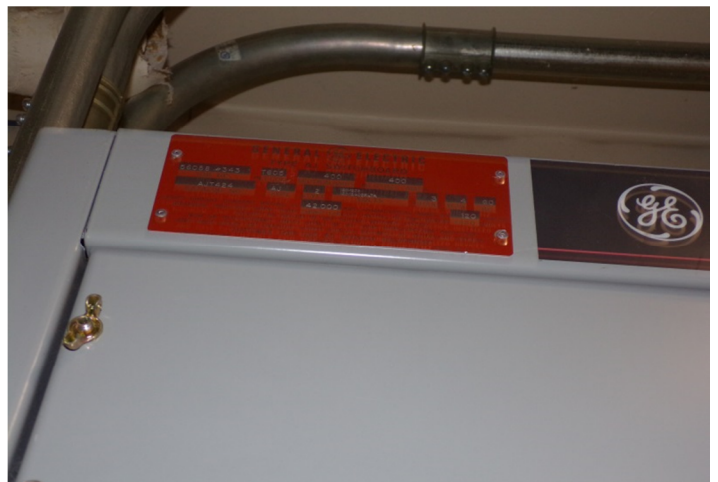
72. The *GE* main electrical service entrance panel is rated at 400 amps.

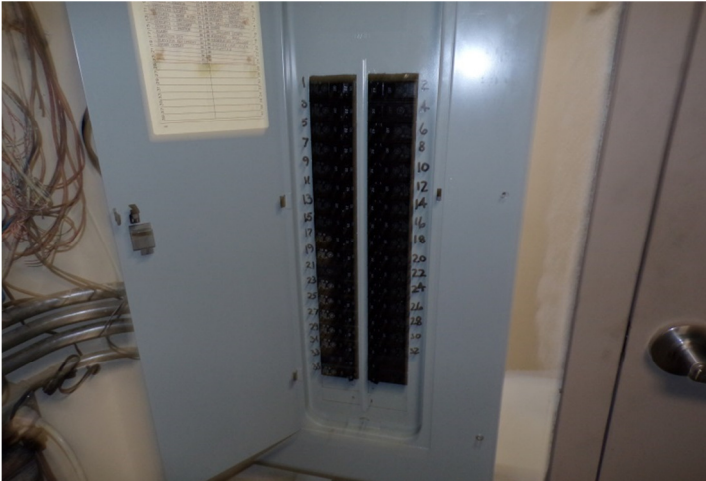
73. Infrared scanning of the electrical distribution system is recommended.

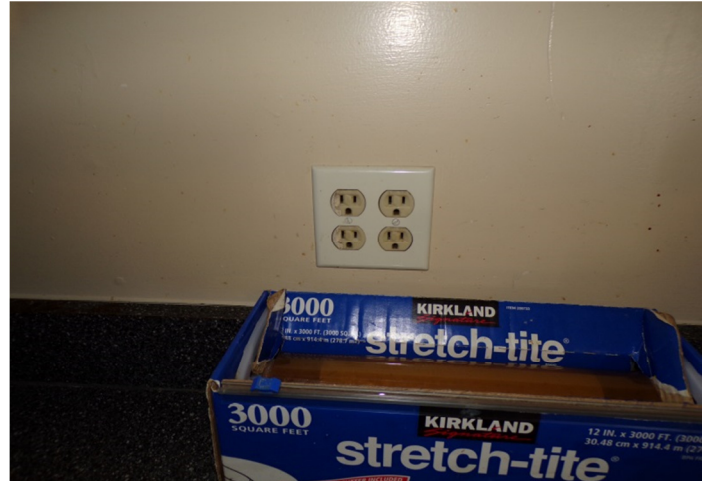
74. GFCI receptacles should be installed in required wet areas (kitchen on lower level shown) where conventional receptacles are currently provided.

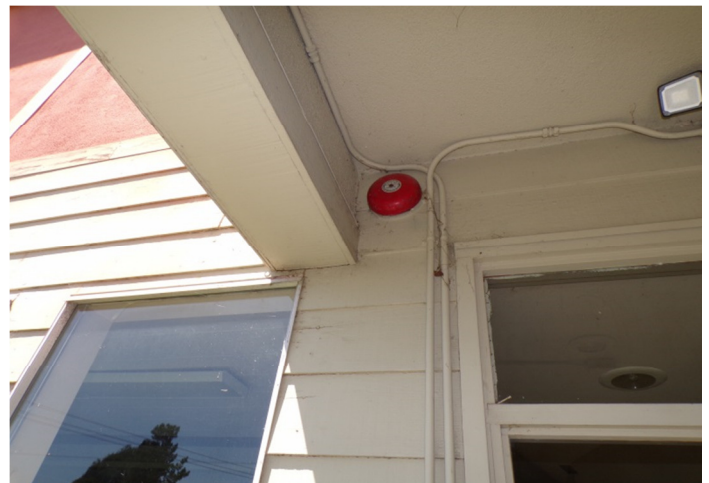
78. Exterior local fire alarm bell shown. Fire alarm device placements are not compliant with current Accessibility codes.

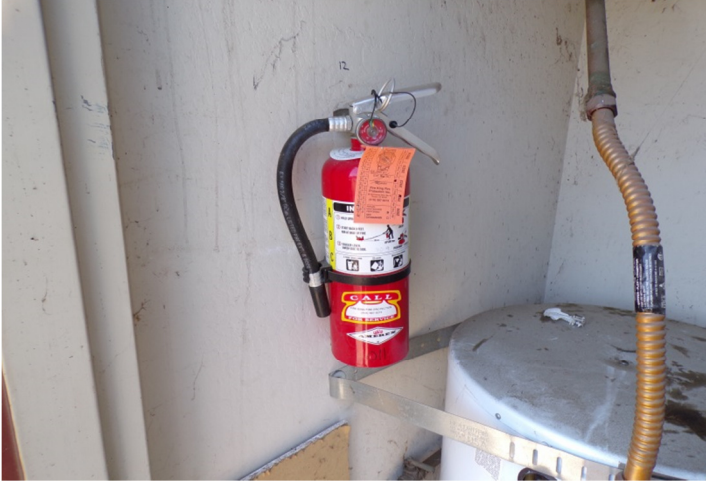
79. Several fire extinguishers were observed with expired inspection tags. The inspection date on this tag is July 29, 2021.

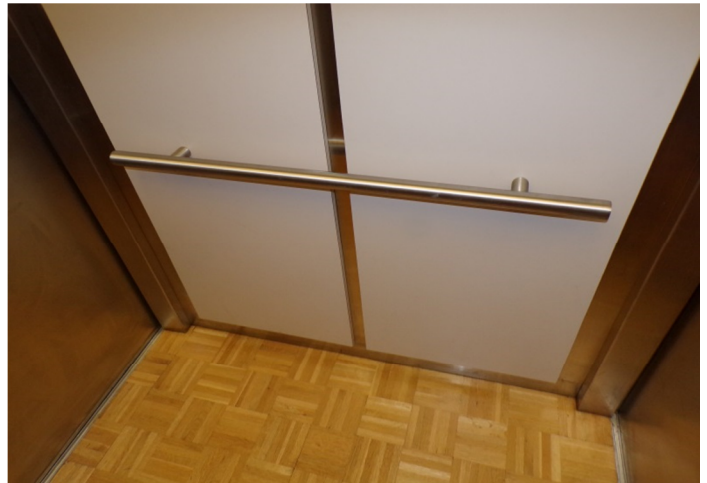
82. Interior finishes in the elevator cab with grab bar shown.

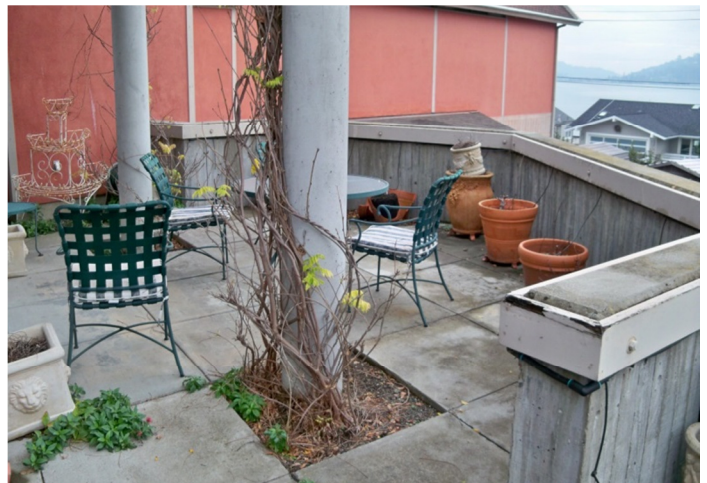
84. Possible differential settlement was reported at concrete-paved patio on west side of building (2016 photo).

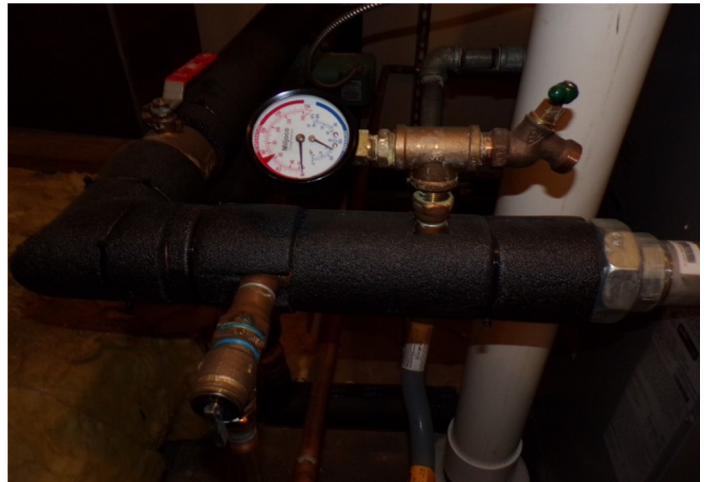
88. The boiler is fitted with a rigid gas line connection.

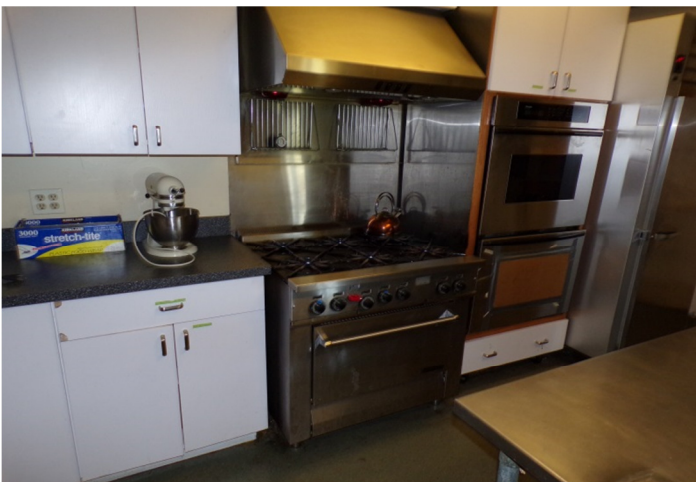
89. The vent hood over the gas stove is not fitted with an *Ansul* fire protection system.

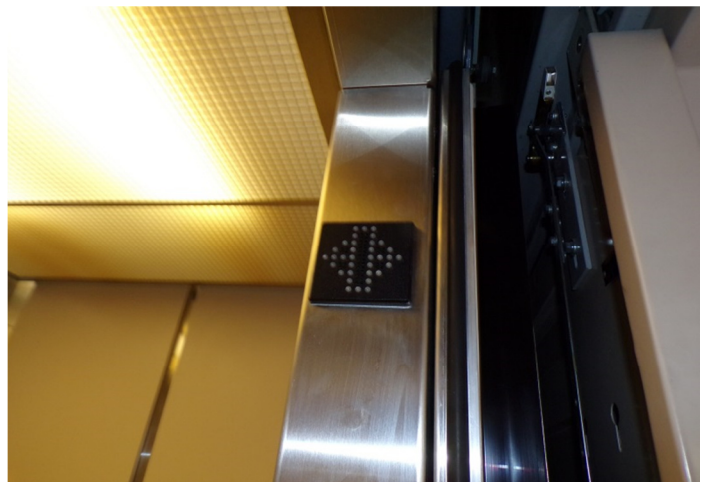
90. Elevator is not provided with Accessibility compliant audible tones.
