## PROPERTY CONDITION ASSESSMENT

**301 Battery Street, San Francisco, CA 94111**

**Project 26030.60  
September 22, 2026**

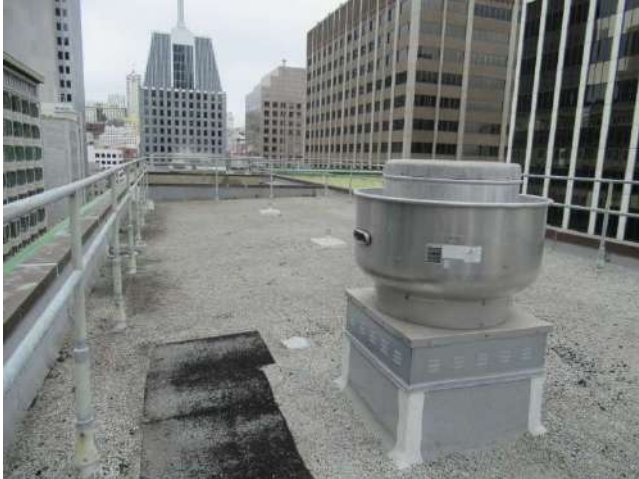
13. Built-up roofing system at top roof.

- Allowance for remedial measures to address deficiencies identified in evaluation report cited above;
- Replace built-up roofing systems in all flat-roofed areas where installed;

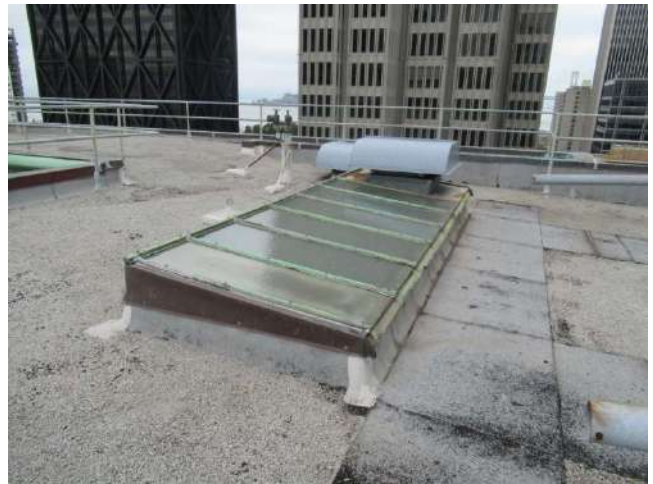
16. Typical roof-mounted skylight.

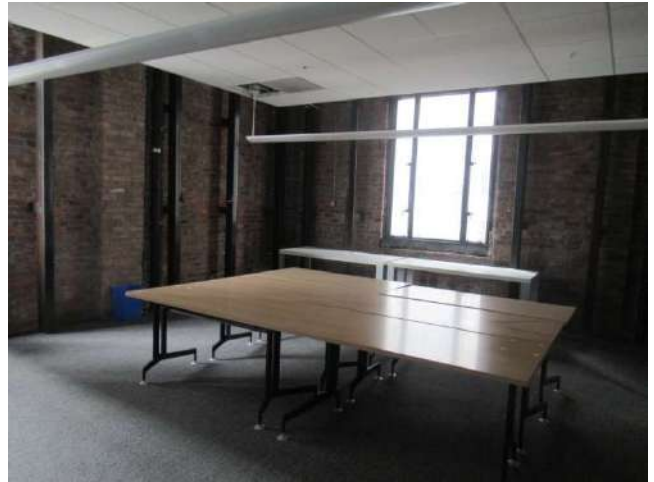
28. Typical seismic bracing at the exterior brick walls.

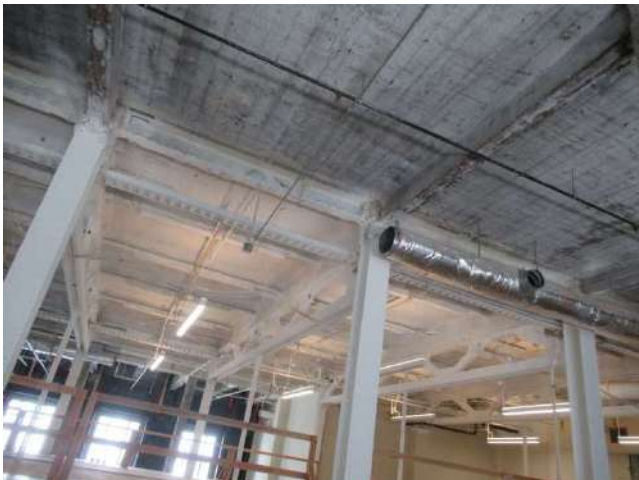
29. Steel trusses above the banking hall roof support the floors above.

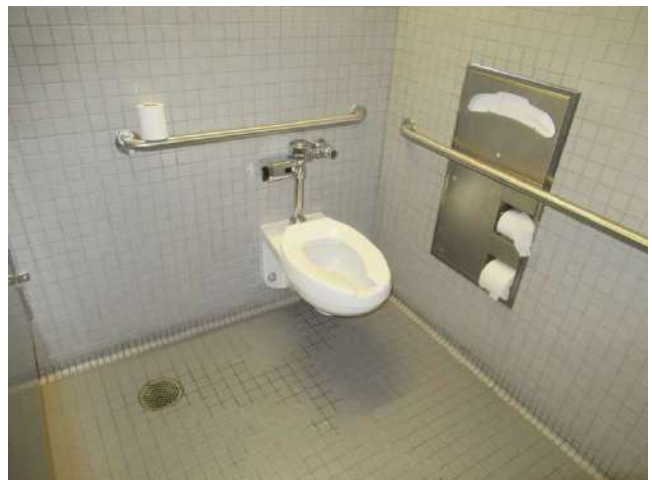
42. Typical Accessible restroom stall.

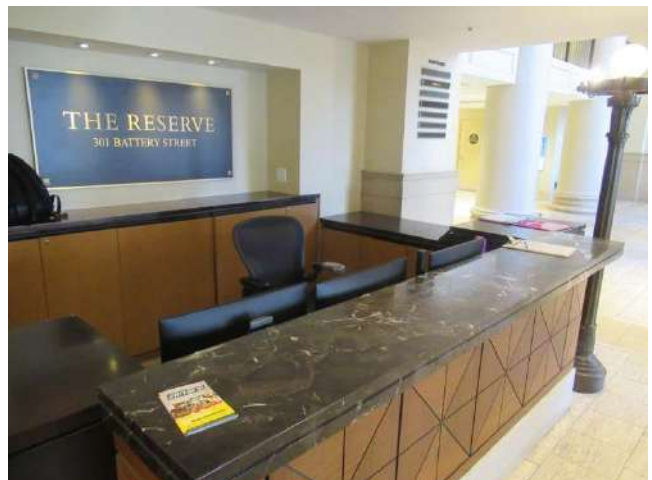
60. The main lobby reception desk includes a lower surface at Accessible height.

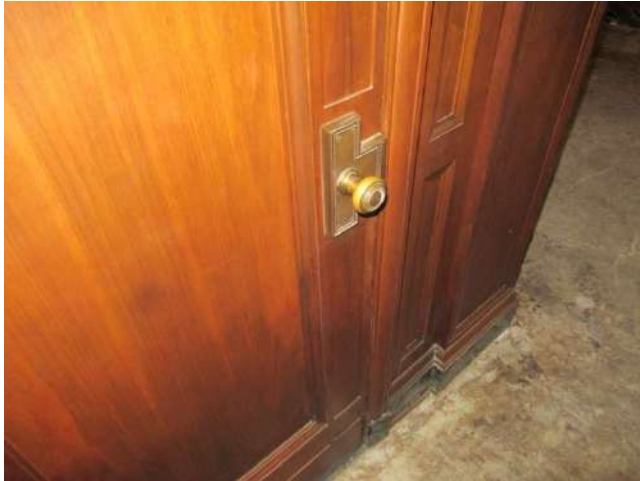
61. Non-compliant conventional door knobs are still installed at historic interiors.

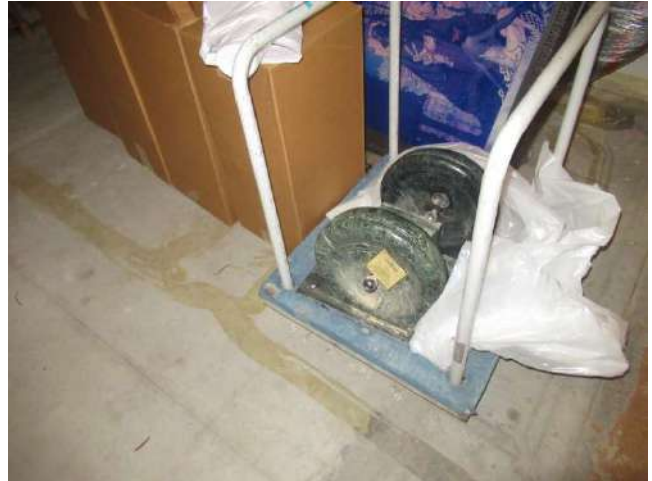
62. Non-Accessible stone water fountain have been removed and are now kept in a storage area.

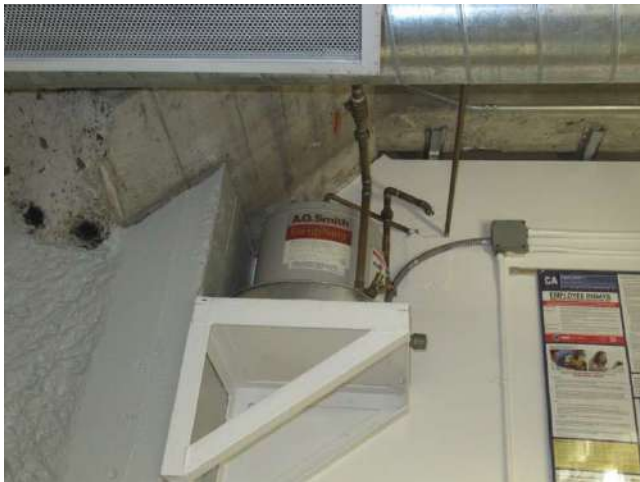
63. Small water heaters are provided for each sink in the building.

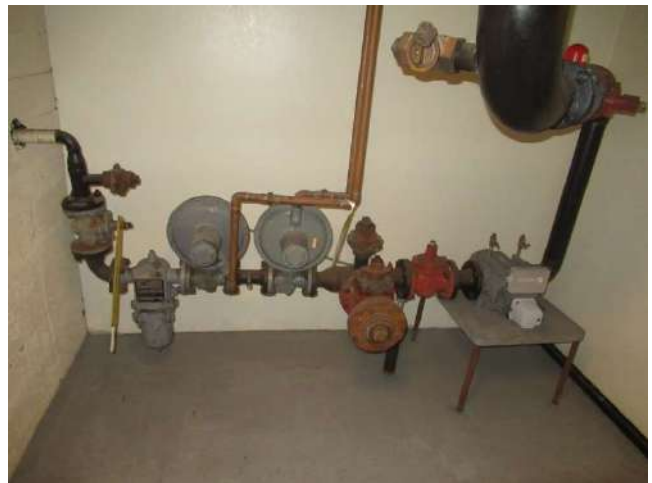
66. Gas service entrance in the basement.

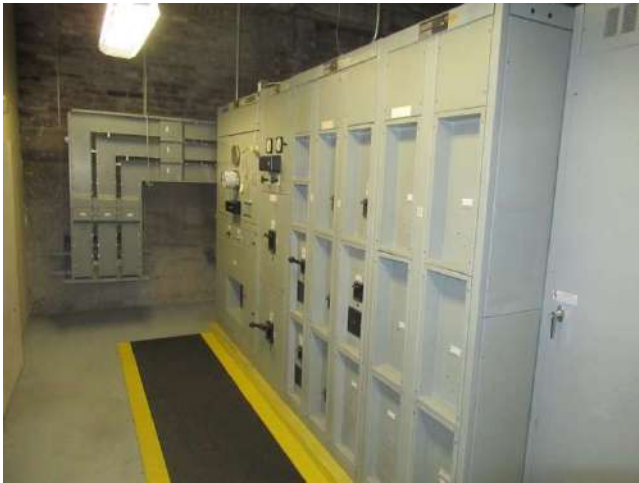
69. The main electrical panel for the building.

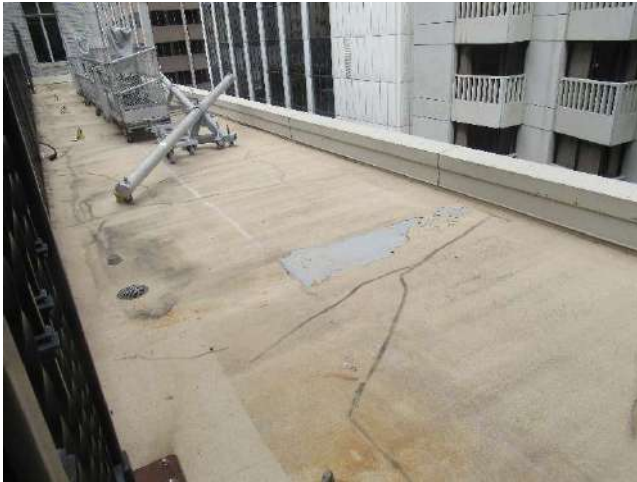
75. Swing stage, booms, and window washing equipment attachment points on 4<sup>th</sup> floor roof.
