### PROPERTY CONDITION ASSESSMENT

**511 Forest Lodge Road, Pacific Grove, CA 93950**

**PROJECT 26007.60  
March 26, 2026**

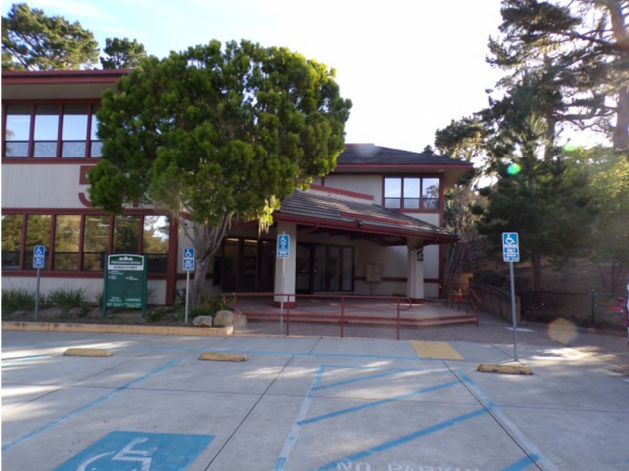
1. Main pedestrian entrance at west reentrant angle. The angle contains the south elevation of the west wing and the west elevation of the east wing.

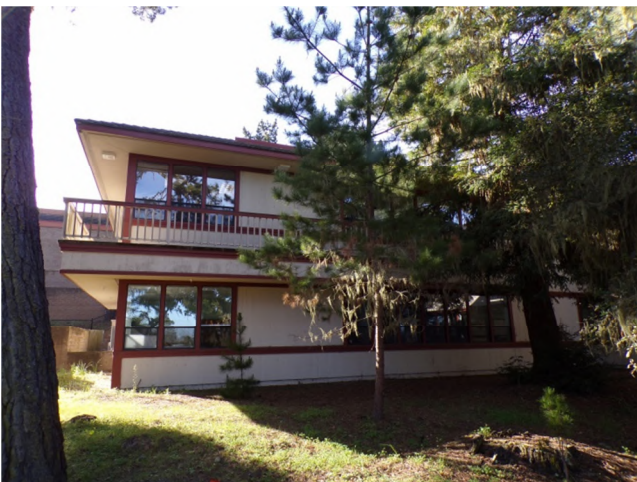
5. North elevation of east wing.

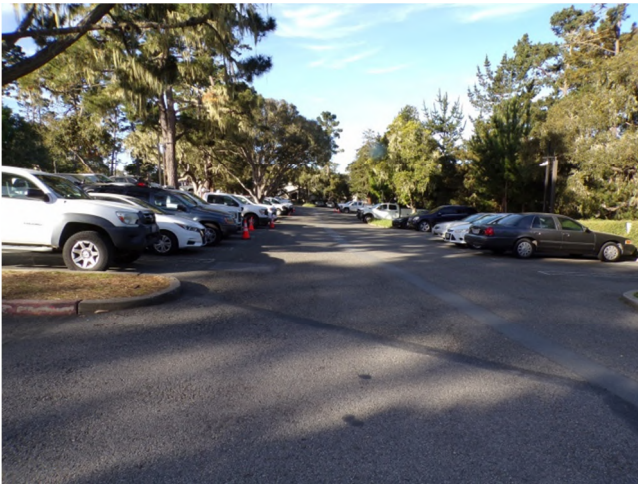
9. South portion of parking lot, looking west.

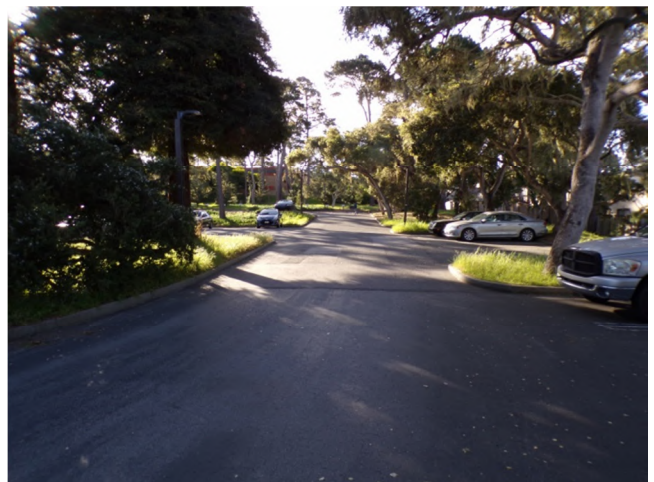
12. Drive aisle connecting north and south parking areas.

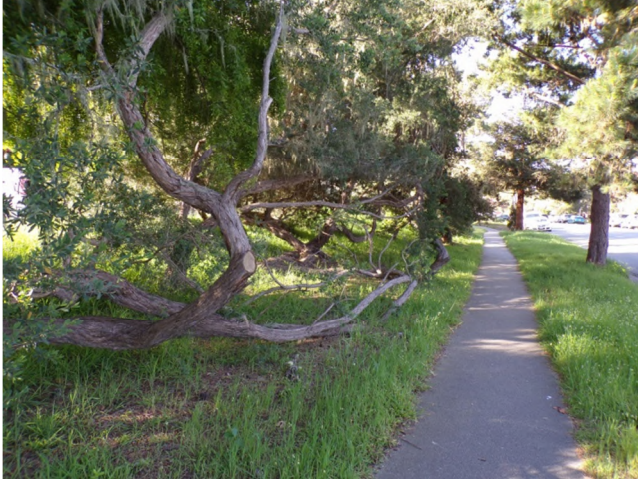
Site improvements appeared in "Good" to "Fair" condition, with the bias towards "Fair". Landscaping consists of mature trees and shrubs and grassy areas. An irrigation system is installed, but it does not serve the overwhelming majority of the grassy areas. The grassy areas have a purposefully untended, native appearance.

19. Much of the landscaping has a purposefully untended appearance.

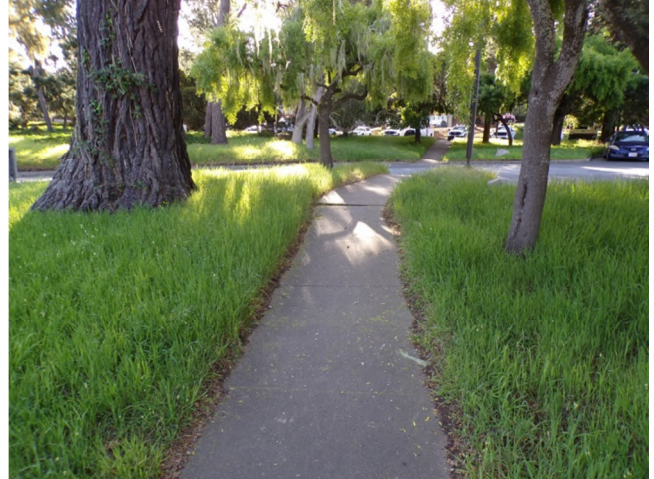
20. The ground cover is largely grass-like, volunteer vegetation.

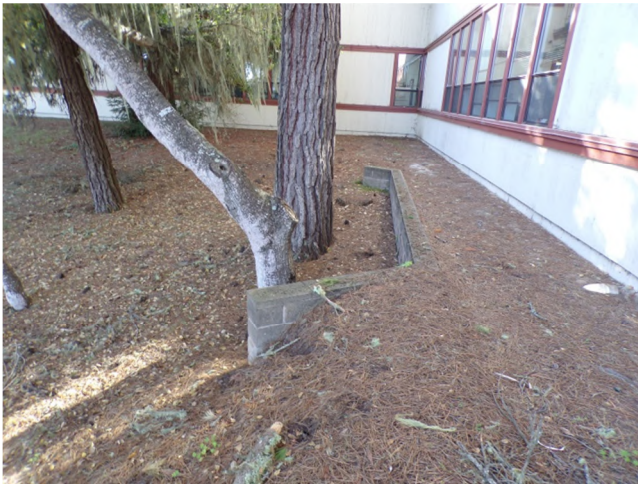
21. Some of what we have called the “grassy areas” are not particularly grassy.

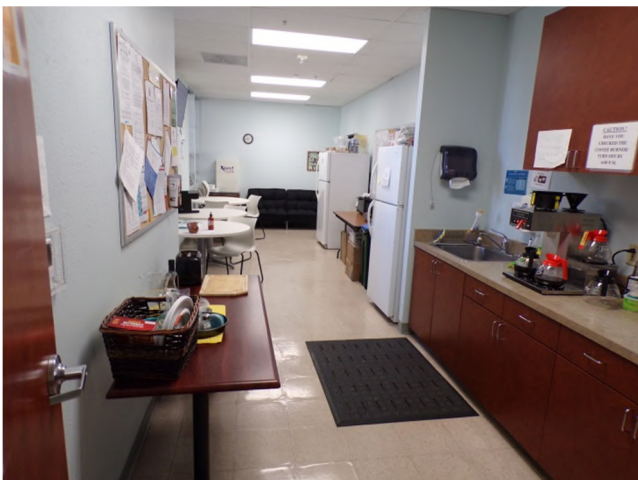
47. Interior finishes and fixtures in breakroom.

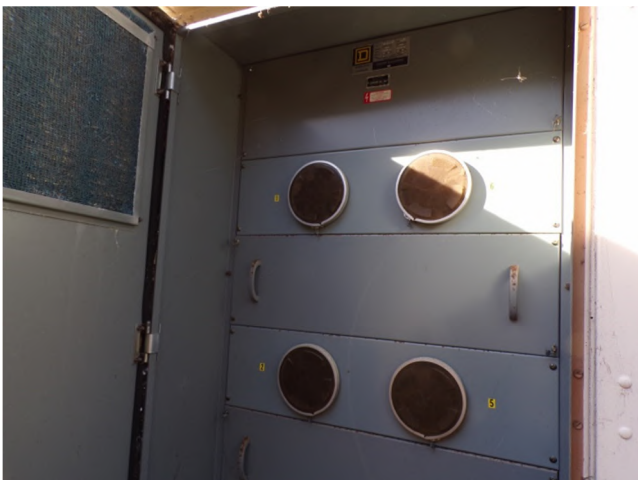
71. Four meter blanks are provided.

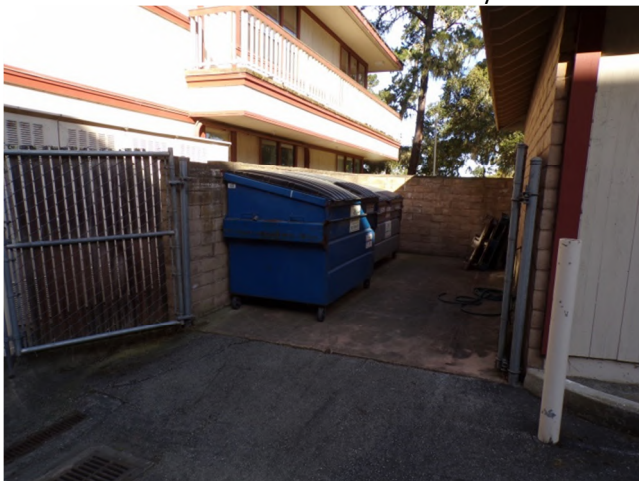
89. The trash enclosure on the east side of the subject building (at left) is shared, likely with the office building on the parcel to the south.

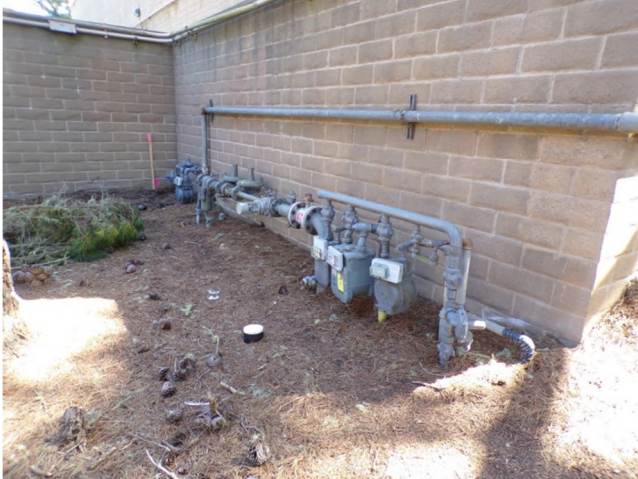
97. Natural gas service is likely supplied from the adjacent parcel to the south.
