## PROPERTY CONDITION ASSESSMENT

345 Middlefield Road, Bldg 15, Menlo Park, CA 94025

ALLWEST PROJECT 25097.60  
June 30, 2025

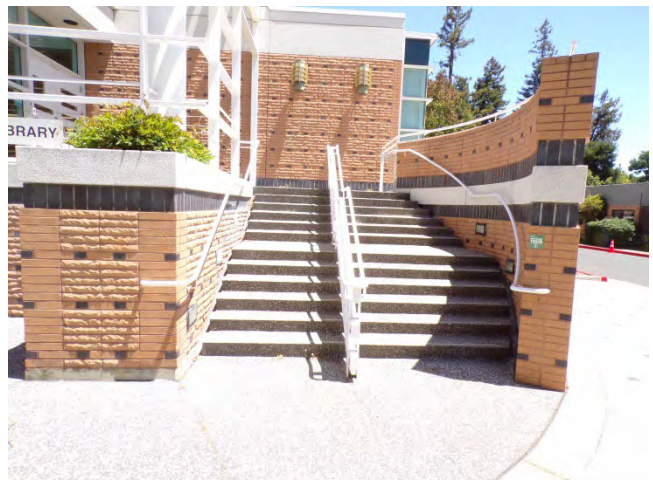
6. Main entrance to library.

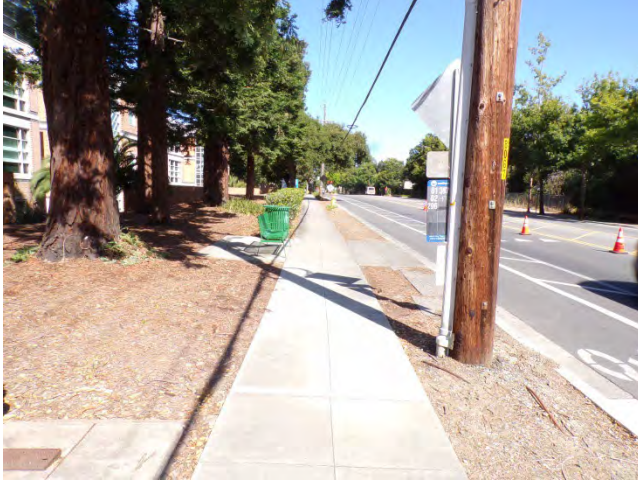
7. Middlefield Road sidewalk, looking west-northwest.

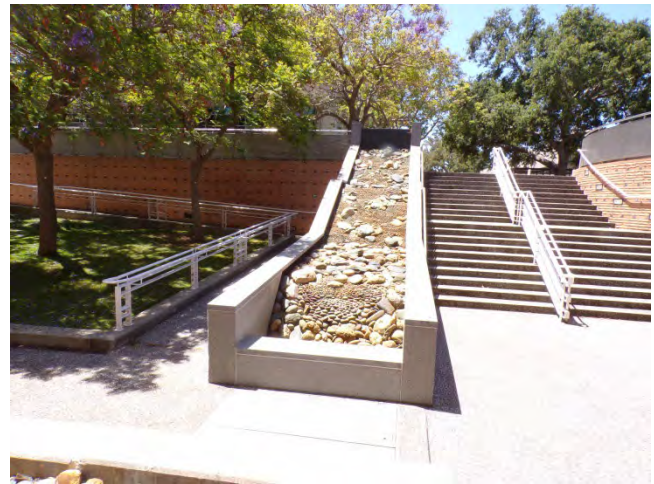
16. Water features are located along the south elevation. None were in operation on the day of our site visit.

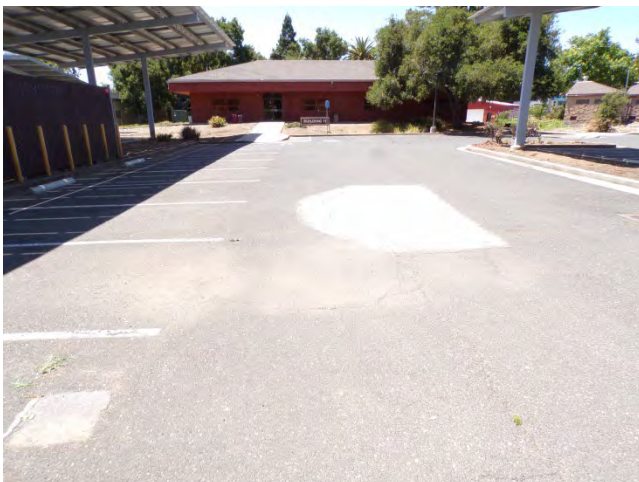
29. Asphalt-paved parking areas are provided in several locations around the subject parcel. The parking areas are outside the scope of work for this project.

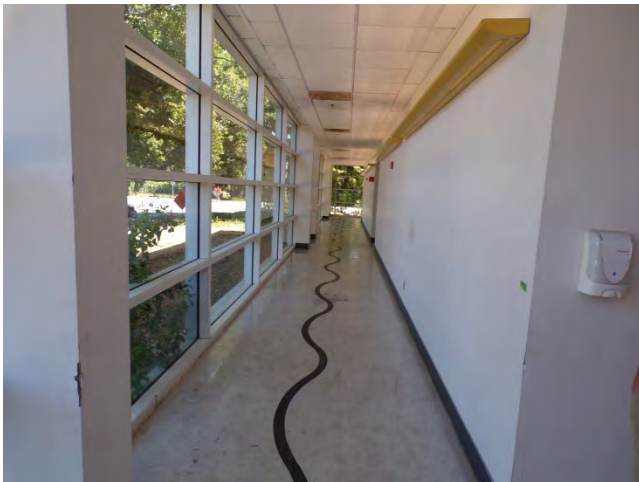
33. Interior finishes and fixtures in a majority of the corridor areas.

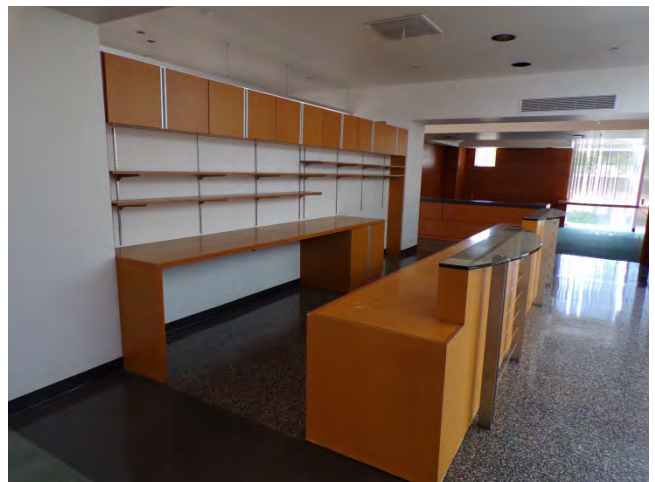
36. Interior finishes and fixtures in library.

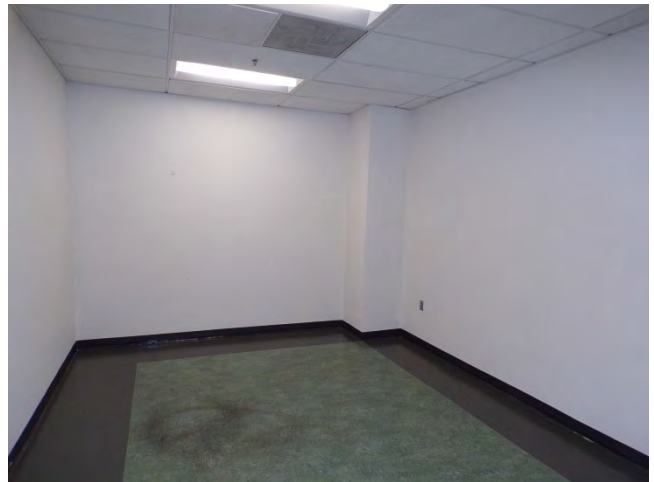
40. Interior finishes and fixtures in office areas.

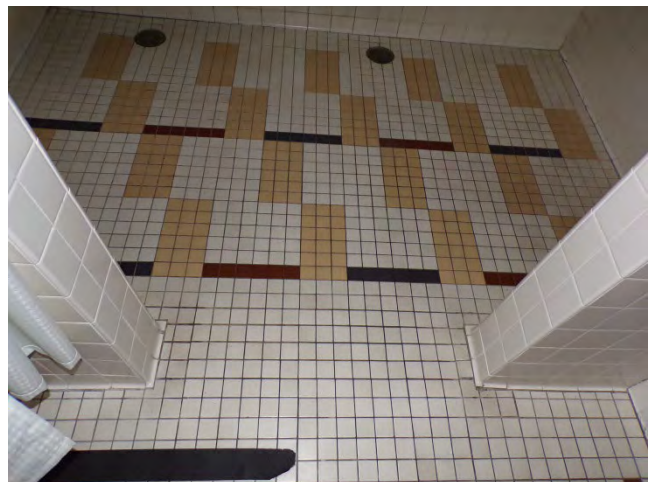
48. Roll-in showers are provided.

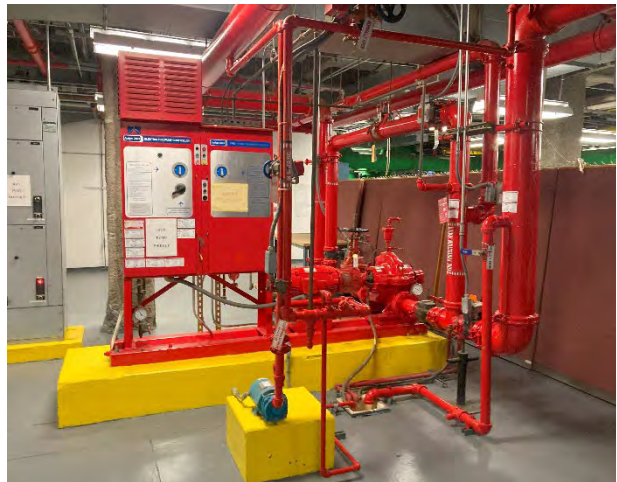
M-17. Fire alarm panel.

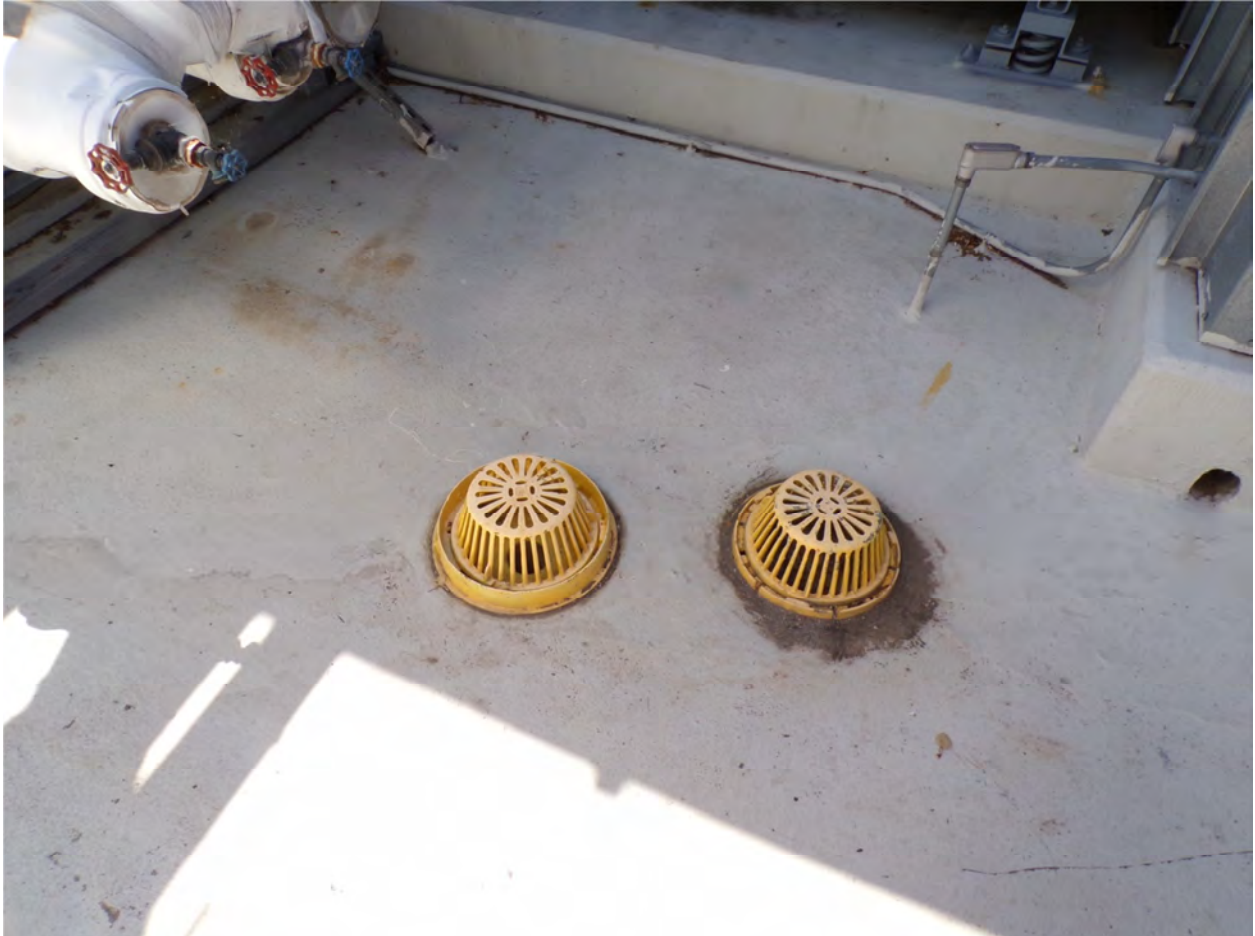
1. Is the roofing system still within its warranty period? **No**
2. If yes to above, can a copy of the warranty be provided? **N/A**
3. Did the roofing systems within the equipment screen areas (see below) receive a coating of some type at one time? This in in the areas where the pea gravel ballast is not installed. **Yes**

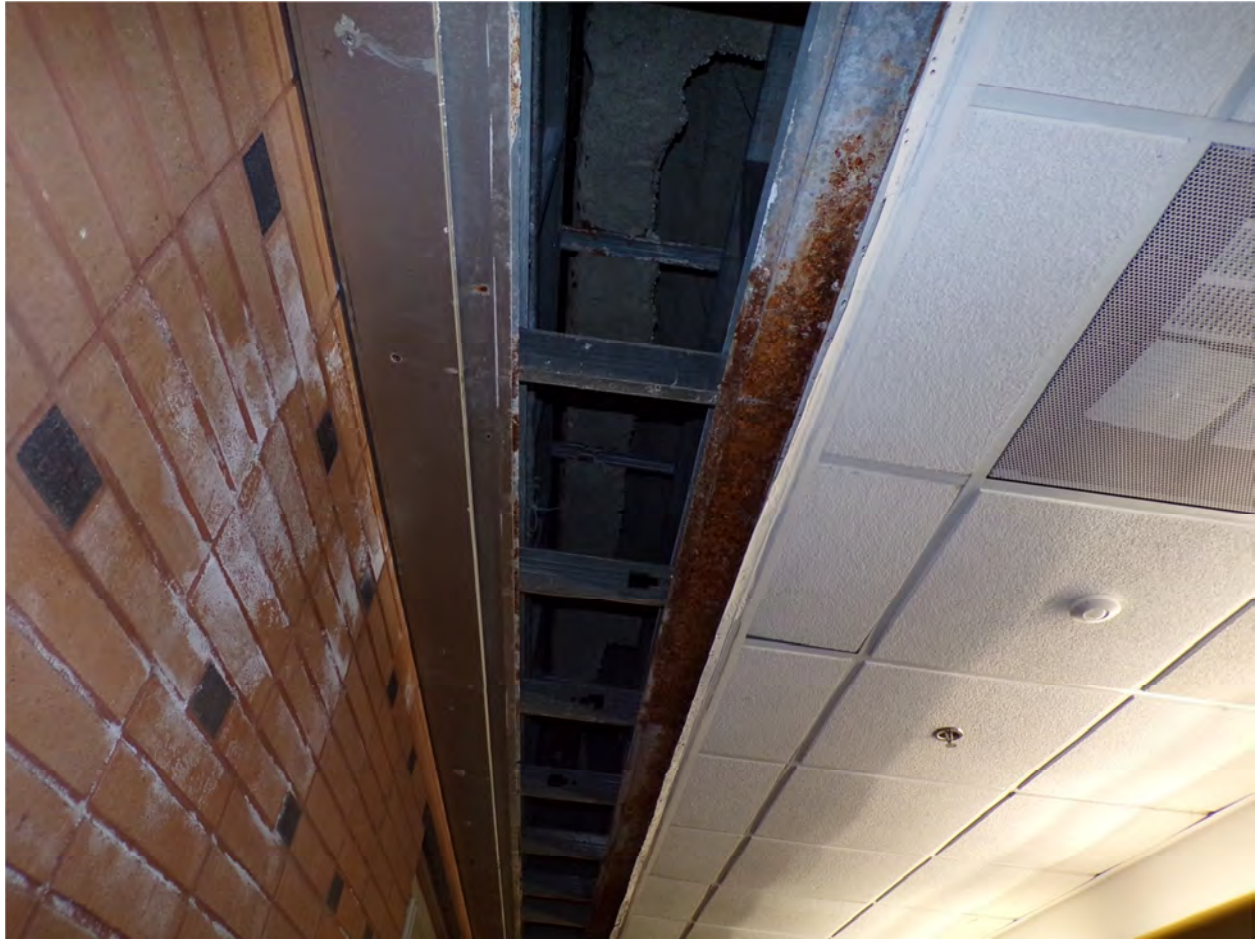
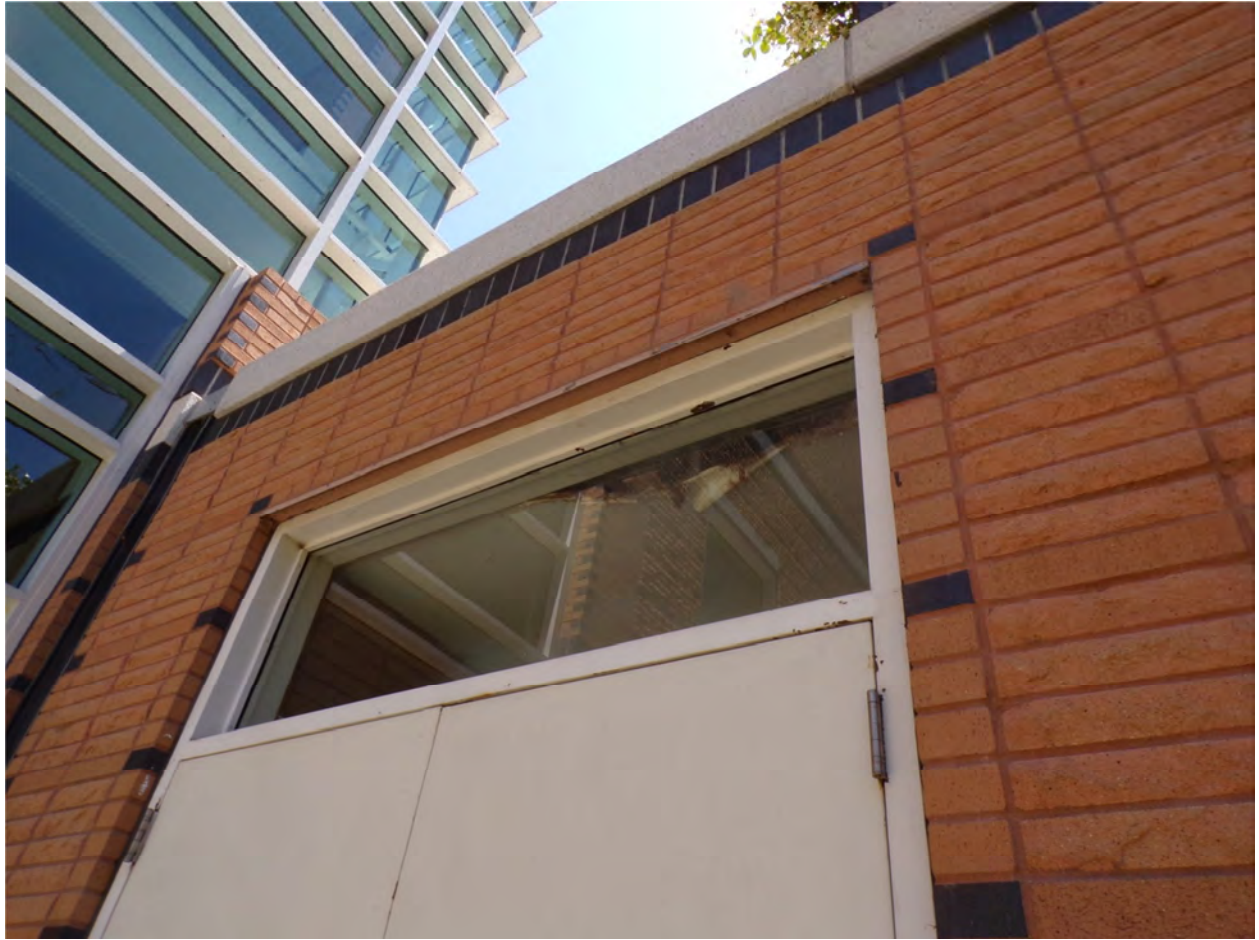
4. What is the age of the roofing system? [30 years old.](#)
5. Are there any known, current leaks though the roofing system? [No known leaks on the roofing system, however there is a leak at the expansion joint on the exterior of the main lobby of building 15 down to the lower level service hallway.](#)

4. Water intrusion damage was observed at ceiling level on the west wall of the short wing of the L-shaped building at the foyer to the west of the main mechanical equipment room. (See following photos.) Has the source of the water been identified? **Leak is rain water run off from the expansion joint located at the exterior of the main lobby. The leak travels down to the lower level service hallway.**
5. And have remedial measures been taken to address the source of the leak described above? **Aside from providing a catch to prevent water from getting on to the floor, no remedial measures were taken.**
