## PROPERTY CONDITION ASSESSMENT

2030 Harrison Street, San Francisco, CA 94110

PROJECT 26008.61  
May 1, 2026

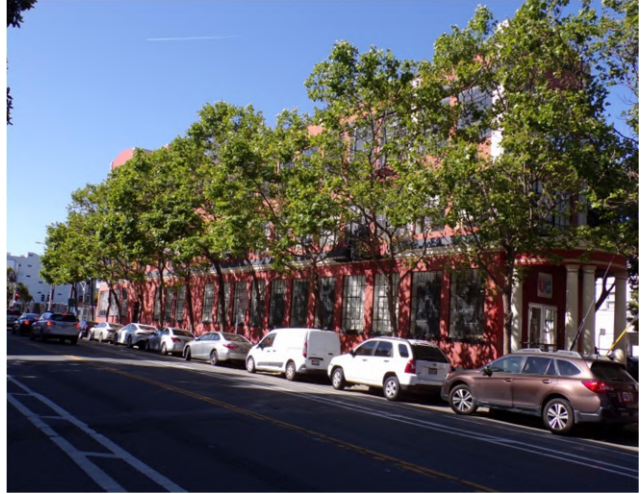
2. East elevation along Harrison Street.

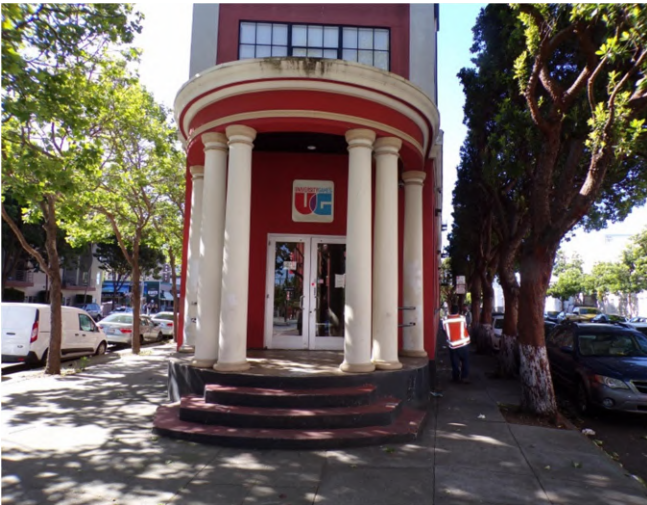
3. Lower portion of the north elevation and primary pedestrian entrance.

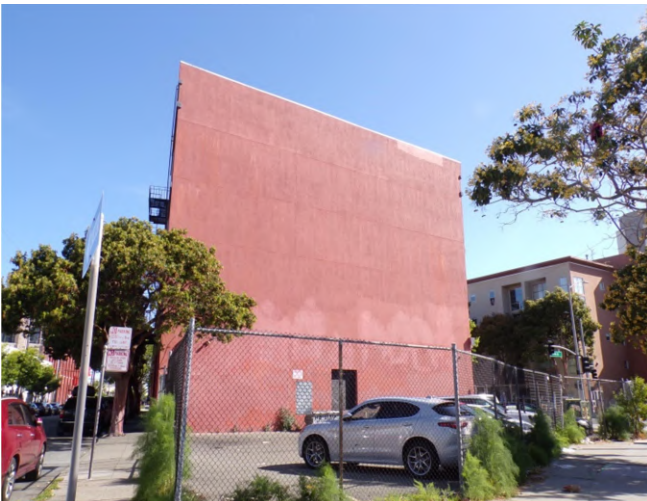
5. South elevation along 17<sup>th</sup> Street.

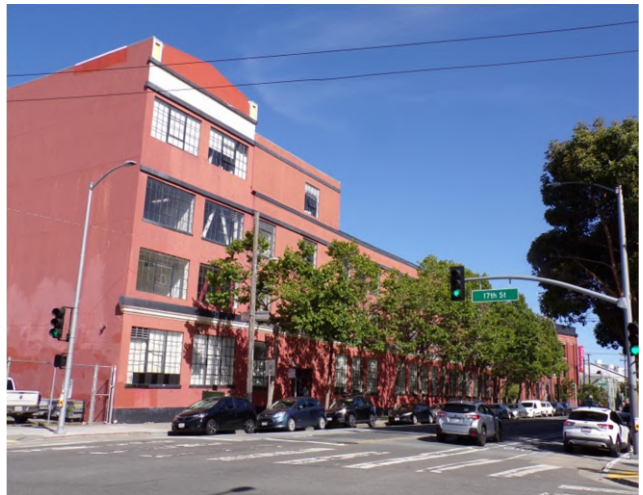
6. East elevation with partial fourth floor and stairwell penthouse shown.

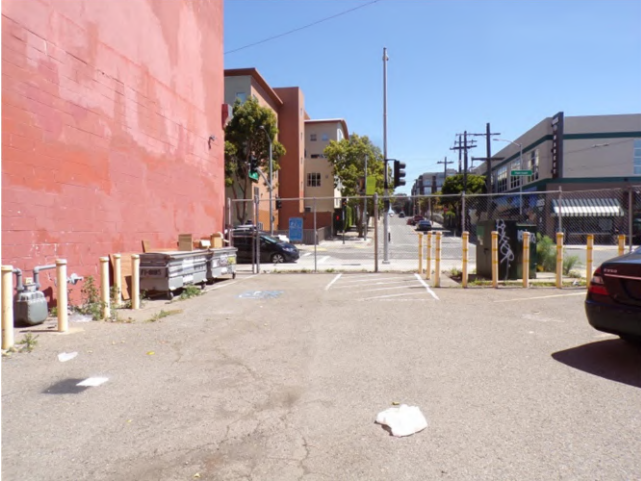
7. The small parking lot is located on the south end of the parcel. Accessible parking stall and access aisle in background.

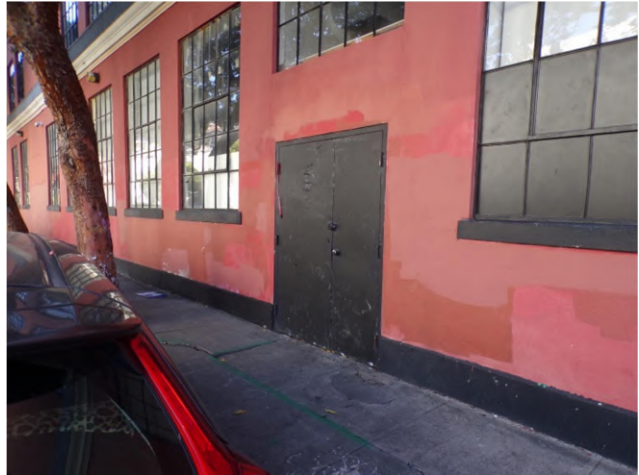
14. Painted service doors on west elevation.

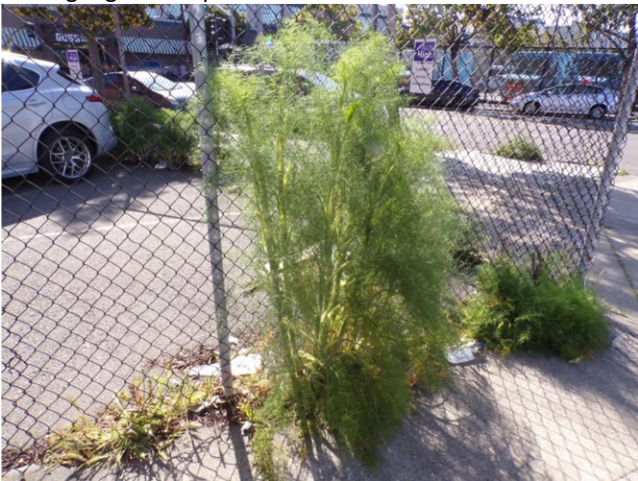
15. Volunteer vegetation should be removed as part of routine maintenance.

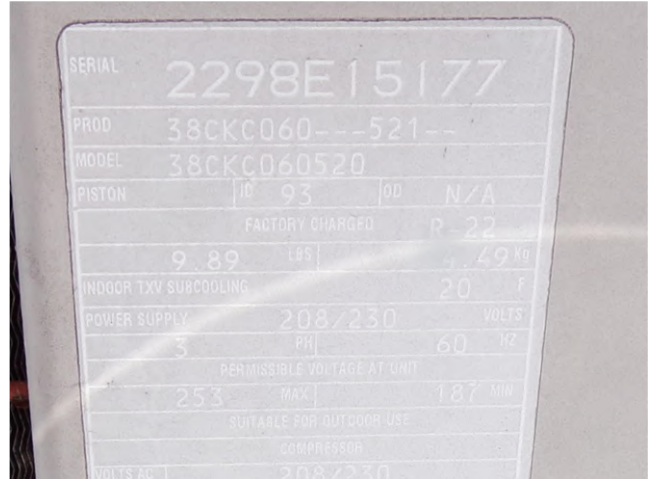
44. Both Carrier split systems were manufactured in 1998.

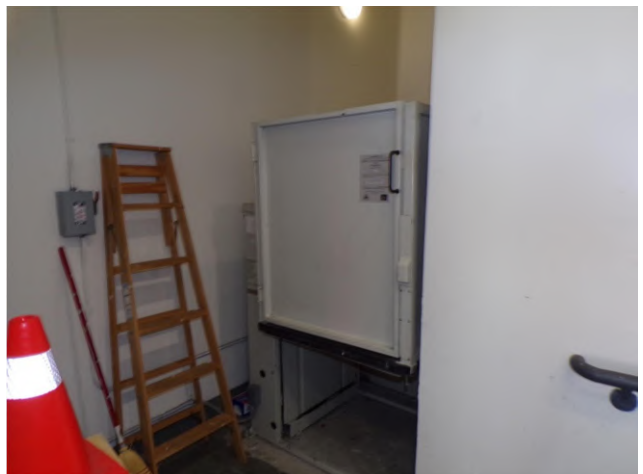
66. Wheelchair lift.

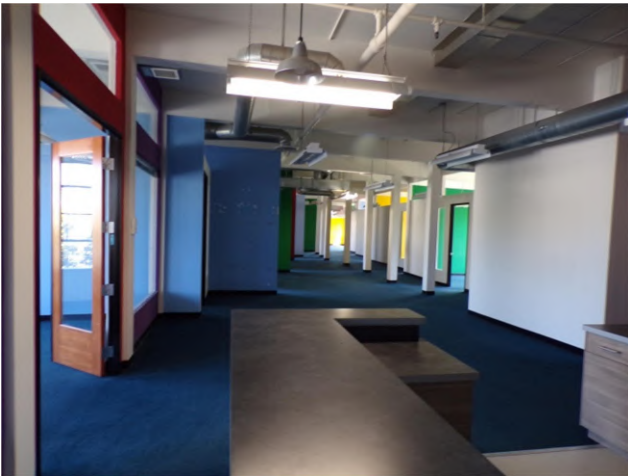
75. Third floor: Interior finishes and fixtures in open office area.

| No | Sec | Photos | | Avg EUL (yr) | EFF AGE (yr) | Nominal RUL (yr) | Quantity | Unit | Cost Estimate Source | Unit Cost | Immediate Needs | Replacement Reserves | | | | | Years 1-5 Cumulative | Modernization Costs (Optional) | | | | | |
|---|---|---|---|---|---|---|---|---|---|---|---|---|---|---|---|---|---|---|---|--|--|--|--|
| 15 | G. | 67-94 | Allowance for performance of minor repairs and general renovation of interior finishes. | N/A | N/A | N/A | 1 | LS | Allowance | \$50,000.00 | | | | | | | | | | | | | |

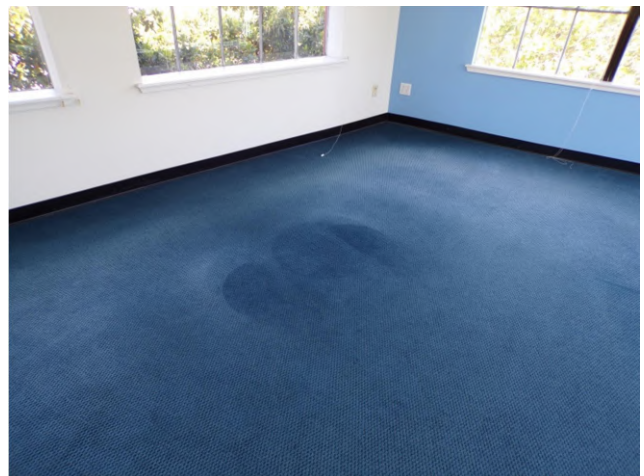
78. Third floor: Interior finishes in private office.

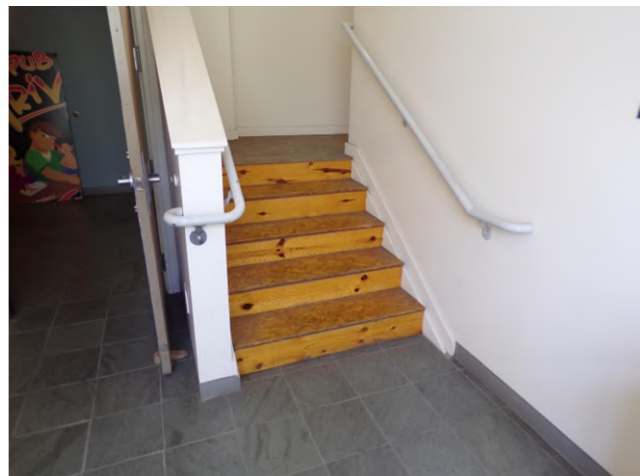
84. Service stairs.

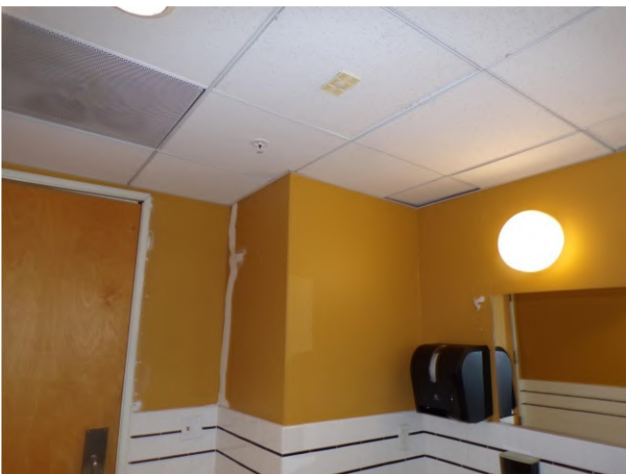
89. Interior finishes and fixtures in restrooms.
