# AllWest Environmental

## PROPERTY CONDITION ASSESSMENT

**5601 & 5733 San Leandro Street, Oakland, California 94621**

**ALLWEST PROJECT 22183.60  
February 10, 2023**

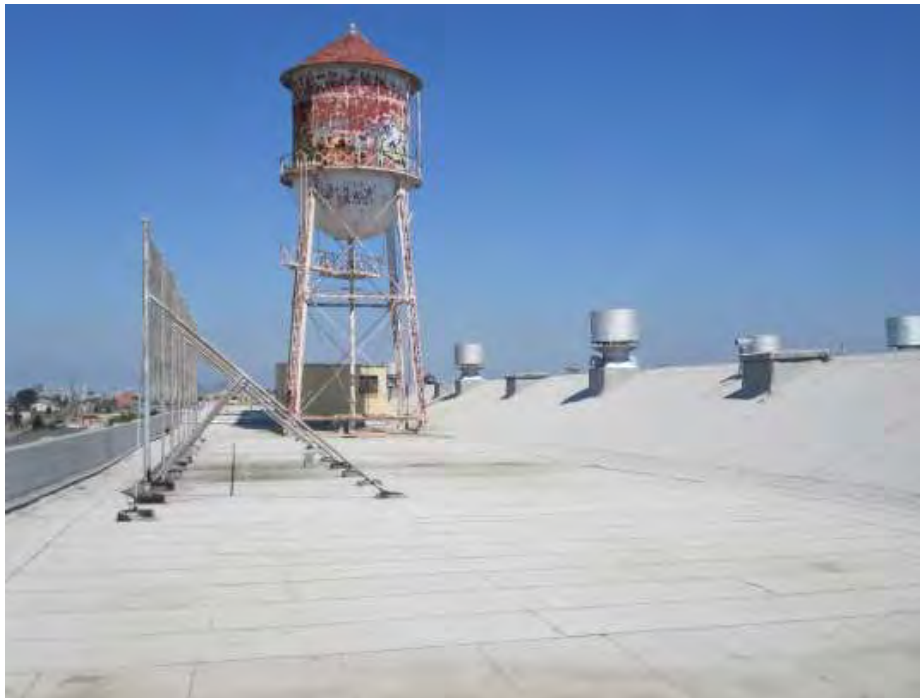
8. The steel framed water tower on the main building roof.
