## PROPERTY CONDITION ASSESSMENT

870 Santa Cruz Avenue, Menlo Park, CA 94025

ALLWEST PROJECT 24117.60  
October 11, 2024

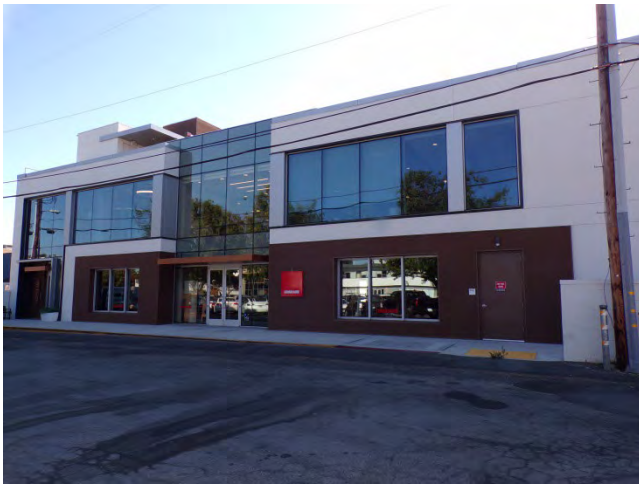
3. West elevation.

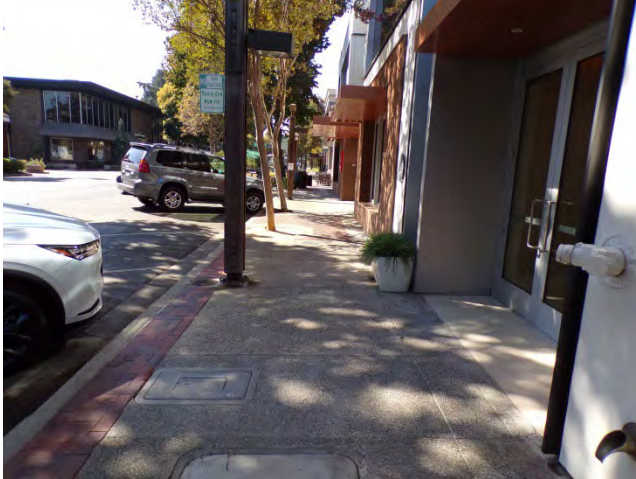
7. View along Santa Cruz Avenue sidewalk, looking south.

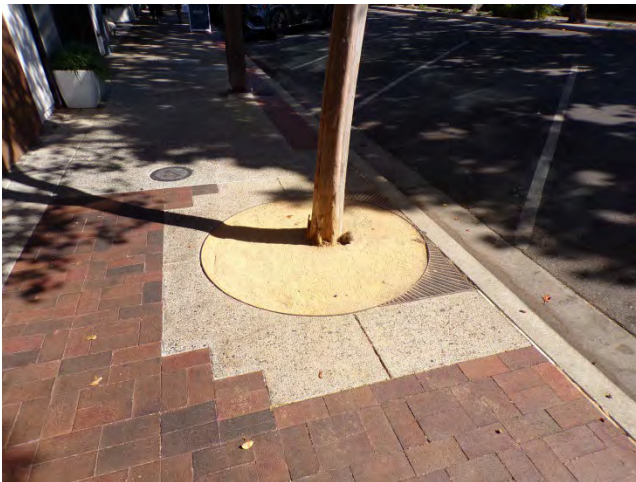
9. The sidewalk along Santa Cruz Avenue combines concrete panels and brick pavers.

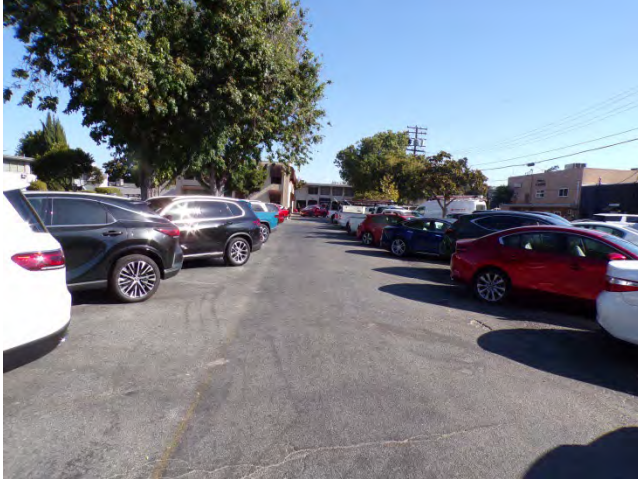
13. The parking lot behind the building is owned by the City.

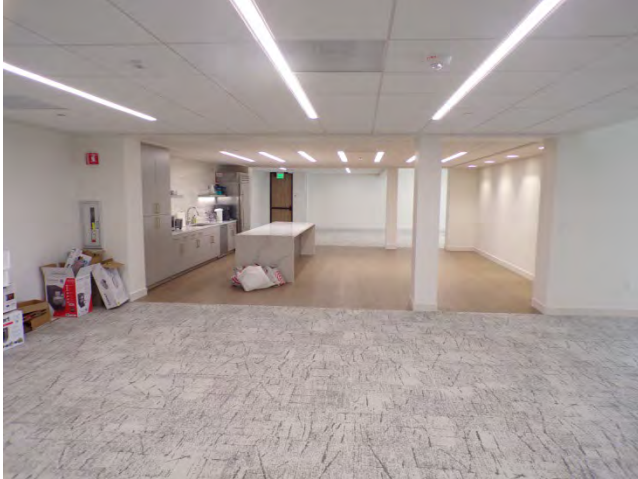
31. Suite 201: Interior finishes and fixtures. The suite is leased, though still unoccupied.

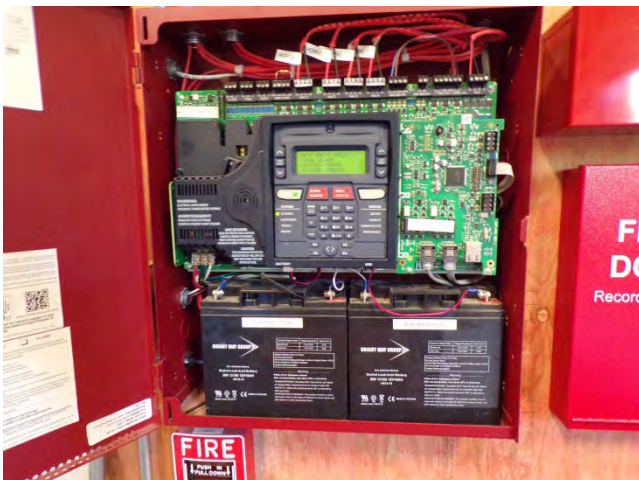
77. The FACP is a FireLite model ES-200, installed in 2022.
