### PROPERTY CONDITION ASSESSMENT

## 2 & 8 Medical Plaza Drive, Roseville, CA 95661

**PROJECT 26006.60**  
**April 13, 2026**

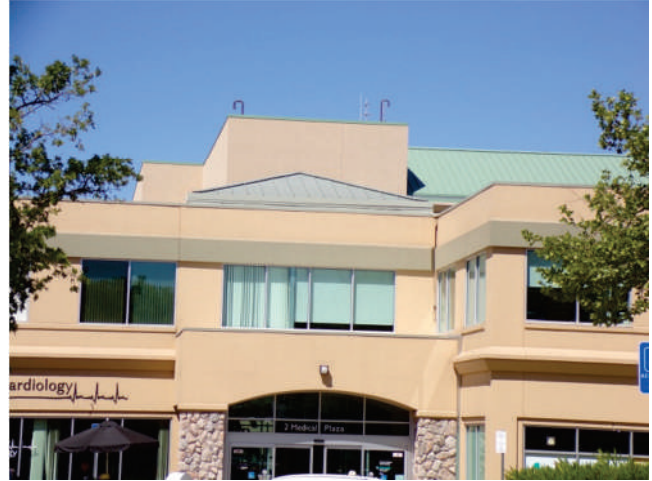
62. MOB 2: The mansards are assumed to date to original construction.

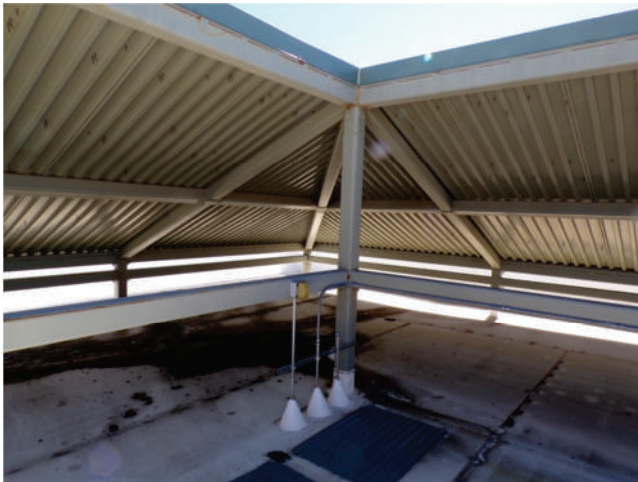
69. MOB 2: The mansards have a significantly different design on the two subject buildings.

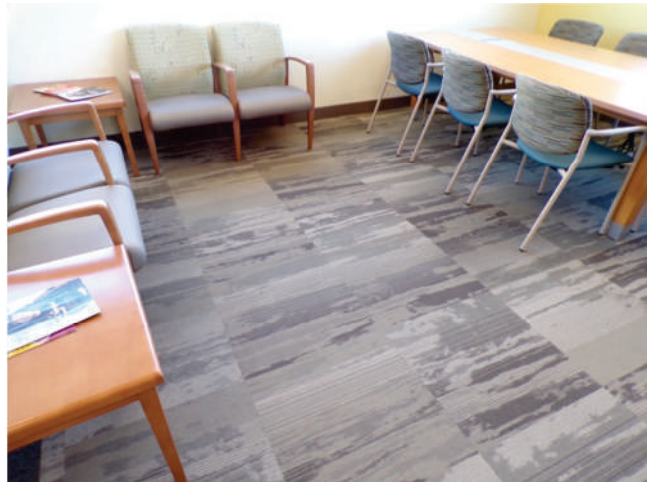
94. MOB 8: Interior finishes and fixtures in waiting rooms.
