## PROPERTY CONDITION ASSESSMENT

La Bahia Hotel & Spa, 215 Beach Street, Santa Cruz, CA 95060

ALLWEST PROJECT 26004.60  
February 6, 2026

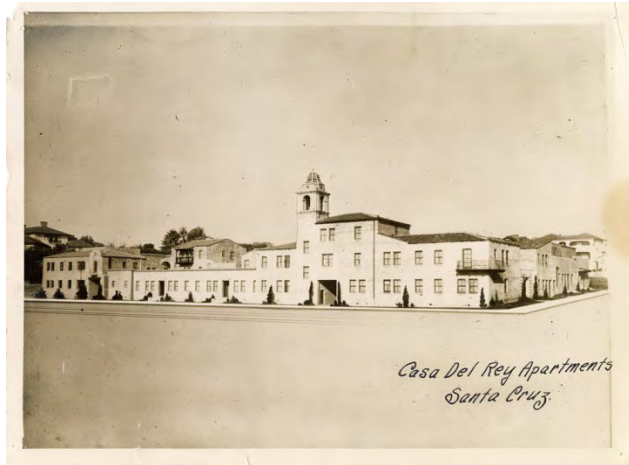
1. The Casa del Rey Apartments once occupied the site. The southwest portion of the building (near the bell tower) was retained and rehabilitated as part of the current hotel.

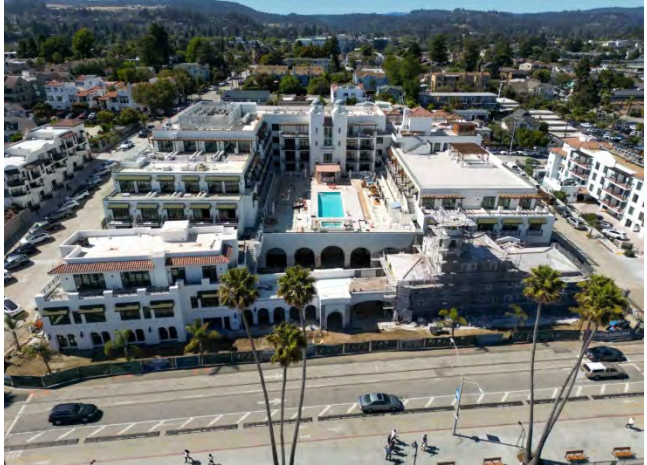
2. Construction completion of the new portion of the hotel was completed in 2025.

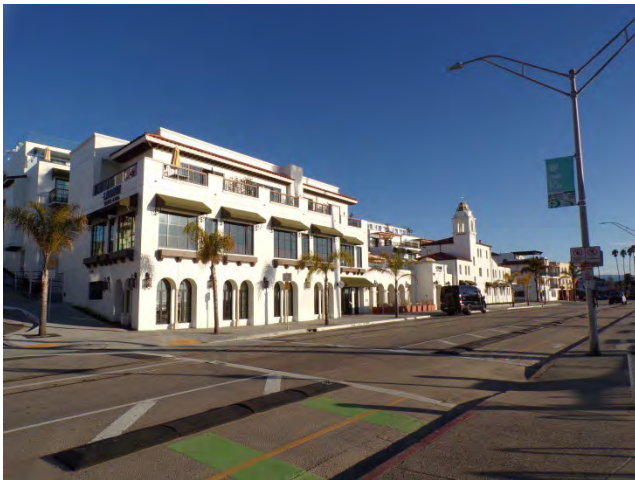
3. South elevations along Beach Street. Tower Bldg in background right.

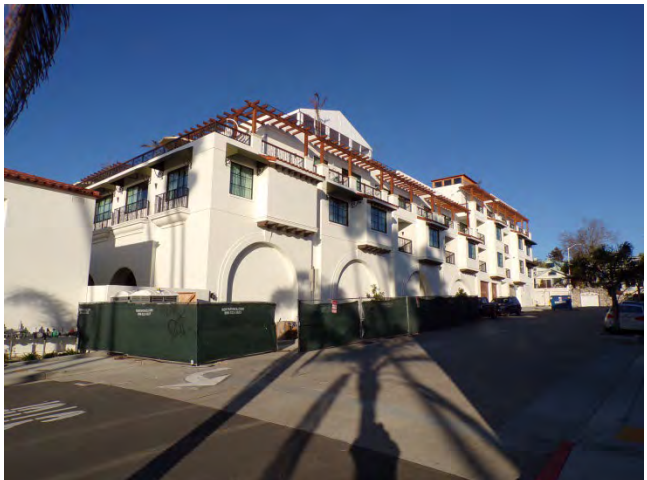
4. Main Bldg: East elevation.

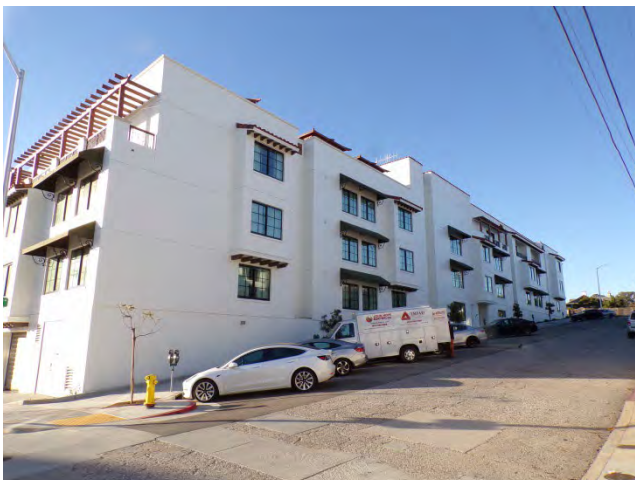
5. Main Bldg: North elevation.

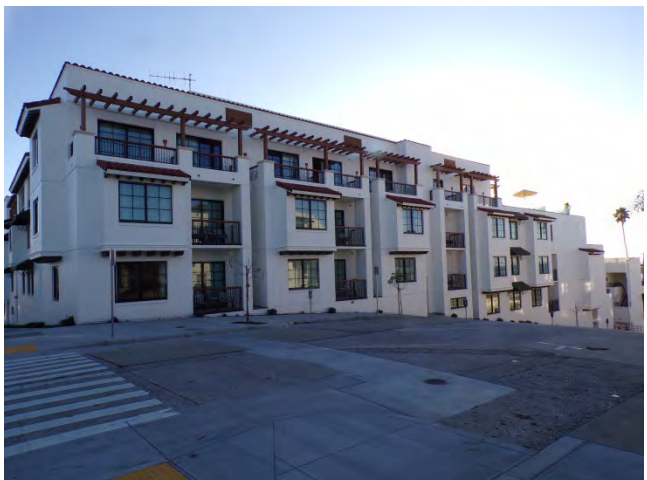
6. Main Bldg: West elevation.

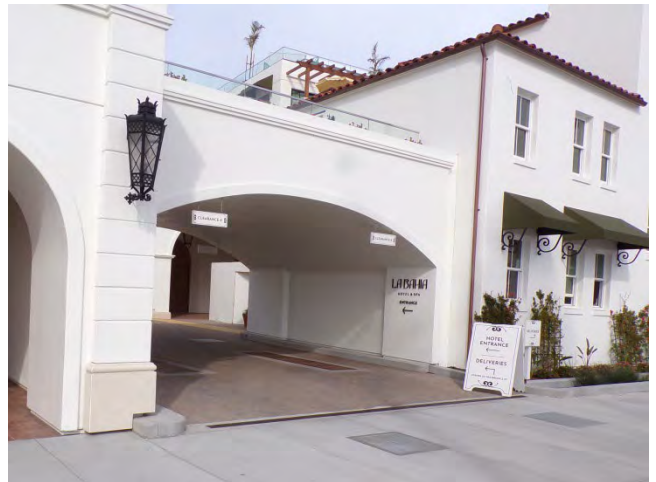
10. Primary vehicular entrance along Beach Street.

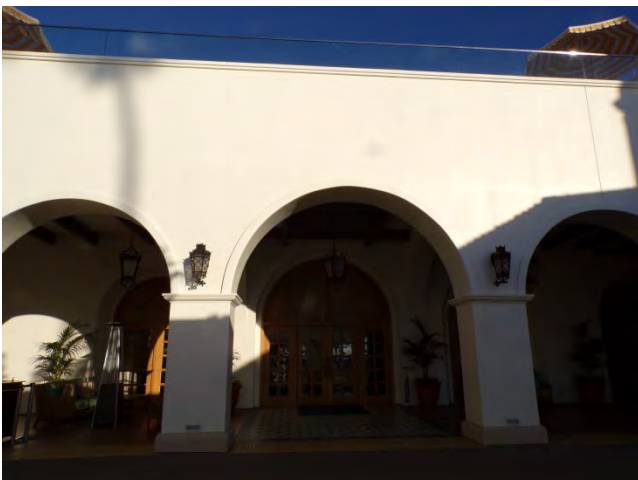
11. Main Bldg: Primary pedestrian building entrance.

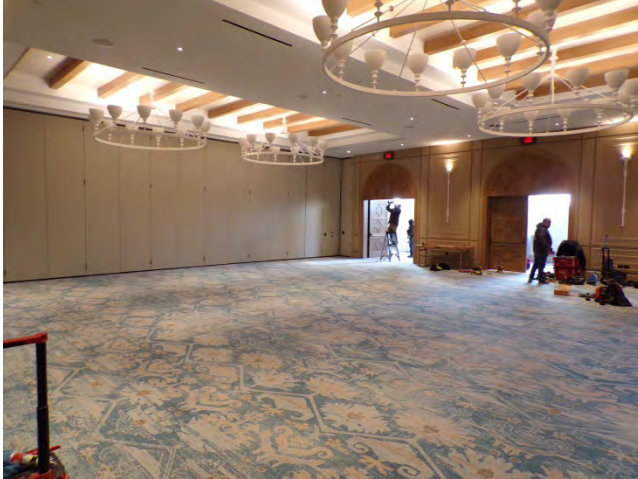
25. Main Bldg: Interior finishes and fixtures in ballroom.

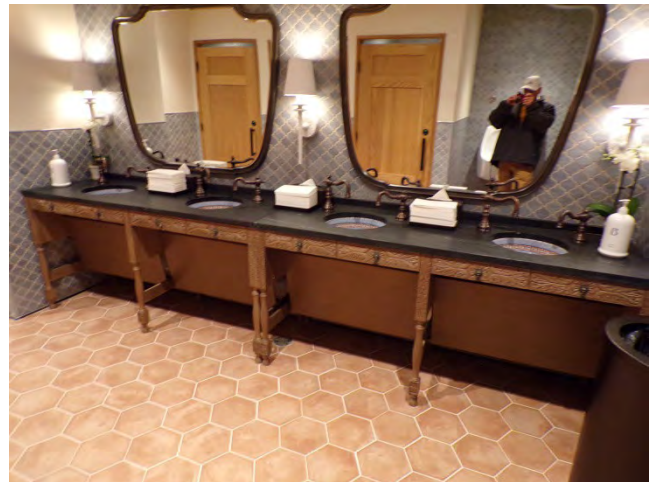
88. Main Bldg: Interior finishes and fixtures in restrooms.

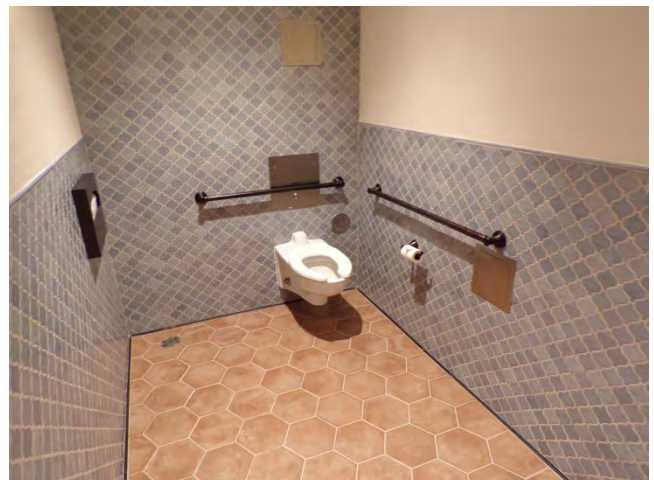
90. Main Bldg: Interior finishes and fixtures in restrooms.

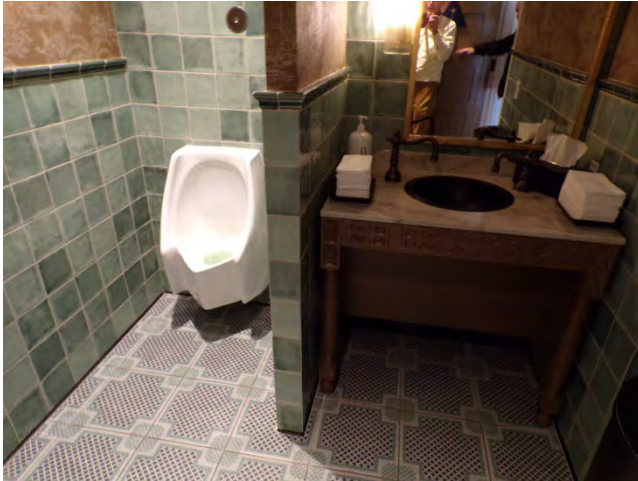
91. Main Bldg: Interior finishes and fixtures in restrooms.

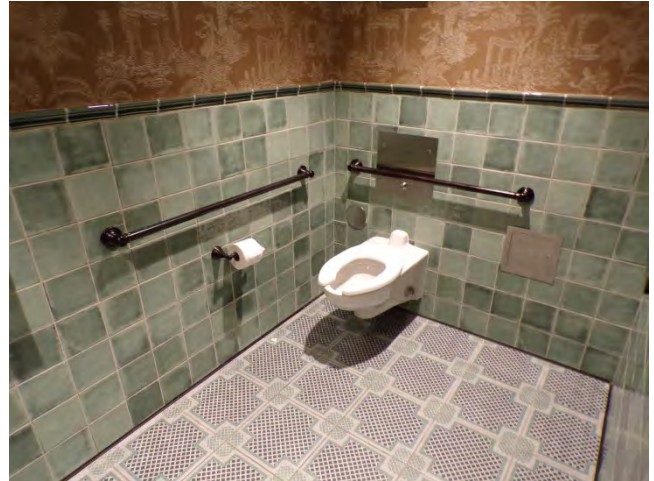
92. Main Bldg: Interior finishes and fixtures in restrooms.
