## PROPERTY CONDITION ASSESSMENT

**Sonoma Country Day School, 4400 Day School Place  
Santa Rosa, CA 95403**

**ALLWEST PROJECT 22088.60  
November 9, 2022**

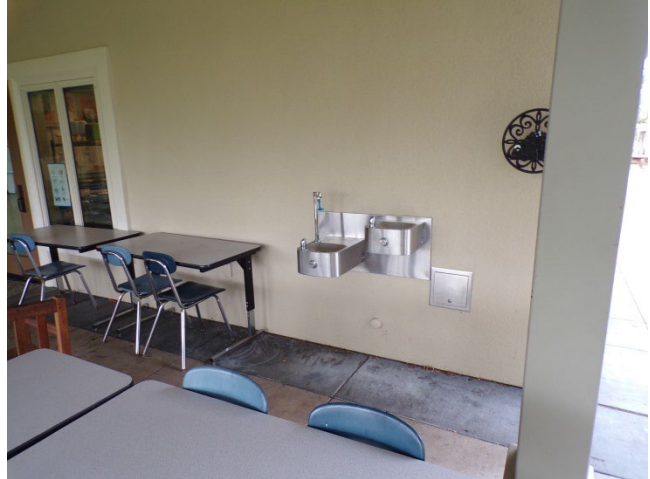
86. All observed water fountains are high-low combinations.

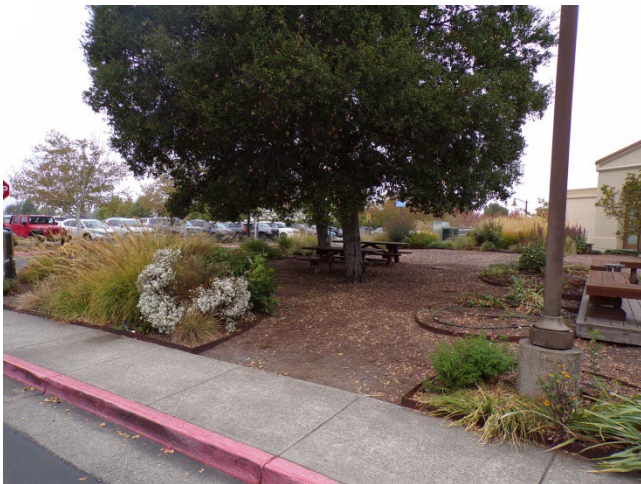
87. In some landscaped areas, the wood chips require renewal; this is a matter of routine maintenance.

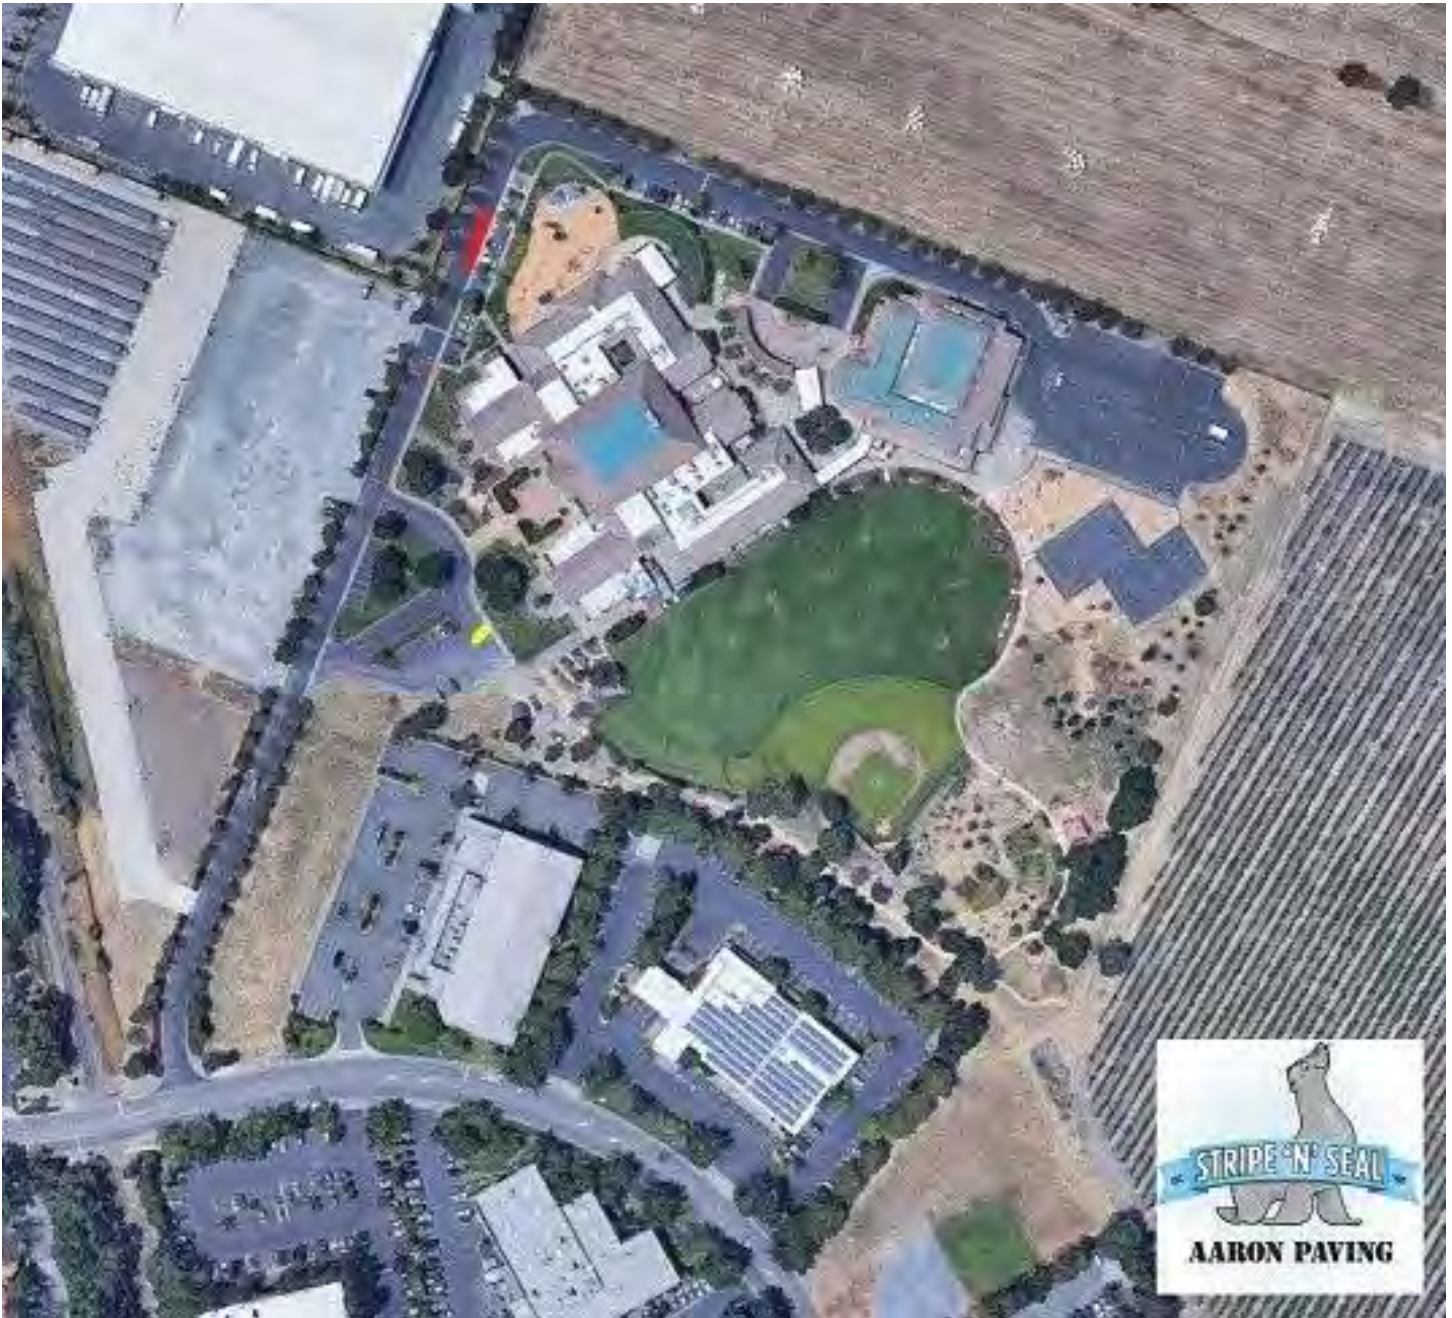
## Asphalt Repair Site Plan

| Item | Description | Cost |
|---|---|---|
| 1. | Asphalt Repair (Red Areas- See Site Plan) | \$8,400.00 |
| 2. | Asphalt Repair (Yellow Area- See Site Plan) | \$1,827.00 |

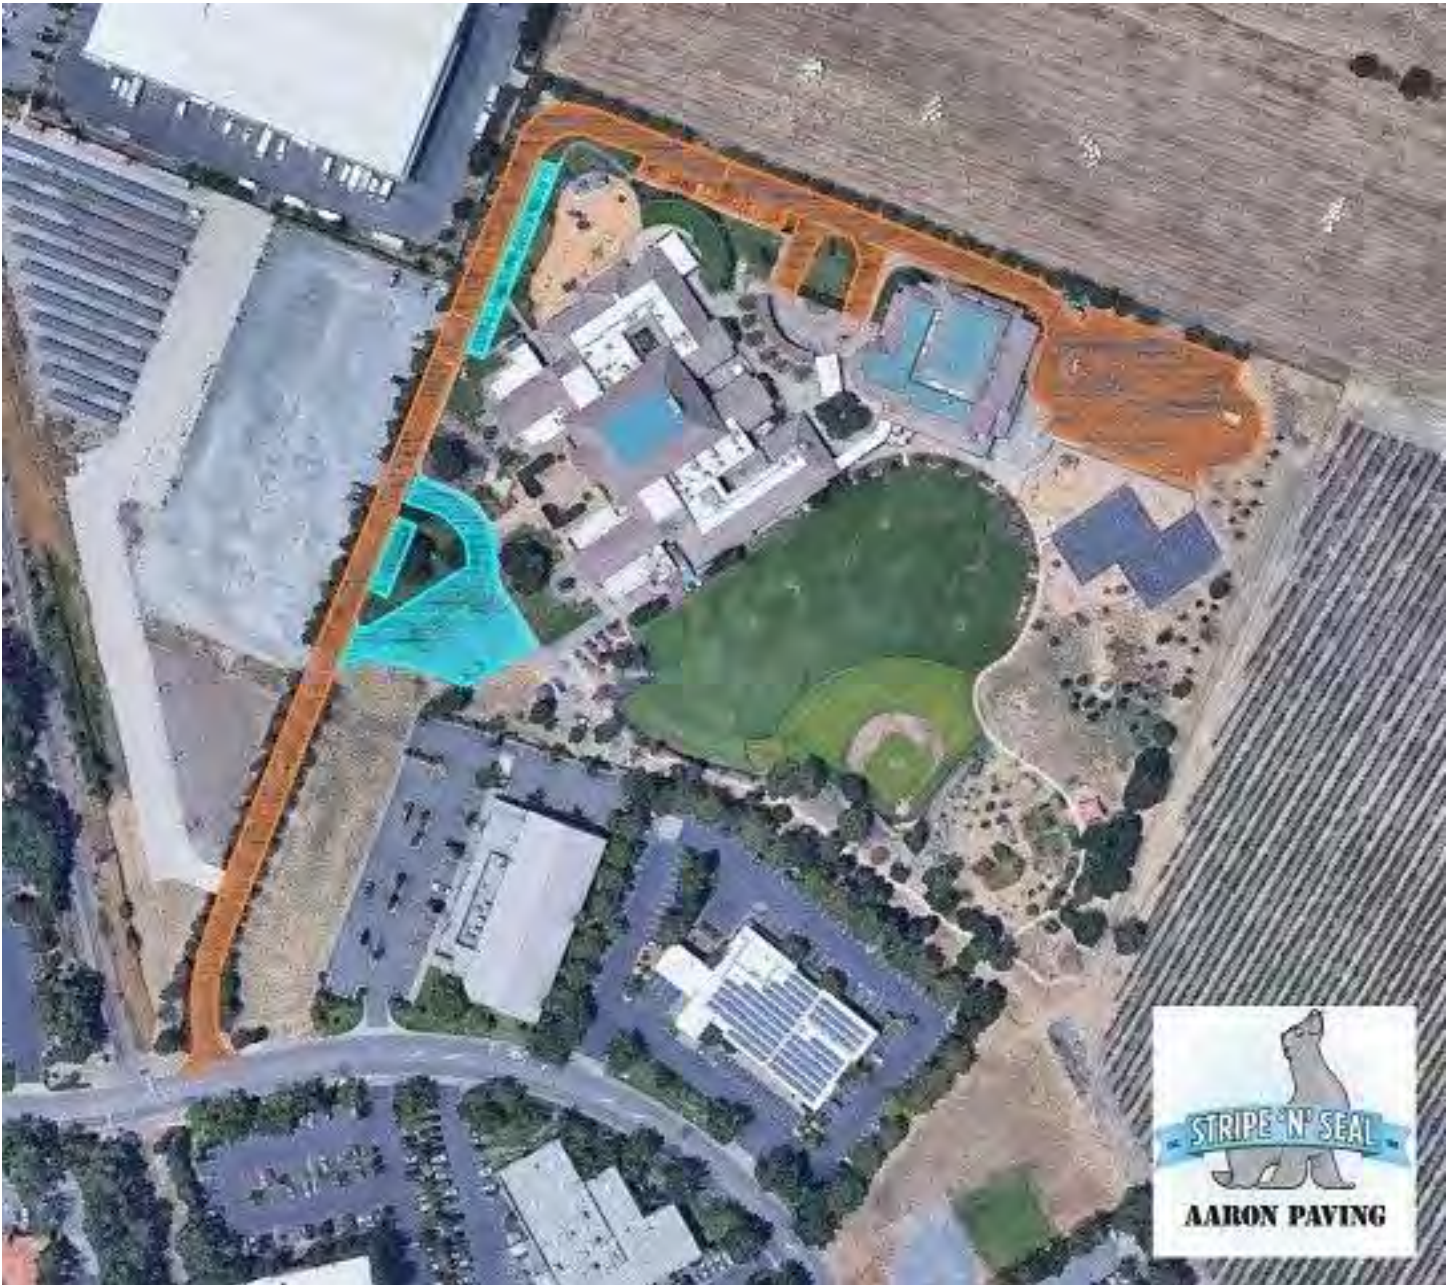
## Asphalt Seal Site Plan

| Item | Description | Cost |
|---|---|---|
| 6. | Crack Seal Sealcoat and Stripe Blue Area (See Site Plan) | \$5,980.00 |

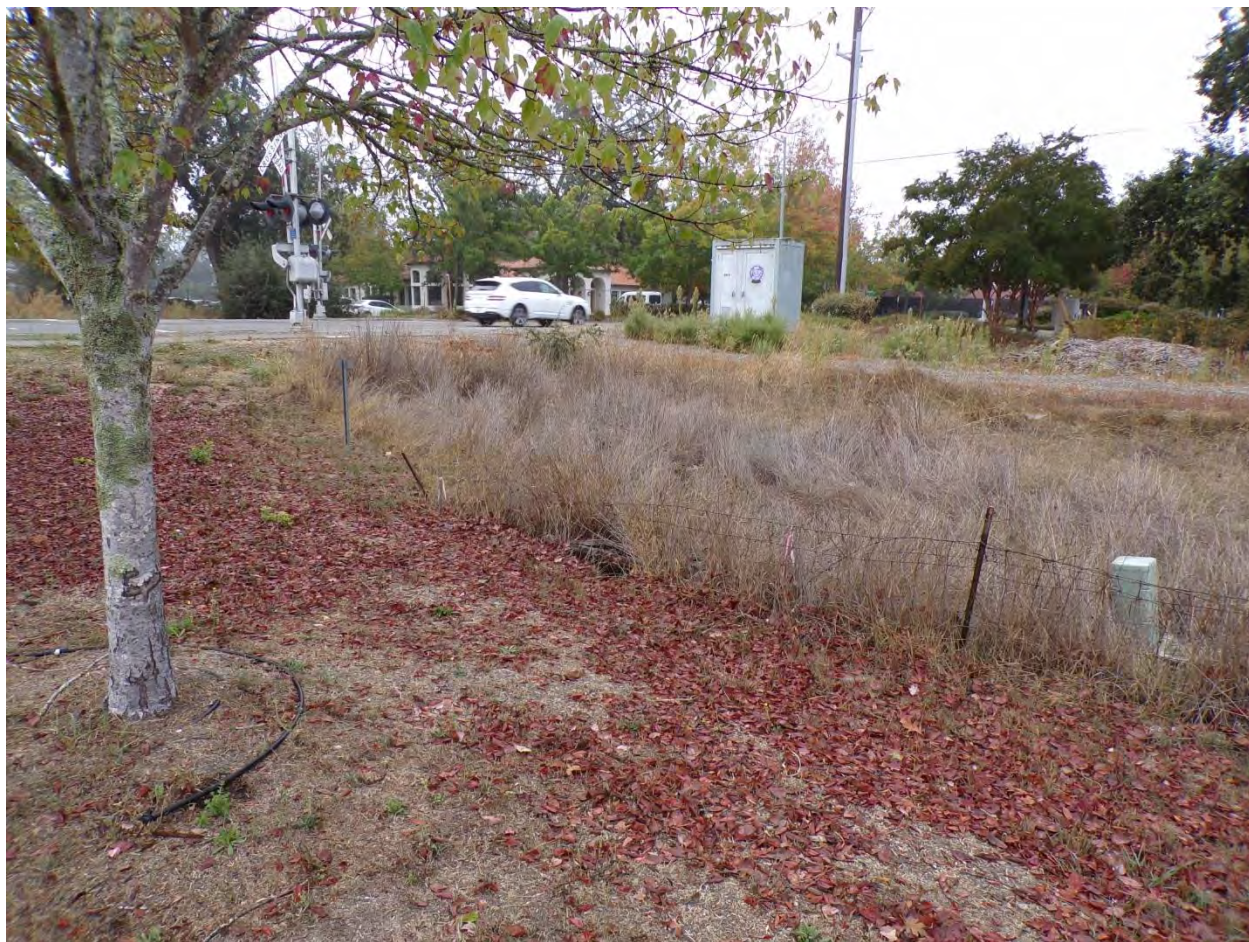
21. There is a dilapidated wire fence along the western edge of the site adjacent to the deactivated railroad tracks (see photo below). Who has financial responsibility for that fence? **Unknown**
