## PROPERTY CONDITION ASSESSMENT

**Our Lady of Loretto Church & School, 1806 Novato Boulevard  
Novato, CA 94947**

**ALLWEST PROJECT 23017.60  
February 27, 2023**

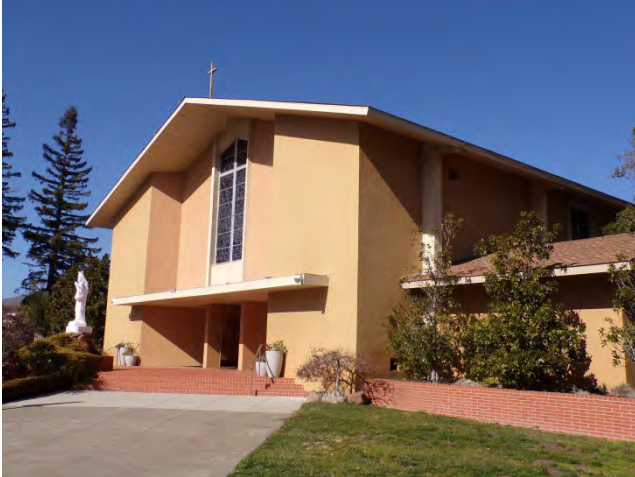
1. Church: The main entrance is located along the south elevation.

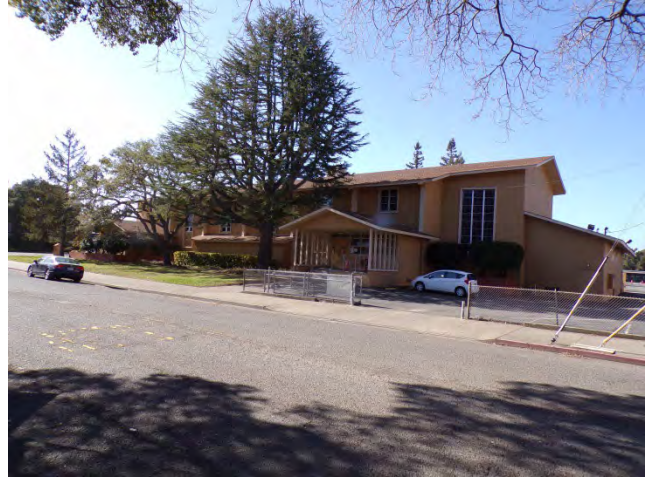
2. Church: East elevation at left; portion of north elevation can be seen at right.

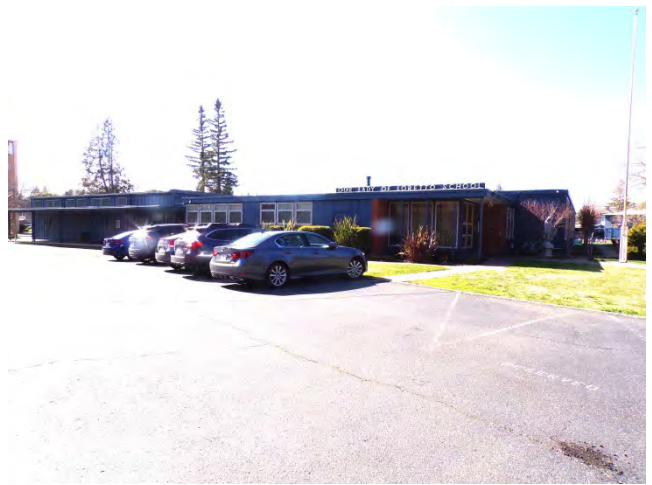
10. School: East elevation.

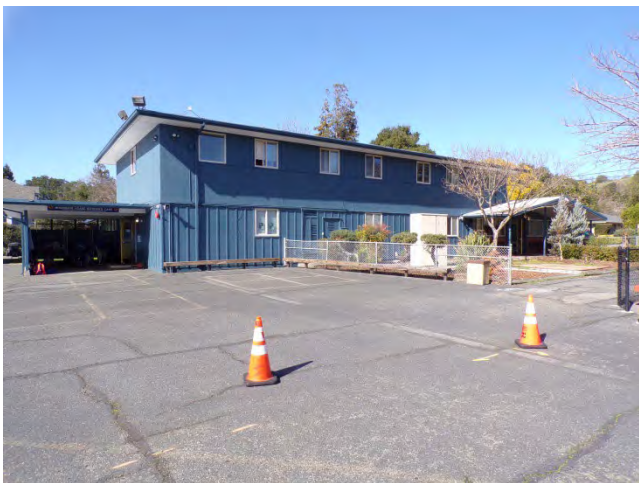
11. Convent: East elevation. South elevation at far left.

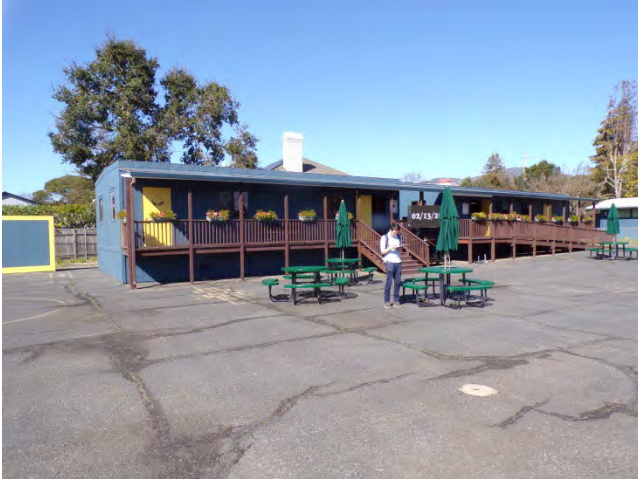
13. Mod Bldg S at left; Mod Bldg N at right.

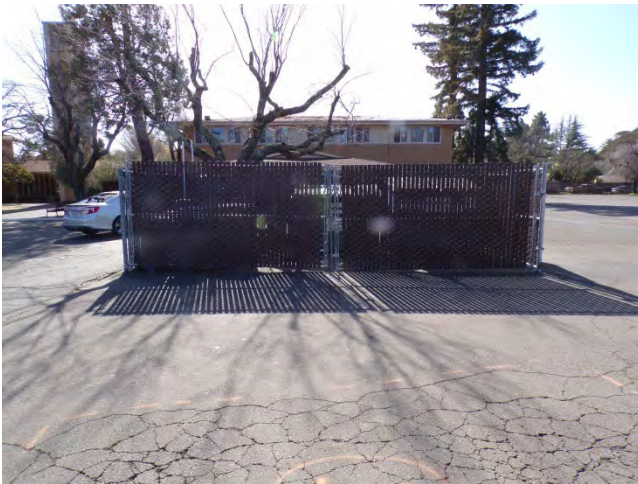
15. The trash enclosure is located to the north of the Rectory (in background).

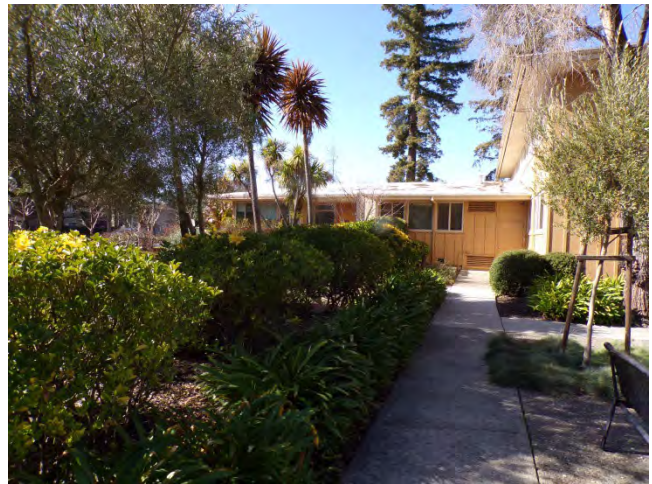
16. Landscaping between the Church and the Rectory (in background).

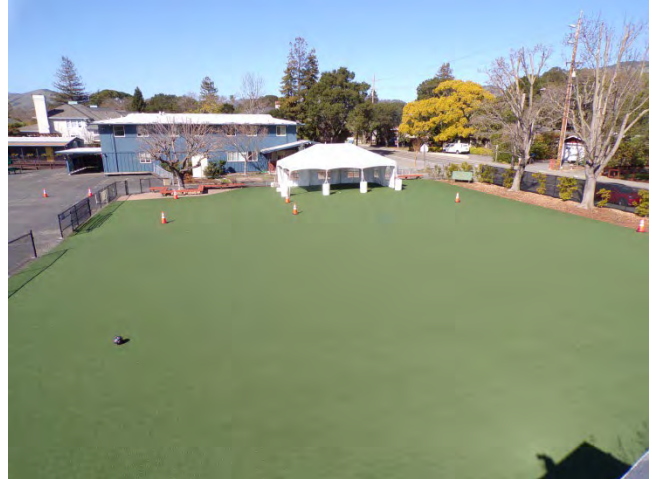
26. A play area with synthetic grass is located between the Convent (in background) and the School.

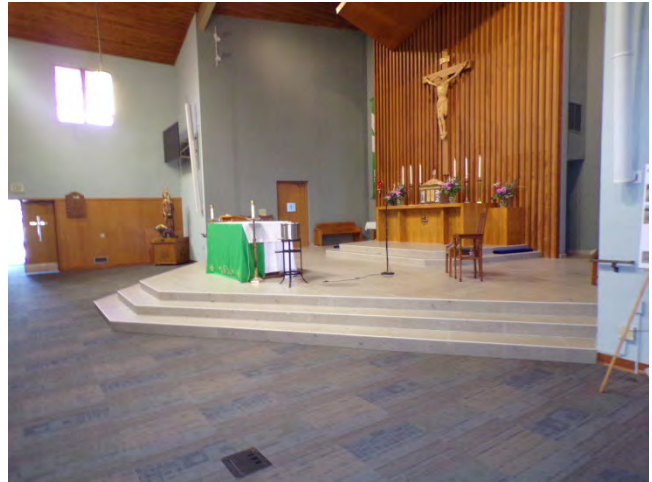
46. Church: Interior finishes and fixtures at chancel.

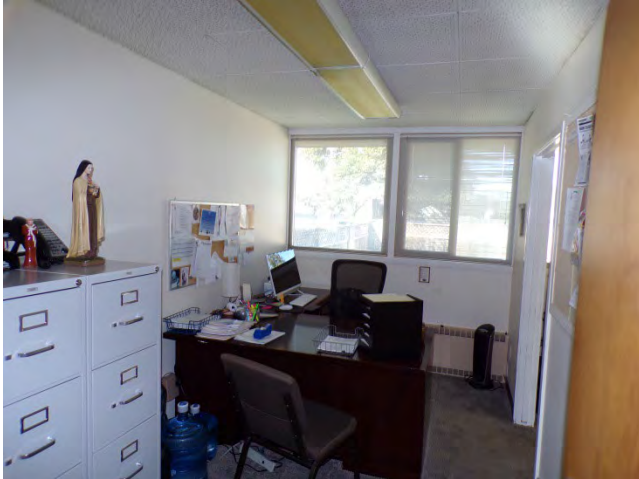
49. Rectory: Interior finishes and fixtures in private office.

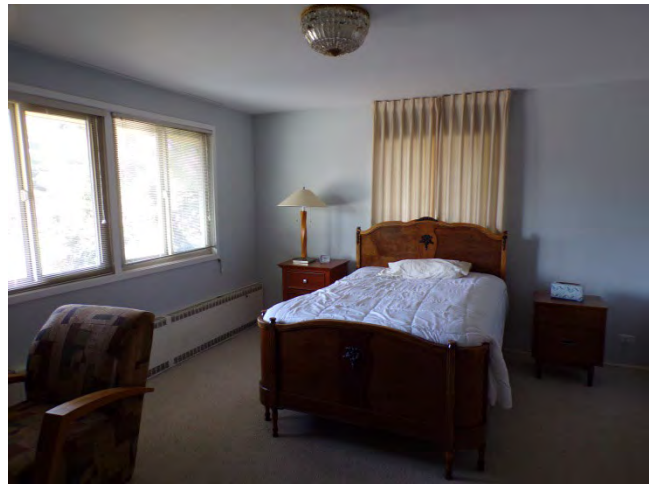
52. Rectory: Interior finishes and fixtures in residential unit.

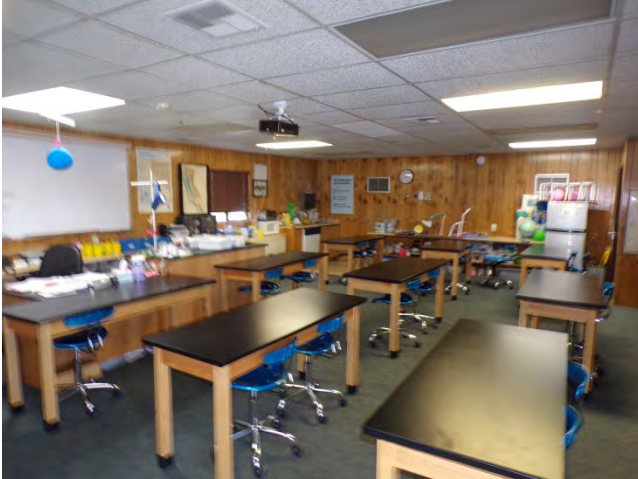
67. Mod Bldg N: Interior finishes and fixtures in classroom.

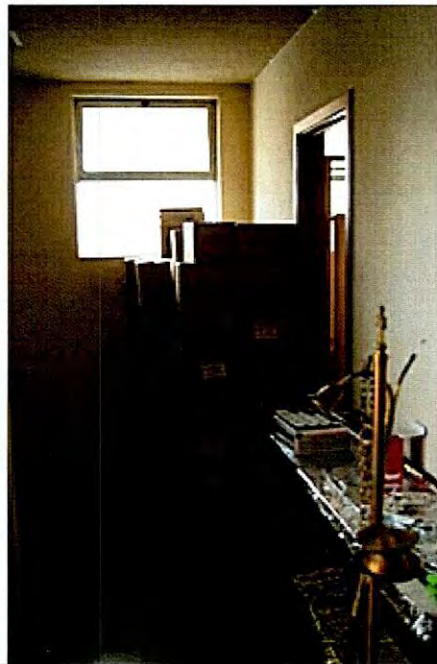
Notes: **Flower room**

Status: **Deficiency**

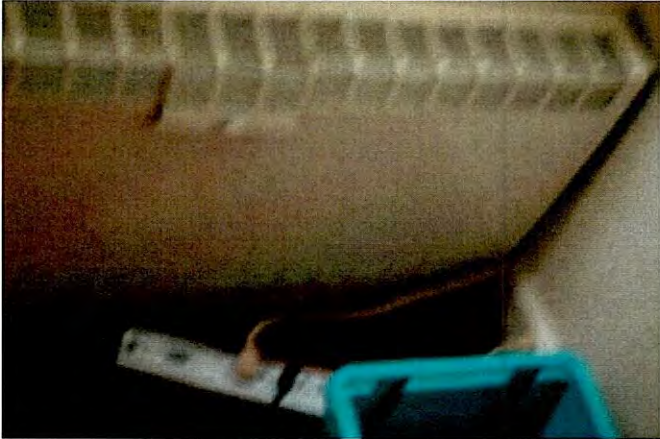
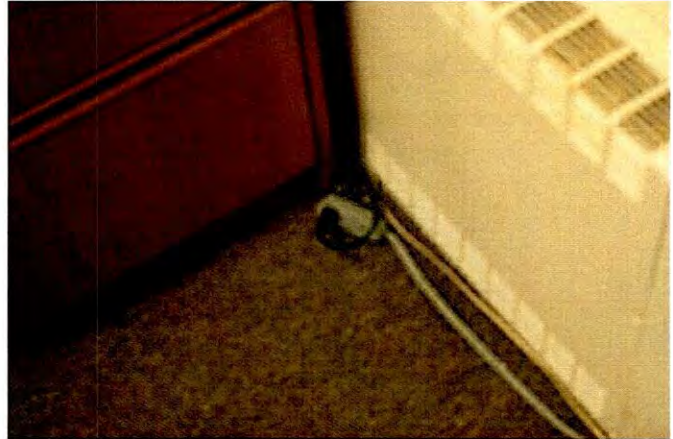
Copier room-extension cord was hot to the touch, extension cord unplugged at time of inspection. Copier shall be plugged into permanent wiring.

Office- extension cord cleared.

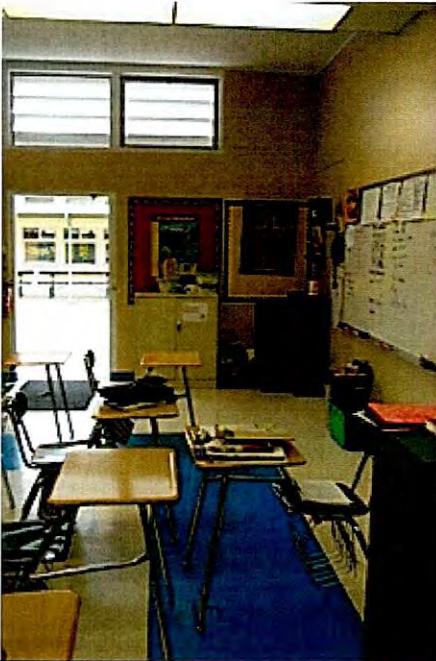
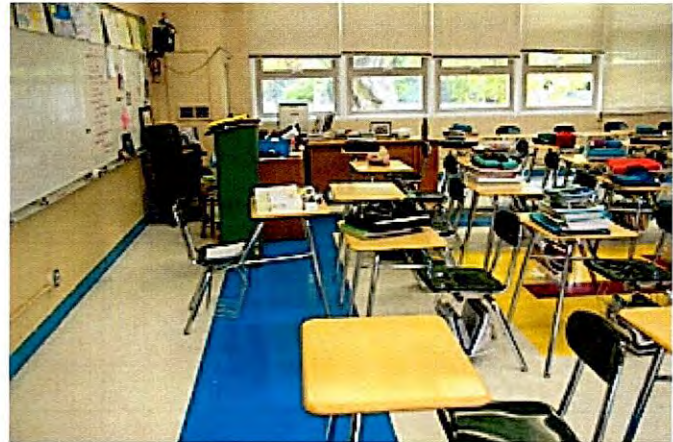
5th grade portable

**Status:** Deficiency

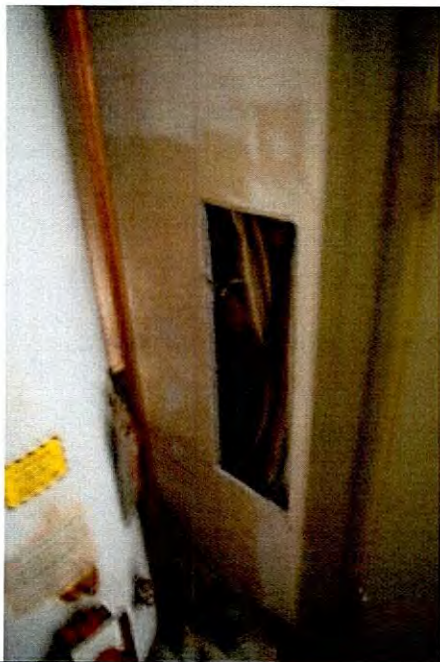
Whenever or wherever any device, equipment, system, condition, arrangement, level of protection, or any other feature is required for compliance with the provisions of this code, or otherwise installed, such device, equipment, system, condition, arrangement, level of protection, or other feature shall thereafter be continuously maintained in accordance with this code and applicable referenced standards.

**Status:** **Deficiency**

**Notes:** **Repair sheetrock in kitchen.**
