**PROPERTY CONDITION ASSESSMENT**

**Tiburon Baptist Church  
445 Greenwood Beach Road  
Tiburon, California 94920**

**June 26, 2023**

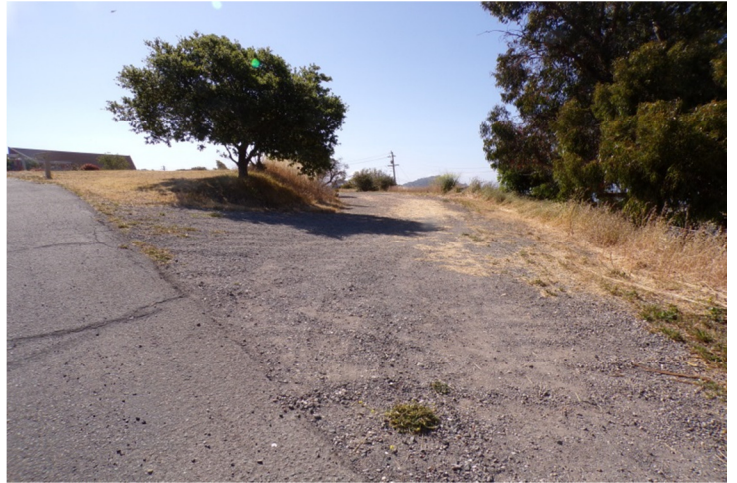
56. The gravel-paved areas will require periodic replenishment of gravel during the reserve term.

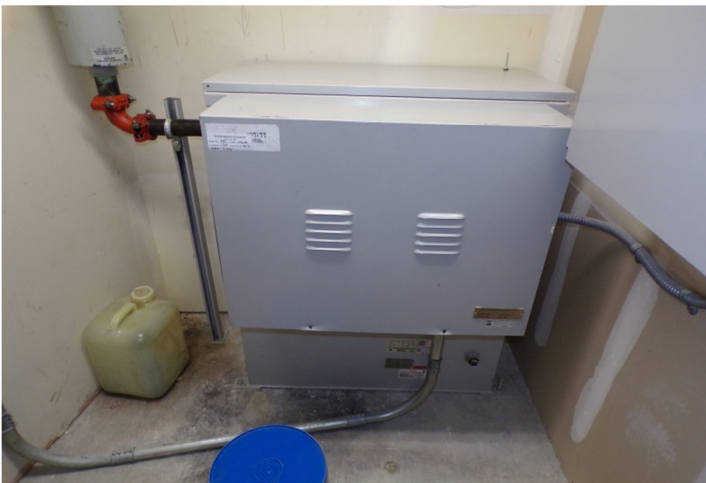
83. The last five-year hydraulic load test is current and was performed on October 31, 2019.
